**51 CRESSINGHAM ROAD, READING**

**BAT SURVEYS**

Report No: RT-MME-125512-01

Date: July 2017

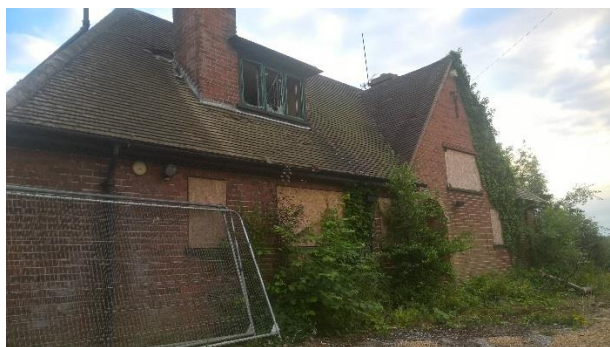
**Plate 4.1: Northern Elevation of Main House**

51 Cressingham Road is a vacant single-storey building. The structure is of brick construction with a hipped clay tiled roof (Plate 4.1). The roof supported four dormer windows and three brick chimneys which had been sealed to the main roof with lead flashing. Hanging tiles covered the sides of the dormer windows. The building has been subject to vandalism with all the dormer windows having been smashed so that only the wooden frames remained. The lower windows had been boarded up. Areas of the roof tiles had been damaged where vandals had attempted to access the roof to remove sections of the lead flashing (Plate 4.2).

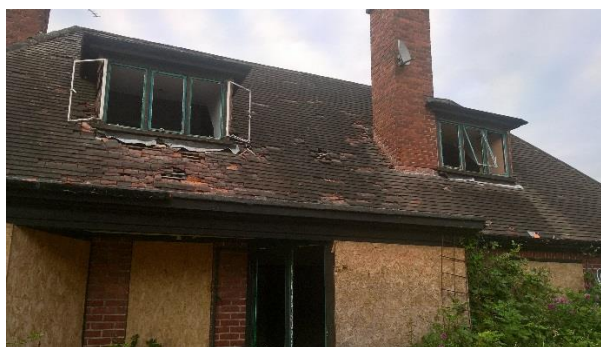
**Plate 4.2: Southern Elevation of Main House**

Numerous features were recorded around the building which could be utilised by bats to gain entry into the building and potential roost locations. These features included:

- Missing/damaged/slipped roof tiles.
- Gaps under the ridge tiles where the mortar is missing.
- Missing tiles around the dormer windows.
- Vent feature.
- Gaps behind the hanging tiles of the dormer windows.

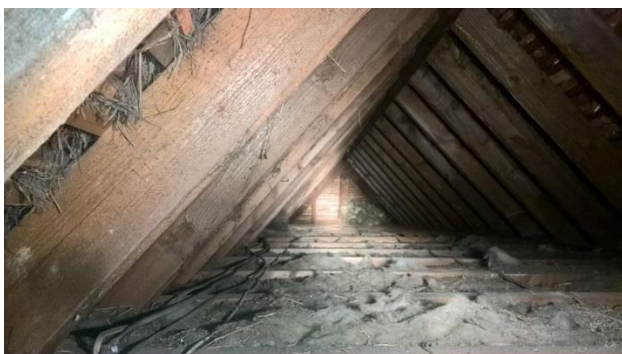
**Plate 4.3: Loft Space Within Main House**

The loft space was approximately 7 m long and 1 m wide. The roof tiles were fitted directly onto the timber rafters and beams (Plate 4.3). A ridge beam was present and the apex height was <1 m. Old loft insulation was present in some areas. The coomb space was of similar construction but lacked a ridge beam (Plate 4.4).

No evidence of bats (e.g. droppings, feeding remains, scratch marks or urine staining) was identified during the internal assessment. However, as detailed in Section 4.1.2 a full assessment of could not be undertaken due to health and safety considerations.

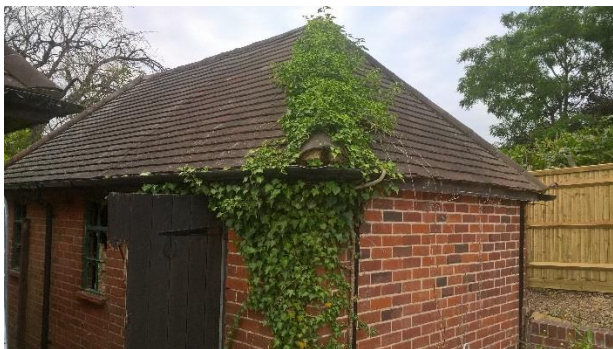
**Plate 4.5: Example of Damaged/Lifted Tiles**

The garage was located to the immediate east of the main house. This was a single-storey structure of brick construction with a hipped clay tiled roof. The garage had windows set in wooden frames and a wooden door. The windows had been smashed and the door was open providing direct flight access into the internal part of the building. The building was generally in good condition with only occasional lifted roof tiles noted (Plate 4.5). Vents were present on the southern gable end which were big enough to allow bats access into the building (Plate 4.6).

- Lifted roof tiles; and
- Air vents.

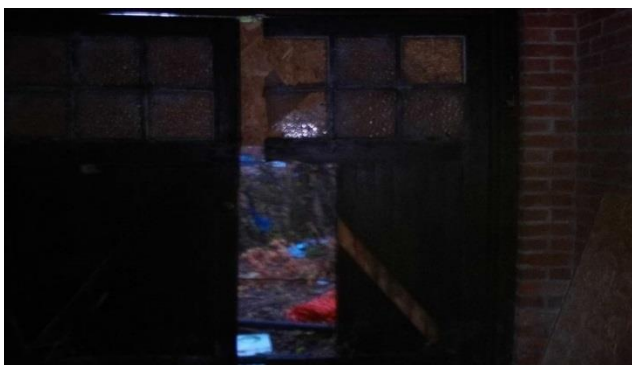
**Plate 4.7 Broken Garage Door**

Internally, the garage had two sections, the larger of the two contained two broken windows and door (Plate 4.7 and 4.8) The smaller of the two had a separate door with no windows. There were also wooden beams within the roof voids which were covered in cobwebs, and therefore there is no evidence of recent activity (Plate 4.9).

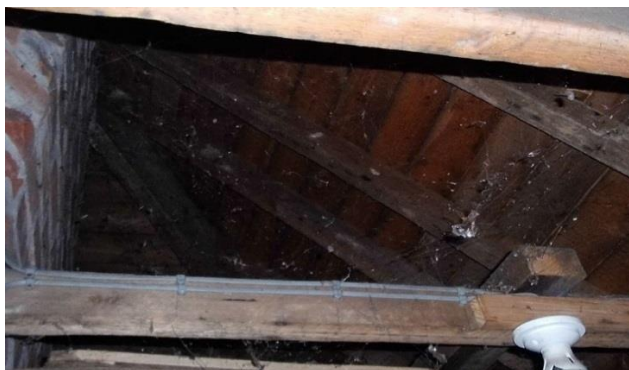
**Plate 4.9: Cobwebs and Beams in Roof Void.**

No evidence of bats (e.g. droppings, feeding remains, scratch marks or urine staining) was identified during the internal assessment of the garage.
