26<sup>th</sup> October 2015

Our Ref: RT-MME-120902

**Endoscope Survey – 51 Cressingham Road, Reading**

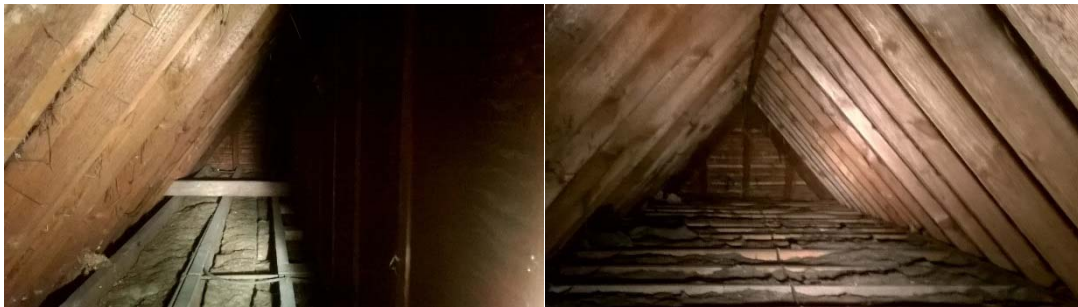
Access was provided to complete an internal inspection of the building. The roof space of 51 Cressingham Road had been converted to a number of loft bedrooms, with only two small unconverted loft spaces present (Plate 1). The larger loft space was approximately 7 m long and 1 m wide. The roof tiles were fitted directly onto the timber rafters and beams (Plate 2). A ridge beam was present and the apex height was <1 m. Old loft insulation was present in some areas. The smaller loft space was similar in structure but lacked a ridge beam. No potential access points for bats into the building were recorded. No suitable holes or crevices were found in the roof void which could be used by roosting bats. Therefore, these roof voids are considered to be of negligible potential to bats. No evidence of bats, e.g. droppings, urine staining, feeding remains or scratch marks, was recorded during the internal inspection of the building and all areas of the loft could be fully surveyed.

Old wasp nests were present in one of the roof voids. Rodent droppings were also present in small numbers on the floor of these loft spaces.

**Plate 1: Internal view of the unconverted loft spaces**

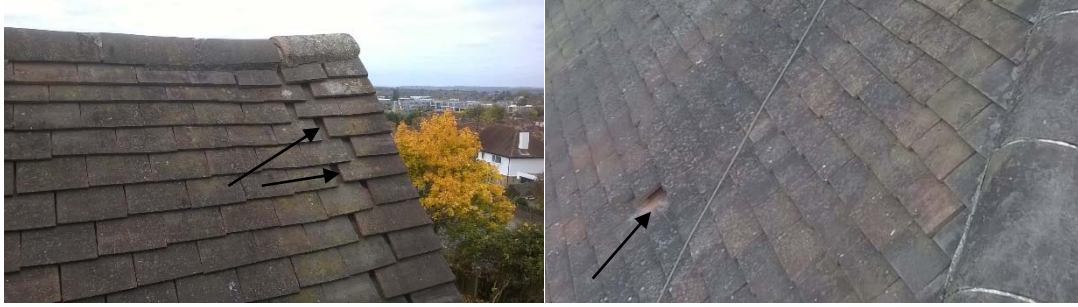
- Missing/broken roof tiles (Plate 3) – All areas of missing, broken or gappy roof tiles were fully inspected. These features did not provide roosting opportunities or ingress points into the roof space for bats and therefore were considered to be of negligible potential to bats.

**Plate 3: Missing/gappy roof tiles**

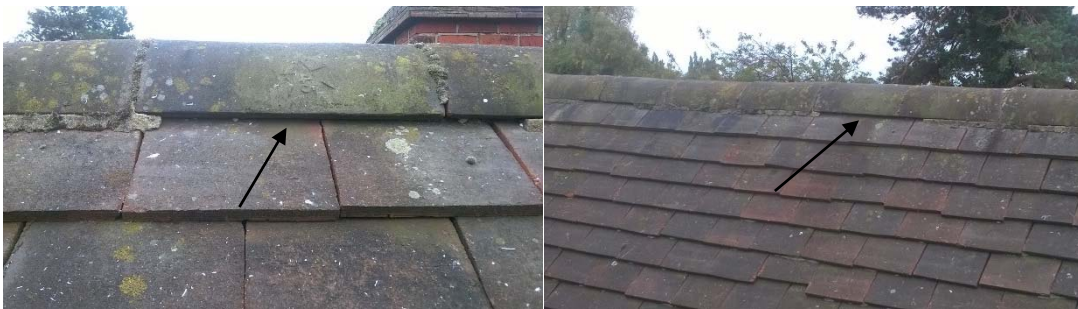
- Gaps under the ridge tiles where the mortar was missing – The majority of these gaps were too tight and not suitable for bats (Plates 4 & 5). Of those considered suitable (Plate 6), no evidence of roosting bats, e.g. droppings, urine staining, feeding remains or scratch marks, was recorded and these features could be fully inspected during the survey (Plate 5).

**Plate 4: Mortar missing under the ridge tile but no suitable gaps present**

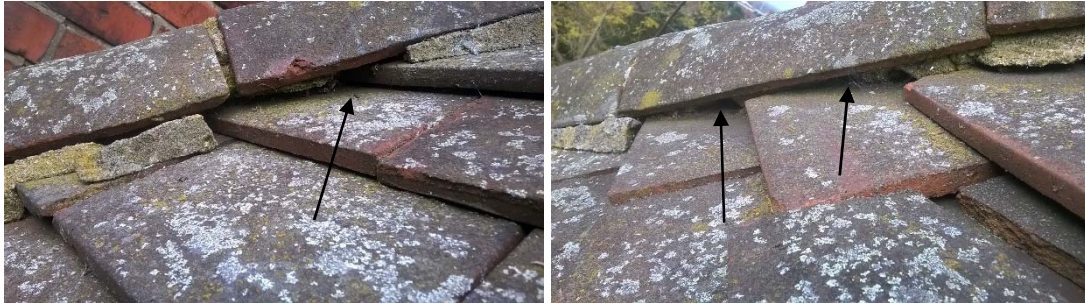
**Plate 5: Gap under the ridge tile with limited suitability for bats**

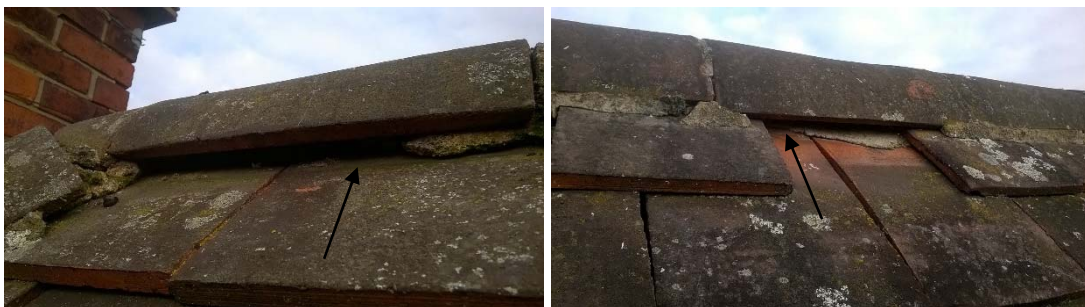
**Plate 6: Gap under the ridge tile suitable for bats**

- Two of the ridge tiles along the southern elevation (Plate 6).

51 Cressingham Road was fully inspected with the aid of a MEWP and an endoscope and no bat roosts were identified. The survey data obtained for the site is valid until September 2016. If the development works to the surveyed building have not commenced until September 2016, due to the presence of a number of suitable features, it will be essential to update the survey effort to establish if bats have colonised the buildings in the interim. This should be in the form of bat activity surveys. As one nocturnal survey was carried out in September 2015, at least one survey (consisting of a nocturnal emergence survey followed by a dawn re-entry survey within a 24 hour period) should be undertaken during the bat activity season to determine the presence/absence of roosting bats within the building. The bat activity season extends from May to September, with mid-May to August being the optimum survey period.

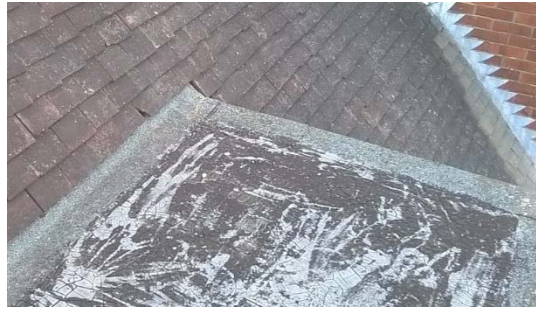
- Broken tiles around the dormer windows (Plate 7) – Closer inspection of these features confirmed that they do not provide roosting opportunities or ingress points into the roof space for bats and therefore are considered to be of negligible potential to bats.

**Plate 7: Broken tiles around the dormer windows**

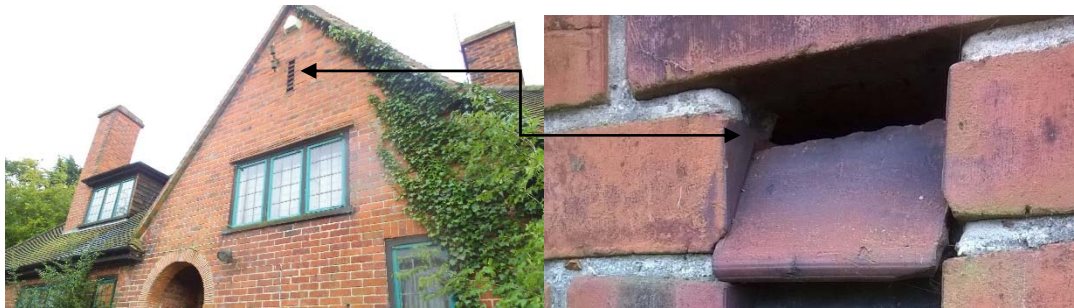
- Vent feature (Plate 8) – A vent feature was recorded in the northern gable-end of the building. This led to a horizontal cavity extending approximately 1 m. The western section of the cavity was filled with an old birds' nest. No roosting bats or their evidence was recorded within the eastern section of the cavity but it was considered to be suitable for roosting bats with access to this section provided through the slats of the vent.

**Plate 8: Vent feature providing access into a wall cavity**

- The cavity in the northern gable end (Plate 8);
- The gap under the tiles covering the dormer window located along the western elevation (Plate 9); and,

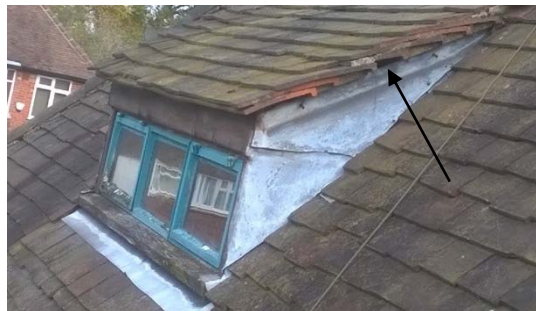
- Dormer window (Plate 9) – A cavity was recorded where the mortar between the roof tile and the dormer window was missing. This feature was considered to be suitable for roosting bats; however no signs of bats were recorded around and within this feature at the time of the inspection.

**Plate 9: Suitable cavity for bats under the dormer window roof tile**
