**51 CRESSINGHAM ROAD, READING**

**DAYTIME & NOCTURNAL EMERGENCE**

**BAT SURVEY**

Report No: RT-MME-120787

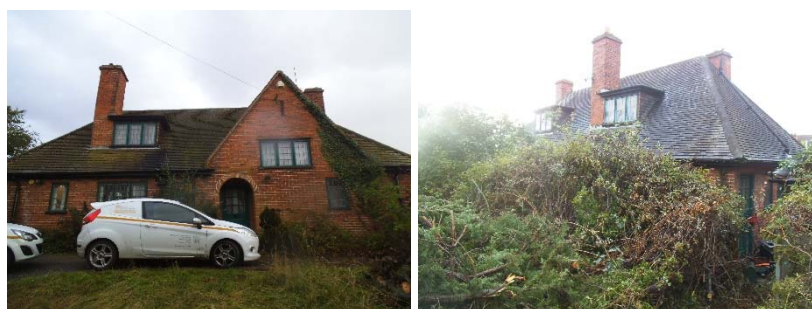
51 Cressingham Road is a single storey, occupied brick building with a hipped roof covered by clay tiles (Plate 3.1). A brick gable-end was also present along the northern elevation of the building (Plate 3.2). The brickwork was generally in a good condition with no suitable holes, cracks or gaps recorded for roosting bats. Whilst the majority of the roof tiles were in a good state of repair, a number of missing and broken tiles were recorded along the northern and southern elevations (Plate 3.3). Furthermore, a number of gaps were recorded below some of the ridge tiles where the mortar was missing (Plate 3.4). In the northern gable-end there was a vent feature which could potentially provide access into the roof space (Plate 3.2). It was not possible to inspect the features noted above due to the height at which they were located and as such it was not possible to establish if bats had used these features to enter a roost location at the time of surveying.

**Plate 3.1: View of 51 Cressingham Road (right – southern aspect, left – northern aspect)**

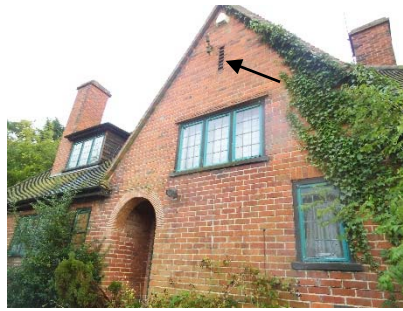
**Plate 3.2: Brick gable-end in the northern elevation with potential access point into the building for bats through the vent**

- Missing roof tiles (Plate 3.3).
- Gaps under the ridge tiles where the mortar is missing (Plate 3.4).
- Missing tiles around the dormer windows (Plate 3.6).
- Vent feature (Plate 3.2).
- Gaps behind the hanging tiles of the dormer windows (Plate 3.5).

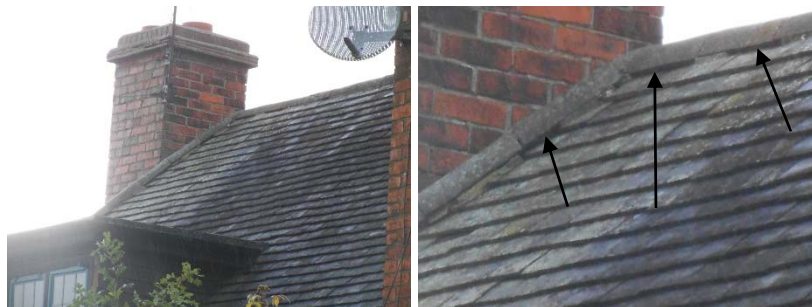
**Plate 3.4: Missing mortar under ridge tiles**

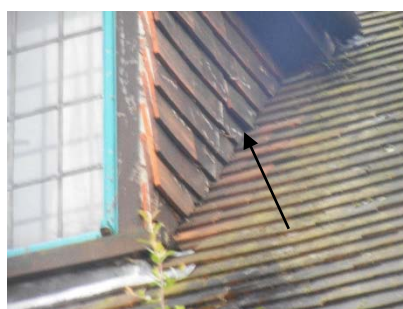
A total of four dormer windows were present along the northern, southern and western elevations of the building. Hanging tiles covered the sides of the dormer windows which were in good condition and were tightly fitted with the exception of one hanging tile with a gap behind (Plate 3.5). In addition, missing tiles were recorded at the junction of the dormer window with the roof (Plate 3.6). Due to the height and location of these features, it was not possible to inspect them and as such it was not possible to establish if bats had used these features to enter a roost location at the time of surveying. A total of three brick chimneys were recorded with tight lead flashing around their base along the northern, western and southern aspects of the building (Plate 3.7). The windows present were also set tightly in their frames with no gaps recorded around them. A wooden soffit box was present in the eaves which was in a good state of repair.

**Plate 3.5: Gap under the dormer window hanging tile**

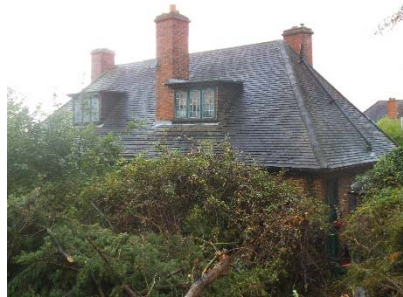
**Plate 3.7: Location of the brick chimneys**

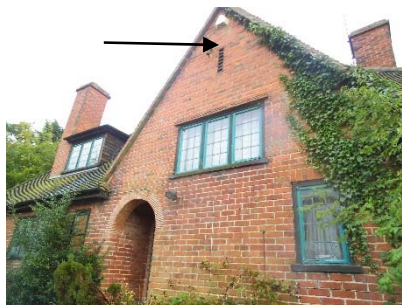
No internal access was provided at the time of survey. However, due to the presence of dormer windows, it is likely that no loft void is present and these spaces have been converted to rooms. Presence of a small roof void could however not be discounted where the brick gable-end was located in the northern elevation (Plate 3.8). The surveyors were however informed that no loft hatch providing access to this area was present.

**Plate 3.8: Location of a potential roof void**
