## **PRELIMINARY BAT SURVEY AT 140 KIDMORE END ROAD EMMER GREEN**

**Prepared for:  
Mr T Edwards  
140 Kidmore End Road  
Emmer Green  
Berkshire  
RG4 8SP**

**6<sup>th</sup> October 2016**

**Ref: SPH/PBS-01/06.10**

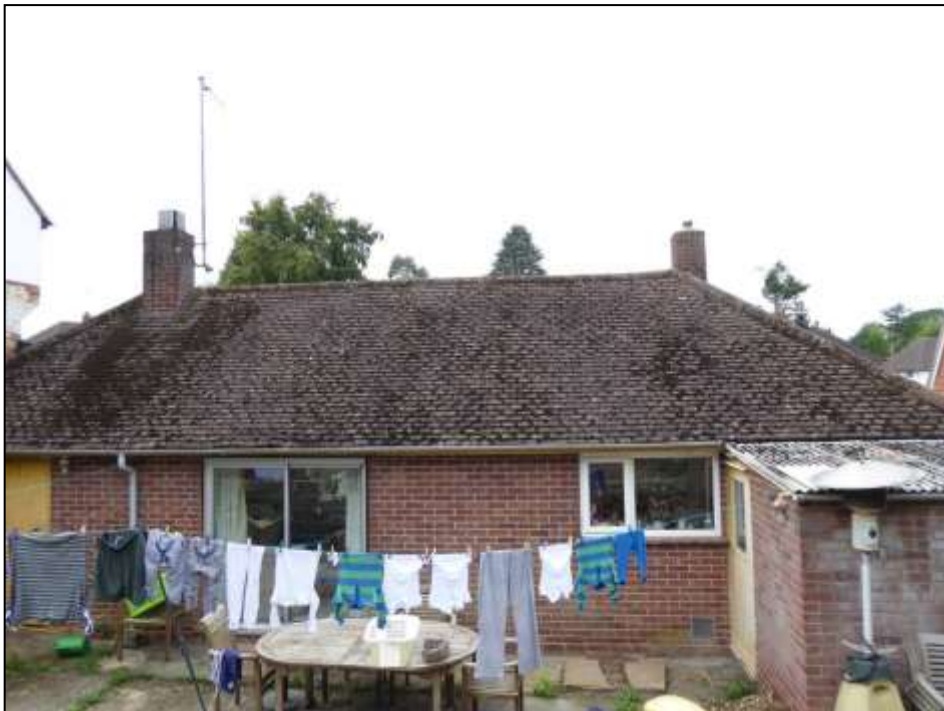
Figure 3. Rear of property, 140 Kidmore End Road, Emmer Green. 06.10.16.

The application site comprises a single storey detached brick built bungalow, with an attached brick built garage to one side. The property is set on a modest plot, with a mature garden which is tiered to the rear and is mainly laid to grass and mature shrubs, see Figure 3 below.

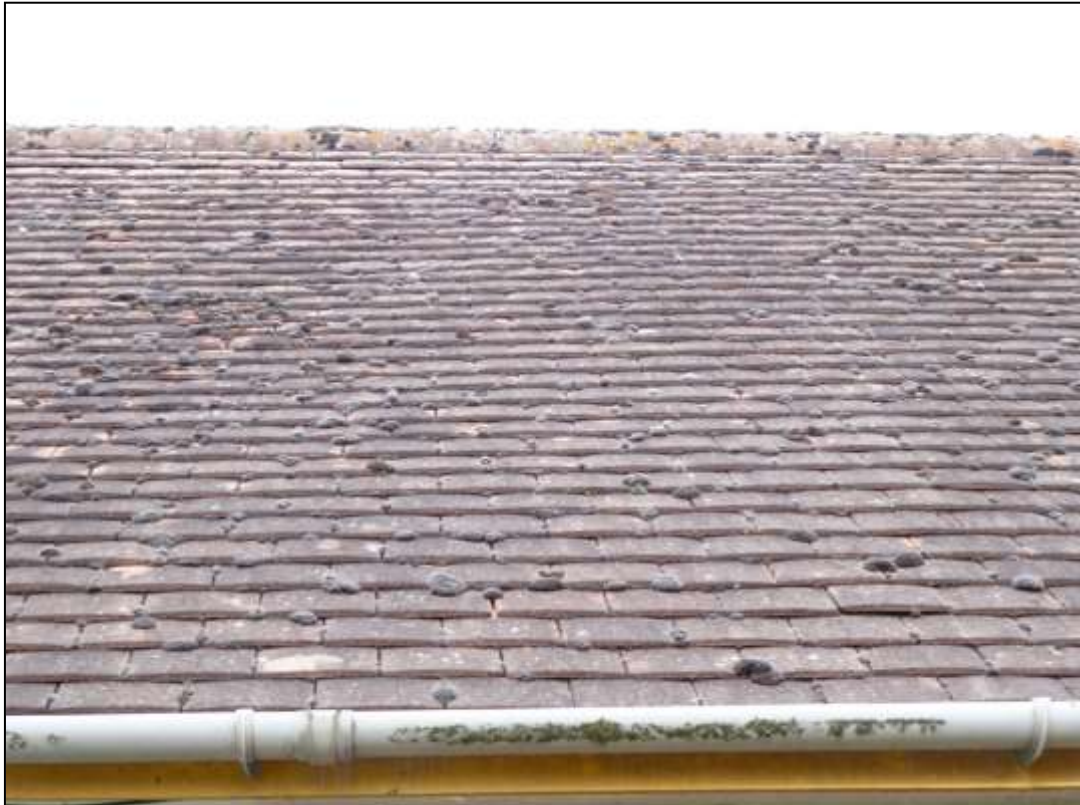
Figure 4. Example of roof structure, 140 Kidmore End Road, Emmer Green. 06.10.16.

The main property has a traditional pitched roof with clay tiles, see Figure 4 on page 8. The roof covering is in a satisfactory condition across the main pitched areas, with slight gaps around the chimney tiles suitable for crevice dwelling bat species to roost, see Figure 5 on page 8. The ridge is in a fair condition, with the verges containing some gaps suitable for crevice dwelling bats. There are numerous missing and broken hanging tiles on the front gable end of the building and gaps within the hanging tiles on the canopy over the front door which could be utilised by crevice dwelling bat species, see Figure 6 on page 9. The soffits require some paint work but are otherwise in a good condition with no gaps, see Figure 7 on page 9.

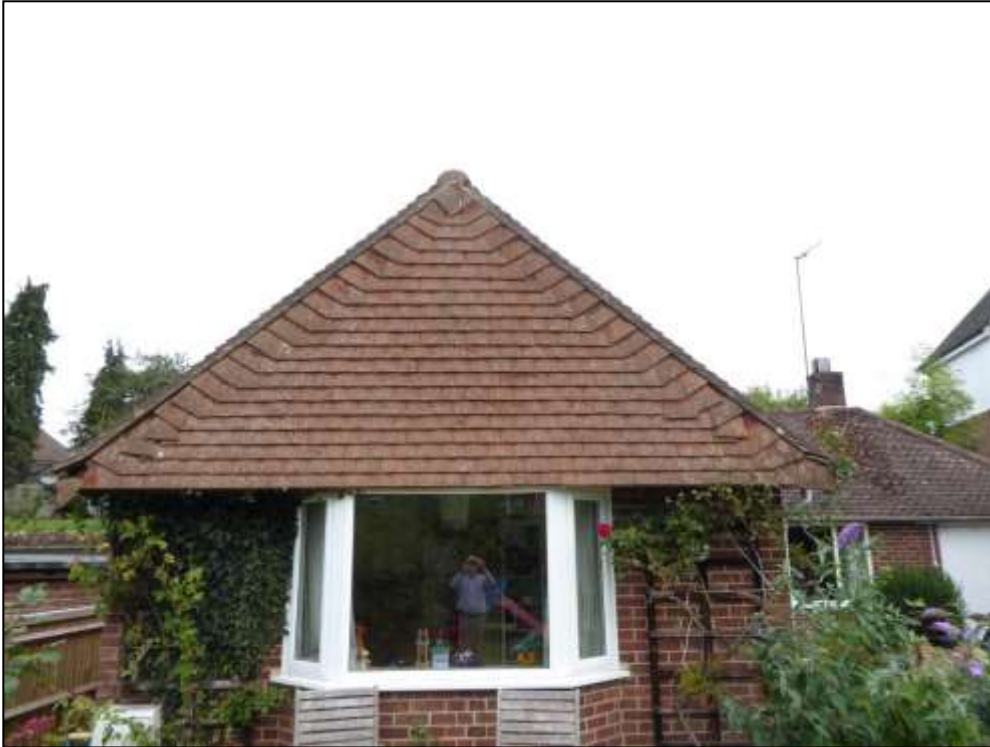
Figure 6. Hanging tiles, 140 Kidmore End Road, Emmer Green. 06.10.16.

The building was found to be in a satisfactory condition, however there were numerous gaps within the tiles on the roof and hanging tiles on the gable end which could provide potential roosting opportunities for bats. A number of bat droppings were recorded within the loft during the internal inspection, suggesting bats are using the loft for roosting.

Based on the above, it is recommended that three further dusk emergence and/or return to roost surveys are undertaken between May and August inclusive, to assess the current status of roosting bats within the building in order to inform appropriate mitigation for the proposed works.

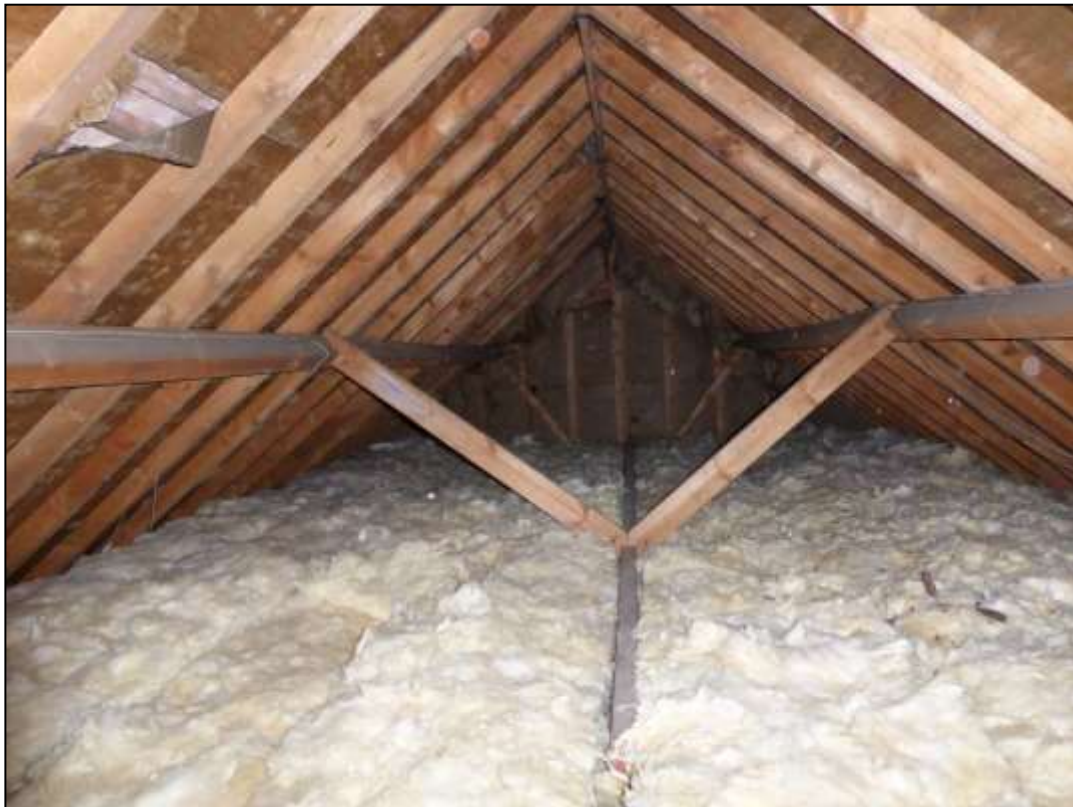
Figure 8. Example of loft space, 140 Kidmore End Road, Emmer Green. 06.10.16.

The loft was accessed via a hatch in the garage. It was well lit, insulated and partially boarded, see Figure 8 below. Light was found to spill into the loft through gaps within the roof when the hatch was closed. The tar lined paper was in poor condition and torn in numerous places especially at the front gable end of the property, see Figure 9 on page 11.

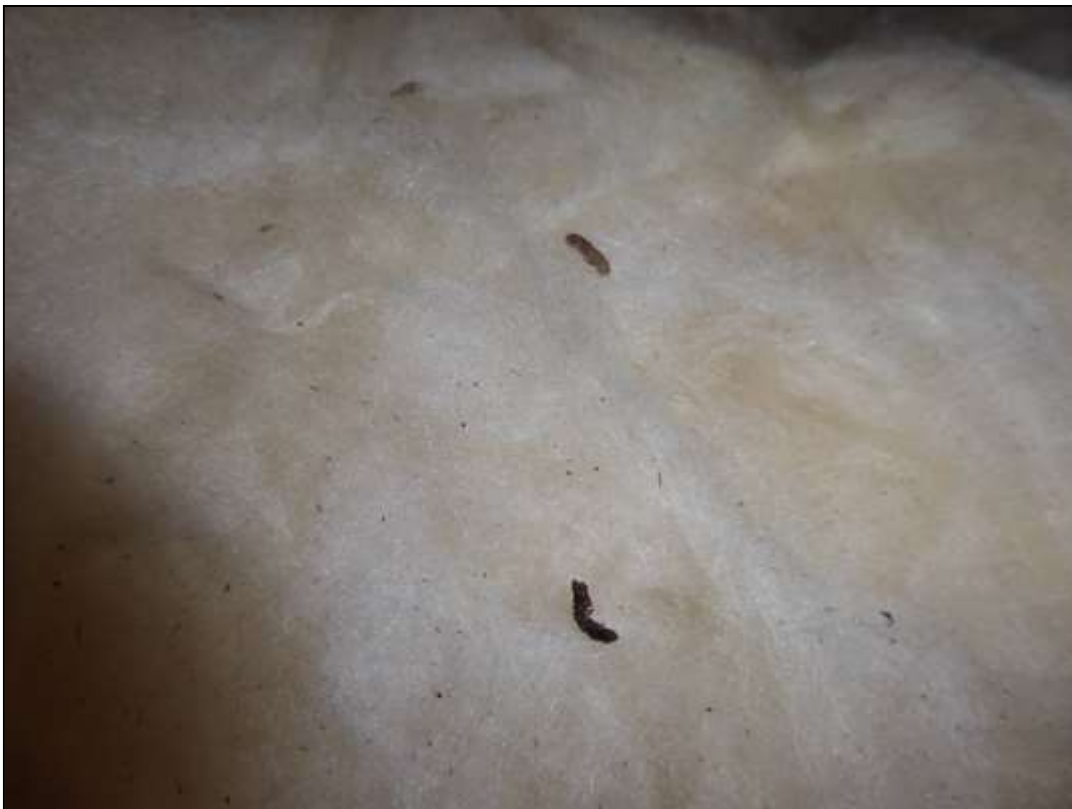
Figure 10. Example of bat droppings, 140 Kidmore End Road, Emmer Green. 06.10.16

Large, individual bat droppings were found scattered across the loft from the chimney stack near the hatch to the opposite end of the loft, see Figure 10 on page 11. Some droppings were also found under the newly laid insulation, indicating occupation of bats over a prolonged period. The accumulations of droppings suggest only low numbers of bats are using the loft for roosting.
