**Phase I Desk Study Environmental  
Assessment**

**Cadogan House, Rose Kiln Lane, Reading,  
RG2 0HP**

**Delta-Simons Project No. 13-0223.01**

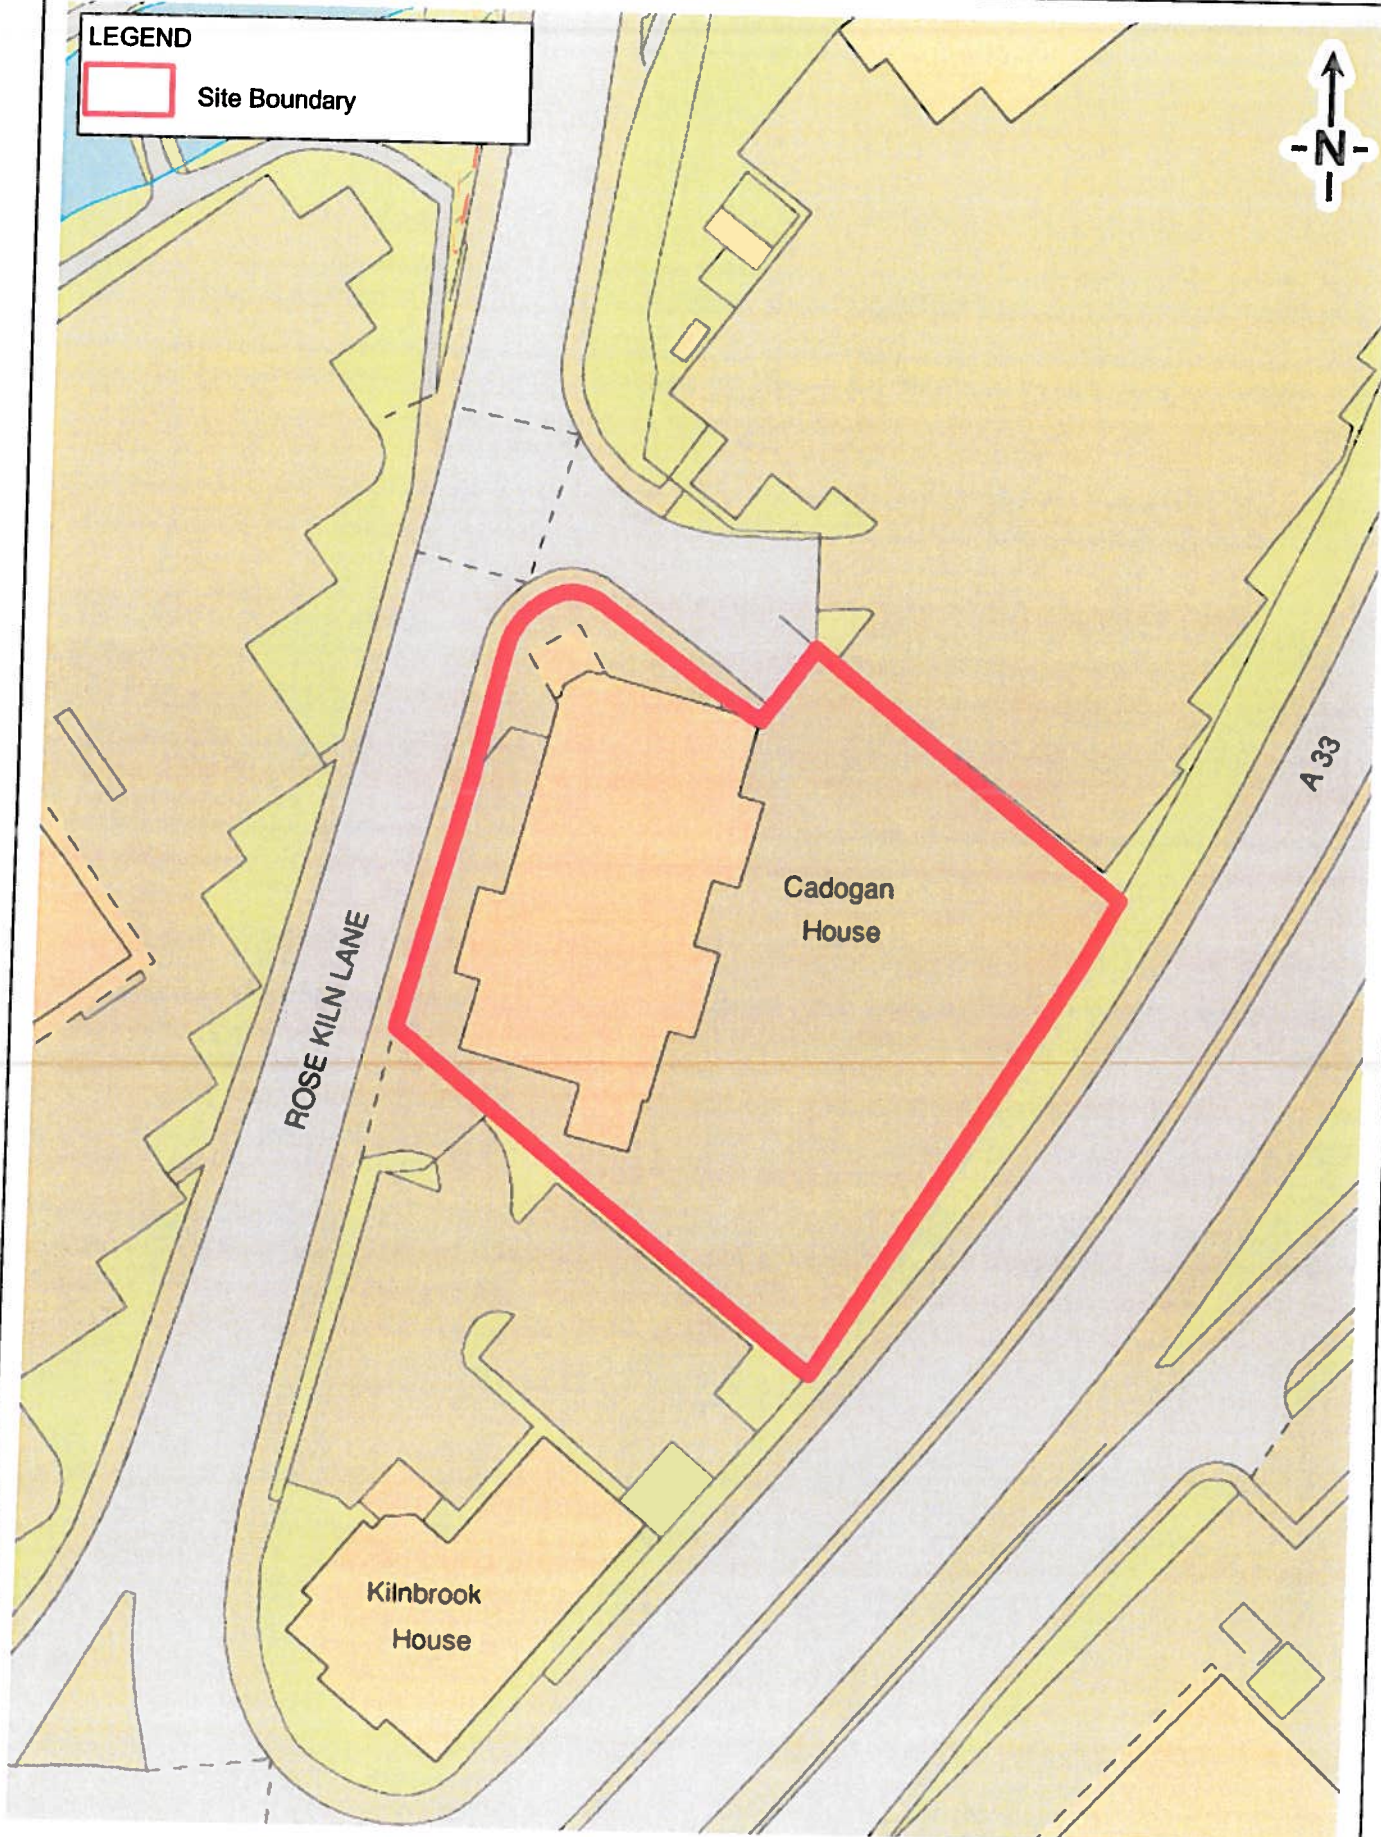
| FIGURE NO: | 2 |

**TITLE**  
Site Layout Plan  
Cadogan House, Rose Kiln Lane  
Reading
