# **Arboricultural Impact Assessment**

## **East MRT, Reading**

**Report Reference Number:** 170608-1.1-EMRTR-AIA-MW

**Peter Brett Associates LLP**

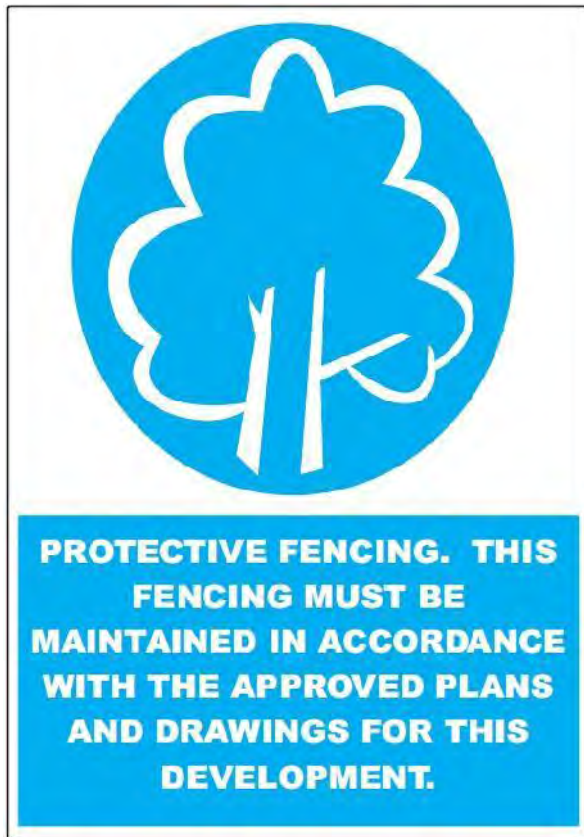
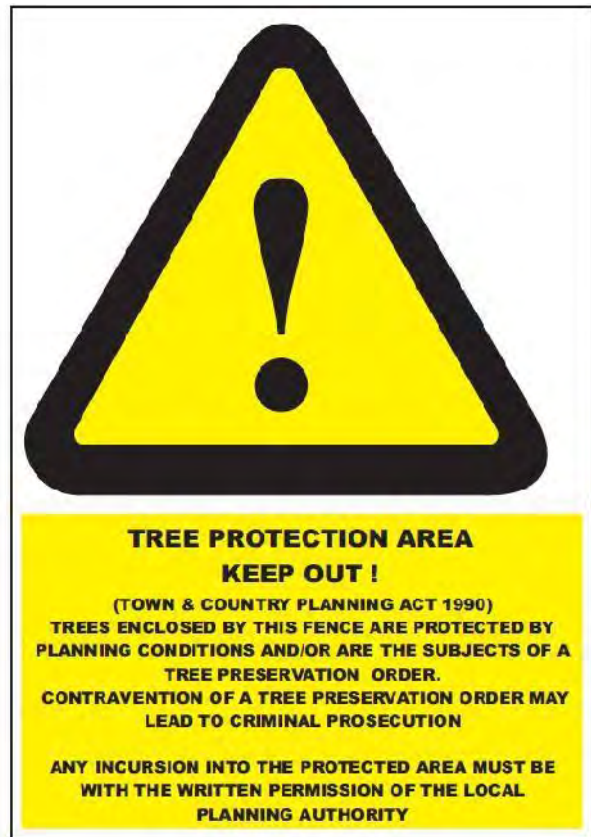
Example Tree Protection Fencing Sign

- o The CEZ will be clearly identified (see Construction Exclusion Zone sign example below)
