# Bat Survey Report

## *Reading Community Church, Oxford Road, Reading*

Project Number: P2894.1.0

Date: 30 June 2017

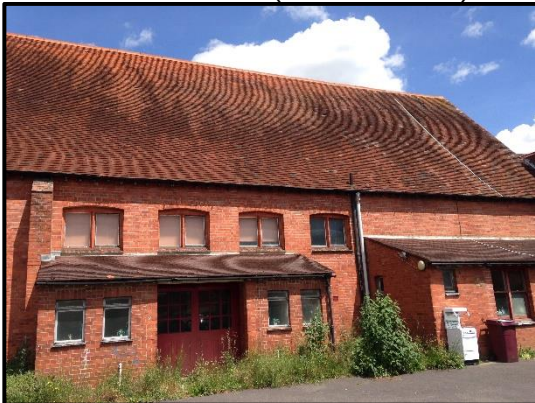
The church was built in 1899. It was a one storey building c. 22m long x 10m wide x 16m tall, with a pitched roof, red brick walls, flat clay tiles and a clay tile ridge. There were wooden eaves and a brick parapet at the western gable. All brickwork, ridge, eaves, gable ends and lead flashing were intact and sealed. Most of the roof tiles were intact and sealed, although several tiles were missing on both the northern and southern elevations. A large slatted vent was noted on the southern elevation but this was found to be sealed behind the slats and heavily cob-webbed.

**Photo 1:** Church (south elevation).

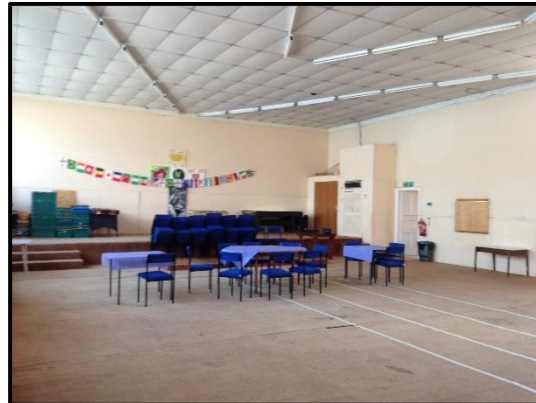
Internally, the church comprised one large space with several small rooms to the south (single-storey extensions). The main room had a suspended ceiling, but was seen to be vaulted and sealed with boarding above the main roof trusses. There was no ridge board, and no gaps / recesses for bats to use.

**Photo 2:** Church interior.

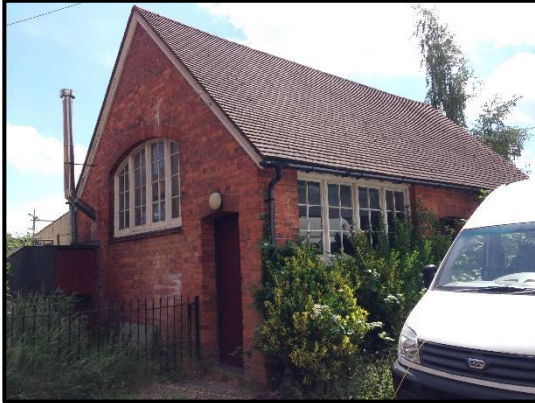
The small church hall was a red brick building likely to have been built in the same era as the church. The hall had a pitched roof clad in flat clay tiles with clay ridge capping. There were wooden overhanging eaves and wooden fascia boards at the gable ends. All brickwork, ridge capping, eaves / fascias and gable end tiles were intact and securely sealed. All doors and windows were intact and sealed. Only two roof tiles were missing from the eastern roof slope, however these were very shallow and unsuitable for bats.

**Photo 3:** Church hall (west elevation).

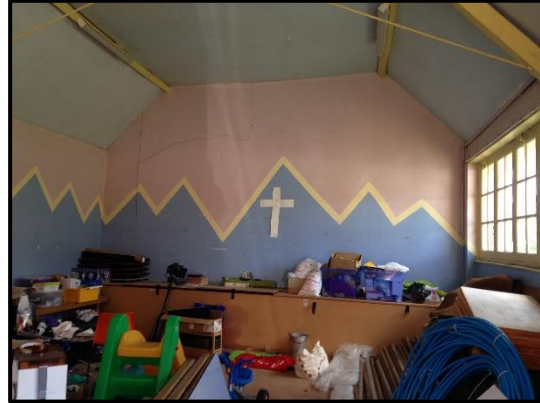
The interior of the small hall was one open space with a vaulted ceiling that was sealed with boarding above the main roof trusses. There was no ridge board, and no gaps / recesses for bats to use.

**Photo 4:** Out-building interior.

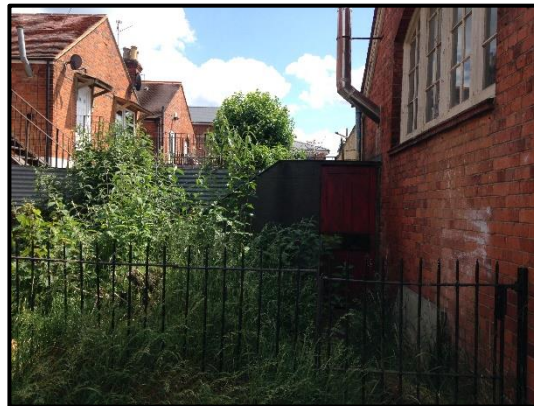
An underground cellar adjoined the north side of the church hall (**Photo 5**). Above ground, the cellar was single skin overlain with felt with a wooden door. The doorway led to an underground storage space. No daylight could be seen from within the cellar and no access suitable for bats was noted.

**Photo 5:** Cellar access which adjoins the Church Hall.
