## Visual Bat Survey Report

**117 Whiteknights Road, Reading RG6 7BB**

March 2017

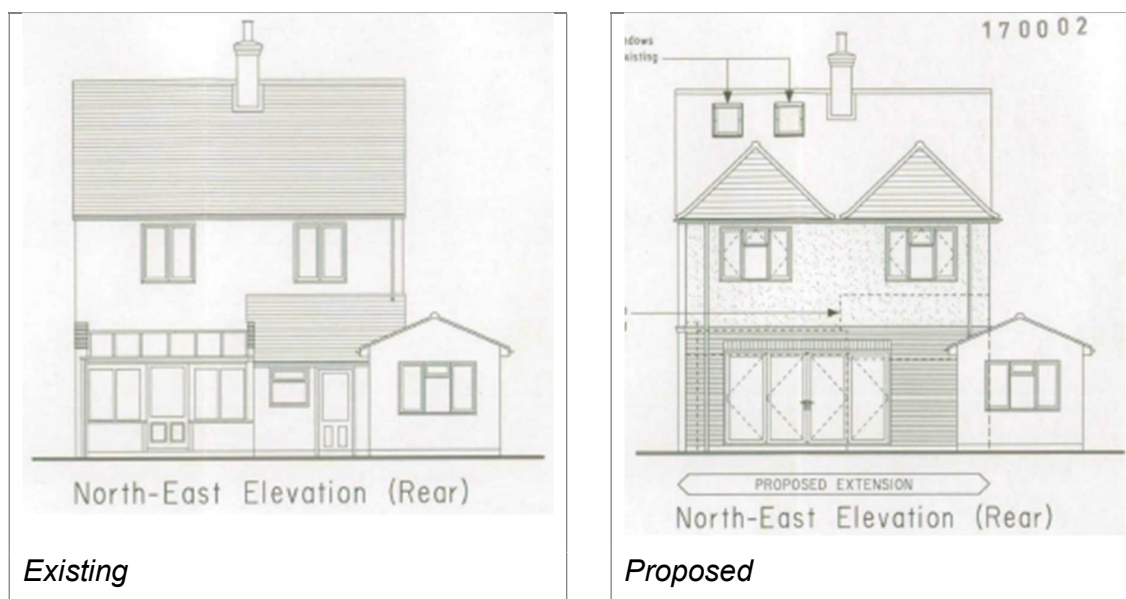
Figure 1 shows existing and proposed rear elevations.

**Figure 1 – Existing and Proposed rear elevations**

It is proposed to extend the existing house through the addition of a new ground and first-floor extension to the rear elevation following demolition of the conservatory and single storey lean-to extension. The proposals will also introduce two small Velux-type

rooflights into the loft to provide sealed light wells down to the first floor bedroom. The loft itself is not being converted and the new light wells will not introduce light into the loft itself.

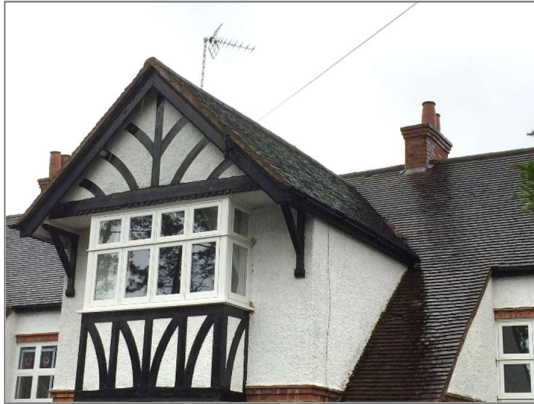
The tiled roof was in good general condition with no obvious damage to tiles or slipped roof tiles. However, the clay tiles are of a type that typically results in the presence of small gaps through the natural manufacturing process and as the tiles settle on the timber roof frame once the house has been constructed.

As a result, there were several areas of the roof faces where gaps were noted that appeared to offer potential points for bats to gain access (see Photos 1 and 2). The rear of the house presented fewer access opportunities, possibly as this is of simpler dimensions with less complexity, resulting in less opportunity for gaps between tiles to be present. The ridge tiles were well-mortared and the soffits were in good condition and tight to the external walls with no gaps noted (see Photo 3). The tiles to the small rear lean-to extension were similarly in good condition (Photo 4).

**Photo 1** – Tiles to front of house

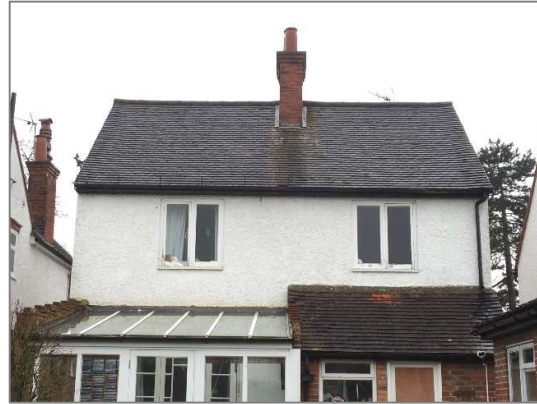
**Photo 2** – Rear of house

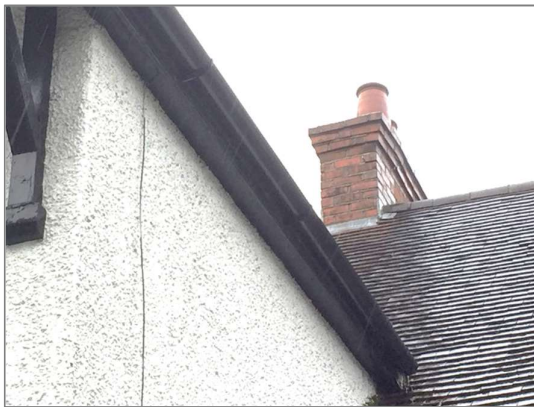
**Photo 3** – Soffits on good condition

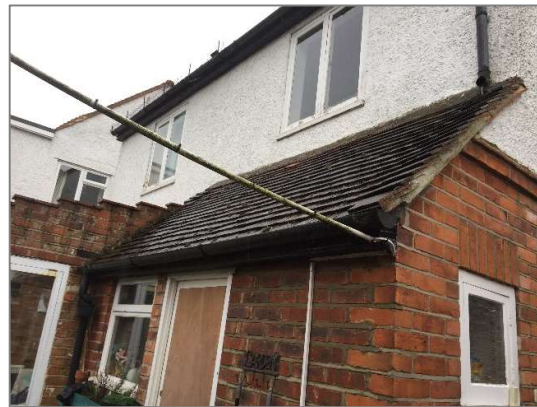
**Photo 4** – Rear lean-to extension

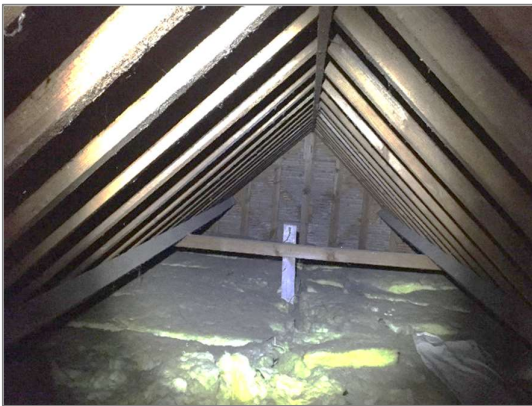
There are two ridge lines to the loft – one running along the width of the house north west to south east, and one running forwards to the front gable. There is a small amount domestic storage to the centre of the loft near the access hatch, but most of the loft was clear. There was generally a moderate level of dust and wind-blown debris in the loft due to the unlined nature of the roof tiles (Photos 7 and 8). Much of the loft had moderate cobwebs to it, and extensive cobwebs were present along much of the main ridge, at the two side gable apexes, and around chimney breasts (Photos 9 and 10).

**Photo 7** – General conditions of loft

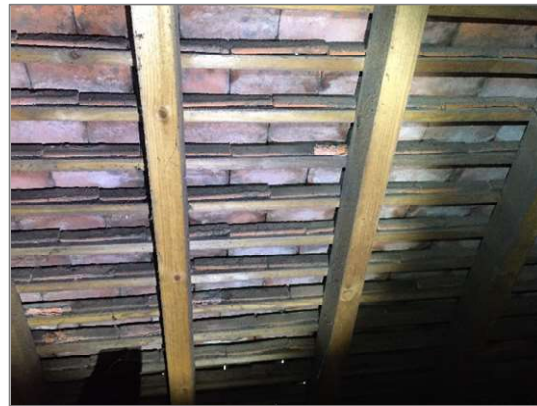
Internally, the loft is of traditional timber joist and rafter construction. There is a layer of mineral wool insulation. The roof tiles are unlined.

**Photo 8** – Roof tiles unlined

The loft in general was noted to be draughty due to the lack of a lining membrane.

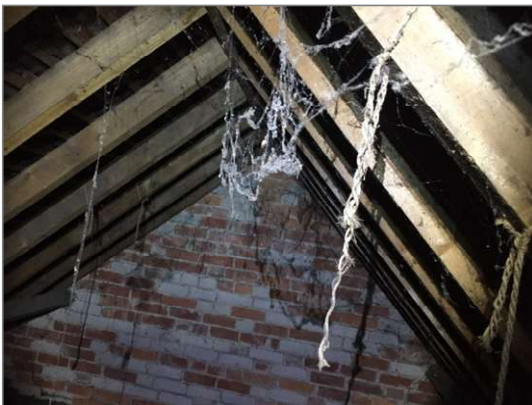
**Photo 9** – Cobwebs to ridge (looking south east)

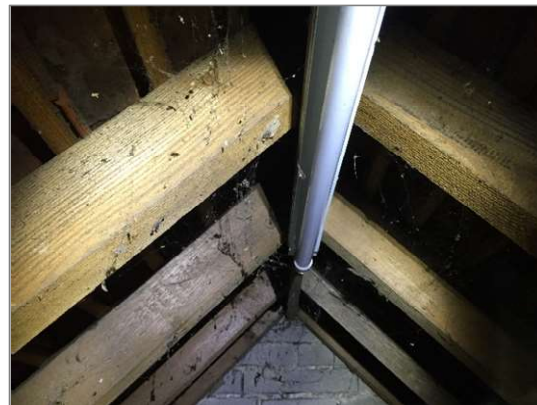
**Photo 10** – north west gable apex

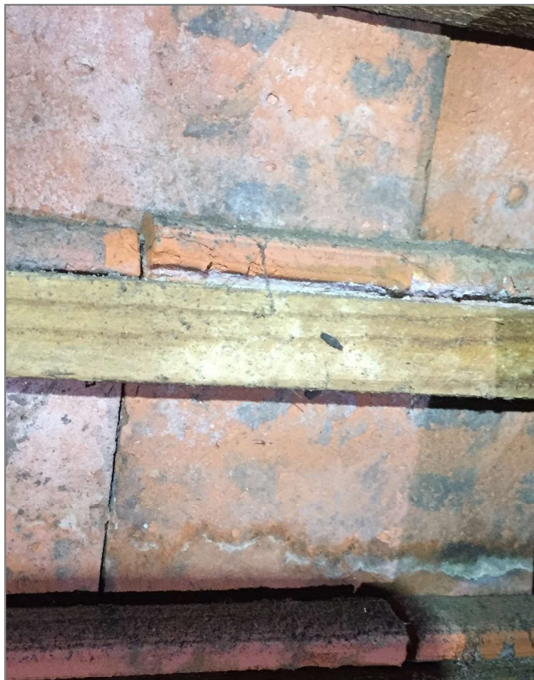
A small collection of approximately 10 pipistrelle-type droppings was found around halfway along the front gable projection, on the south-east side. A small number of these droppings were found close together adhering to the underside of the unlined roof tiles, battens and rafters (Photos 11 and 12), with the rest found in a loose group on the loft insulation below these. These droppings appeared somewhat fresher, retaining their integrity and with no apparent dust covering.

**Photo 11** – Bat dropping to tile batten

Based on the location and quantity of droppings, it is considered that at this point there is an occasionally-used roost for a single pipistrelle bat, which is gaining access through a gap in the tiles and roosting along the underside of one of the tile battens where this meets the tile.

- Accidental damage / modification of the roost will be avoided through the erection of a temporary partition of rough plywood across the existing rafters that are present between the two areas of the loft as shown in Figure 5, below. This barrier will be removed upon completion of the works.

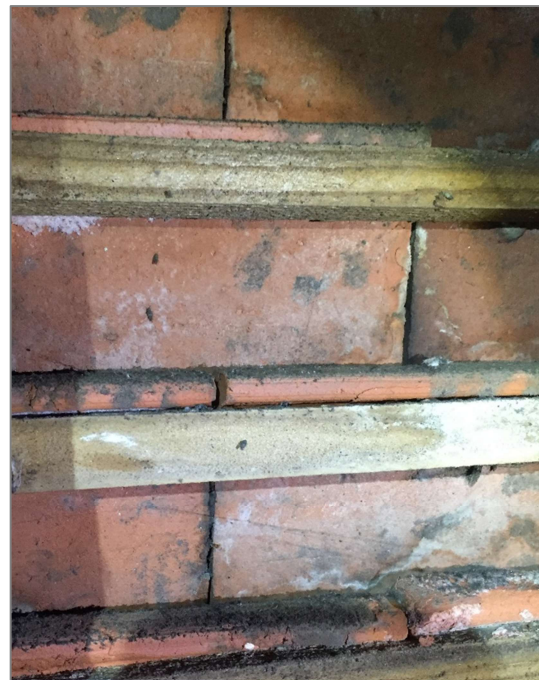
**Photo 12** – Bat droppings to underside of tiles
