Handrail and stone step scope of works

13/10/2017

Flat A, 6, Bath Road, Reading, Berkshire, RG1 6NB

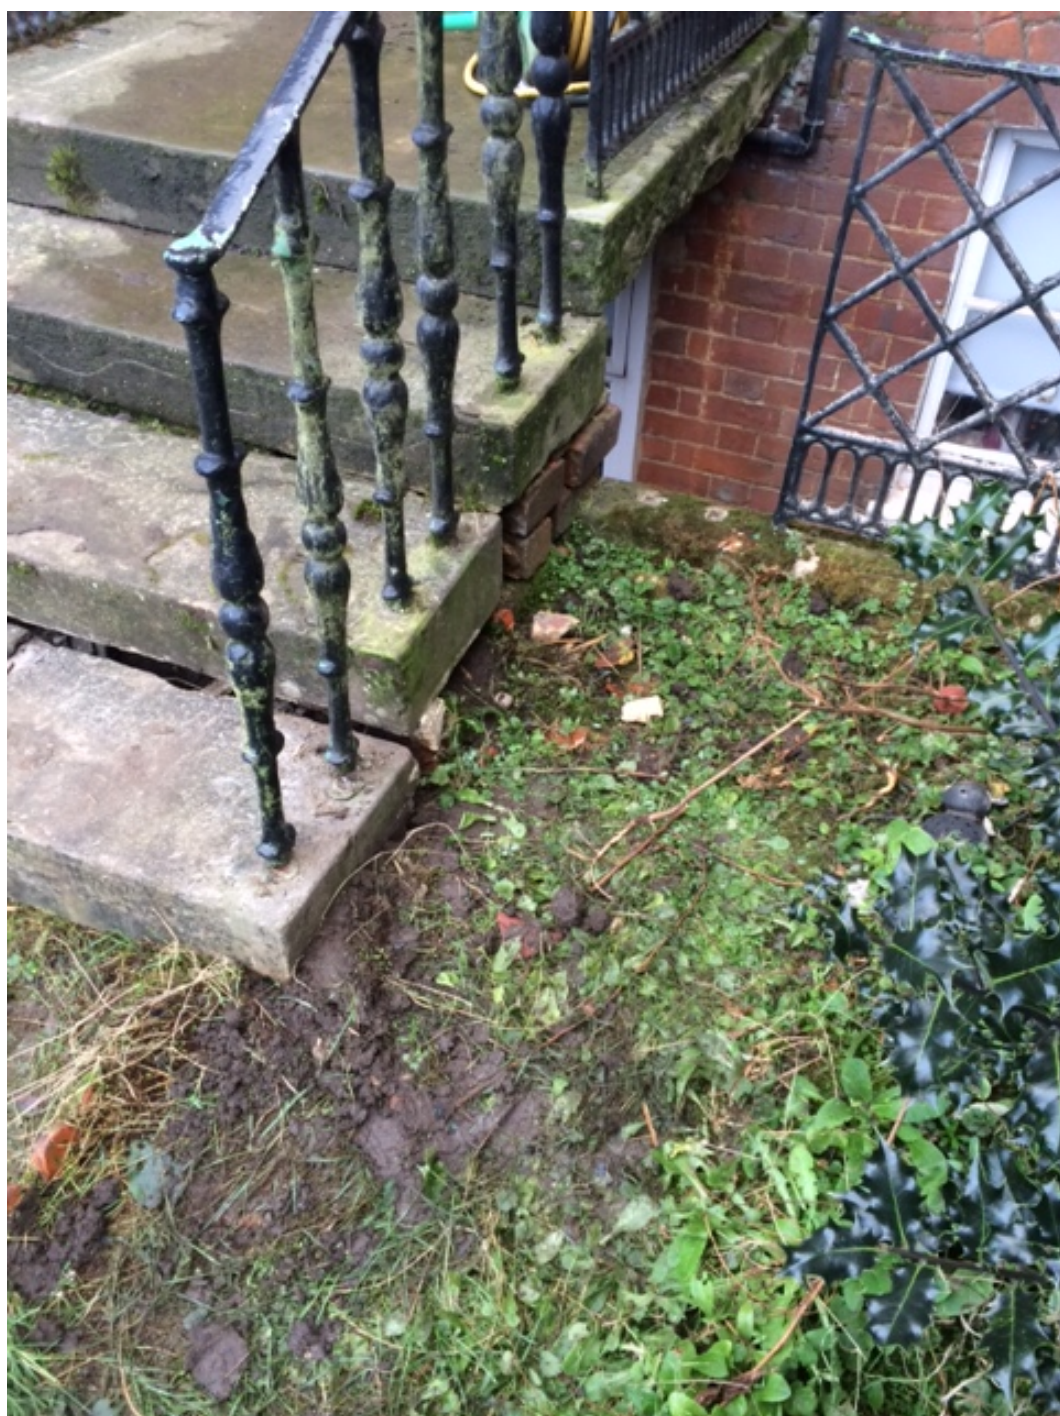
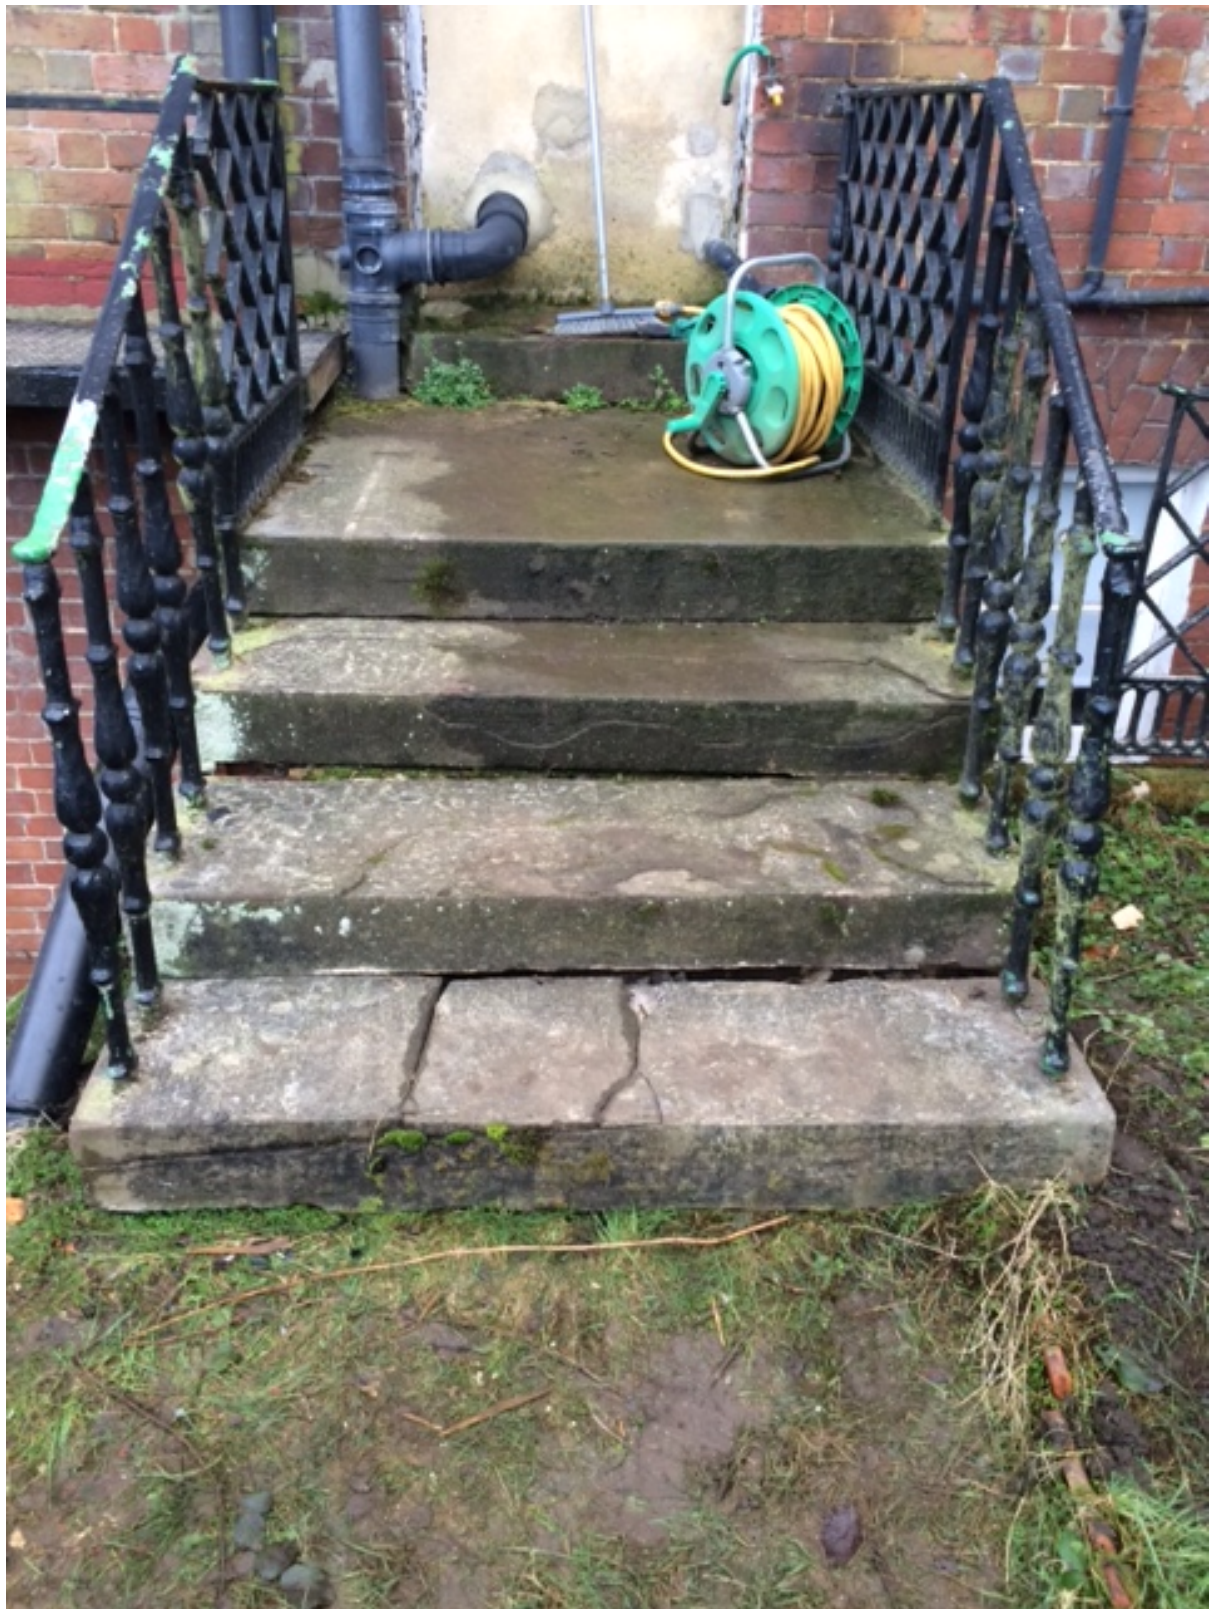
Flat A forms the ground floor of no. 6 Bath Road which with its neighbour, no. 4, comprises a large 4 storey early 19<sup>th</sup> century block. Flat A, benefits from the full ownership of the rear garden which is accessed via an existing metal balcony and associated stone steps which bridge over the full width basement light well created by an existing retaining wall from which the steps derive some support. The existing balcony has not historically been well maintained and is in poor condition with large areas of rust being evident. Furthermore the balcony is supported by metal brackets built out from the rear wall of the building and at the point of contact with the face brickwork there is significant cracking in the masonry which clearly demonstrates the unsound nature of the balcony above. The upper section of the retaining wall also shows evidence of deterioration of the masonry which casts doubt upon its long term structural integrity to both retain the ground beyond and support the stone steps above. The metal balcony has been deemed by a structural engineer to need urgent replacement. Due to the structural uncertainty of both the balcony and stone steps, the garden has been left overgrown and provides limited opportunity for use until remedial works have been approved and completed.

- 1) Take full dimension's..
- 2) Looking at the house from the garden we will remove all the right had side of the railings starting from the brick wall and down to the bottom of the last step
- 3) On the same view, the railings will be removed from the first post which joins to the steel platform, down to the bottom of the left step.
- 4) In order to remove all the railings we will cut flush at step level the railings fixings where to tong is fitted into the stone step, the wall fixing will be drilled out for removal.
- 5) Send all the railing to Cast Iron Welding for restoration work.

- 1) The steps will be will be removed leaving the top plinth in its already supported position.
- 2) Remove all the hard core material from under the steps and reset the steps with a brick foundation, it may be possible for the loose brick work which is already in the garden to be reused under the steps.
- 3) Screen off the top plinth on both sides to prevent anyone falling off the plinth, leave the site ready for the steps to set.

- 1) Receive all the railing sections and blast clean
- 2) Dismantle the railings and manufacture any missing sections, gas weld the new sections to all the cracked and broken pieces and gas fusion weld approximately 14 tong fittings on the end of each post for refitting into the steps.
- 3) Hand paint with black sheen paint for sending to site.

- 1) Drill out the original cut flush tong fittings that were originally used to fix the railings into the steps
- 2) Fit the railing into the newly made holes and grout into position with a similar colour match as the pavement.
- 3) Fit the railing section into the wall aperture and fix with grout and leave to set
- 4) Connect the railing with bolt fixings and arc weld any areas that require a cosmetic fixing.
- 5) Complete with touch up paint work.
- 6) Leave site tidy
