## **ECOLOGICAL SURVEY REPORT (BATS) AT 11 DARELL ROAD CAVERSHAM**

**Prepared for:  
Mr H Pringle  
11 Darell Road  
Caversham  
Reading  
RG4 7AY**

**31<sup>st</sup> August 2017**

**Ref: SPH/BAS-01/31.08**

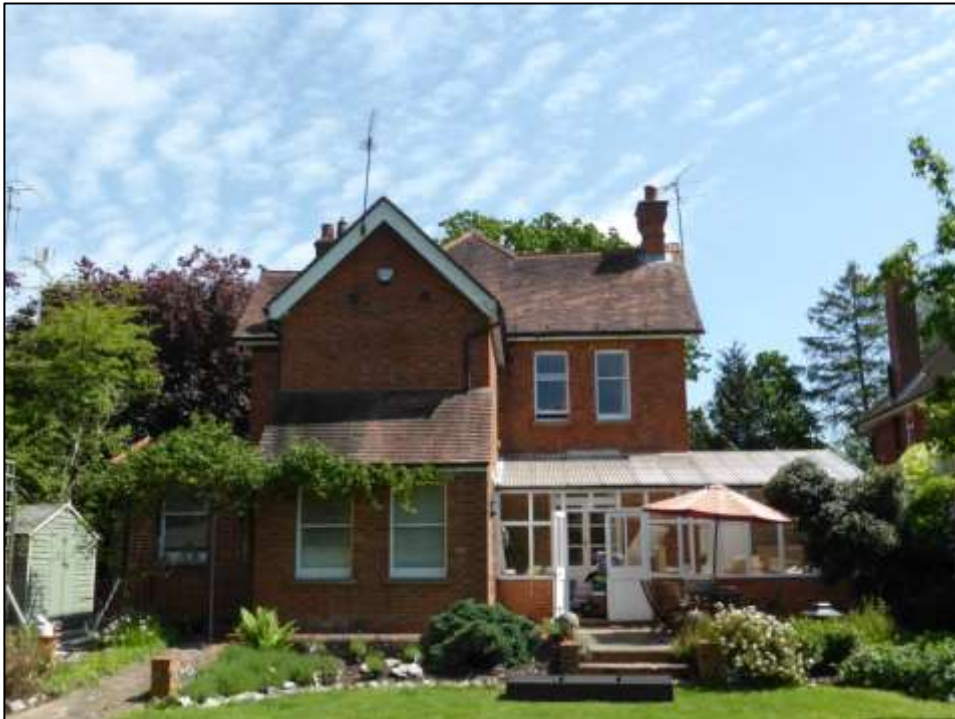
The application site is located in Caversham a suburb to the north of the urban conurbation of Reading and is surrounded by properties of a similar size, see Figure 2. It comprises a detached, brick built two storey property and attached garage. The habitat on site consists of a front garden with large gravel parking area and large matures trees and the rear garden consists of a large expanse of lawn surrounded by mature shrubs with occasional mature trees. The site itself provides good foraging and commuting habitat for bats including hedges and trees which provide connectivity to foraging areas along Darell Road and beyond.

Figure 2. Rear aspect of 11 Darell Road, Caversham.

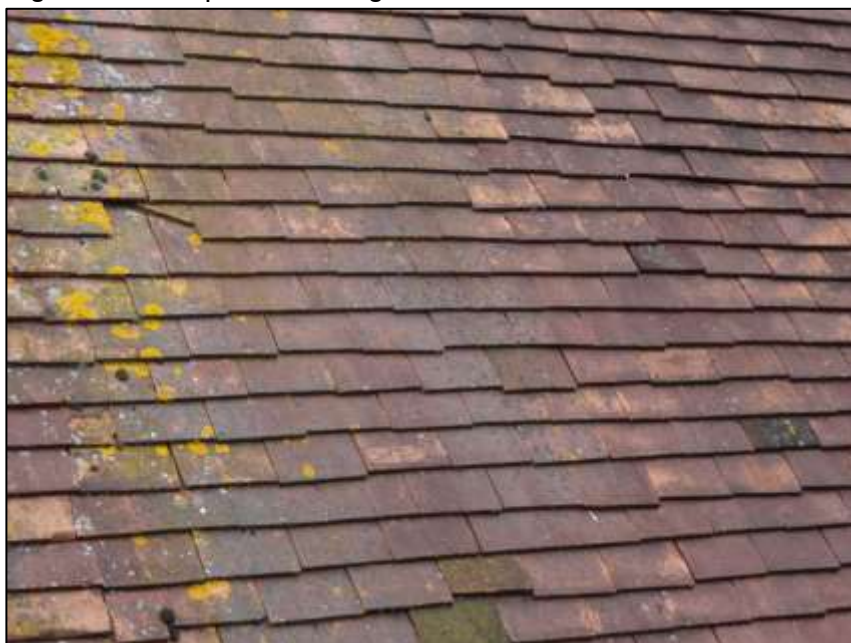
The property is of standard brick construction with a multi pitched, clay tiled roof. The roof alignment is complex however, it broadly aligns with the main compass points, north to south and east to west. Gaps and missing tiles were observed on the rear section of the roof, see images at Figure 3 below and 4 on page 10. There are also gaps where the lead flashing meets the tiles, see Figure 5 on page 10.

Figure 3. Example of missing tiles, 11 Darell Road, Caversham.

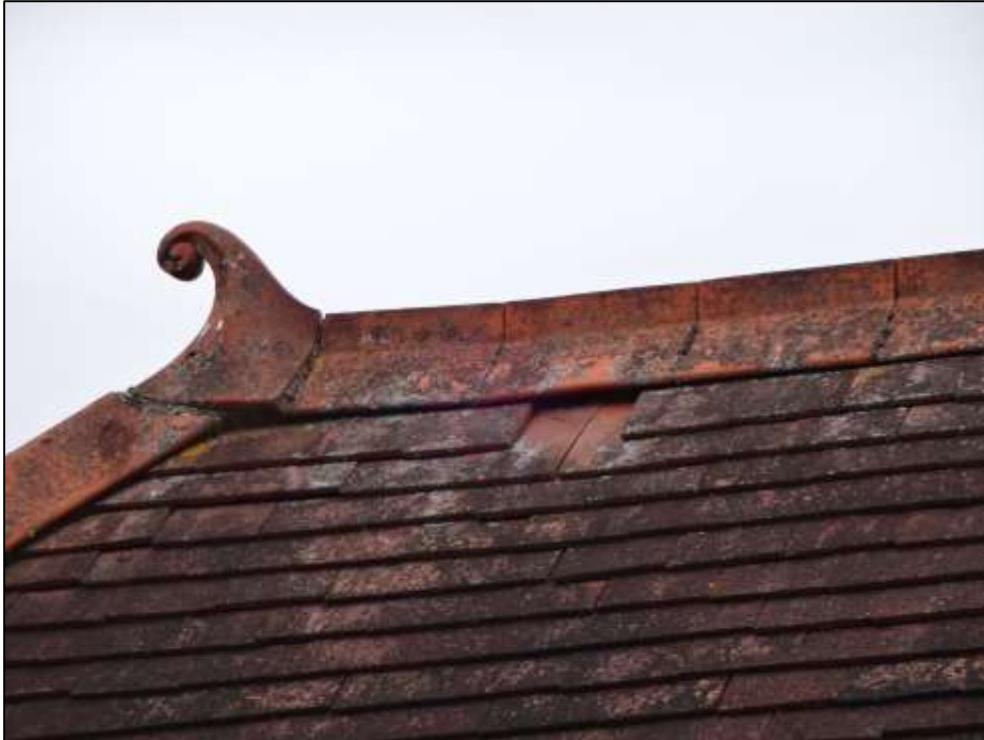
Figure 4. Example of gaps in ridge tiles, 11 Darell Road, Caverham.

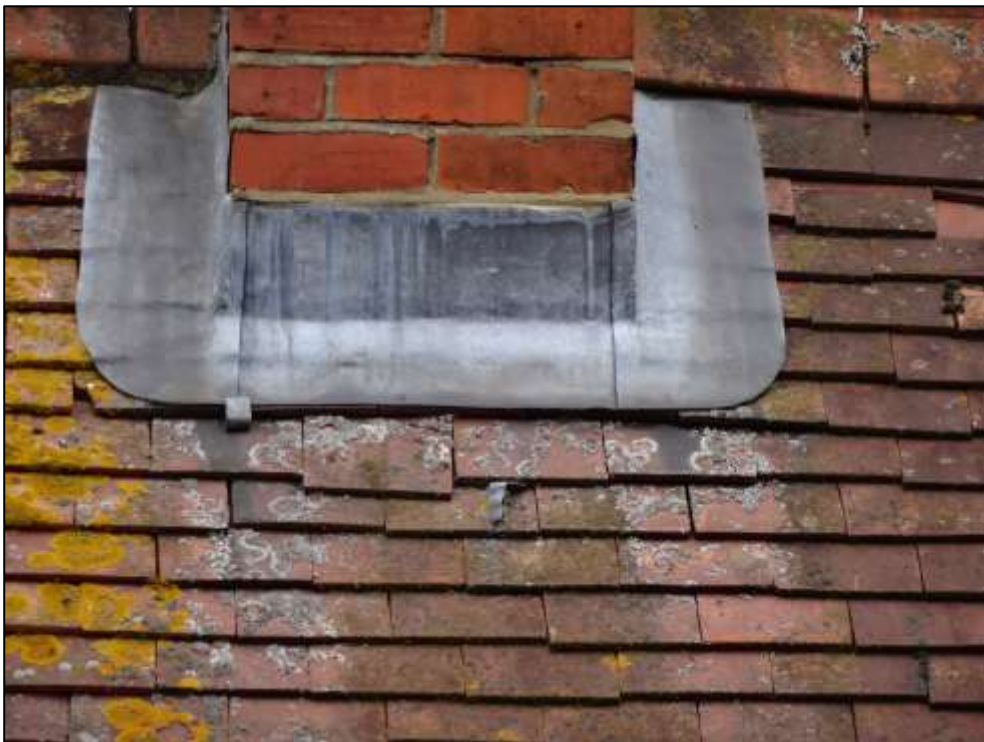
Figure 5. Example of gaps in lead lashing, 11 Darell Road, Caversham.

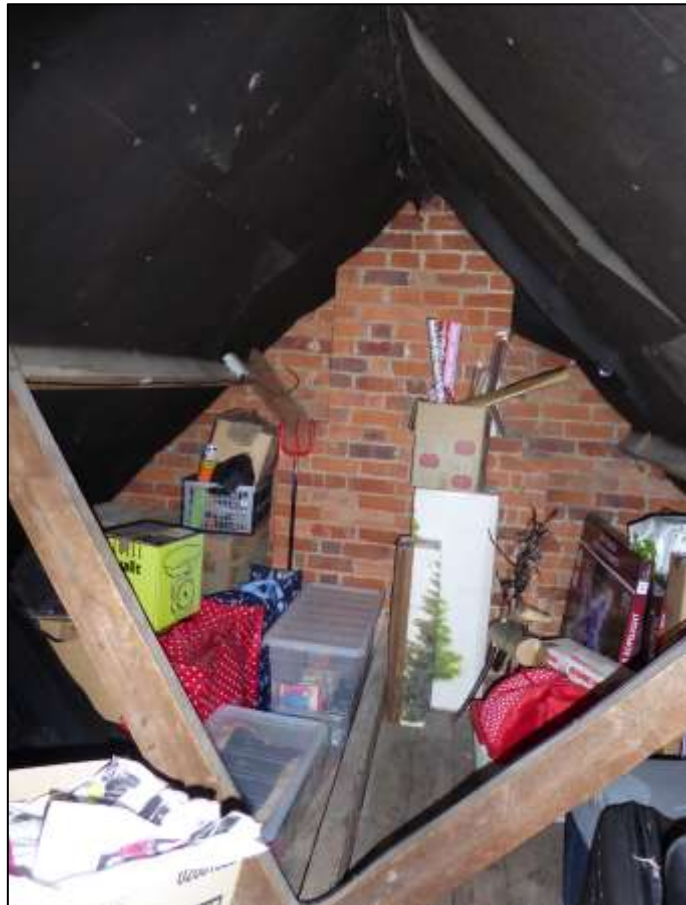
An internal inspection of the main roof void was carried out. It was accessed from the staircase to the second storey and a small hatch to the main loft apex. The roof consisted of a series of converted rooms with small loft above. The unconverted area is partially illuminated and the boarded area is easily accessible, see Figure 6 below.

Figure 6. Example of unconverted loft space. 11 Darell Road, Caversham.

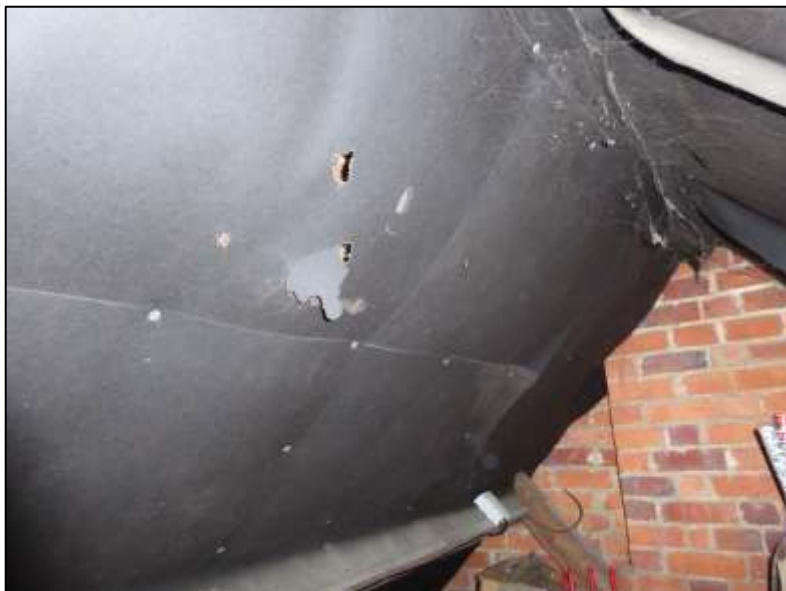
The roof is lined with a heavy, black man made material that is sagging and is torn, see Figure 7 below.

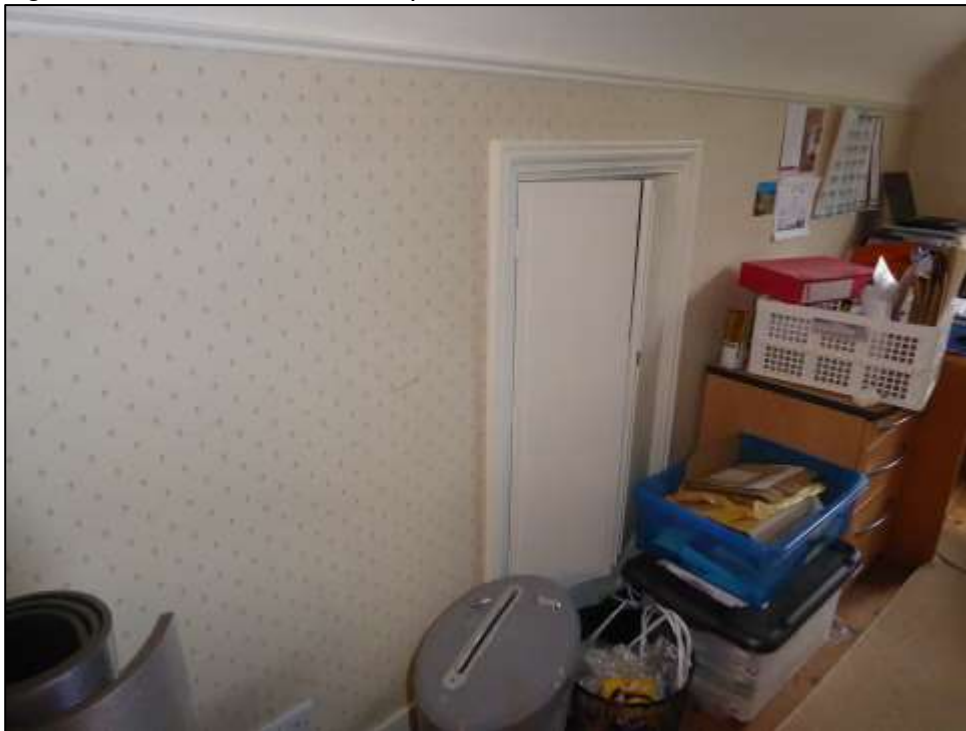
The eaves spaces formed by the rooms are boarded out and only a limited area was examined. It was accessed via a door in a bedroom, see Figure 8 below. The loft space above the rooms is insulated with chippings but not boarded or lined, see Figure 9.

Figure 8. Access to eaves loft space, 11 Darell Road, Caversham.

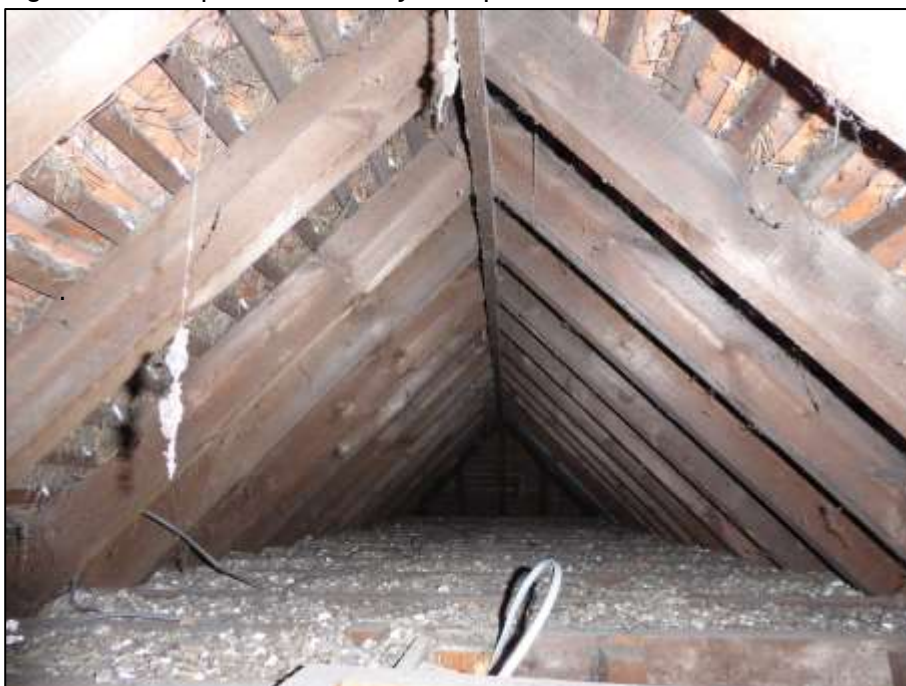
Figure 9. Example of subsidiary loft space. 11 Darell Road, Caversham.
