# Initial Bat Assessment

**6 Cleveland Road**

**16-005-IBA**

**July 2016**

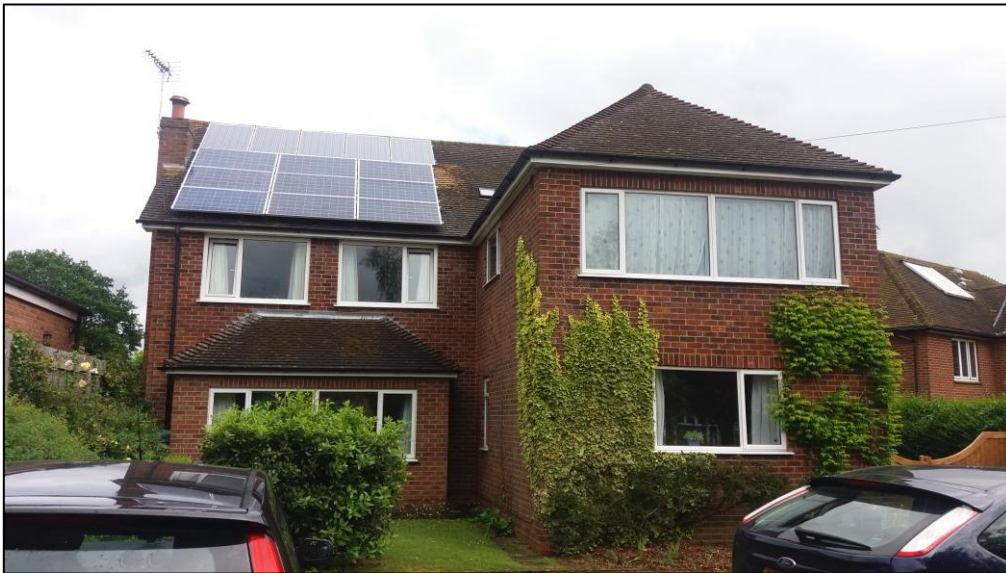
**Figure 2 - Front elevation of 6 Clevedon Road**

The site consists of a detached, two storey building of brick construction (Figure 2) with a pitched roof, consisting of timber rafters resting on the walls and machine-made tile covering (Figure 3). Here are solar panels located on the front (southern) elevation. The property is in good condition and is currently occupied.

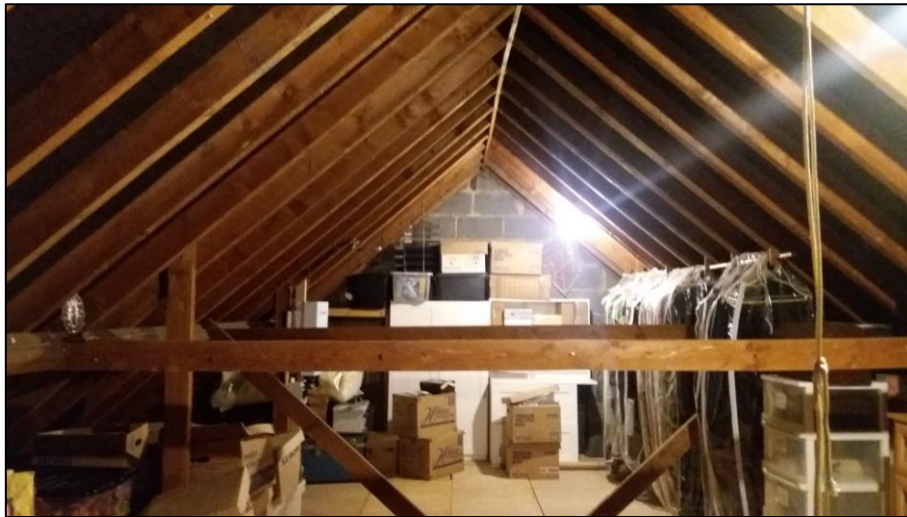
The property had a single, L-shaped roof void accessible through a hatch in the ceiling. The roof void was approx. 2m high (at the ridge) throughout the length of the roof and had a bitumen felt underlay fitted (Figures 4&5). The roof void had a small chimney stack on the western elevation and was in good condition. There were no visible access points or draughts to suggest gaps in the roof covering and the eaves were covered with vented soffits. There was a moderate level of cob-webbing, suggesting bats had not recently been flying around and no evidence of bats was found in the roof void.

**Figure 4** – Roof void showing lighting present

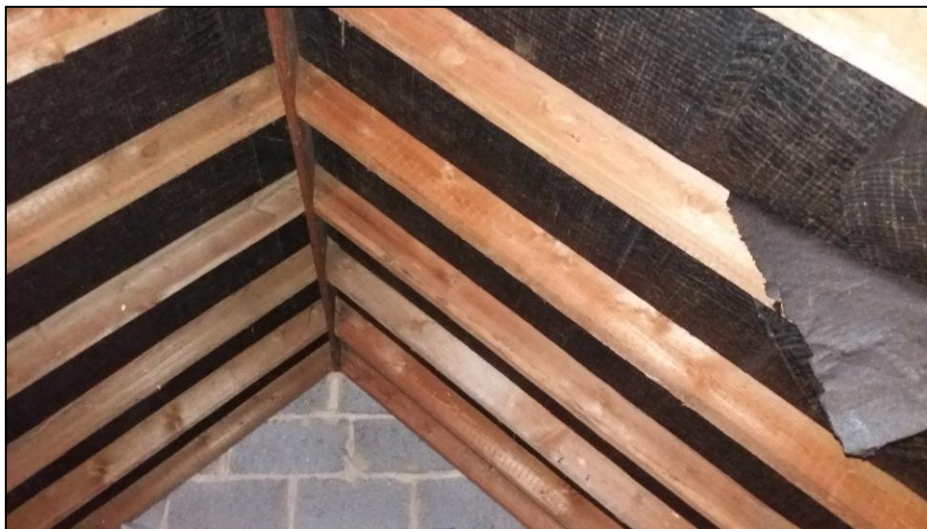
**Figure 5** –Bitumen felt underlay was in very good condition

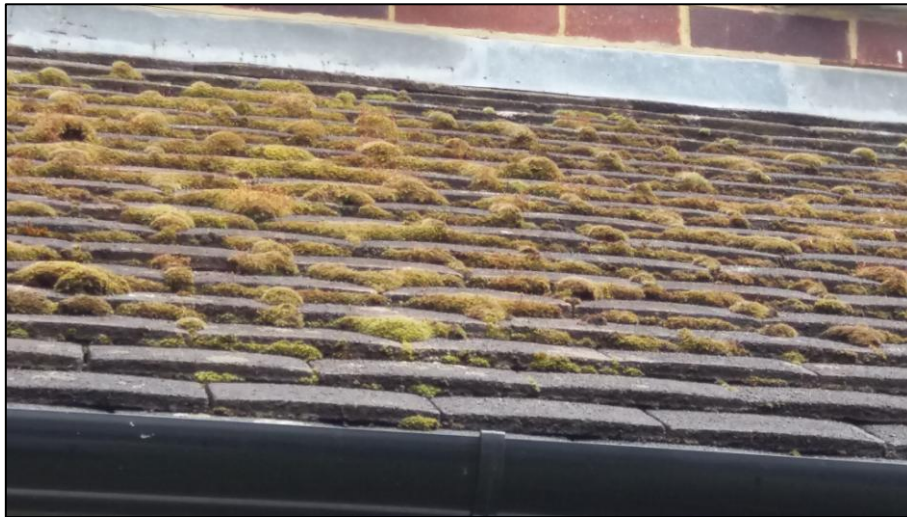
The primary roof covering consisted of machine-made tiles which interlocked and were in good condition. There were no missing or broken tiles (Figure 6), which could provide access to roosting bats. The mortar along the ridge and verges was in good condition with no missing sections that could be utilised by bats. Around the chimney the lead flashing was in good condition with no areas missing or lifted. The eaves were sealed and the soffits in very good condition.

**Figure 6** – machine made tile roof covering showing good condition

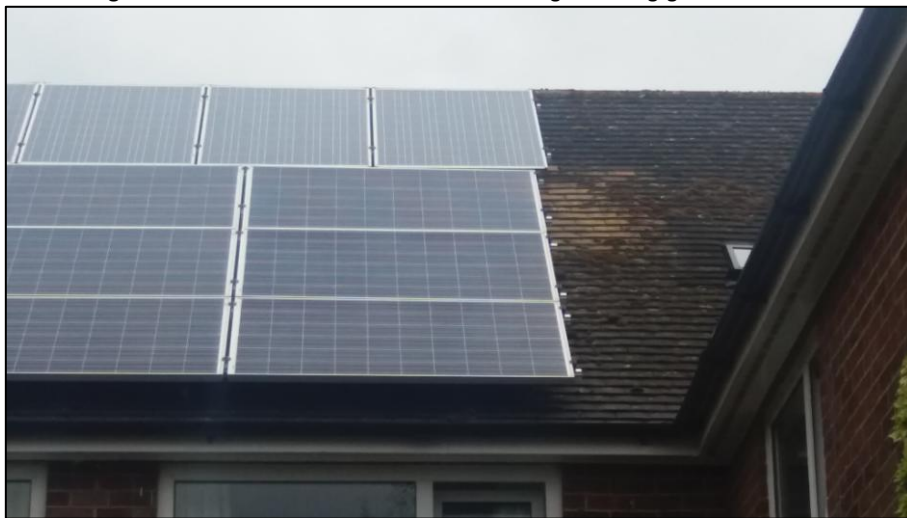
The southern elevation of the roof also had a number of solar panels fitted (Figure 7) which would cause fluctuations in the roof temperature, as such they were deemed to lower the potential for bats.

**Figure 7** – Solar panels fitted on southern elevation
