## **Extended Phase 1 and Bat Risk Assessment**

Gas Works Road, Reading

## EXTENDED PHASE 1 SURVEY

### Gas Works Road, Reading

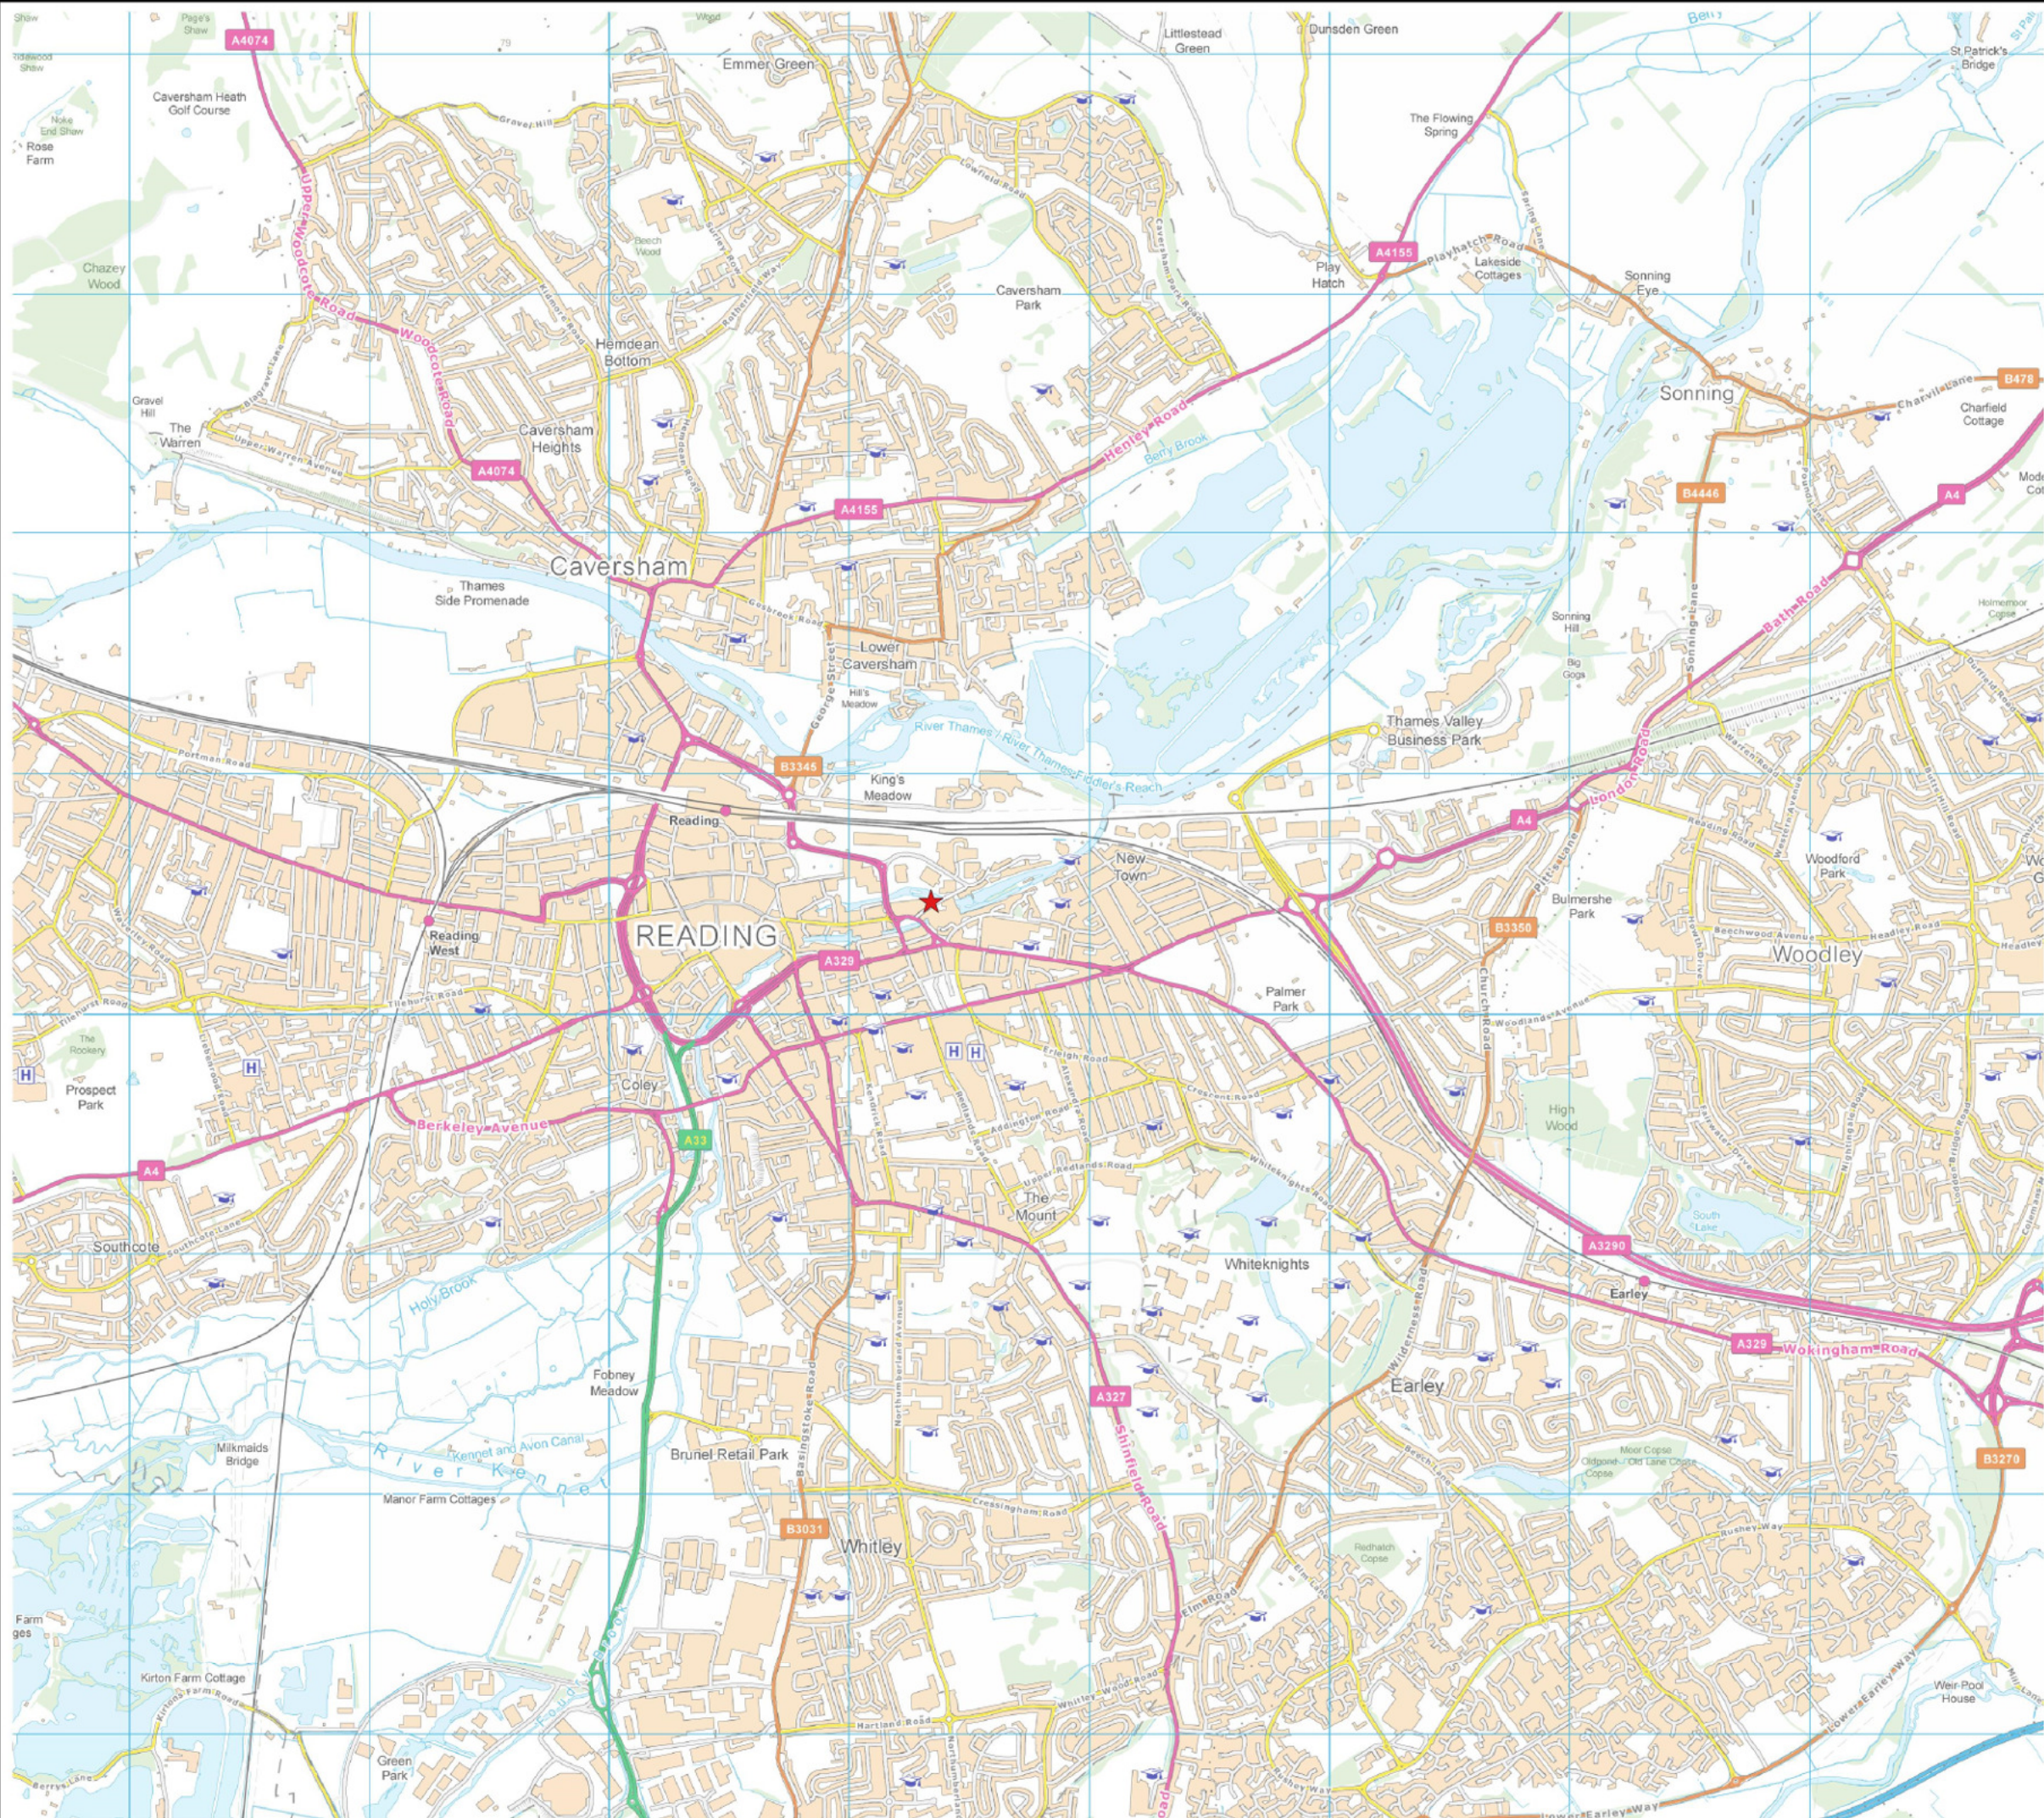
| Ref | Figure 1 |

The site has two main buildings. A two-storey building (B4 on Figure 1, Appendix A), the former Southern Gas Social Club, of red brick construction with a pitched, slate tile roof. This building has two extensions: the eastern extension is of similar construction to the main building with a flat roof and the western extension (B5) comprises two adjoining pitched-roof buildings with corrugated iron walls and roof.

The larger of the two buildings is the former Southern Gas Social Club (B4 in Figure 1, Appendix A), of red-brick construction with a pitched slate-tiled roof. On the western side of the building there is a single-storey corrugated iron extension (B5 in Figure 1 in Appendix A) with two adjoining pitched corrugated iron roofs, and a flat-roofed red-brick extension on the eastern side of B4.

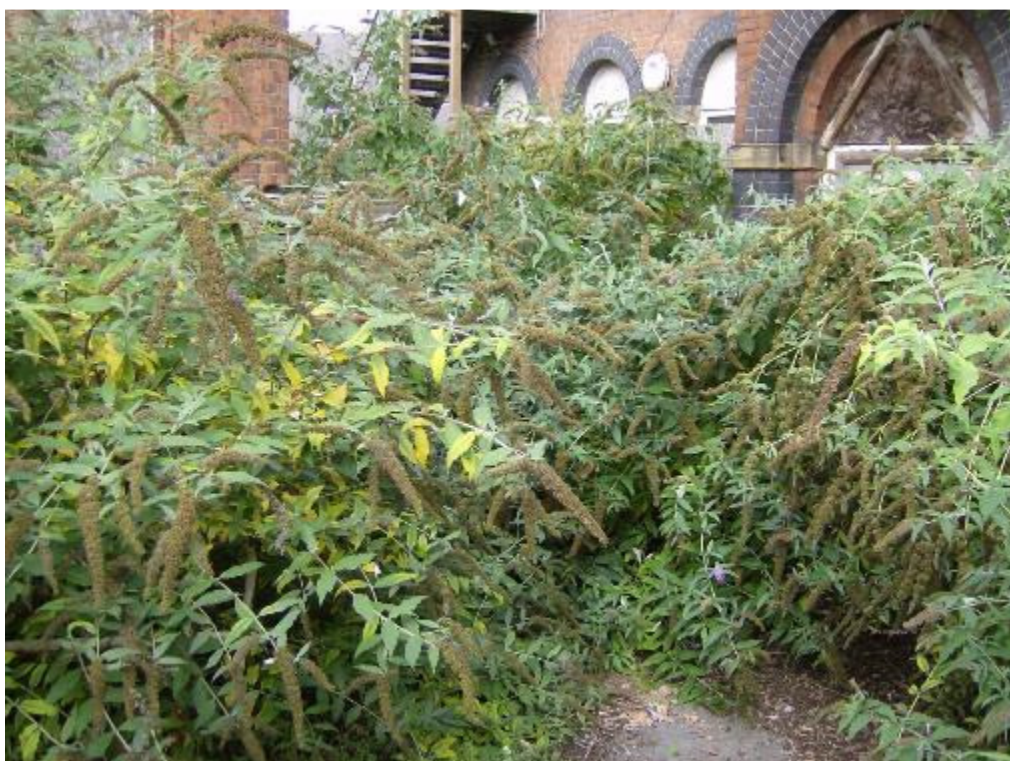
The majority of the site is covered by concrete hardstanding in the form of pavement and stairs leading into the site from Gas Works Road and up towards the buildings' entrances.

The concrete areas of the site have predominantly been cracked and overgrown by dominant buddleja *Buddleja davidii*, frequent bramble *Rubus fruticosus*, occasional red valerian *Centranthus ruber*, wood avens *Geum urbanum*, ivy-leaved toadflax *Cymbalaria muralis*, and rare rowan *Sorbus aucuparia*, elder *Sambucus nigra* and silver birch *Betula pendula*.

**Photograph 1:** Hardstanding overgrown with buddleia.

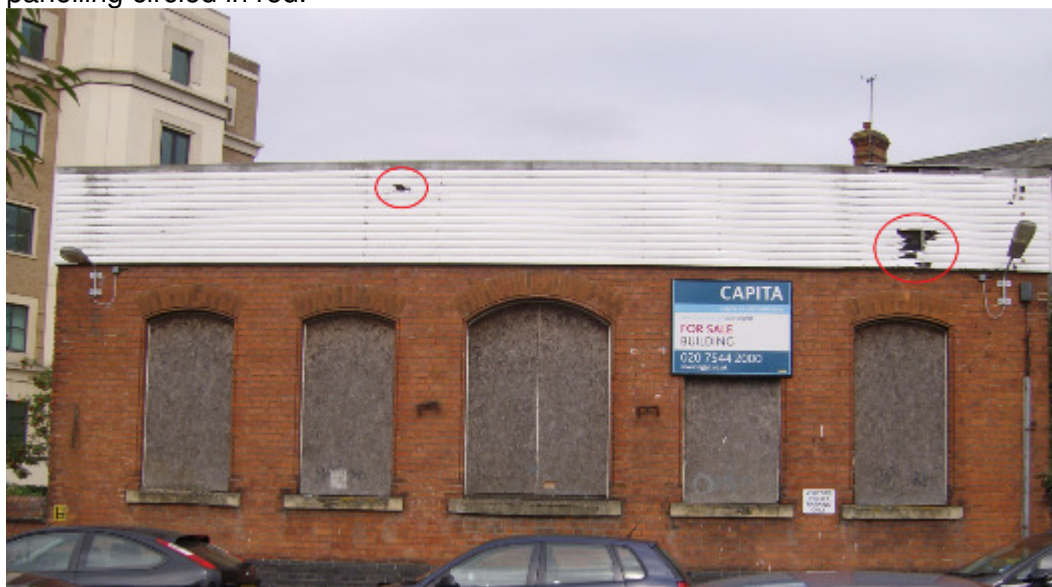
Several potential access points for bats were noted on B1 and B4 on site. On B1 plastic panelling on the external walls was broken in places on two sides of the building in addition to a few gaps in the brickwork on the eastern wall (although these gaps were located under 2 m from ground level, which is not optimal for bat access). B4 has a large hole on the northern side of the roof, missing ridge tiles, broken windows, in addition to there being some small gaps on the fascia and soffits of B5 an adjoining corrugated iron extension. Both of the main buildings were valued as having low bat roost potential.

**Photograph 2:** Building 1 (Figure 1, Appendix A), southern wall with cavities in panelling circled in red.

The two main buildings on site were assessed as being of low bat roost potential, based on the internal and external features of the buildings (see Table 2). It is recommended that the two main buildings (B1 and B4) on site are subject to presence/absence survey for bat roosts. In line with the Bat Conservation Trust Guidelines (Hundt, 2012), buildings with low roost potential should undergo one dusk emergence survey or pre-dawn re-entry survey during May to September (Inclusive).

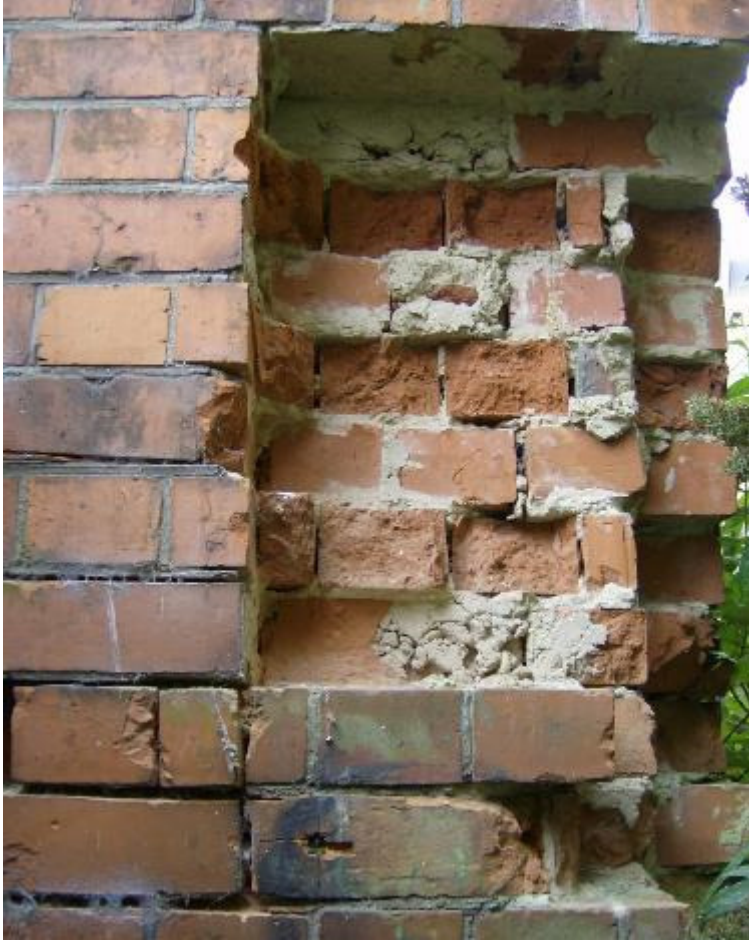
**Photograph 3:** Gaps in brickwork on eastern wall of B1.

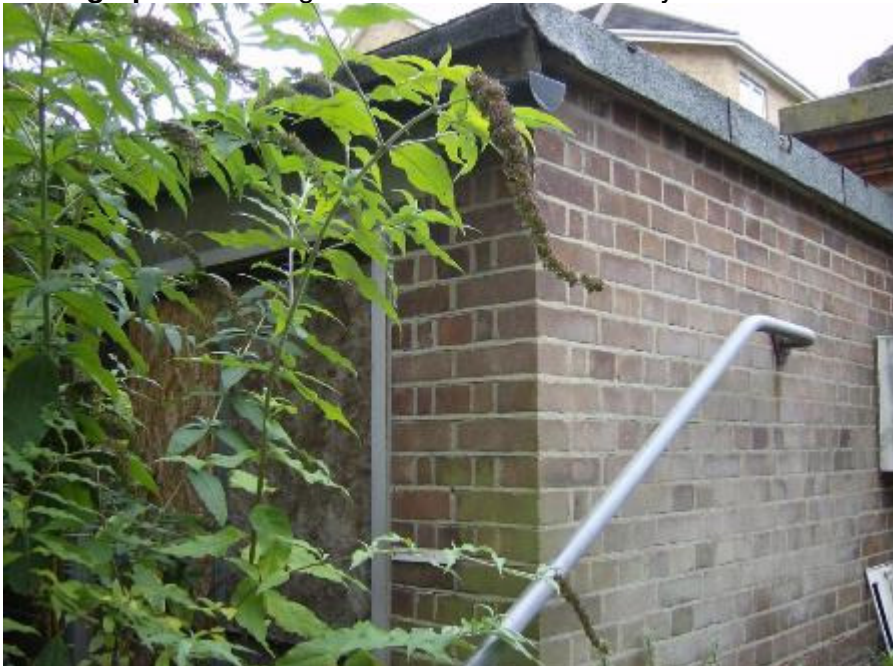
| Building Code<br><br>(Figure 1, Appendix A) | Building construction details | Structural features present | | | | | | Other structural features of note | Potential bat access and roosting points | Internal features | Evidence | Bat Roost Potential |
|---|---|---|---|---|---|---|---|---|---|---|---|---|
| <b>B2</b> | Small red-brick out-house with a flat, felt covered roof (Photograph 4, Appendix B).<br>No windows and a wooden door. | <b>X</b> | ✓ | <b>X</b> | <b>X</b> | <b>X</b> | <b>X</b> | None | Small hole at the end of guttering along the (western) side wall, covered in dense cobwebs (Photograph 5, Appendix B). | No internal access. | None | Negligible |

**Photograph 4:** Building 2 and a small out-house by site entrance.

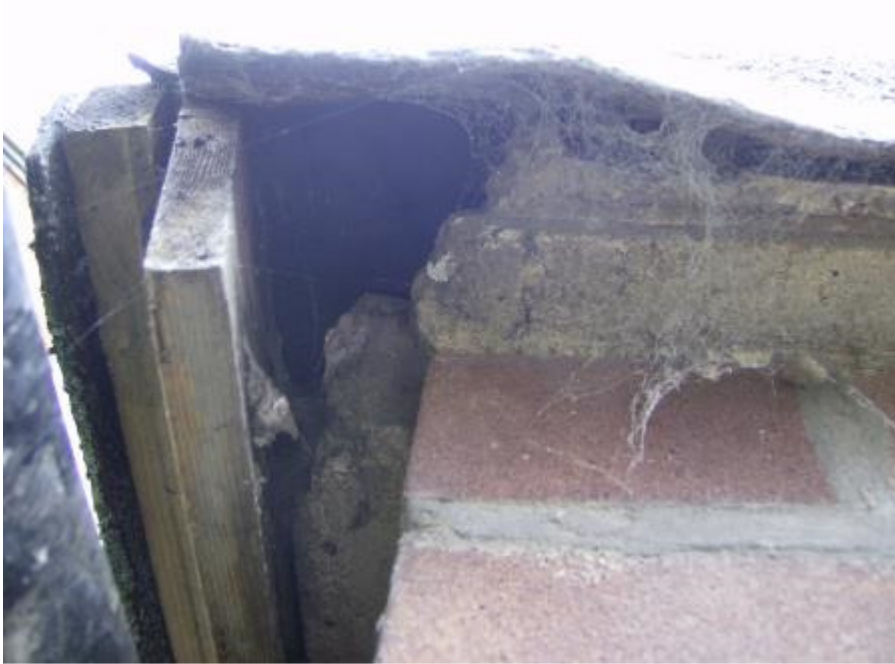
**Photograph 5:** Building 2 – hole between roofing and side wall, covered in dense cobwebs.

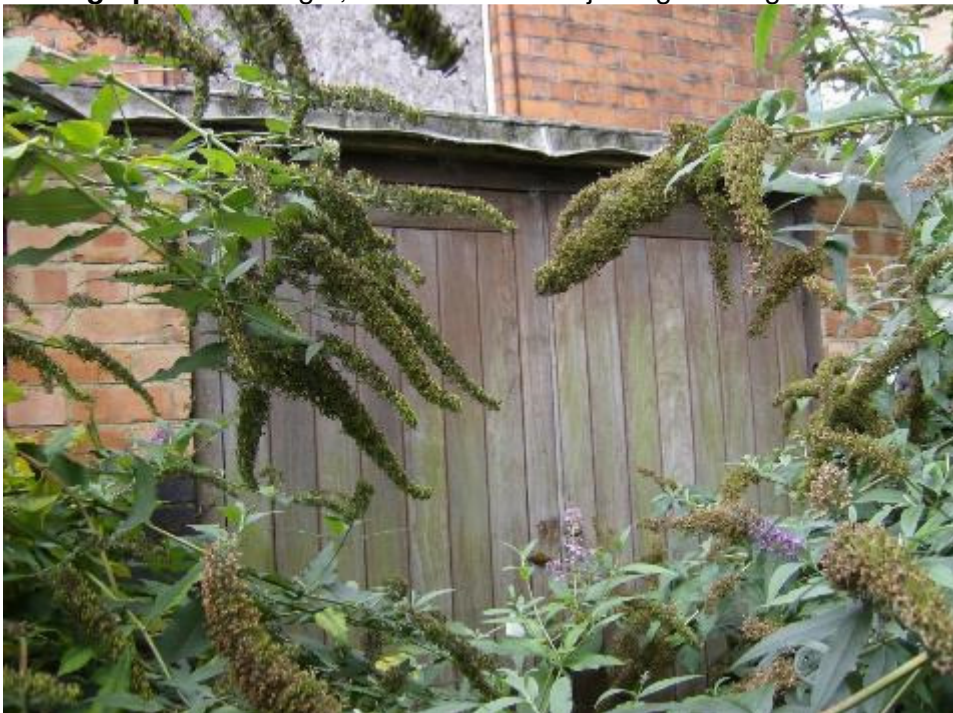
| Building Code<br><br>(Figure 1, Appendix A) | Building construction details | Structural features present | | | | | | Other structural features of note | Potential bat access and roosting points | Internal features | Evidence | Bat Roost Potential |
|---|---|---|---|---|---|---|---|---|---|---|---|---|
| <b>B3</b> | Small red-brick lean-to building adjoining B1 to the east. Flat roof with damaged metal covering (Photograph 6, | <b>X</b> | <b>X</b> | <b>X</b> | <b>X</b> | ✓ | <b>X</b> | None | Small gaps in flashing covered in cobwebs, but overall building is well sealed. | No internal access. | None | Negligible |

**Photograph 6:** Building 3, a small lean-to adjoining building 1.

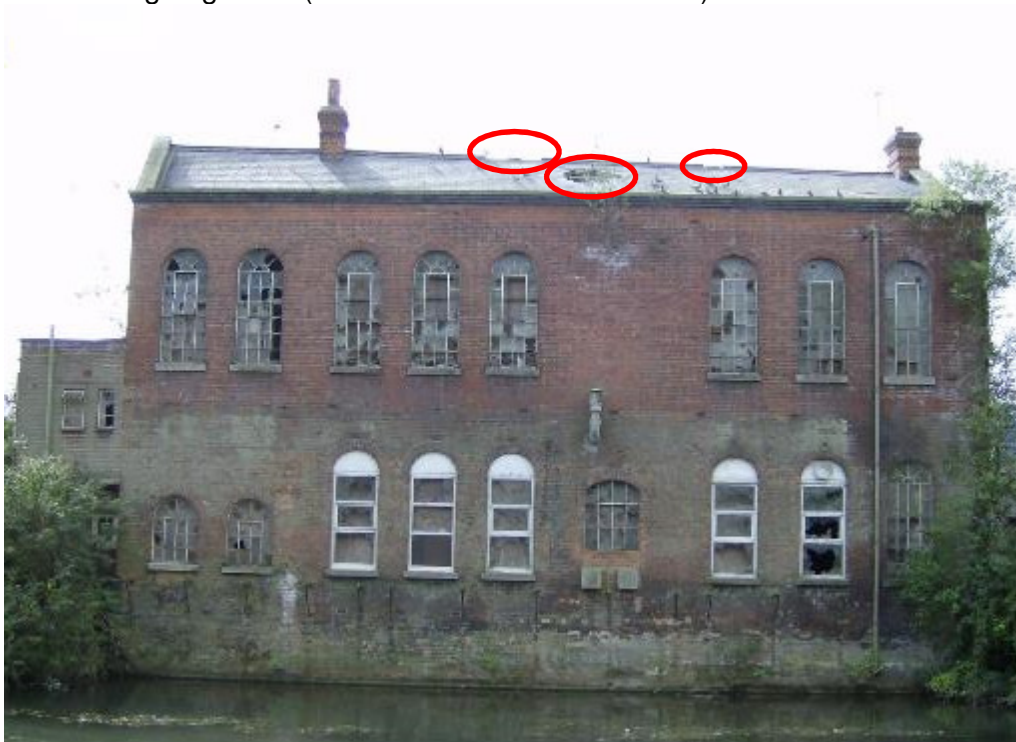
A bat risk assessment was carried out on the buildings on site. The larger of the two main buildings (B4) has a large cavity in the roof, missing ridge tiles and broken windows, while the smaller of the two main buildings (B1) has cavities present on the external panelling, all providing potential entry points for bats. Both the main buildings were valued as being of low bat roost potential, while the small buildings and extensions on site were considered to have very low or negligible roosting potential for bats.

| Building Code<br>(Figure 1, Appendix A) | Building construction details | Structural features present | | | | | | Other structural features of note | Potential bat access and roosting points | Internal features | Evidence | Bat Roost Potential |
|---|---|---|---|---|---|---|---|---|---|---|---|---|
| <b>B4</b><br><b>(Southern Gas Social Club)</b> | Double storey, early 1900s, red-brick building with a pitched slate-tiled roof with gable ends. On eastern wall there is a red-brick, flat roof extension reaching halfway up to the second storey of the main building. Windows and doors with wooden frames. | ✓ | X | X | X | ✓ | ? | None. | Potential roof void.<br><br>Rear windows (northern wall) broken and not covered by plywood boards.<br><br>Large cavity in roof and missing ridge tiles on northern side of building (Photograph 7, Appendix B). | No access to second storey or majority of ground floor. | None. | Low |

**Photograph 7:** Building 4 – northern view – with broken windows, a cavity into roof and missing ridge tiles (last two features circled in red).

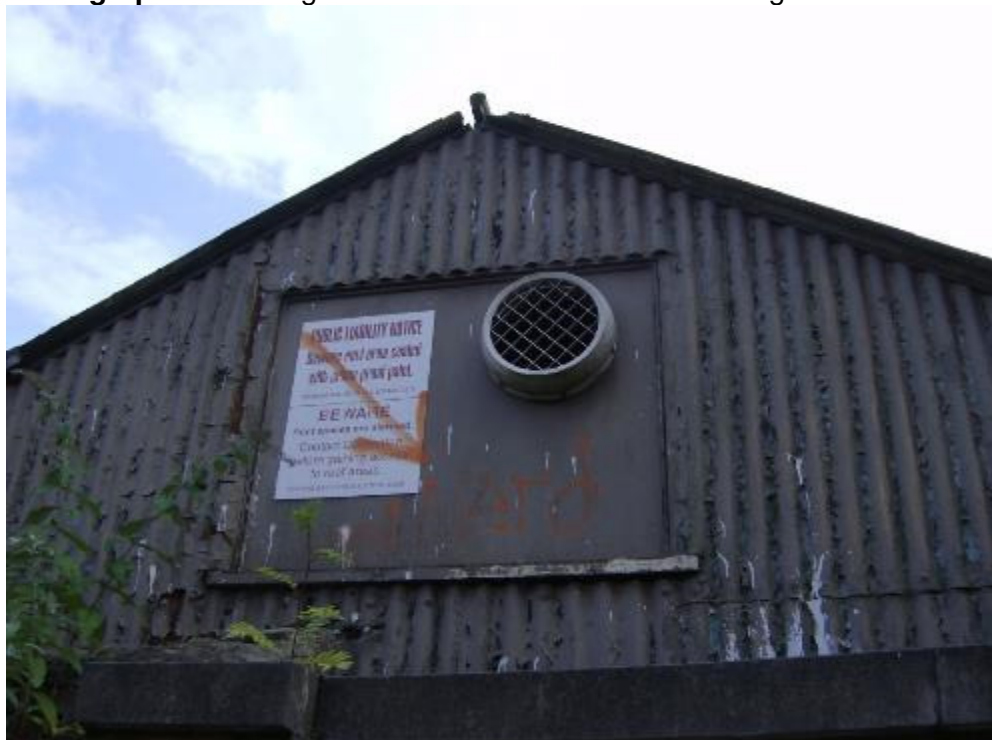
| Building Code<br>(Figure 1, Appendix A) | Building construction details | Structural features present | | | | | | Other structural features of note | Potential bat access and roosting points | Internal features | Evidence | Bat Roost Potential |
|---|---|---|---|---|---|---|---|---|---|---|---|---|
| <b>B5</b> | Corrugated iron extension to B4 with two adjoining pitched roofs and no windows. | ✓ | ✓ | ✓ | X | ✓ | ? | None. | A large vent is present on the western wall into the building (Photograph 8, Appendix B).<br><br>Flashing lifted in places by | No internal access. | None. | Negligible - Low |

**Photograph 8:** Building 5 – vent on western side of building.

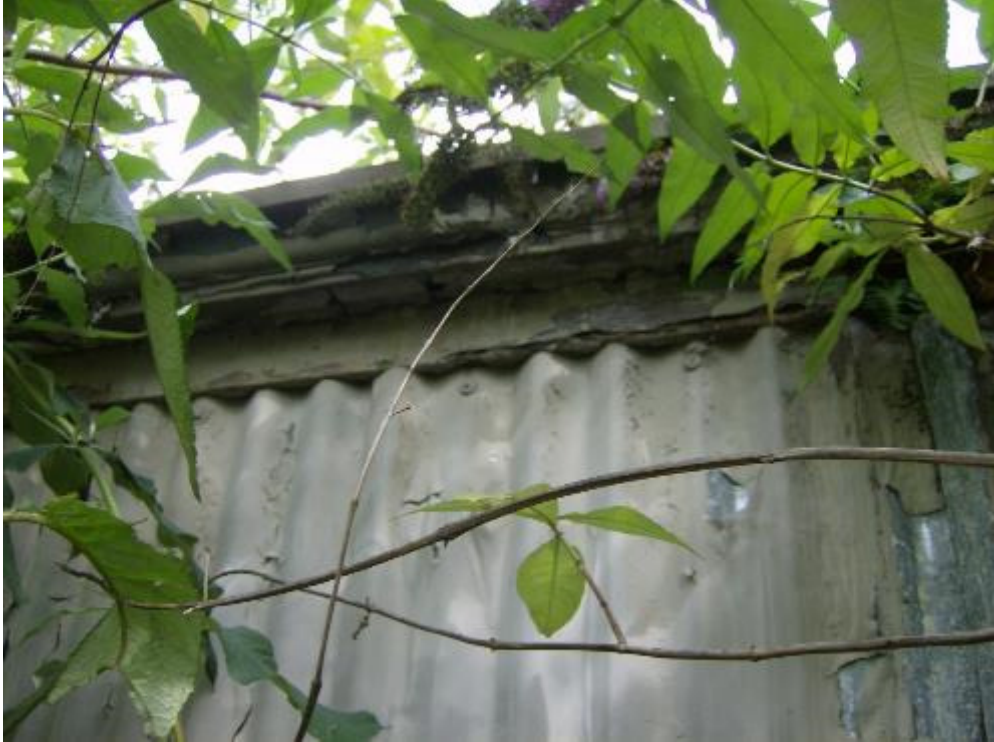
| Building Code<br>(Figure 1, Appendix A) | Building construction details | Structural features present | | | | | | Other structural features of note | Potential bat access and roosting points | Internal features | Evidence | Bat Roost Potential |
|---|---|---|---|---|---|---|---|---|---|---|---|---|
| | | | | | | | | | the chimney.<br>Gaps in rotten soffits and fascia boards in places (Photograph 9, Appendix B). | | | |

**Photograph 9.** Potential bat access point – gaps in rotten soffits and fascia boards.

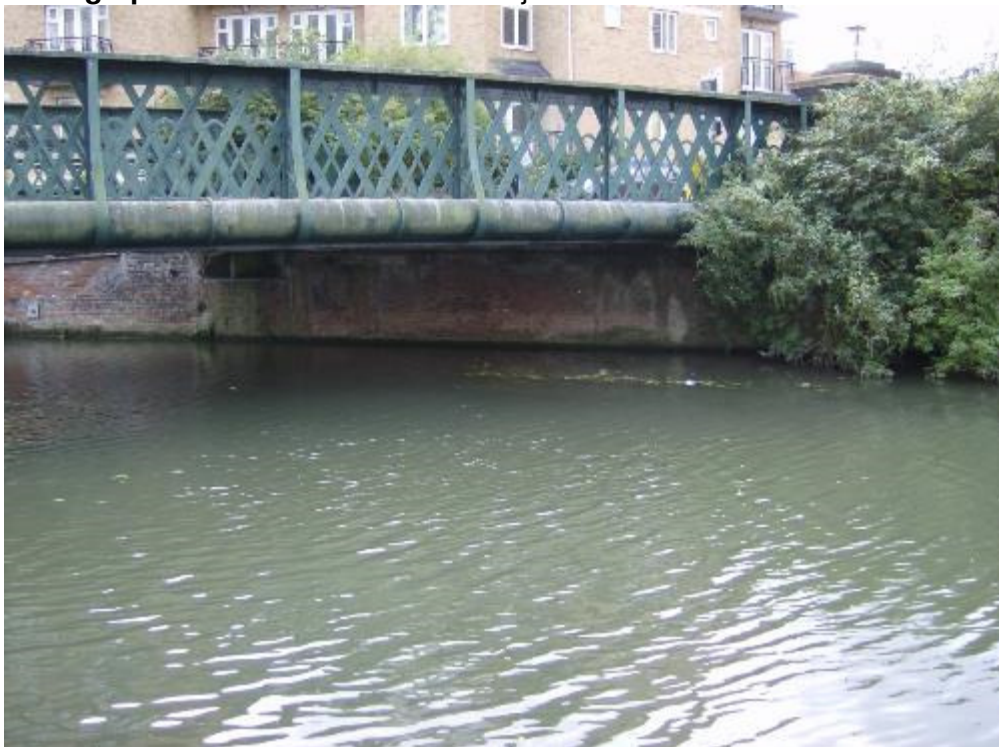
No evidence of otter or water vole activity was noted during the site walk-over survey. The river banks adjacent to the site are predominantly composed of brick walls (Photograph 10, Appendix B), providing no suitable habitat for otter holts or couches, or water vole burrows to be created. Additionally the proposed development works will not directly affect the River Kennet. Given these factors otters and water voles are not considered a constraint to development.

**Photograph 10:** River Kennet banks adjacent to the site.
