# Caversham Weir

## Hydrogeological Desk Study and Risk Assessment

## **Introduction**

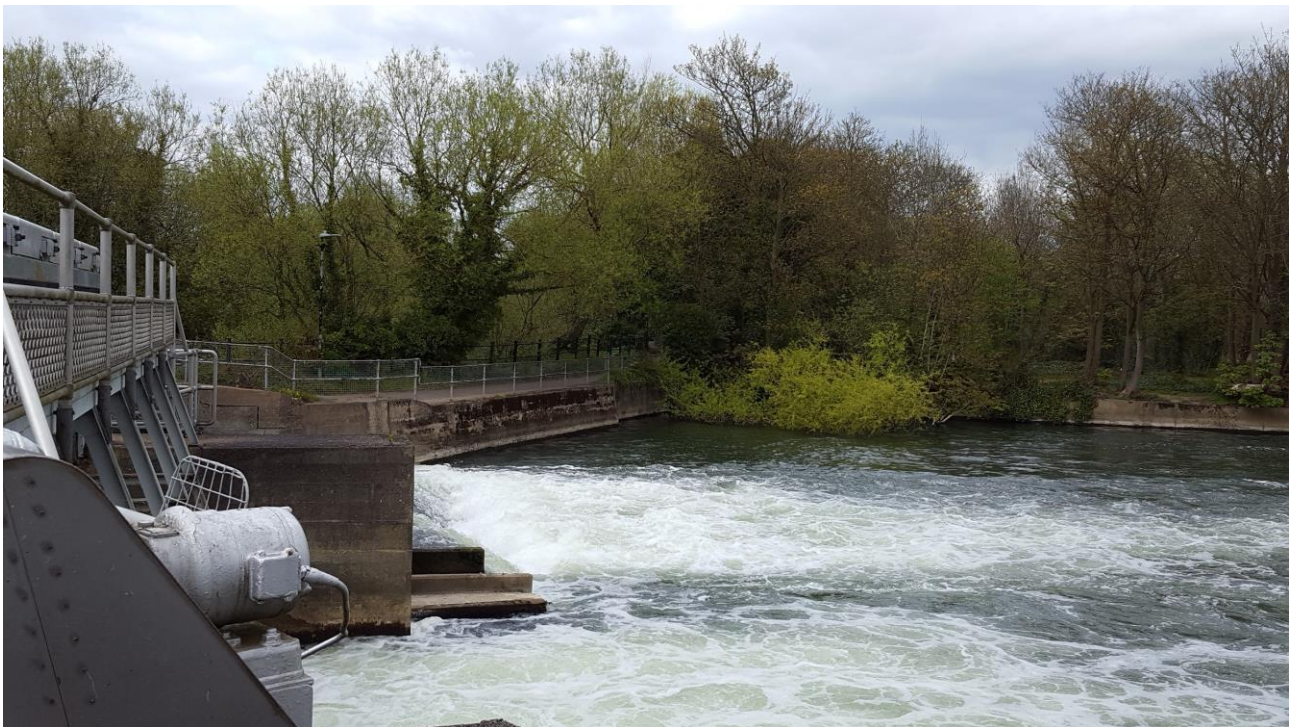
The hydro scheme itself will be inserted only in the existing abutment and adjacent river bed, between the weir and View Island.

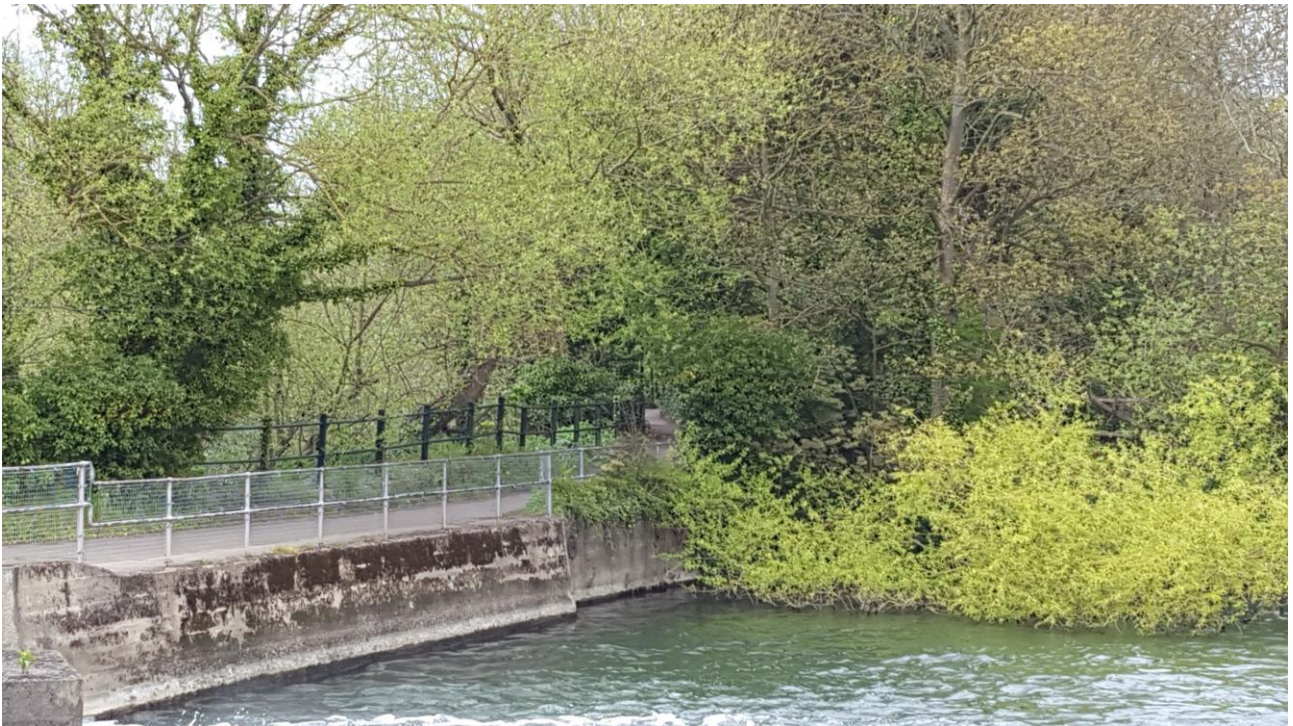
The site of the proposed Reading Hydro electricity generating scheme is a two-sided made ground embankment above the Quaternary sand and gravel deposits. It forms a narrow tract where the former mill stream has been divided off from the Thames to channel water behind View Island from above the weir. The embankment forms the eastern abutment to Weir C and supports a footpath.

The made ground is likely to consist of reinforced concrete, disturbed alluvium and sand and

gravel deposits and perhaps some broken building materials. The upper surface is currently tarmac, with fencing either side.

The difference in water level from the mill stream side to the weir tail side averages 1.4m, varying with river flow. This narrow strip of concrete-sided abutment is a public right of way, and has served no other purposes.

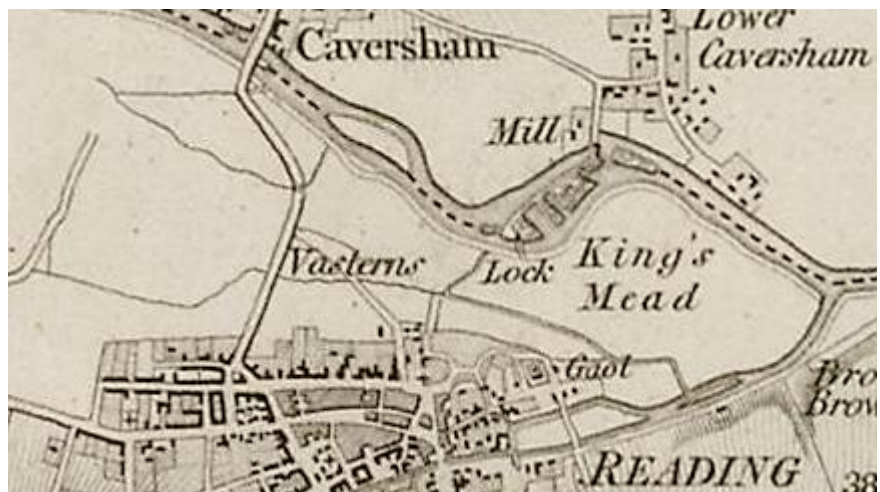
View Island can be seen as open land and a different shape in the 1830 OS map (pictured above). Here Lock Island looks much wider and shorter than currently, although this map may not be entirely accurate.

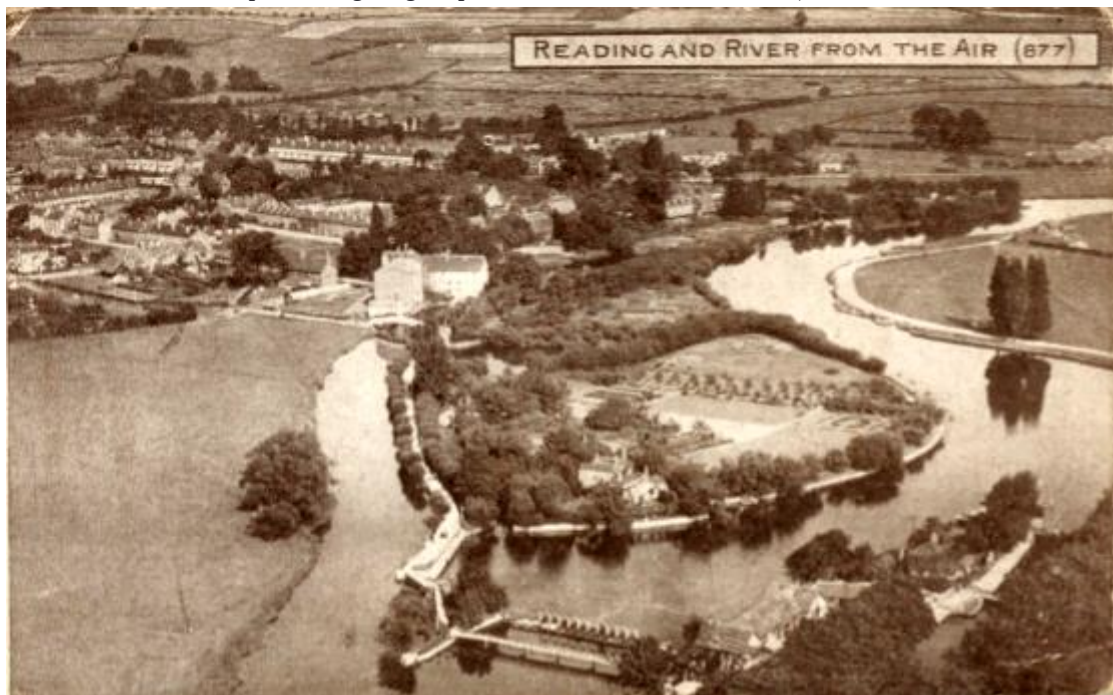
1932 map showing View Island house/hotel grounds now covering the whole island.

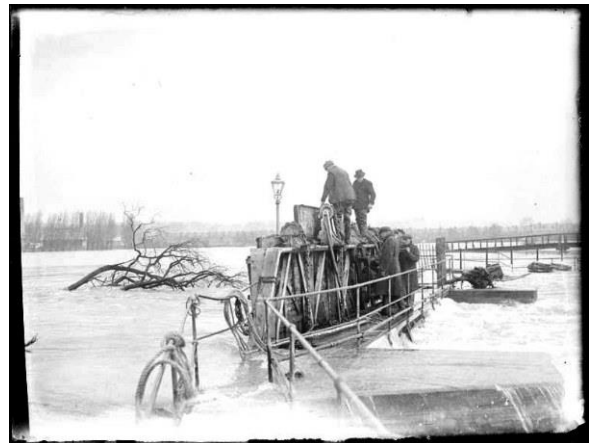
The highest floods in recent history were in 1947, before the 1954 electric weir operating system with far greater flow capacity was put in place. The photograph to the right shows workmen clearing debris at Caversham Weir in March 1947, with water over-running the abutments and with only a small difference in river level above and below the weir [Photograph via Reading Museum, from the Reading Chronicle Collection].

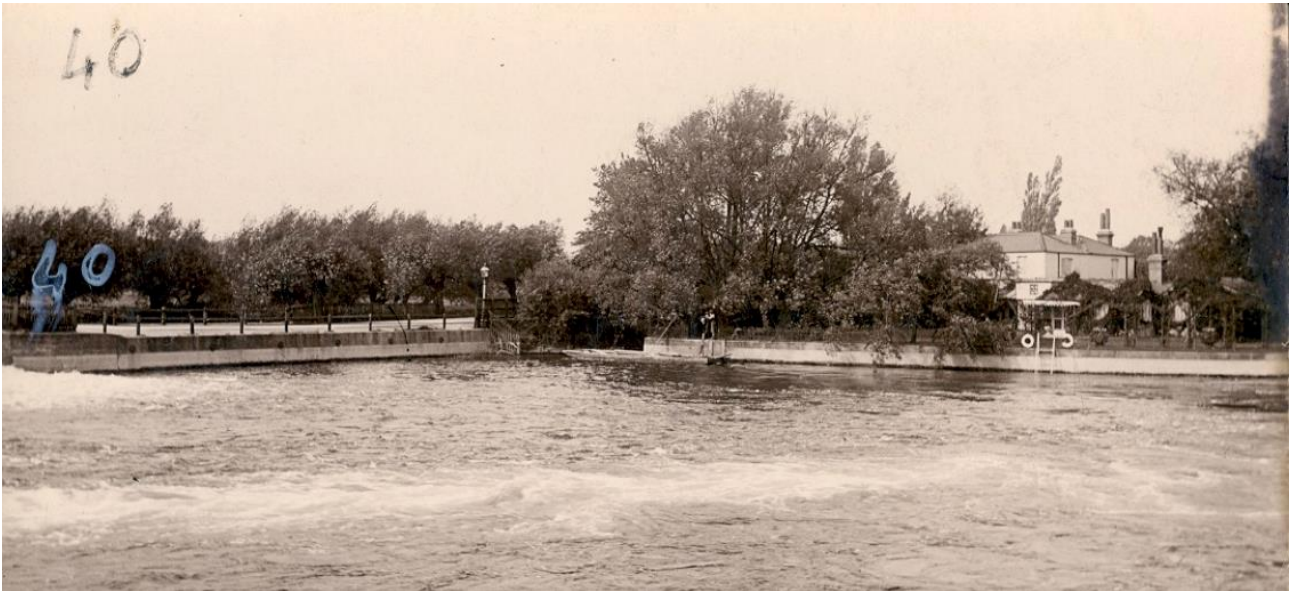
into the bedrock both at the upstream and tail end of the weir. The concrete abutments date to a much earlier time, most likely the 1884 rebuild of the weir. This includes the raised path section where the Reading Hydro site is proposed, just west of View Island.

On the 1950's plans this abutment is shown to contain 'existing universal piling', but it is not stated of what material this is constructed. The whole abutment construction is covered in concrete. A photo from the early 1900's shows the site looking in very good condition, as further evidence that it would have only been a couple of decades old [pictured below left in a relatively newly built state, c. 1890; Reading Libraries archive].

The 1951 weir reconstruction plans show the upstream piling to a depth of 100.29ftaOD, equalling 30.6maOD. Since local boreholes show the Chalk upper surface being between 28.1 and 30.2maOD, it is unlikely that the upstream piling penetrated the Chalk, particularly since the closer boreholes to the site are at the lower end of this range [ref borehole table]. However, the downstream piling was planned to penetrate to 90ftaOD, equalling 27.4maOD, and thus will probably have penetrated the Chalk.
