**St George's Road, Reading**  
Preliminary Geo-Environmental and  
Geotechnical Assessment

# **St George's Road, Reading**

## **Preliminary Geo-Environmental and Geotechnical Assessment**

| ISSUE RECORD | | | | | |
|---|---|---|---|---|---|
| Report Reference: 1303010.001.01 | | | | | |

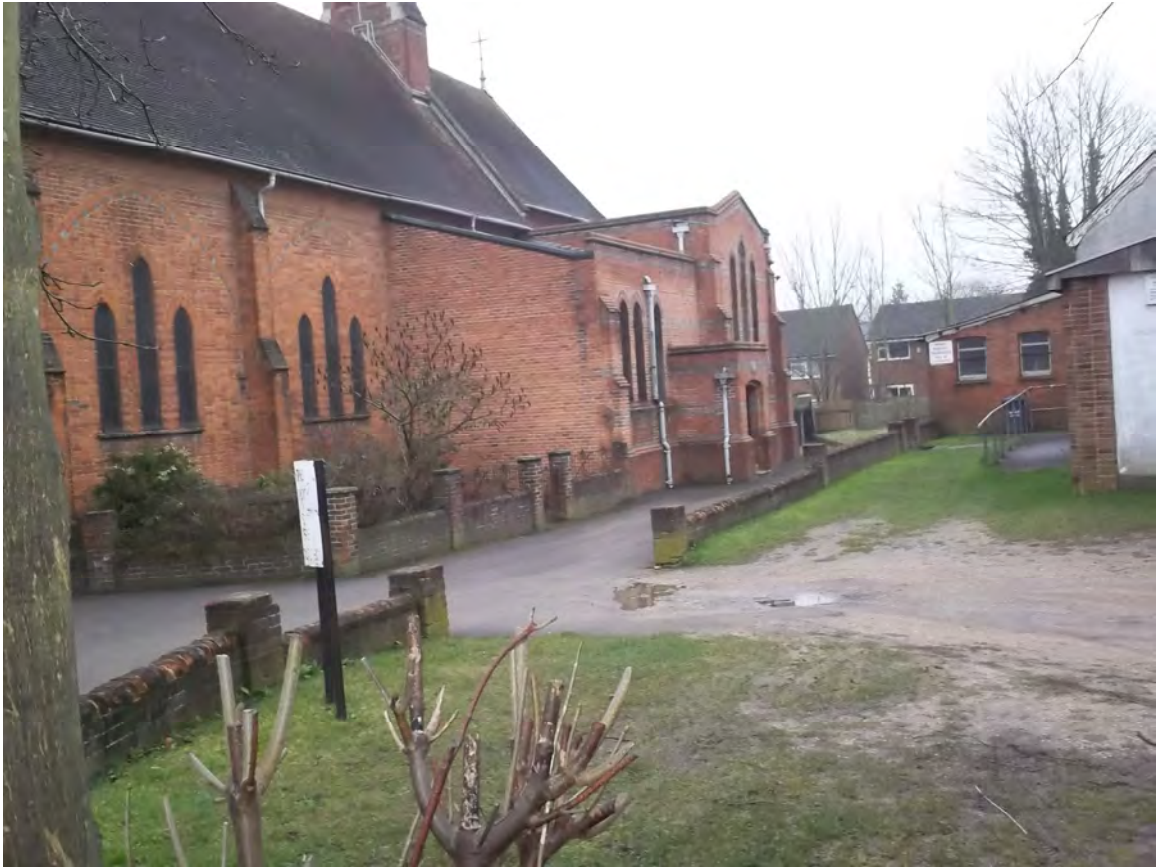
- 2.2.2 The site was observed to comprise a parcel of land containing a single storey building, understood to be utilised as a church hall (Photograph 1) associated with the brick-built church in the west. A tarmac hard standing driveway provides access on to the site was observed with a parking area laid to bare soil. The remaining site area was observed to be laid to soft landscaping (grass). With areas of bare earth surrounding the access drive.

Photograph 1: Bare earth visible at current site entrance.

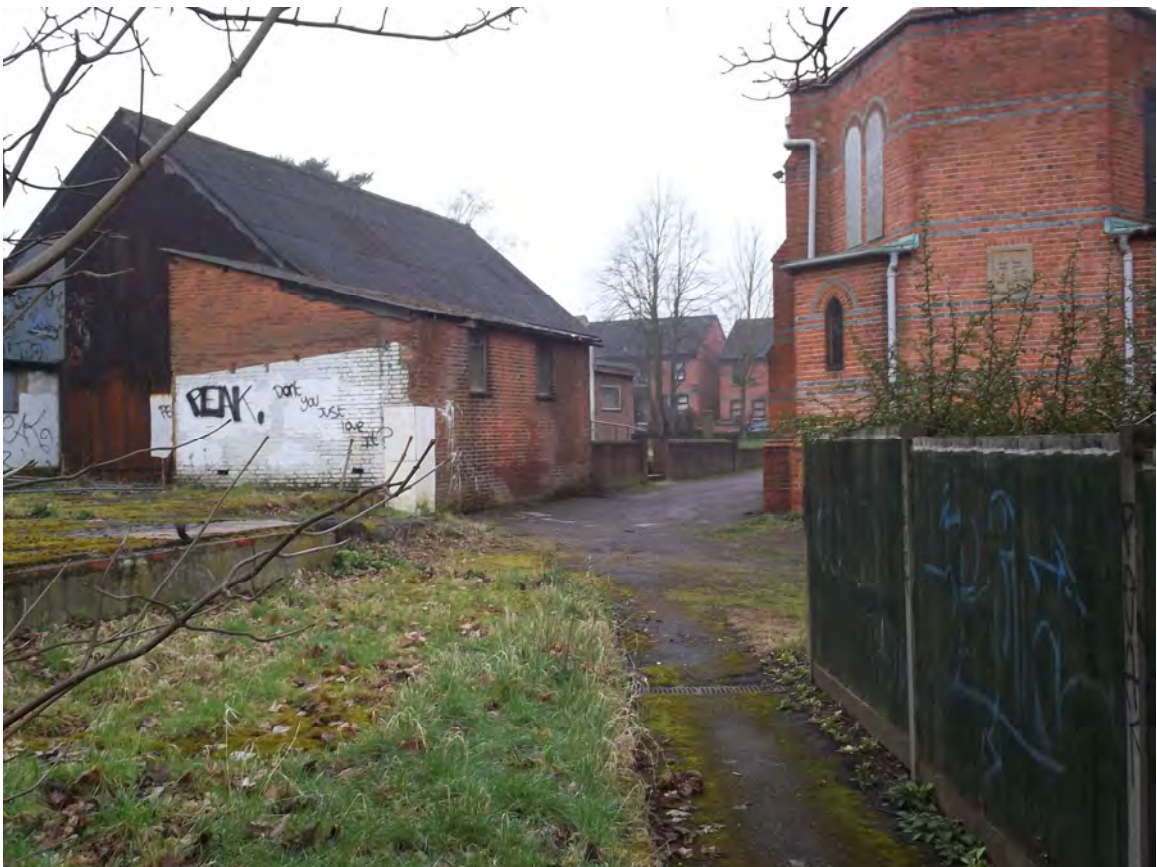
- 2.2.11 Localised areas of standing water were observed in the grassed area of the site. A surface water drain was observed within the tarmacadam hard standing area of the site. In addition a number of manhole covers were observed at the ground surface (Photograph 2).

Photograph 2: Area of land to rear.

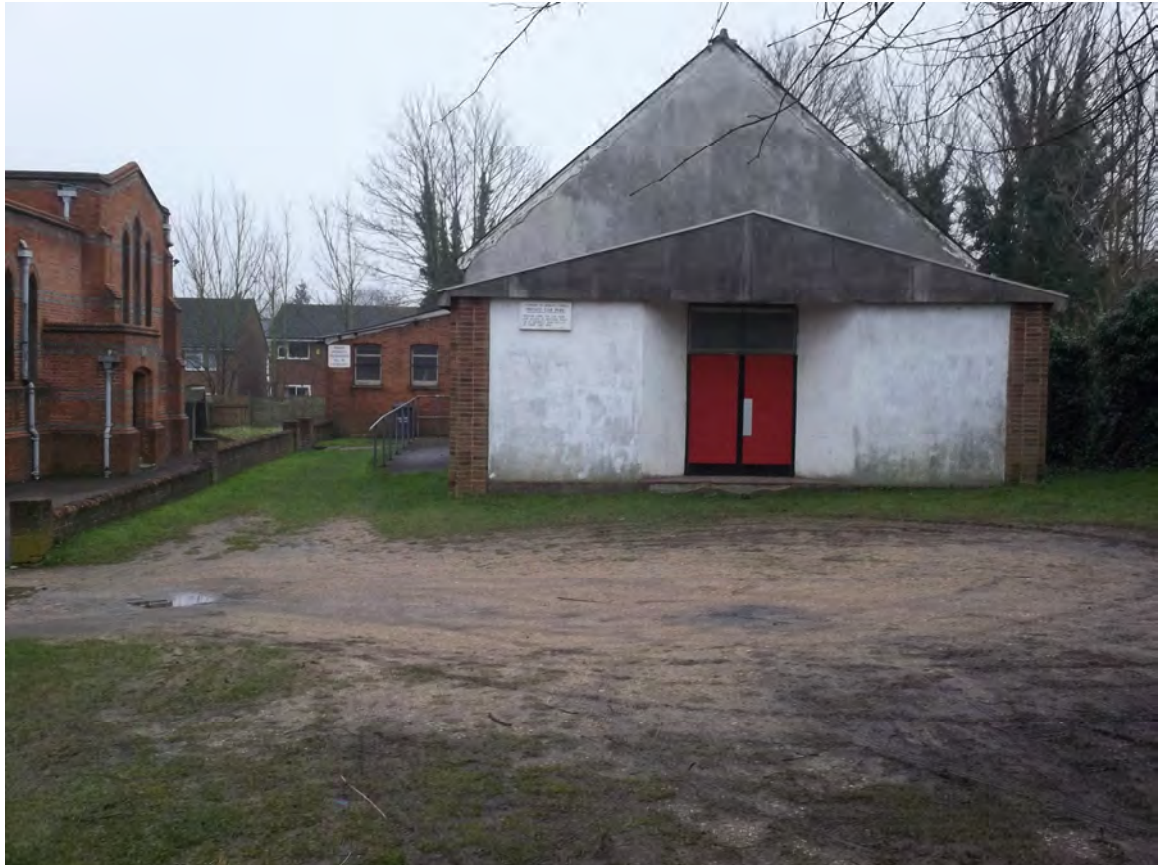
Photograph 3: Front of current Hall building
