## **BAT SURVEY AT 26 WOODS ROAD CAVERSHAM**

**Prepared for:  
BuildVantage Limited  
104-106 Cranbrook Road  
Ilford  
Essex  
IG1 4LZ**

**15<sup>th</sup> September 2015**

**Ref: SPH/PBS-01/15.09**

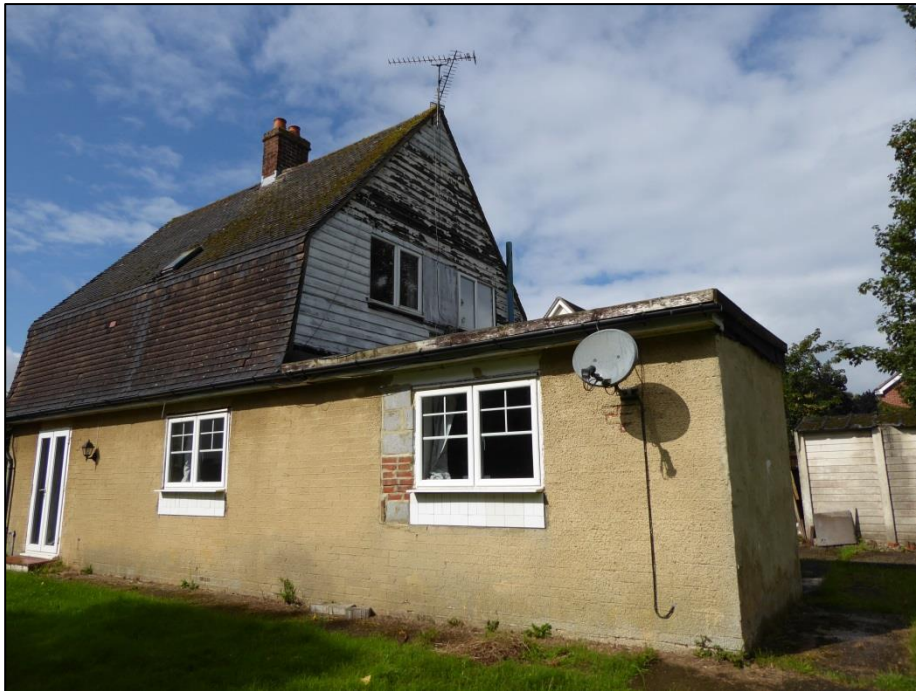
The application site contains a two storey detached house with detached garage at the rear. The property and garage are unoccupied and in a poor state of repair, see pictures at Figure 3 and 4. The property has a single storey, flat roofed front porch and rear kitchen extension. The remains of the application site comprised of a garden that is laid mainly to grass with herbaceous shrubs and large trees around the boundary.

Figure 3. Rear aspect of 26 Woods Road. 15.09.2015.

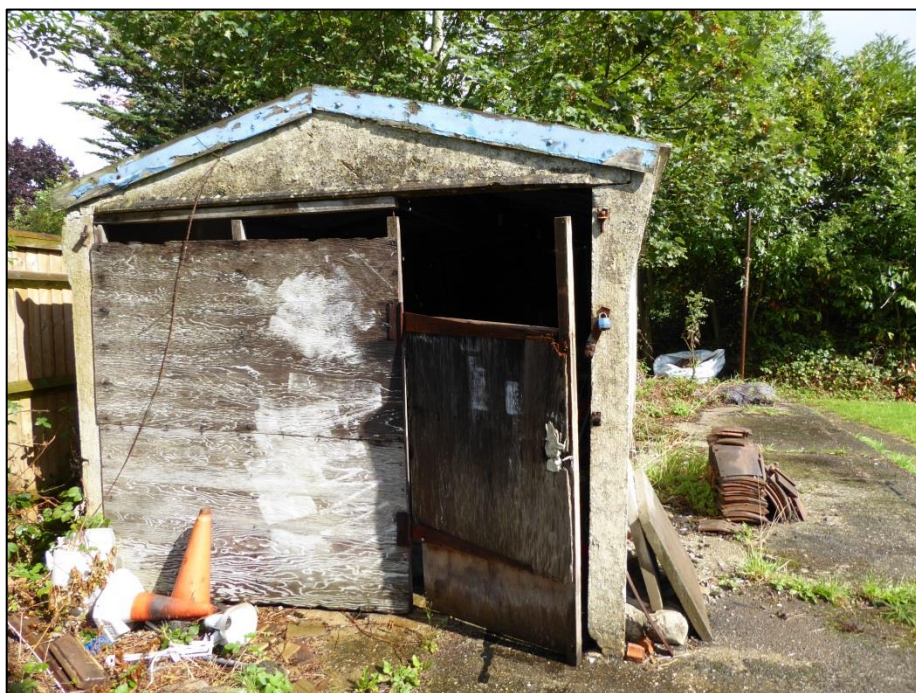
Figure 4. Garage of 26 Woods Road. 15.09.2015.

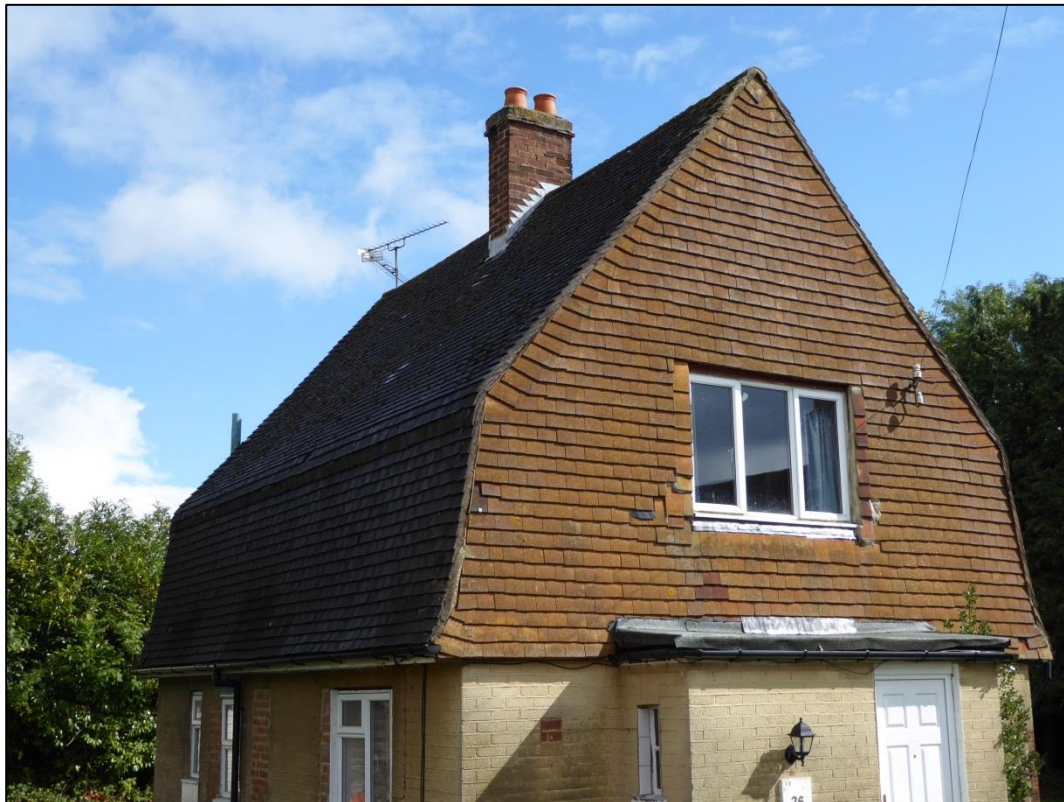
The property inspected is of standard brick construction with a gambrel, clay tiled roof. There are hanging tiles on the south west elevation and timber cladding on the north east elevation. The roof alignment is broadly north east to south west. There are gaps in the roof tiles and hanging tiles, see images at Figure 6 and 7 on the next page. During the external survey no sign of recent or historic bat use was observed.

Figure 6. 26 Woods Road, gaps in hanging tiles. 15.09.15.

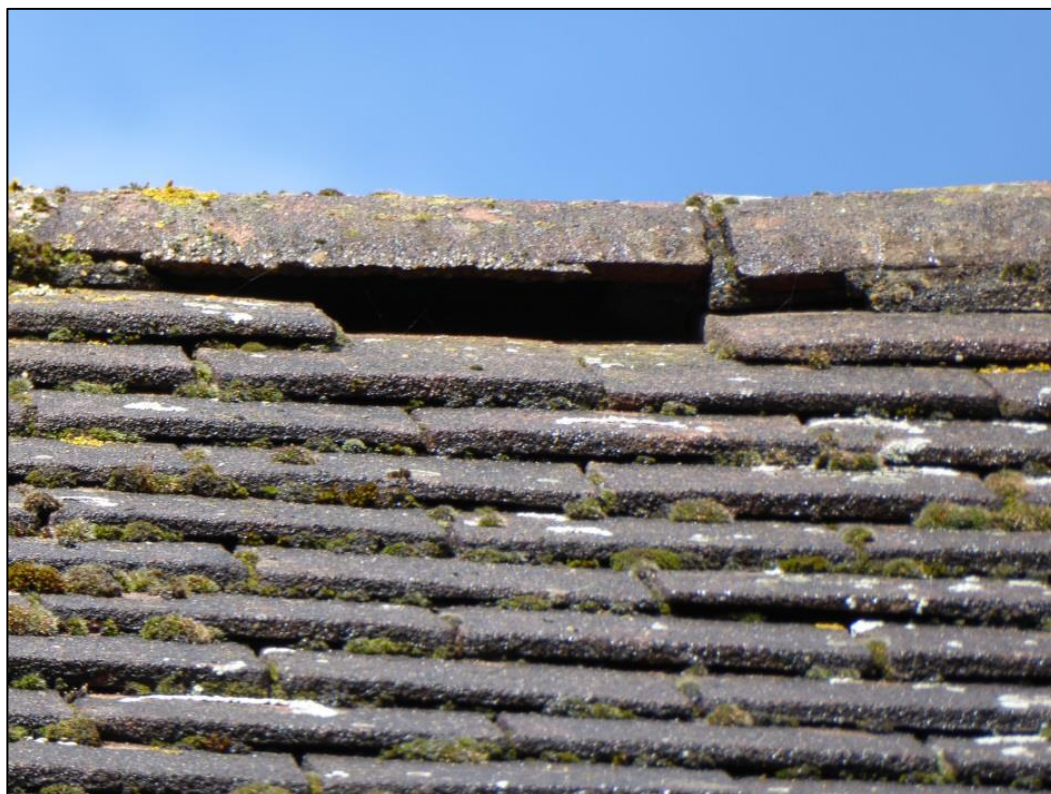
Figure 7. 26 Woods Road, Gasp in ridge. 15.09.15.

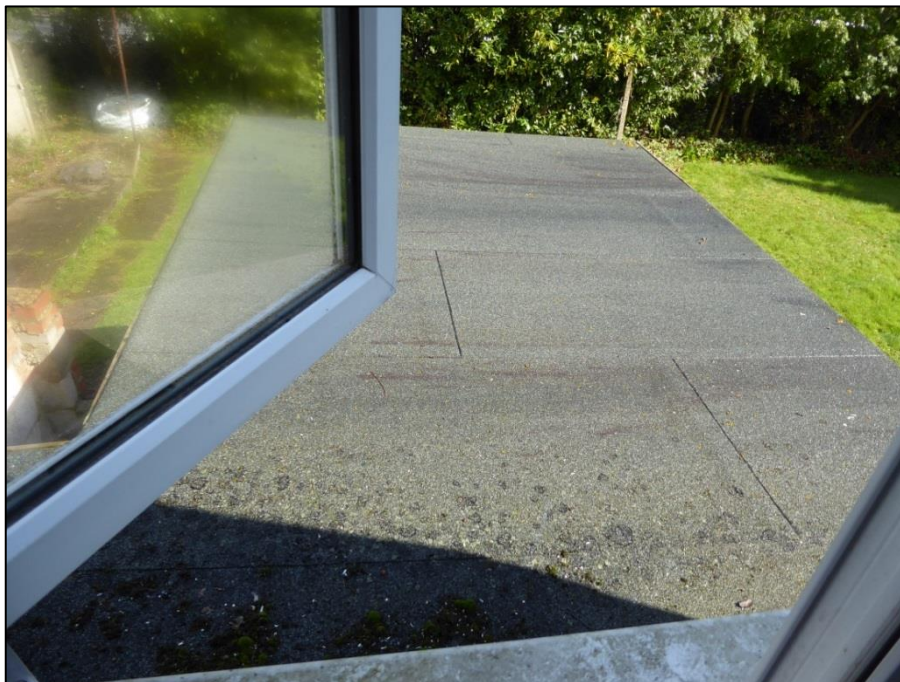
The rooves over the porch and kitchen extensions are covered in bitumen felt and are in good condition, providing no access for bats to exploit, see photos at Figure 8.

Figure 8. 26 Woods Road, rear kitchen roof, 15.09.15.

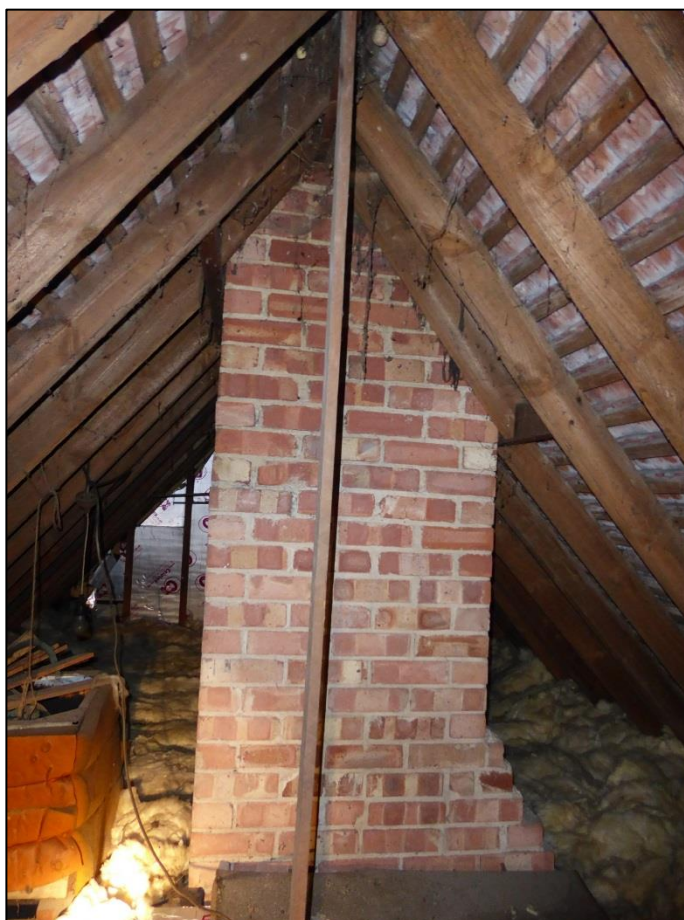
The main roof void is accessed from a bedroom on the first floor. The roof consisted of a main void with central chimney stack, the floor is partially boarded, with a deep layer of insulation, see Figure 9. The roof has no lining exposing the roof tiles and various gaps were observed making the roof void cold and draughty.

Figure 9. 26 Woods Road, roof voids, 15.09.15.

The roof void was examined for any signs of bats (as described in section 4.2). The condition of the loft areas indicated that it had not been cleaned or tidied recently and no recent or historical signs of bats were observed.

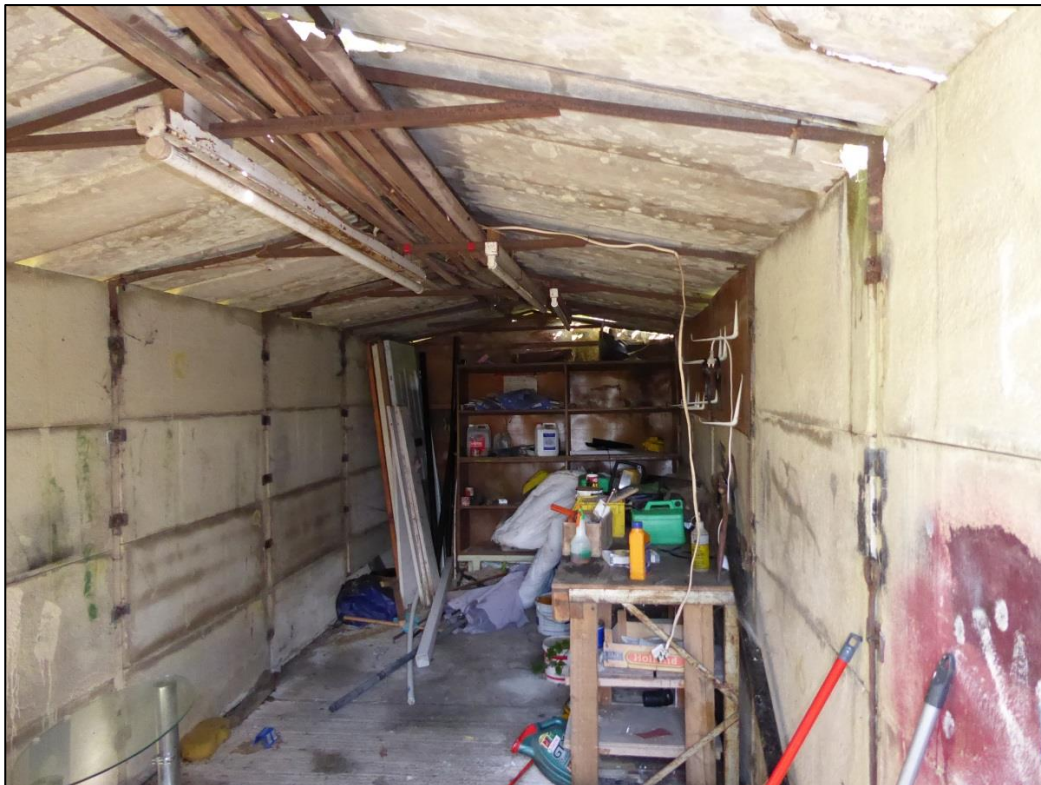
The garage was examined for any signs of bats (as described in section 4.2). The garage roof consists of concrete or asbestos sheets with various gaps, making the space cold and draughty, see photo at Figure 10.

Figure 10. 26 Woods Road, internal view with gaps in garage roof, 15.09.15.

The condition of the garage indicated that it had not been cleaned or tidied recently and no recent or historical signs of bats were observed.

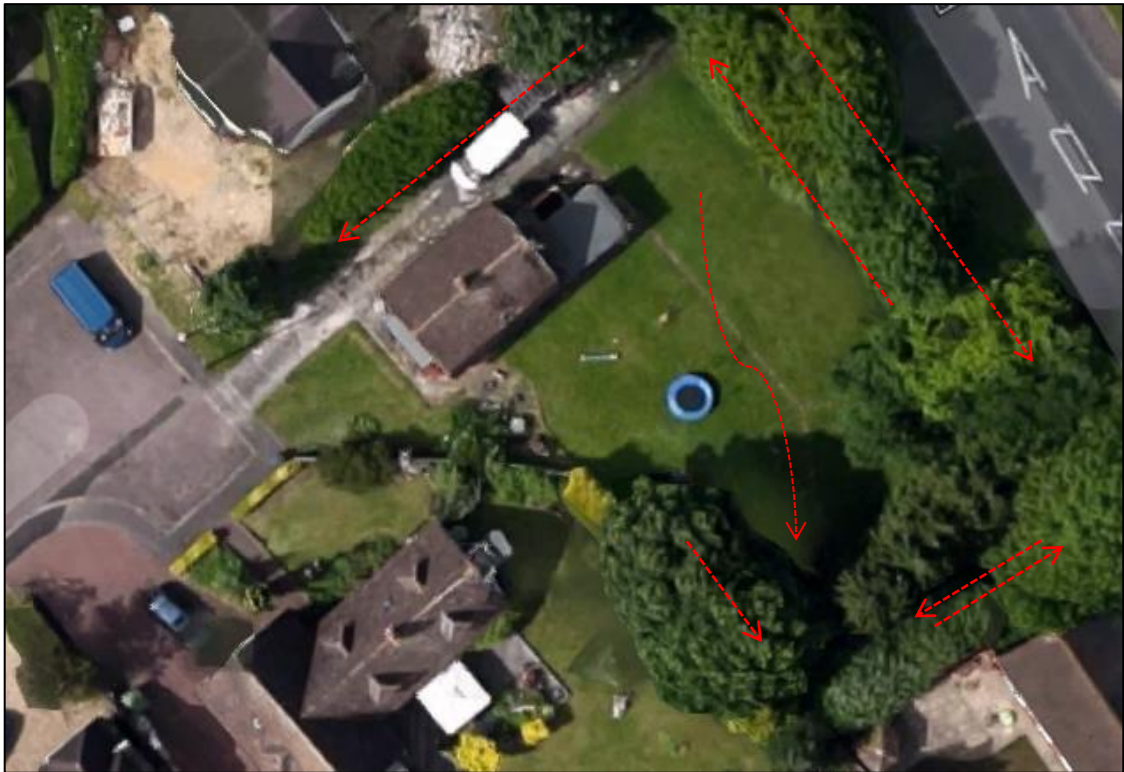
During the dusk survey no bats were seen emerging from or returning to the house or garage to roost. In total four different species were recorded foraging within the vicinity of the house and commuting across the site. Bat passes were low around the site, a simple summary of the bats recorded can be seen in Table 2 on the next page and the most frequently used flight paths are shown in Figure 11 below.

Figure 11. Commonly used bat flight paths at 26 Woods Road. 27.09.15.
