## **Bat Scoping Survey; 60 Redlands Road, Reading, RG1 5HU**

**Author: Ryan Walker**

**4st June 2015**

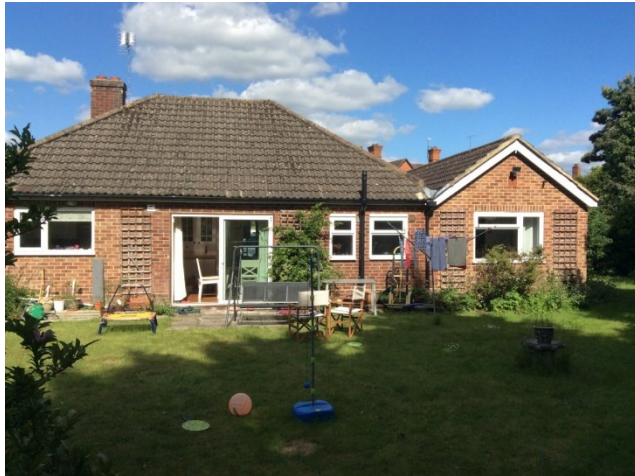
The small, modern brick bungalow supports two areas of pitched roof (Fig. 2). The roof is clad in modern, concrete, interlocking roof tiles (Fig. 2). These tiles are well fitting and devoid of gaps that could be considered suitable for potentially supporting crevice roosting bats. The modern PVC soffits are well fitting and devoid of gaps (Fig. 3). The brick work is in good condition, whereby there are no gaps within the bricks or masonry. All of the external aspects of the bungalow upon the west facing elevation are in good condition, devoid of gaps, and unsuitable for potentially supporting roosting space for crevice roosting bats.

**Figure 2.** The west facing elevation proposed for development within the bungalow at 60 Redlands Road.

The results of the survey suggest that the west facing elevations and roof voids of the bungalow at 60 Redlands Road, proposed for development, have a negligible potential to support roosting bats. Therefore no further survey work or mitigation in relation to bats is recommended.

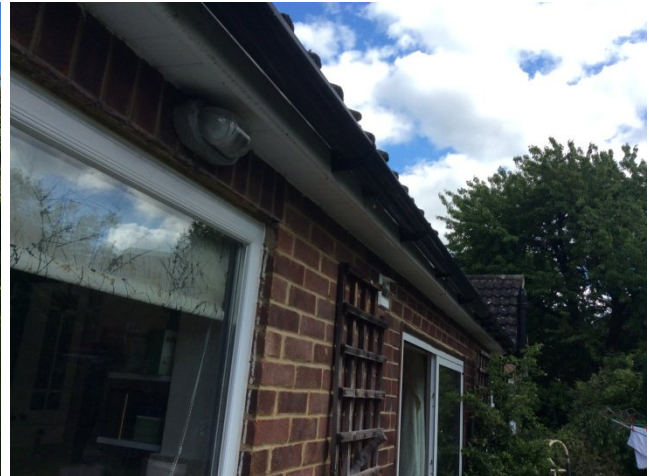
**Figure 3.** Well fitting, PVC soffits upon the west facing elevation of the bungalow at 60 Redlands Road.

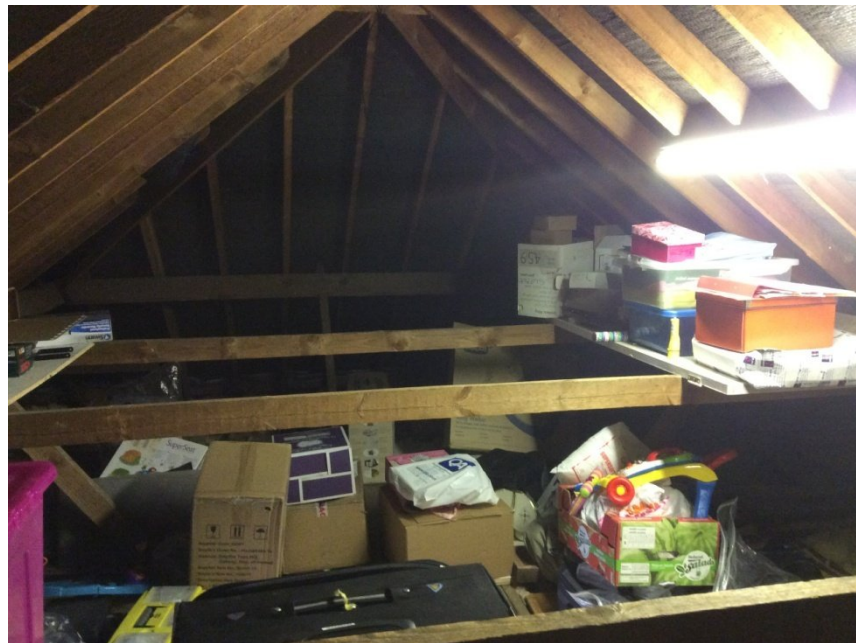
The bungalow supports two roof voids. The void within the northern section of the bungalow is large, measuring approximately 3m in floor to apex height and approximately 9x12m in floor space. The void supports a timber frame and is internally clad in bitumen roofing felt (Fig. 4). There are no obvious potential entry or exit points within the void, that could be used by roosting bats. There is no evidence to suggest that the void has been used by roosting bats within the recent past.

**Figure 4.** The larger, timber framed roof void within the northern section of the house at 60 Redlands Road.
