**73 Brunel Road  
Reading  
Berkshire  
RG30 3JJ**

## **Daylight Bat Survey**

Ref: R1278/a

**December 2015**

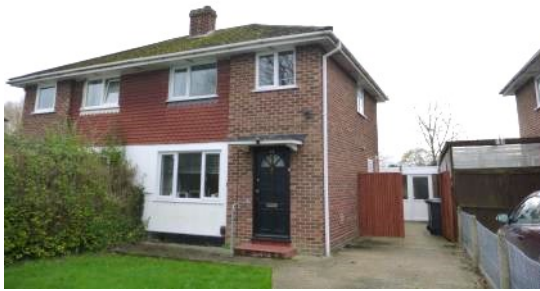
- 3.2.1** The semi-detached house had a hipped roof covered in interlocking roof tiles (**Photographs 1 & 2**).
- 3.2.2** The interlocking concrete roof tiles were all in place and tightly fitted, offering limited access and roosting opportunities for bats (**Photograph 3; Target note 1**). The hip and ridge tiles were all in place and mortared fully on the front and side elevation (**Photograph 4; Target note 2**). Mortar was missing from underneath one hip tile on the rear roof elevation; however the gap was only superficial and considered unsuitable for use by bats (**Photograph 5; Target note 3**).

1. Front of the house viewed from the north

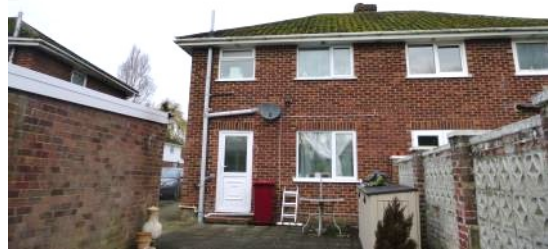
2. Rear of the house viewed from the south.

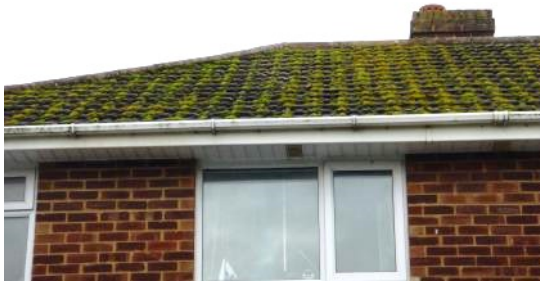
3. Interlocking roof tiles tightly fitted on the roof.

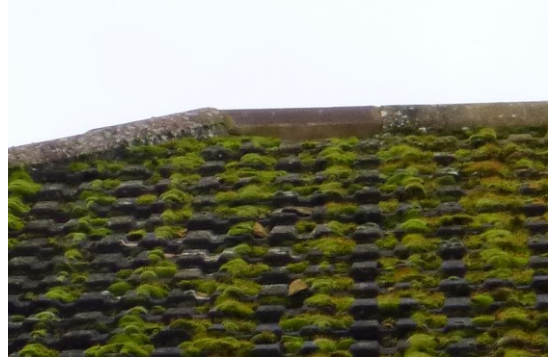
4. The ridge and hip tiles all in place and mortared fully.

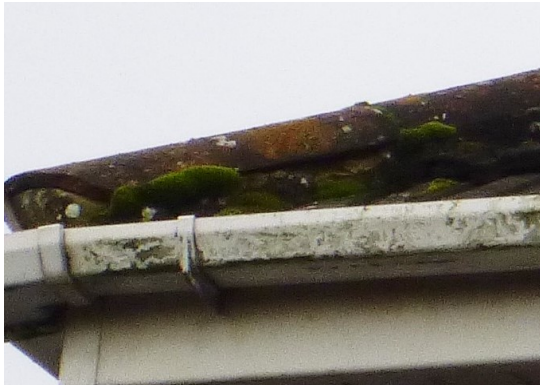
5. Mortar missing from a hip tile to the rear of the house.

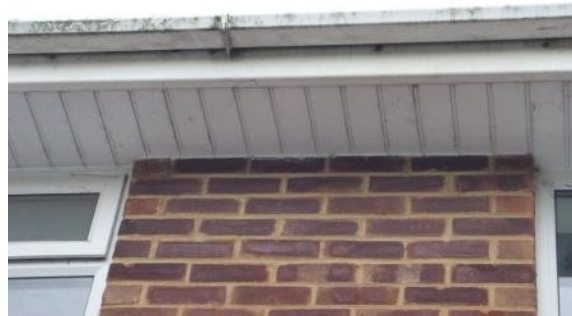
- 3.2.3** Soffits boxes around the eaves of the house were sealed tightly to the brickwork walls and window frames (**Photograph 6; Target note 4**). Lead flashing was tightly fitted around the chimney with limited roosting and access opportunities for bats (**Target note 5**). A number of gaps were present behind the hanging tiles on the wall to the front of the house in particular around the bottom corners of the window (**Photograph 7; Target note 6**),

6. Soffits boxes around the eaves of the house sealed tightly to the brickwork walls and window frames.

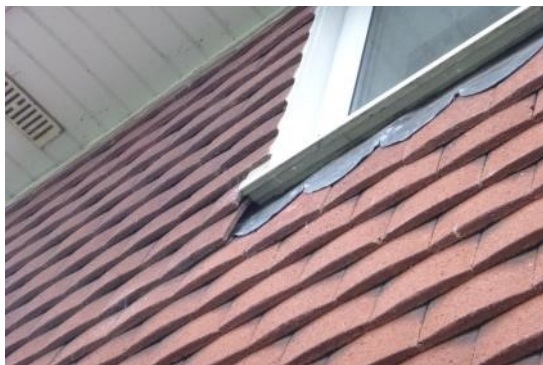
7. Gaps behind hanging tiles around window to the front of the house.

- 4.1.1** The only external features the house had suitable for crevice dwelling bats, were the gaps behind the hanging tiles to the front of the house; however the planned extension will not have an impact on the tiles and they will be retained as existing. Therefore, in the absence of any evidence of the presence of bats, it is considered highly unlikely that the planned work to extend the property will have any impact on bats or their roosts.
- 4.1.2** In the unlikely event that bats are encountered during the course of the building work, the work should stop immediately and a licensed ecologist called to site to attend to the bat and provide advice on how to proceed; work should not continue until further written advice has been received. At this point, a European Protected Species licence may be required to permit the work to continue lawfully.

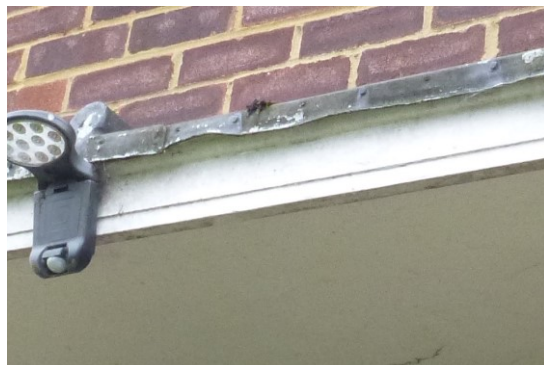
- 3.2.4** A narrow gap was present behind the lead flashing on the flat roof above the front door, which was thickly cobwebbed and didn't lead into any crevices suitable for roosting bats (**Photograph 8; Target note 7**).

8. Narrow gap behind lead flashing on the porch to the front of the house.

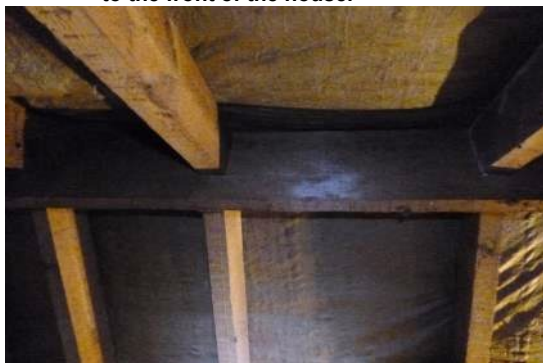
- 3.3.1** The roof space was accessed through a loft hatch and had an estimated floor to ridge height of 1 ½ - 1 ¾ metres. The hipped roof was of 'cut and pitch' construction with a ridge beam which was lightly cobwebbed throughout (**Photograph 9; Target note 8**). The roof was lined with paper covered roofing felt, which had a number of gaps present including where the felt overlapped, where it was sagging and holes were visible exposing the undersides of the roof tiles especially at eaves level (**Photograph 10; Target notes 9 & 10**). The floor of the space was boarded with fibreglass insulation which had been installed in 2014. The eaves were mostly filled with fibreglass insulation (**Photograph 11; Target note 11**).

9. The hipped roof with a ridge beam which was lightly cobwebbed.

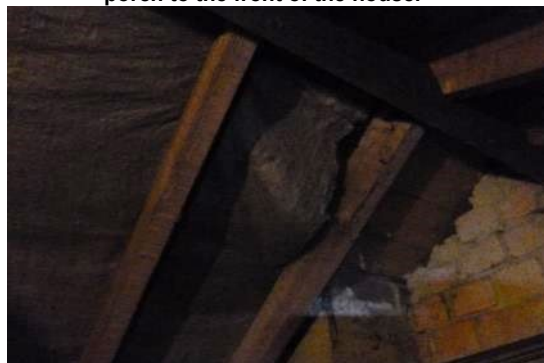
10. Paper backed felt sagging in places.

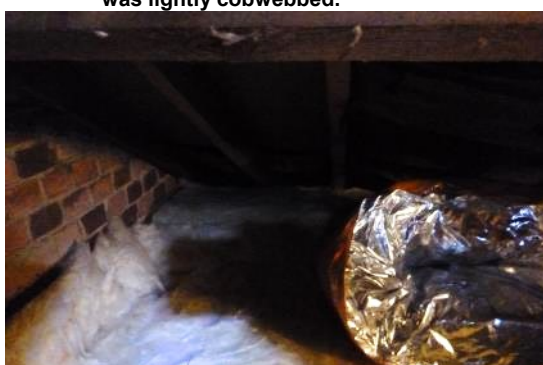
11. Fibreglass insulation extending to the eaves.

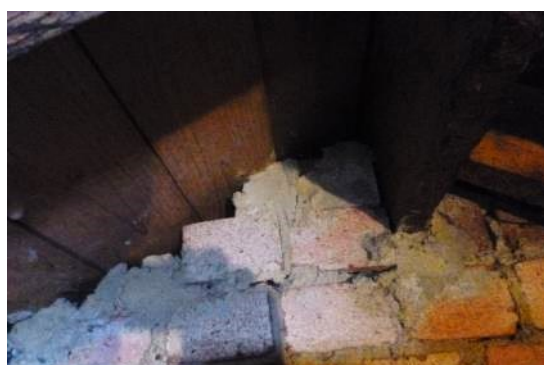
- 3.3.2** Gaps were visible around the blockwork of the internal dividing wall leading into the neighbouring property (**Photograph 12; Target note 12**). The chimney also had gaps where the felt was loose which were cobwebbed (**Target note 13**).

12. Gaps visible around the internal dividing wall.
