## **Reading Abbey Revealed: The Abbey Gate – Heritage Statement**

**The Forbury, Reading  
September 2015**

Historic Buildings Team, HCC Property Services,  
Three Minsters House, 76 High Street, Winchester, SO23 8UL

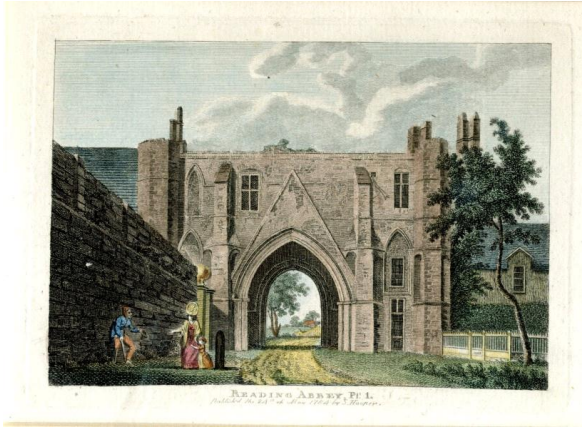
4. Engraving of the north side of the Gate in 1769  
soon after it lost its battlements  
Paul Sandby Reading Borough Council

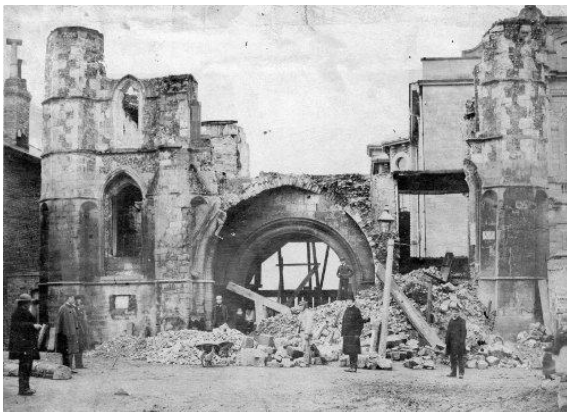
6. Partial collapse and dismantling in 1861  
Reading Borough Council

The ownership of the Abbey Gate (Inner Gate) was split either side of the archway but both parts were sold to the Corporation during the 1850s just in time for the collapse of the archway vault and its subsequent comprehensive reconstructive restoration by Gilbert Scott in 1861. His work is considered to be a faithful reconstruction of the exterior as it appeared in the 13<sup>th</sup> century, though the interior is unexceptional with few features and has been much adapted since. In 1859-61 the new county assize courts (now the Crown Court) were built immediately to the west of the gate facing the Forbury Gardens.

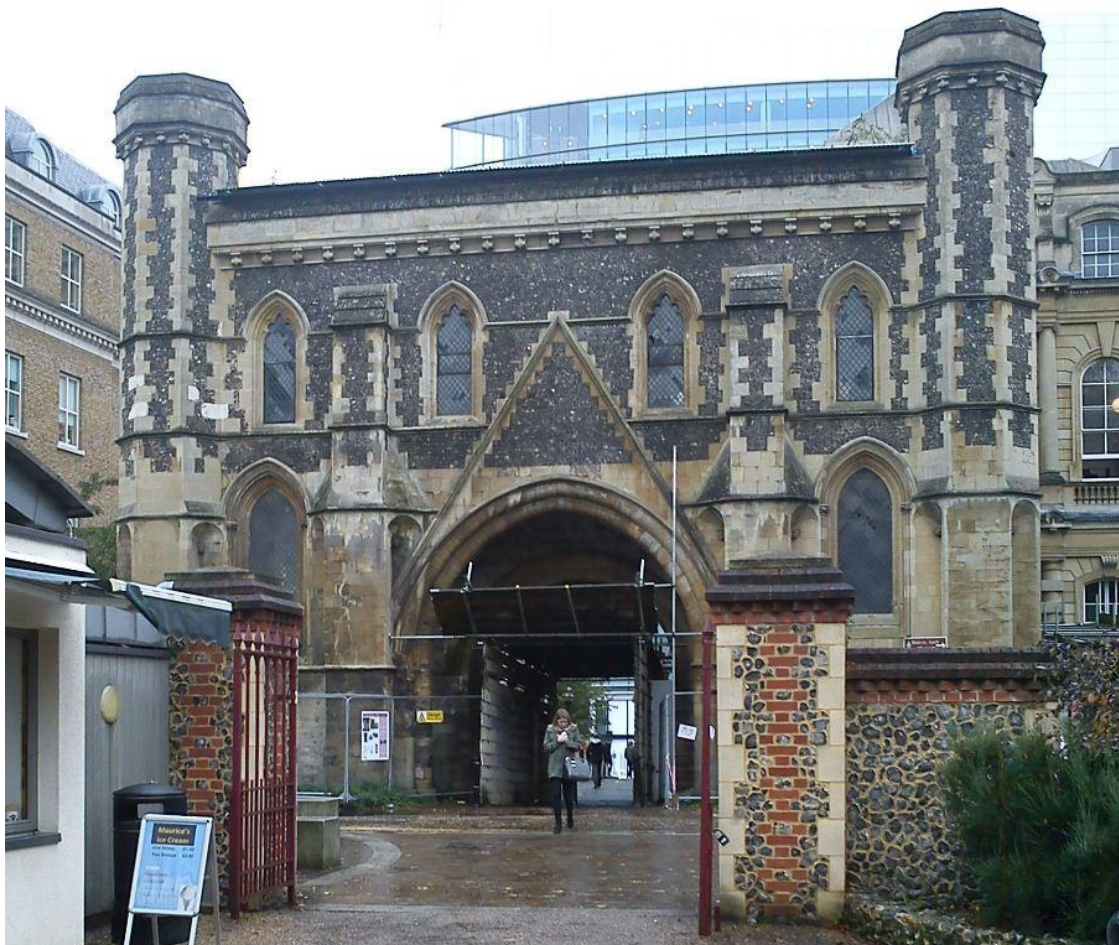
8. Photograph of the north side of the Gate in its current state with scaffolding fans, fencing and temporary roof in Place. This photograph and front cover HCC Property Services

Given the urgent need to stop water getting into the building in order to stop further damage to the fabric Reading Borough Council installed a temporary scaffolding supporting a sheeting roof and downpipes. This is allowing the fabric to dry out thoroughly before permanent repairs can be undertaken.

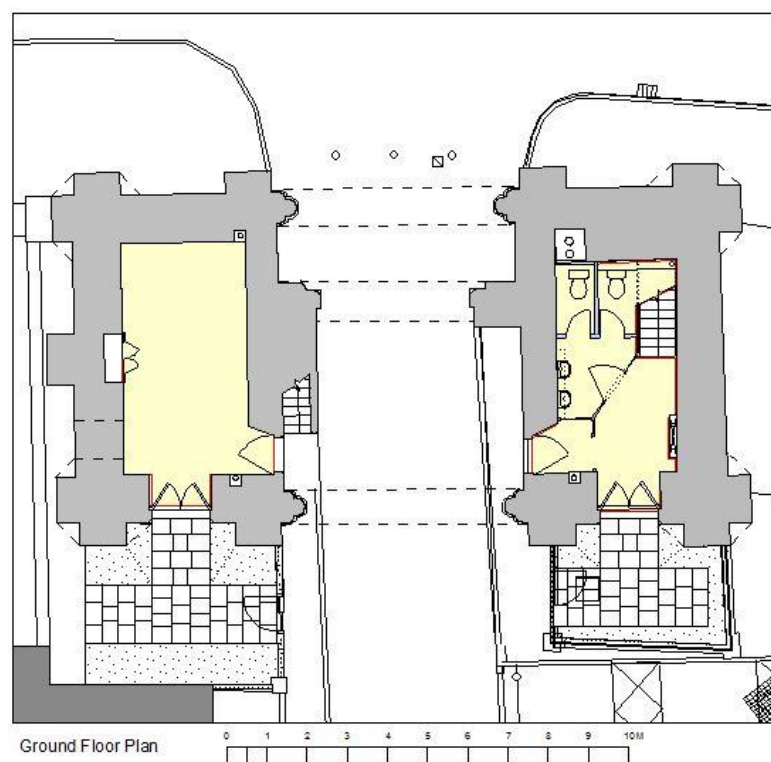
Ground Floor Plan

2. Ground floor east side: removal of twentieth century kitchen fixtures. Installation of timber frame partitions and two toilets, water supply and drainage. Stub stack and below ground branch foul drain connection.

4. External works: dismantling of yard wall on south east side of the Gate and its replacement with railings on a dwarf wall. Landscaping of yard areas on both sides on the south side of the Gate.

The removal of this masking wall will enable the whole of the south elevation of the Gate to be seen from Abbey Street. In the process of doing this the unsightly exposed footings of the existing wall will be removed and will be replaced by a dwarf wall built to same line re-using the bricks to be salvaged from the wall and surmounted by relatively transparent railings.
