07<sup>th</sup> May 2015  
Our reference: Garrard House

Bridgeway Consulting Limited was asked by Andmore Planning and Titan Property Developments to provide an ecological assessment of Garrard House (30 Garrard Street, Reading RG1 1NR) following communication from you regarding the possibility to have black redstarts nesting at Garrard House.

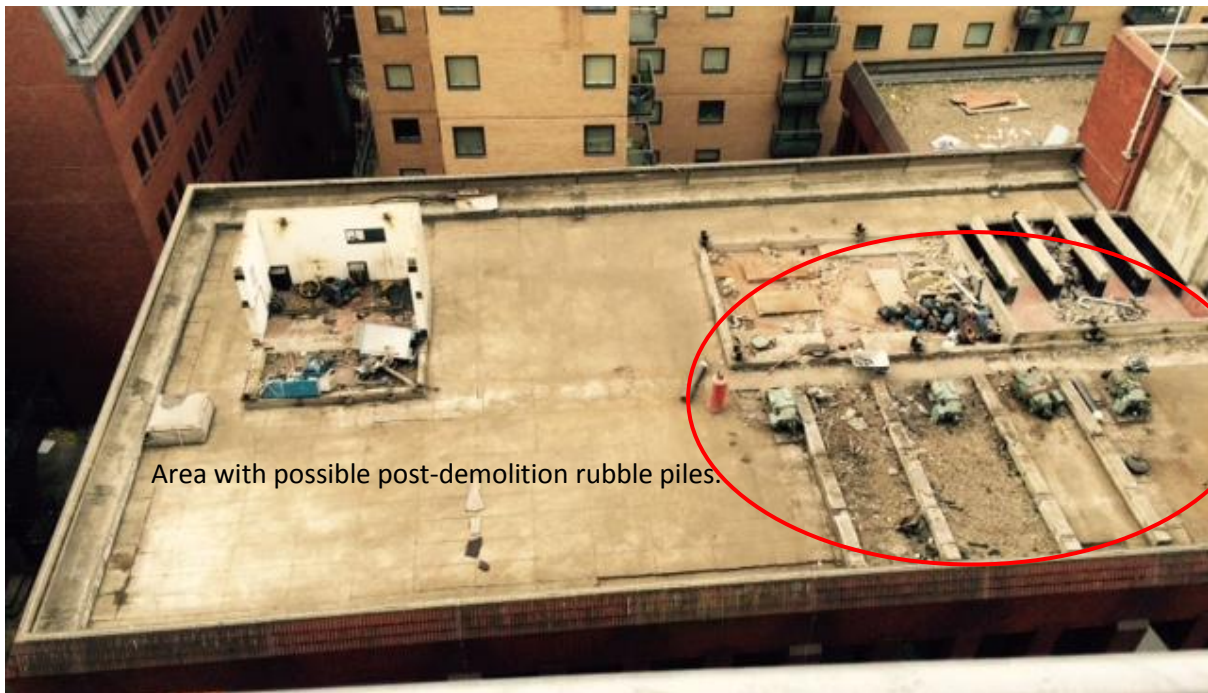
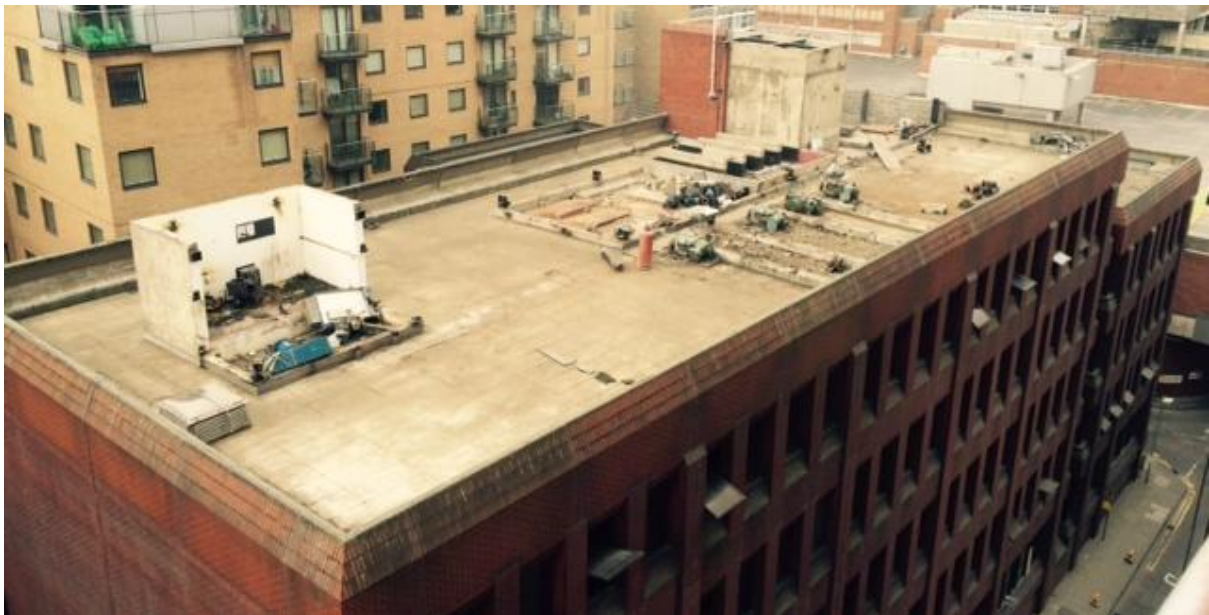
Photograph of the rooftop used for the production of this letter (far away pictures):

- The rooftop comprised of concrete slabs and buildings (before demolition) without gravel or rubble piles and as such black redstarts would have been unlikely to be breeding there due to the absence of suitable habitats. From the further away pictures, it appeared that there were possible post-demolition rubble piles on the rooftop however, close up pictures of the area showed the rooftop to be clear of rubble and gravel with the concrete slabs intact; and,
- The absence of soil material makes it highly unlikely that an invertebrate population is present on the rooftop and as such, the rooftop would have been unlikely to be used by black redstarts for foraging.

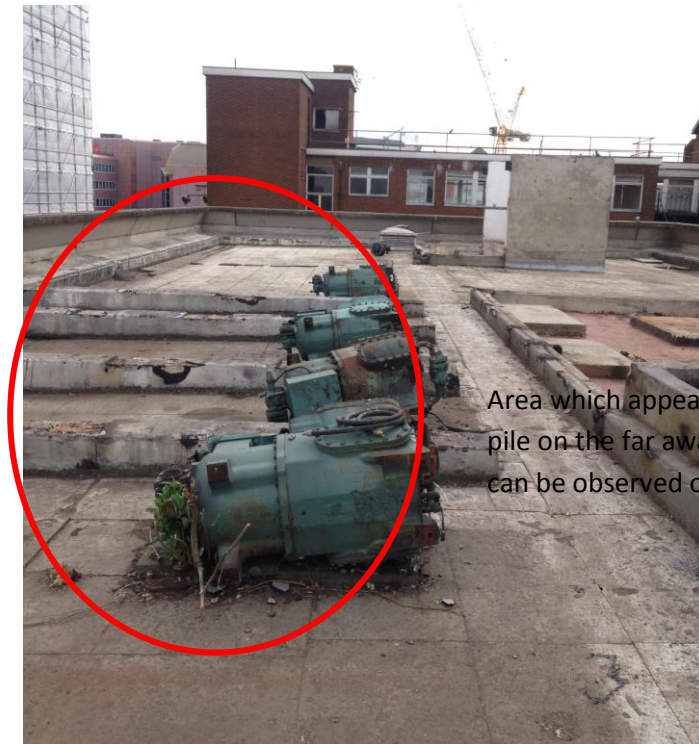
Photograph of the rooftop used for the production of this letter (close up pictures):

Area which appeared to have had gravel/rubble pile on the far away photograph but no piles can be observed on the close up photograph.
