**Bat Survey Report for  
Tonilla,  
Upper Warren Avenue,  
Caversham,  
Reading, RG4 7EB**

Tonilla, Upper Warren Avenue, Caversham, Reading - Bat Survey Report

Report Number: 42024-01 NKM Assoc

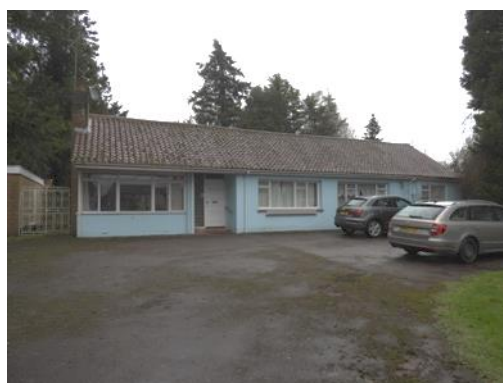
**Fig. 1 Detached pitched roofed bungalow**

The survey site comprised a detached pitched roofed bungalow with extended pitched roofed gables to its rear and a detached flat roofed garage (Fig. 1).

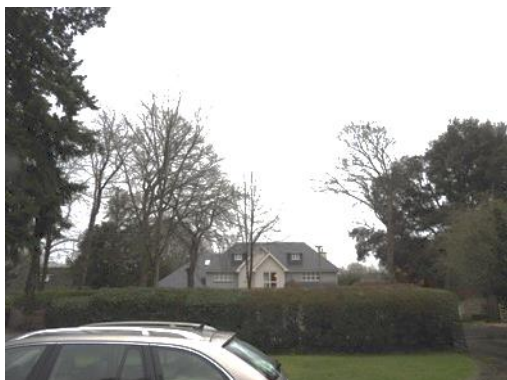
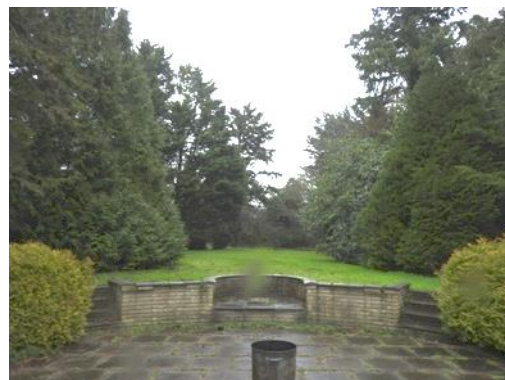
**Figs. 3 & 4 Views to the front (L) and rear (R)**

To the front of the bungalow and garage was a hard surfaced drive, an area of lawn, hedgerow to the south and mature trees on its side boundaries and in the distance (Fig. 3). The rear garden had a paved patio area adjoining the bungalow with a central lawned area with large mature trees on the boundaries (Fig. 4).

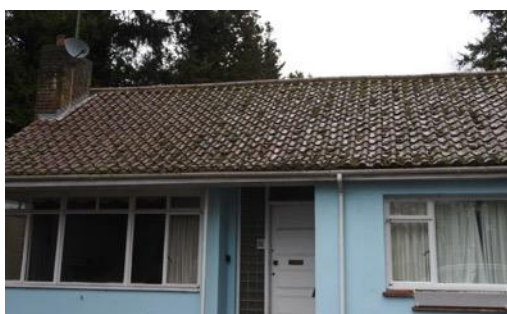
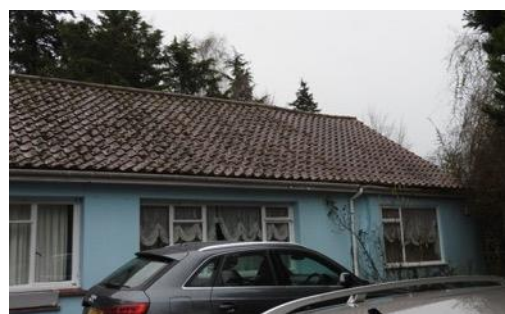
**Figs. 5 & 6 Ridge and roof tiles to the front**

All the ridges were intact and sealed, whilst all the roof tiles were tightly overlapping with no broken, dislodged or missing tiles observed (Figs. 5 – 13).

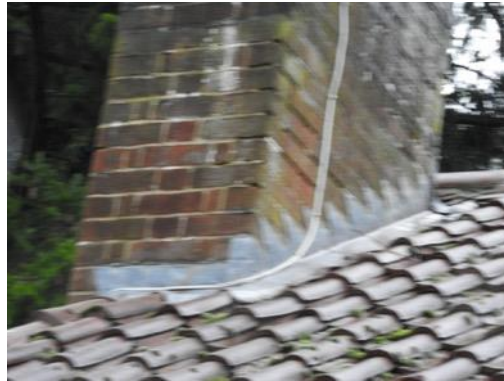
**Fig. 14 Tightly moulded lead flashing**

The chimney base was sealed with tightly moulded lead flashing (Fig. 14).

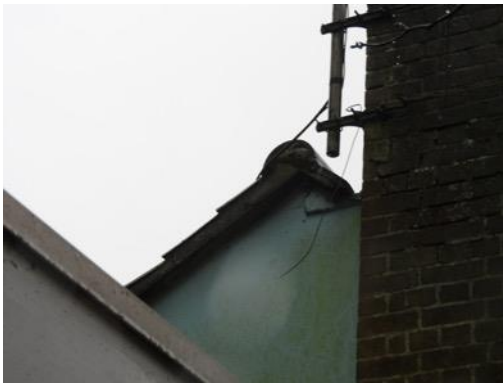
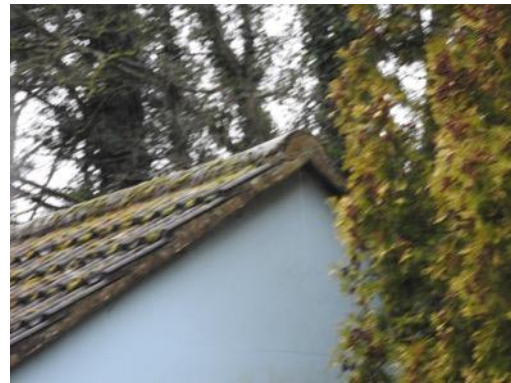
**Figs. 15 & 16 Sealed gables to the west and northwest**

The gables were sealed with the roof verges cement sealed to the gable wall plates all round (Figs. 15 – 19).

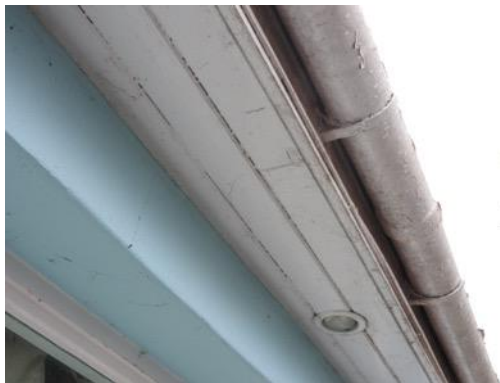
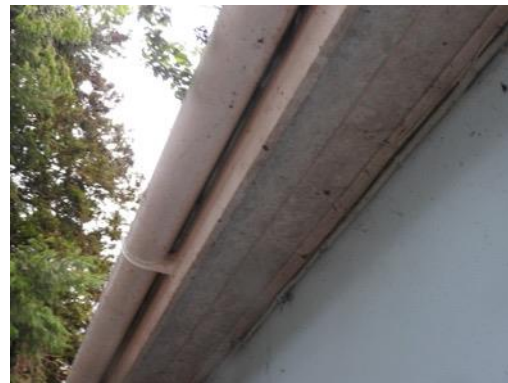
**Figs. 20 & 21 Tightly fitting boxed soffits against the walls**

The eaves were finished with tightly fitting boxed soffits against the walls all round (Figs. 20 and 21).

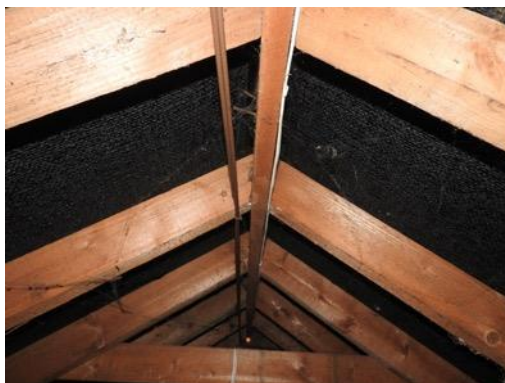
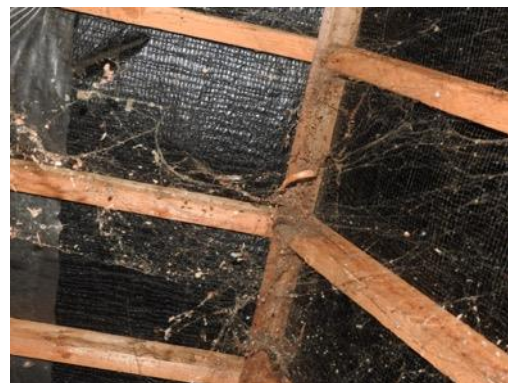
**Figs. 22 & 23 Cobwebbed ridges**

Internally the bungalow had a single roof void including the extensions to its rear. All the roofs were lined with tarred felt in good condition with no holes or tears observed. The ridges, plumb cuts and gable ends were cobwebbed (Figs. 22 – 26).

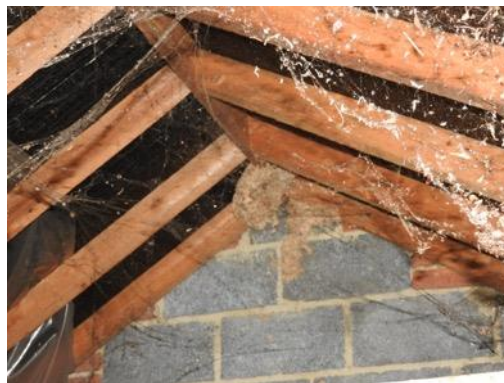
**Fig. 26 Cobwebbed gable end**

No light penetrated the roof void, and no evidence of bat activity was found inside the bungalow.

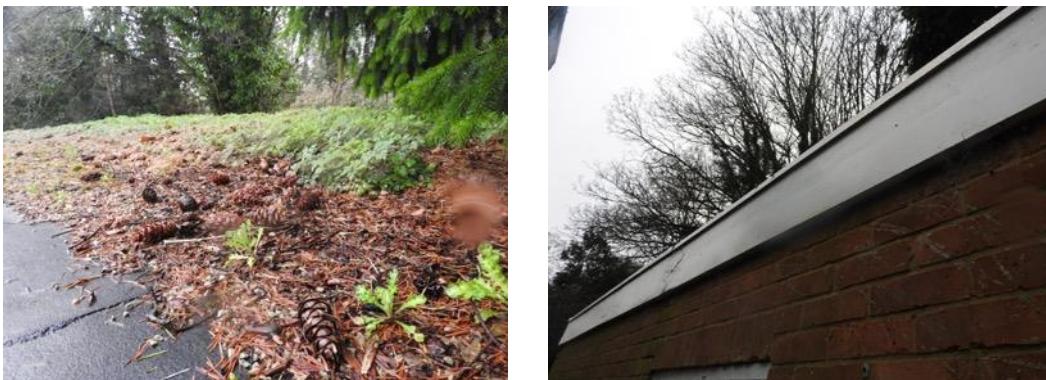
**Figs. 27 & 28 Vegetation covered roof and tightly fitting timber fascia boards**

The flat roof of the garage was finished with tarred felt and a covering of vegetation (Fig. 27). The eaves were sealed with tightly fitting timber fascia boards all round (Fig. 28).

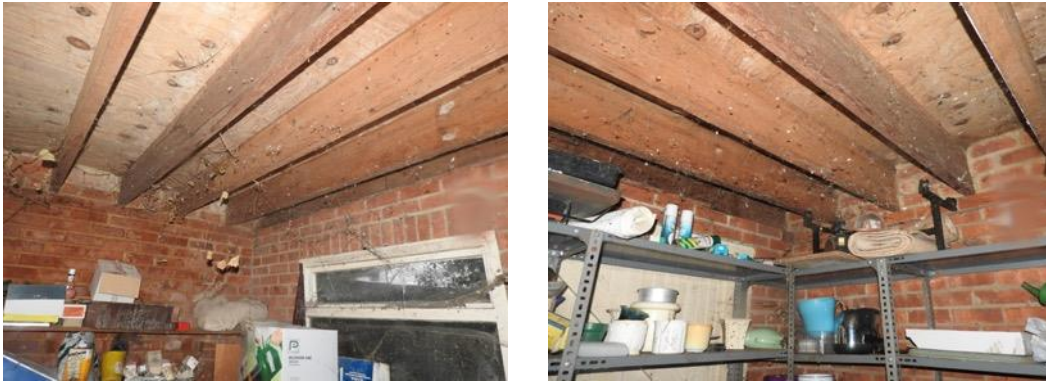
**Figs. 29 & 30 Cobwebbed garage roof**

Internally the garage was open to the underside of the flat roof, this was cobwebbed all over (Figs. 29 and 30).

Light penetrated the garage through the window, and no evidence of bat activity was found inside the garage.
