# Thales Research and Technology Ltd, Worton Grange Industrial Estate, Imperial Way, Reading (Application Ref. 231254 PRE APP) – Ecology Response

## Background

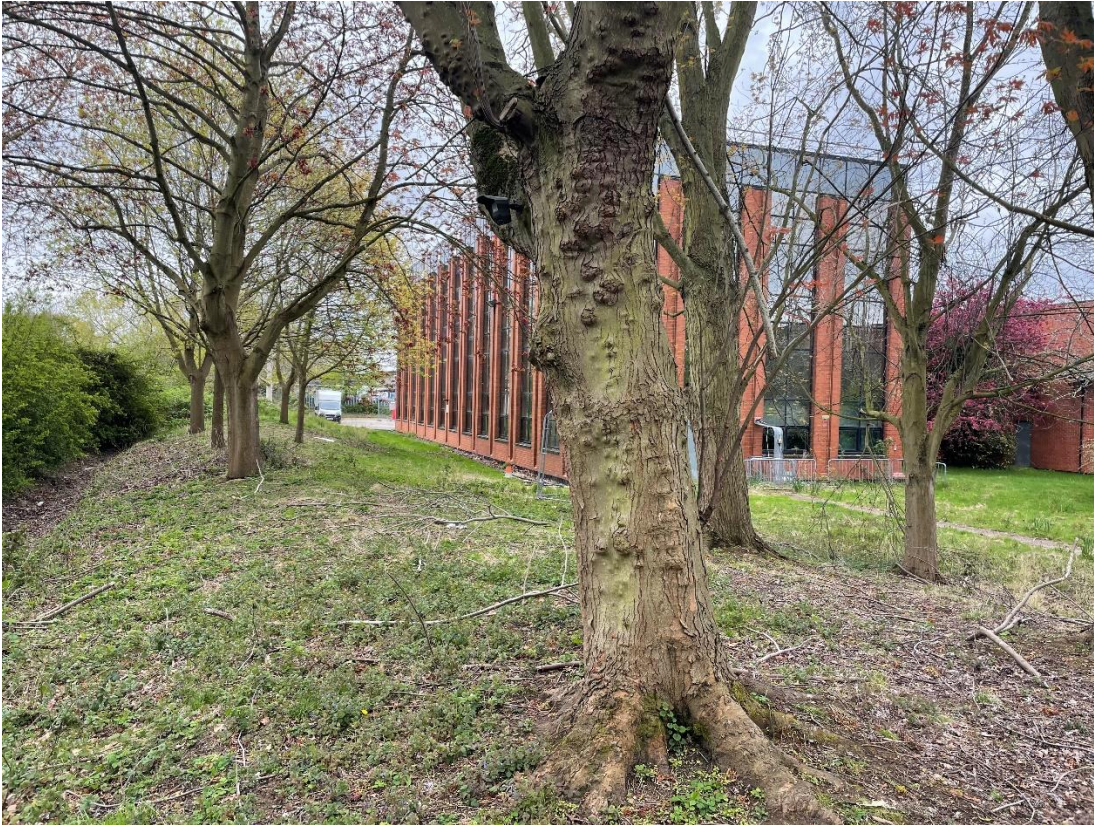
The definition of a watercourse, in this case a ditch, by the Biodiversity Metric 4.0, is an “*Artificially created linear water-conveyancing features which are less than 5m wide and are likely to retain water for more than 4 months of the year.*” The ditch in question was completely dry during our site visits (see photo below) with no evidence of aquatic or damp ground plant species that would indicate the channel holds standing water for significant periods. The channel was also partly overgrown with bramble suggesting it does not provide an important drainage function that necessitates regular clearance and maintenance. On this basis, the feature, judged to be located just beyond the Site boundary, was not considered to be a watercourse or ditch in UKHab or Biodiversity Metric 4.0 terms, and did not support characteristic plant or animal assemblages associated with permanent or ephemeral aquatic habitat.

*Photograph taken April 2023 showing dry ditch on left hand side.*

The project engineers have also reviewed the status of this dry ditch and confirm that it has no meaningful hydrological significance in relation to the Site. They have also noted that the drainage strategy for the new development does not propose to discharge runoff into this ditch, so there will be no change in the volume of water entering it.

In summary, the potential watercourse identified by the RBC officer from OS maps and Google Earth is not (based on field inspection) considered to be a watercourse in ecological or hydrological terms. Policy EN111 (Waterspaces) of the Reading Local Plan 2019 which requires watercourses to be buffered is not therefore considered relevant.
