## **PRELIMINARY ECOLOGICAL APPRAISAL (DBW) AT 8 AVEBURY SQUARE READING**

**Prepared for:  
Mr & Mrs Lyon  
8 Avebury Square  
Reading  
RG1 5JH**

**27 February 2024**

**Ref: SPH/NP/PEA-24/13.02**

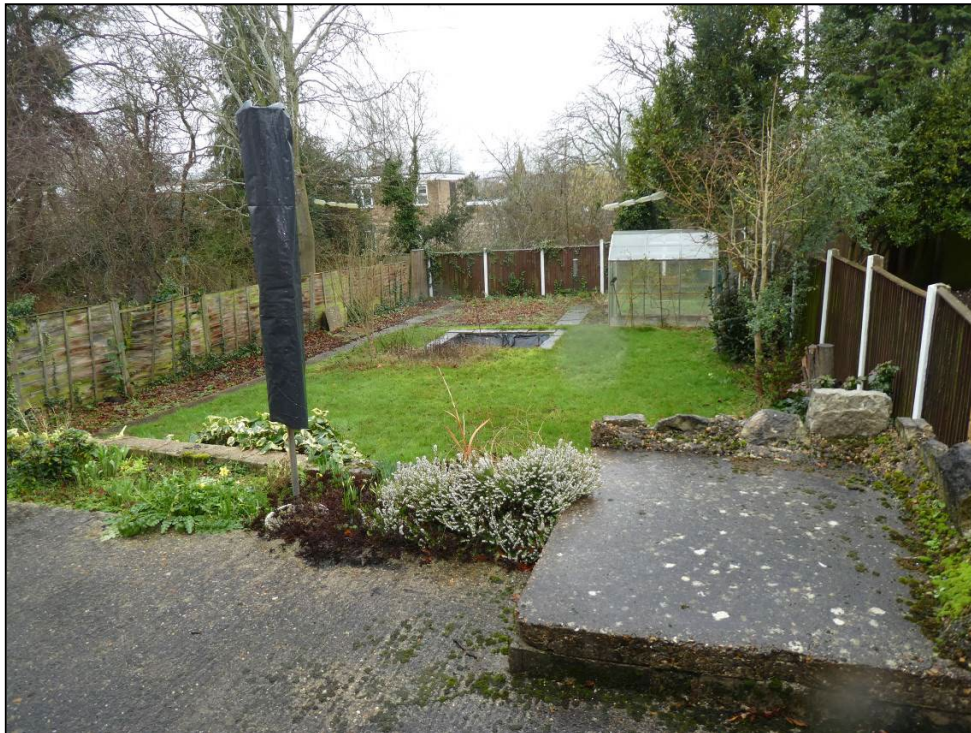
Figure 3. Rear garden. 8 Avebury Square, Reading. 13.02.24

The application site comprises a semi-detached, brick-built dwelling with a single storey side extension connected to the detached single garage. The remainder of the site comprises a tarmac driveway and a rear garden, which has an area of concrete patio and an area of lawn with some shrubs throughout, see Figure 3 below. The site itself offers limited foraging and commuting habitat for bats and there is poor ecological connectivity to the wider landscape.

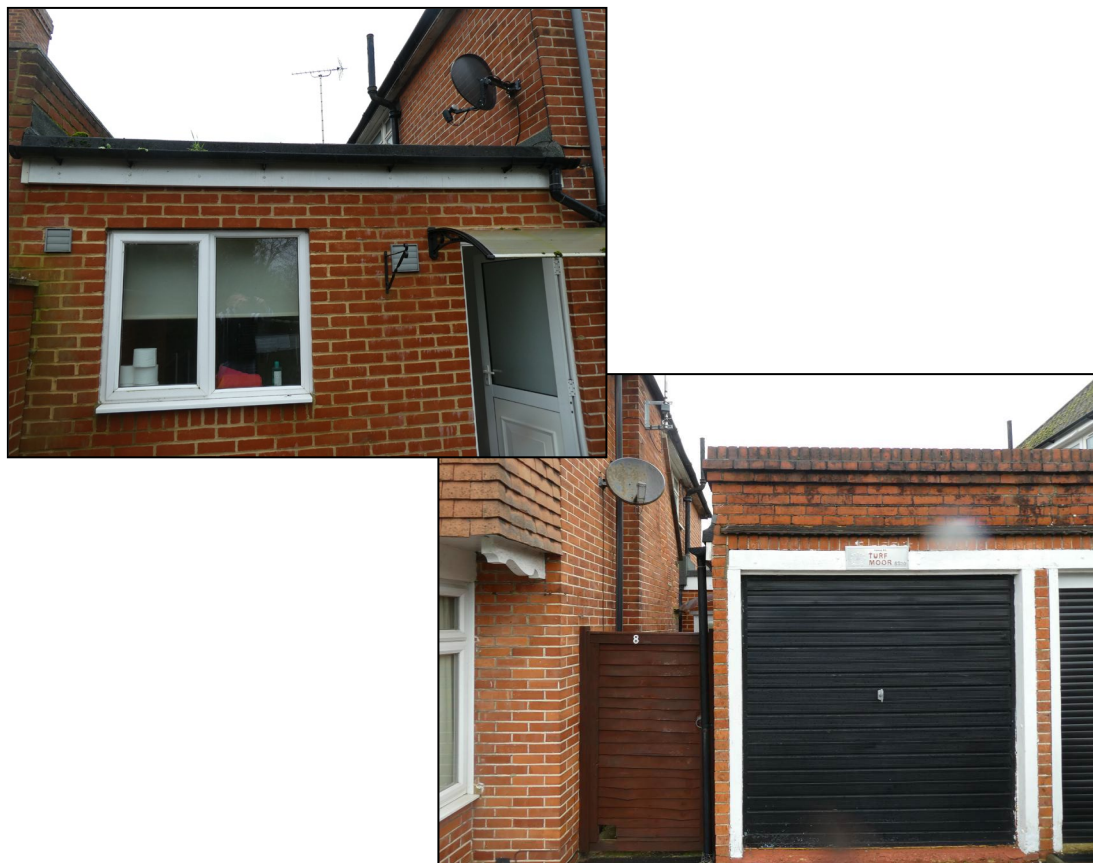
Figure 10. Single storey side extension connected to the detached single garage. 8 Avebury Square, Reading. 13.02.24

On the side elevation is a single storey side extension connected to the detached single garage, see Figure 10 on page 11. The roof of the garage and single storey section of the property is flat and covered in bitumen felt, all of which is in a good condition with no rips or tears which could be used by roosting bats, see Figure 11 on page 12.

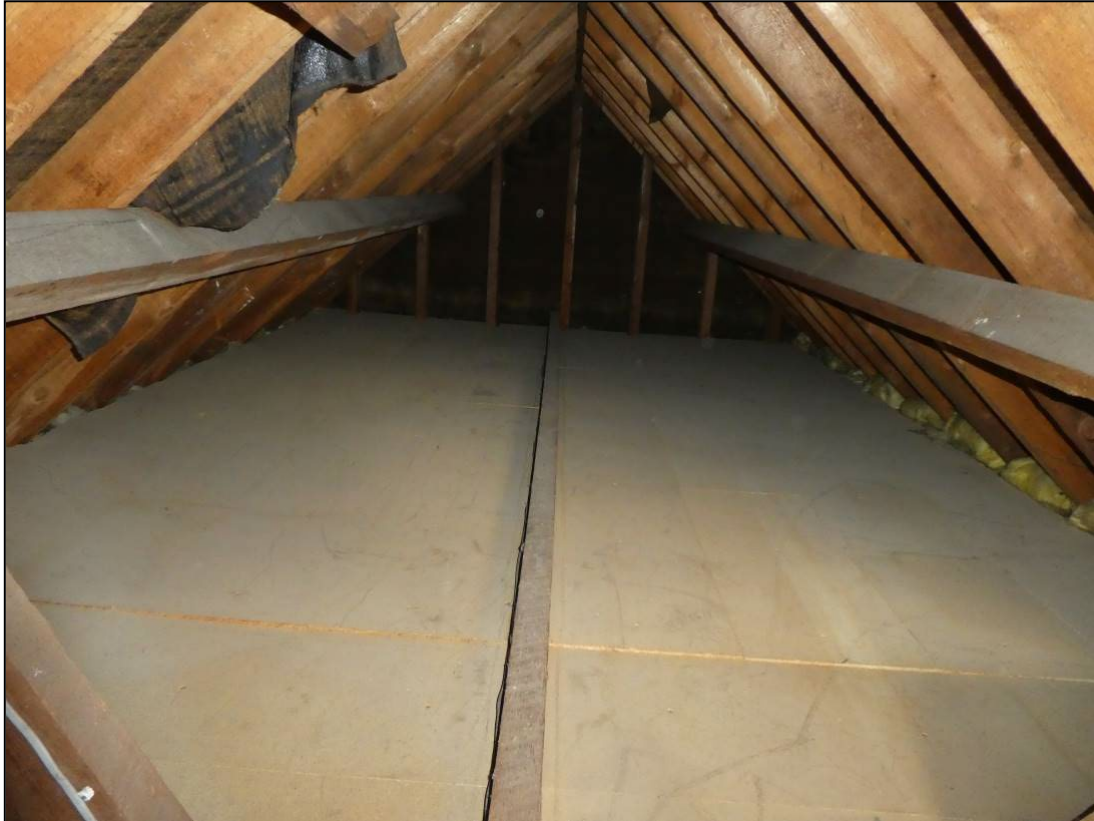
Figure 12. Example of loft space. 8 Avebury Square, Reading. 13.02.24

The loft was accessed through a hatch, via an integral ladder and is in a good condition. The loft is not cluttered, lit, boarded and insulated, see Figure 12 on page 13. The roof tiles are lined with bitumen felt, some of which is ripped or torn in places, see Figure 13 on page 13.

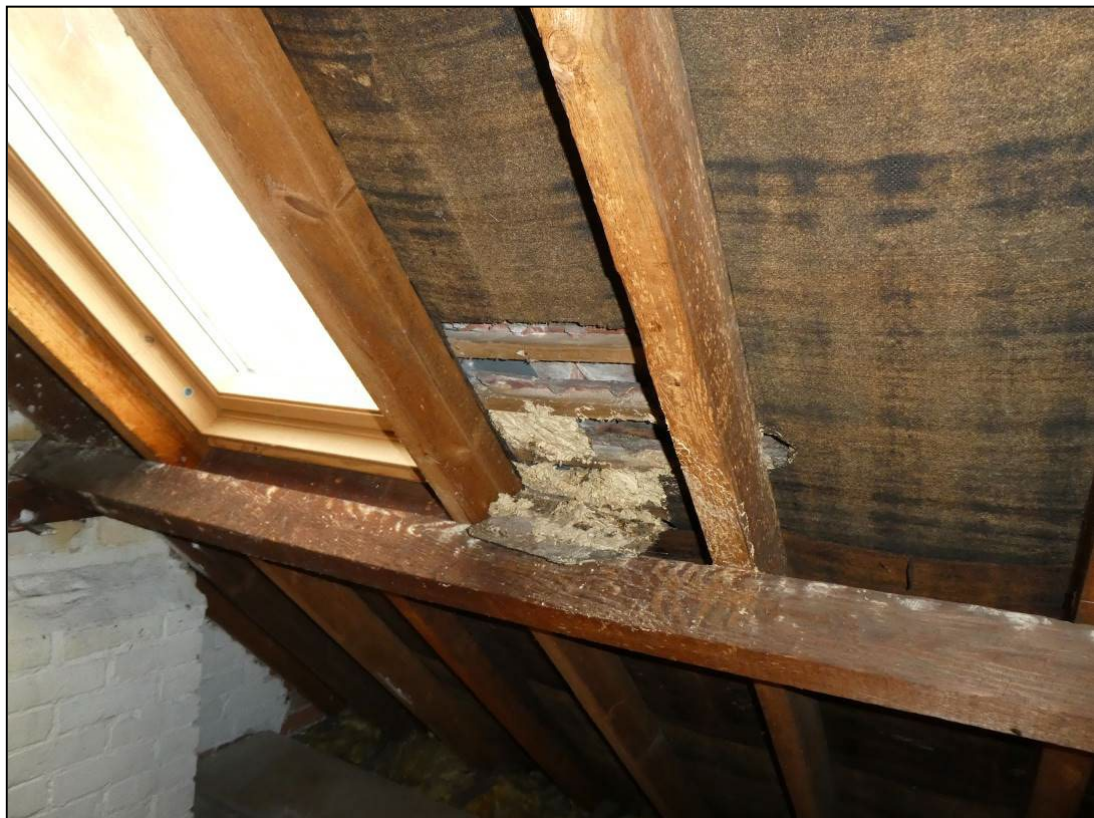
Figure 13. Example of ripped bitumen lining in loft. 8 Avebury Square, Reading. 13.02.24

No bats or evidence of bats was recorded during the internal inspection of various sections of the building and although some of the bitumen lining of the loft is torn, there were no access points externally into the loft space for bats.

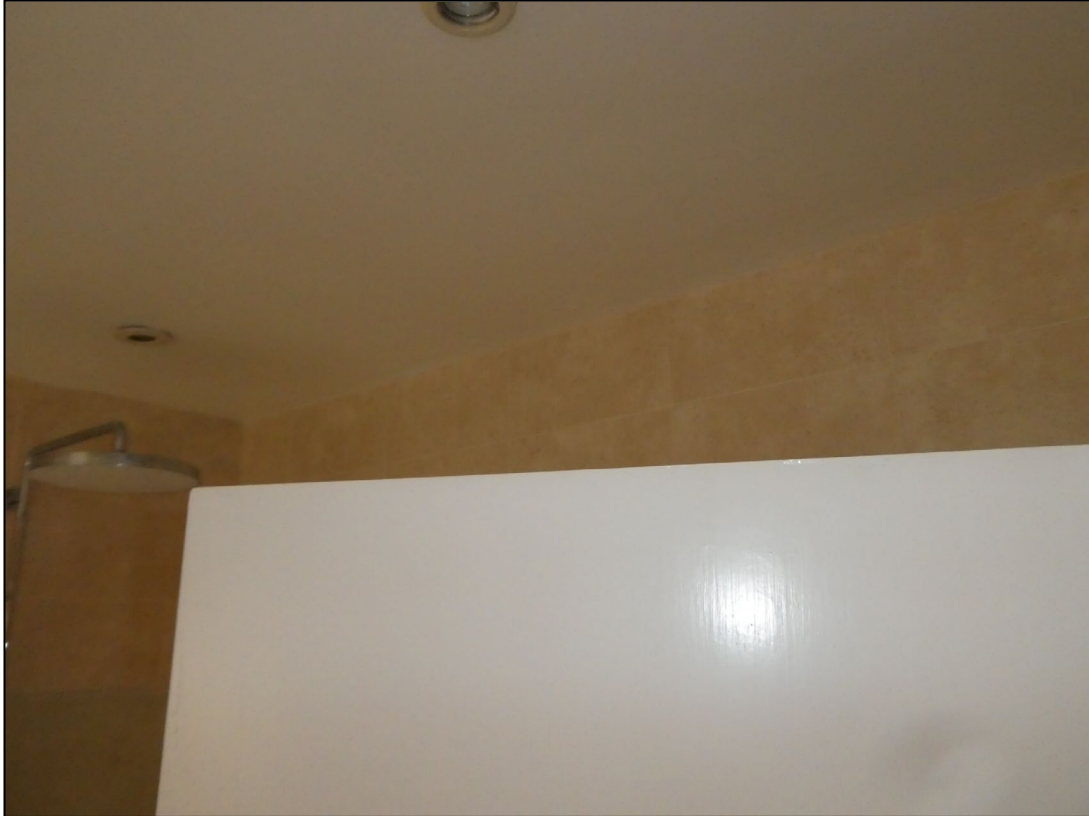
Figure 14. Boarded/plastered/painted ceiling of single storey side extension. 8 Avebury Square, Reading. 13.02.24

The single storey side extension and detached single garage were also inspected internally. The ceiling of the single storey side extension is boarded, plastered and painted, with no gaps suitable for bats, see Figure 14 on page 14. The garage ceiling also had no cracks or splits in which roosting bats could utilise, see Figure 15 on page 14.
