# ONE STATION HILL

## Pest Management Strategy Report for Planning Authority

Document No: SHRN-GEN-XX-XX-RP-A-0002  
Revision: P01

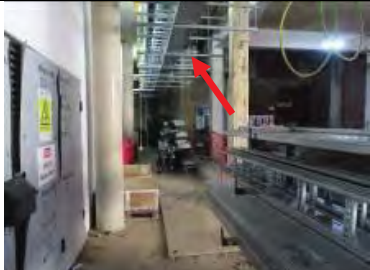
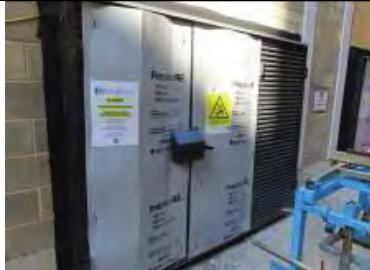
| Inspection Observations & Recommendations | | | | | | | | |
|---|---|---|---|---|---|---|---|---|
| | 10 | Level P2 Undercroft adjacent to Thames Tower | Louvre panels are present on plant room doors and Transformer room doors. Rodents could potentially enter via louvre panels. | Check louvre panels on all plant room and transformer room doors to ensure a metal screen mesh panel is in place to reduce risk of rodent access. | Inspection and proofing required. | Appendix Table Ref 3 | CAST | |

| Appendix Table 3. P2 Undercroft next to Thames Tower road access & Ground floor retail units | | |
|---|---|---|
| P2 Undercroft under slung services next to Thames Tower road access. Localised bird netting recommended. | Undercroft Plant rooms next to Thames Tower road access. Check all Louvre panels on all plant rooms /transformer room doors. If necessary install a metal screen mesh panel to reduce the risk of rodent access. | Ground floor retail units: Any retail food units will have a high risk of rodent ingress. Close fitting external doors are required as mice can penetrate gaps >5mm. |

Insect mesh to be applied to MEP louvre and louvred doors, SRM to proof

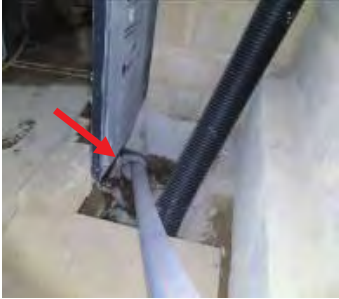
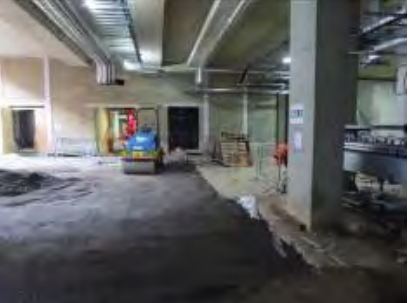
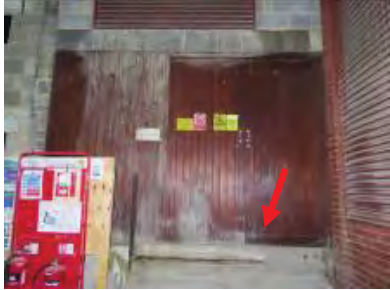
| Inspection Observations & Recommendations | | | | | | | | |
|---|---|---|---|---|---|---|---|---|
| | 3 | Level P2 Tank rooms | Tank room: There is a large gap around the pipe conduit in the floor.<br><br>The uncapped conduit could provide a route way for rodents to emerge from the open conduit. | Check all pipe and cable conduits below ground and ensure that they are capped so that rodents cannot use cable or pipe route ways to enter the fabric of the building. | Checking & proofing | Appendix Table Ref1 | CAST | |
| | 4 | Level P2 Undercroft | During and post construction there will be a risk of rodent access into the undercroft. | Rodent monitors will be required on completion. | Rodent monitoring | Appendix Table Ref 1 | PestCo | |
| | 5 | Level P2 Electrical substation | If mice are able to emerge into the substation via gaps around electrical cabling, they could pass under the door into the undercroft area. | Seal the gap at the base of the external doors to reduce the risk of rodent egress or ingress. | Proofing | Appendix Table Ref 1 | CAST | |

| Appendix Table 1. P2 Tank room, P2 Undercroft & P2 Electrical Substation | | |
|---|---|---|
| Check cable/pipe entry points & seal gaps around any open-ended conduits to prevent risk of rodent access. | P2 Undercroft during and post construction there will be a risk of rodent access into the undercroft. Rodent monitors will be required on completion. | P2 Electrical substation – ensure the base of the doors are adequately proofed to prevent rodent egress or ingress. |

Penetrations, pipes and cable conduits allocated and highlighted on the plan to be sealed and capped. SRM to proof

Client to confirm

SRM to proof

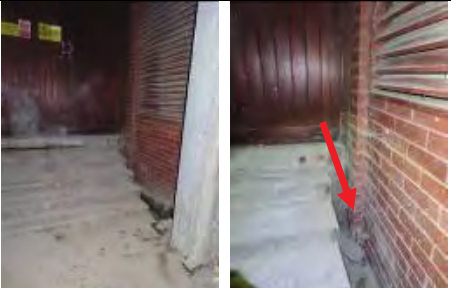
| Inspection Observations & Recommendations | | | | | | | | |
|---|---|---|---|---|---|---|---|---|
| | 6 | Level P2 Electrical substation | Wall-wall junction to the right of the substation: the mortar joint is damaged and could provide a risk of rodent harbourage. | Reinforce the wall joint with mortar or cement. | Proofing is required. | Appendix Table Ref 1 | CAST | |

| Appendix Table 1. P2 Tank room, P2 Undercroft & P2 Electrical Substation | | |
|---|---|---|
| P2 Electrical substation – there are gaps in the wall-wall mortar joint. Reinforce the joint to reduce the risk of rodent harbourage. | | |

SRM to proof

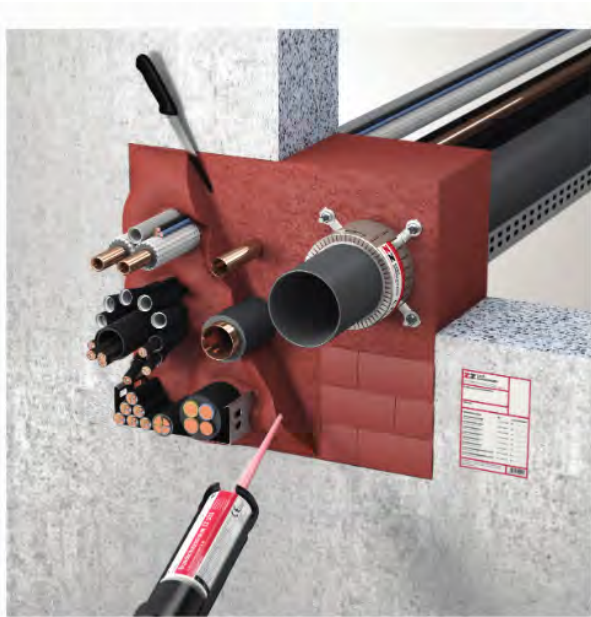
Figure 2.4  
Mixed penetration seal or equally approved

Mixed penetration seal or cable penetration seal up to EI 120 for rigid walls, rigid floors and flexible walls. Through penetration firestop system for electrical cables, telecommunication cables and optical fibre cables, conduits, as well as combustible and non-combustible pipes.

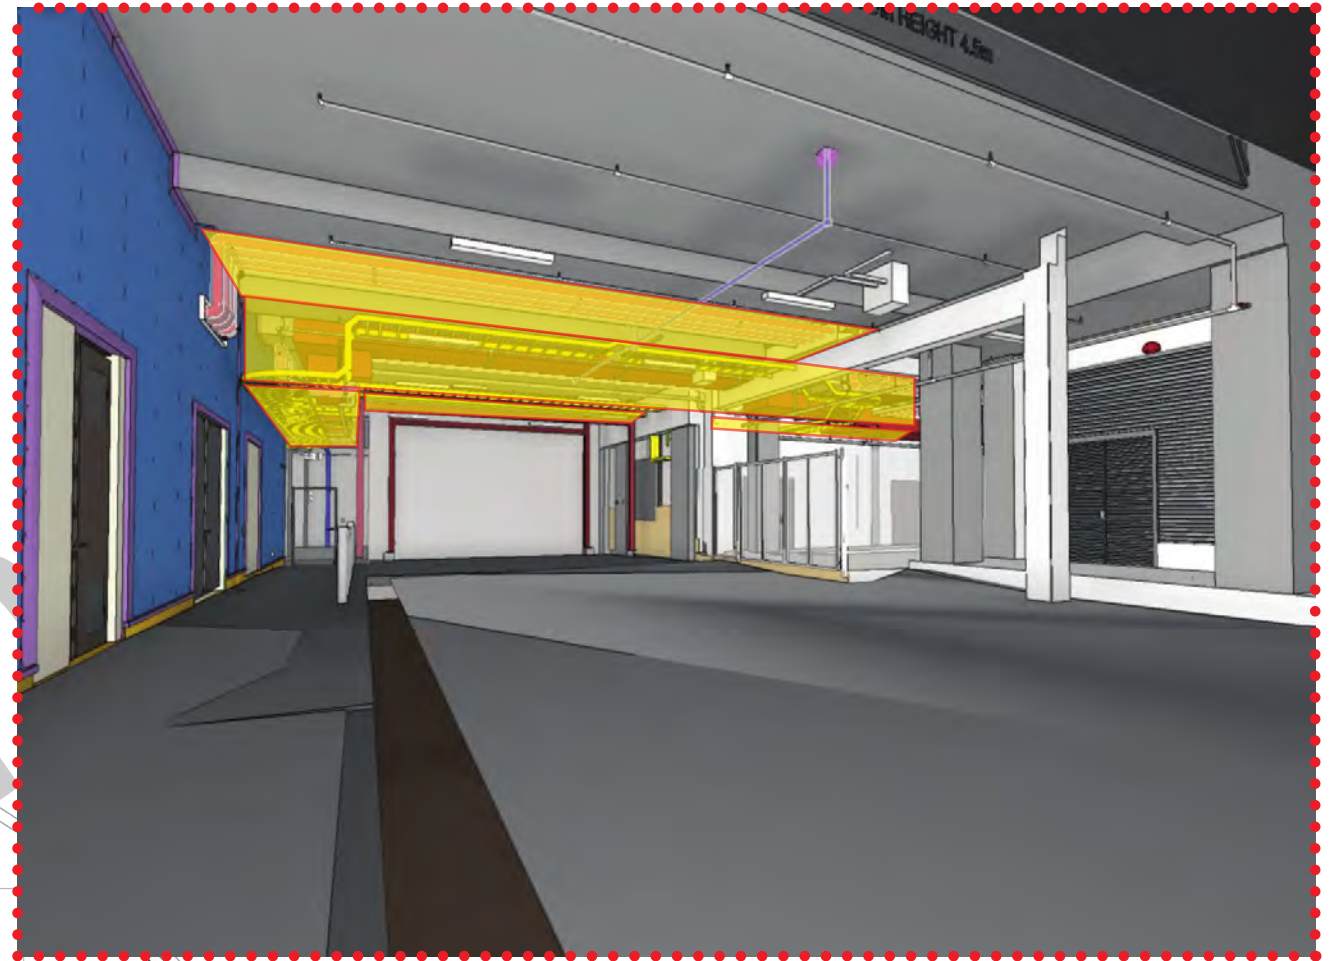
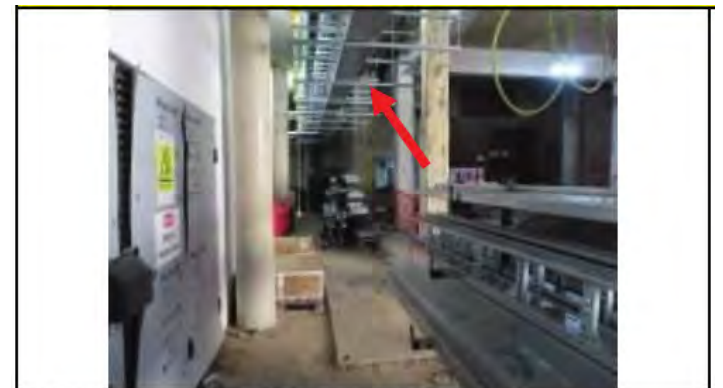
P2 Undercroft under slung services next to Thames Tower road access. Localised bird netting recommended.

Bird netting and brid spikes installation highlighted on the plans, SRM to proof

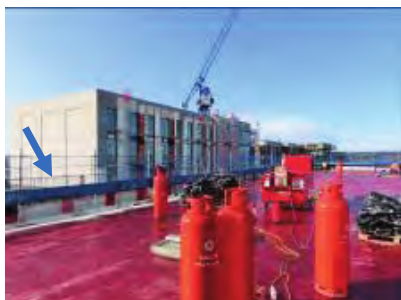
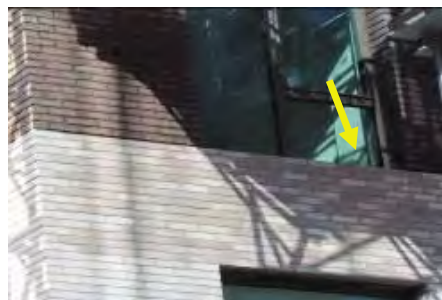
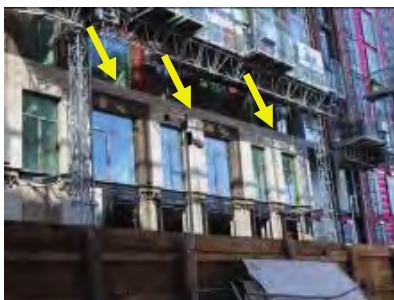
| Inspection Observations & Recommendations | | | | | | | | |
|---|---|---|---|---|---|---|---|---|
| | 19 | Level 8 Terrace platform | This is a south facing terrace and it overlooks Garrard Street where a high level of pigeon activity was noted.<br><br>Bird activity on the south side of P2 is likely to be higher because adjacent buildings and roof tops are lower than P2 and more sheltered. | X 14 pigeons were noted on the green roof top opposite.<br><br>X 30 pigeons were present on | Due to high pigeon activity on the south side of P2 there is a risk of pigeons using perch points on the south facing side of P2. Vigilance is required and possible localised proofing. | Appendix Table Ref 6 & Ref 7 | | |

| Appendix Table 6. Level 8 Terrace & pigeon perch points in close proximity in P1 | | |
|---|---|---|
| Outer coping ledge could provide a perching point for pigeons. The installation of high tension wiring is recommended on the outer ledge. | High risk of pigeon activity occurring on L8. Ledges below windows in P1 will provide pigeon perch points opposite Level 8 on the south side of P2. | |

Area to be monitored to determine if the additional localised bird proofing measures are required during the building operation

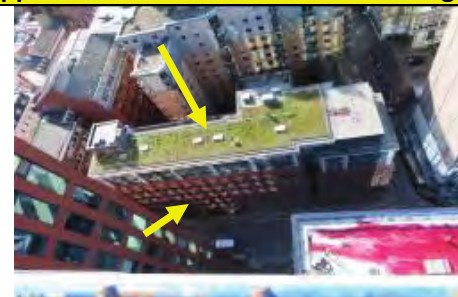
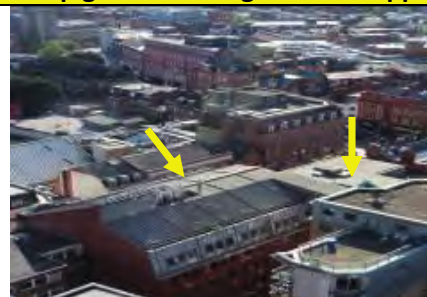
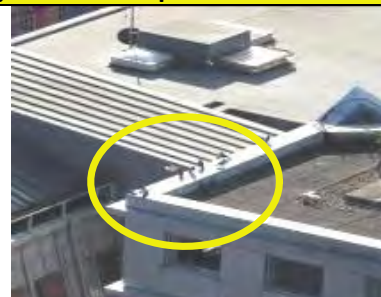
| Appendix Table 7. Level 8 Terrace & high numbers of pigeons on the green roof opposite and adjacent roof top | | |
|---|---|---|
| High risk of pigeons alighting on available surfaces on the south side of P2. Opposite Level 8 x 14 pigeons were present on the 'Green' roof. Upper ledges on that building provide potential perch points for birds. | South side of P2 x 30 pigeons were present on a lower, adjacent roof top. Lower roofs provide better shelter for pigeons. Close proximity to level 8 increases the risk of bird activity at P2. | Pigeons alighted on coping edges on an adjacent building opposite P2 (south side). These birds are located in the area of the right-hand arrow in the previous photo. |
