# LEVEL MONITORING

### 15 RUSSET GLADE, EMMER GREEN, READING, RG4 8UJ

| Our Ref: | M19185 |

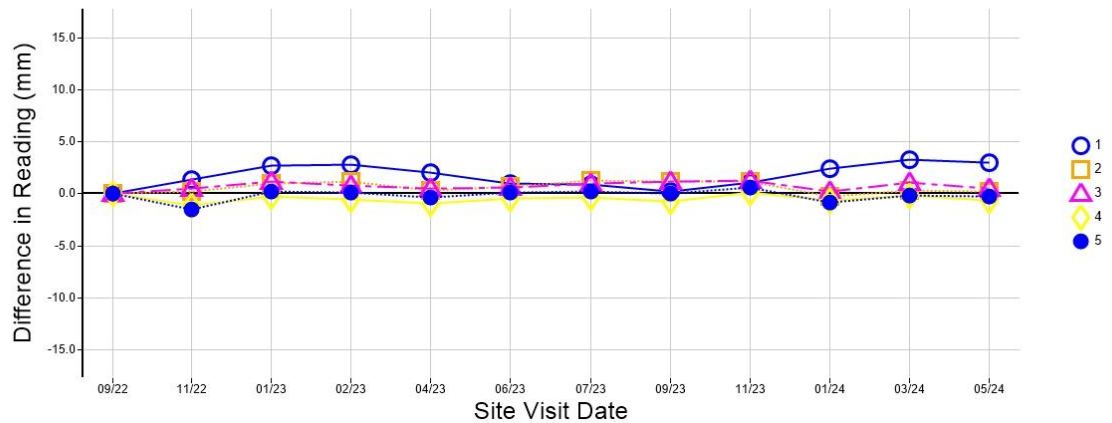
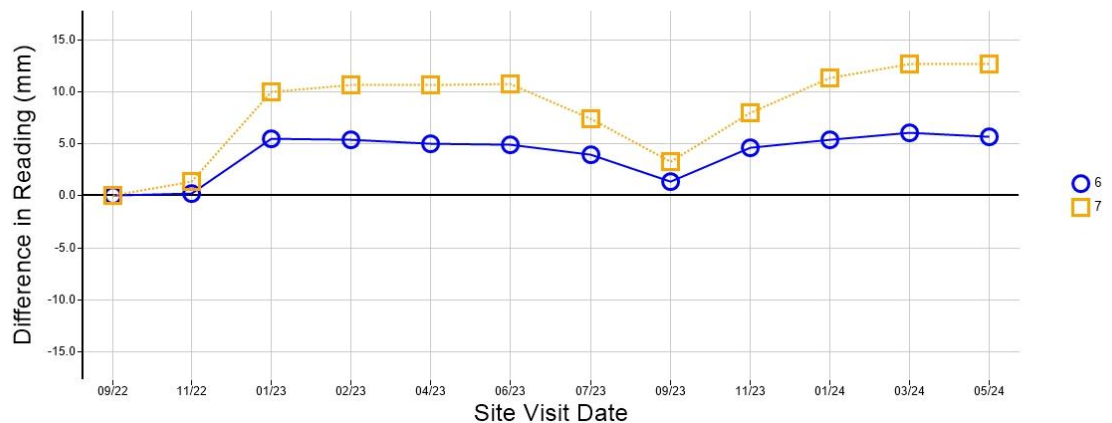
## Level Monitoring Difference Graphs

The following graphs display the progressive movement that each Level Monitoring Station recorded at each separate site visit date to give an overall look at how much the property is moving.

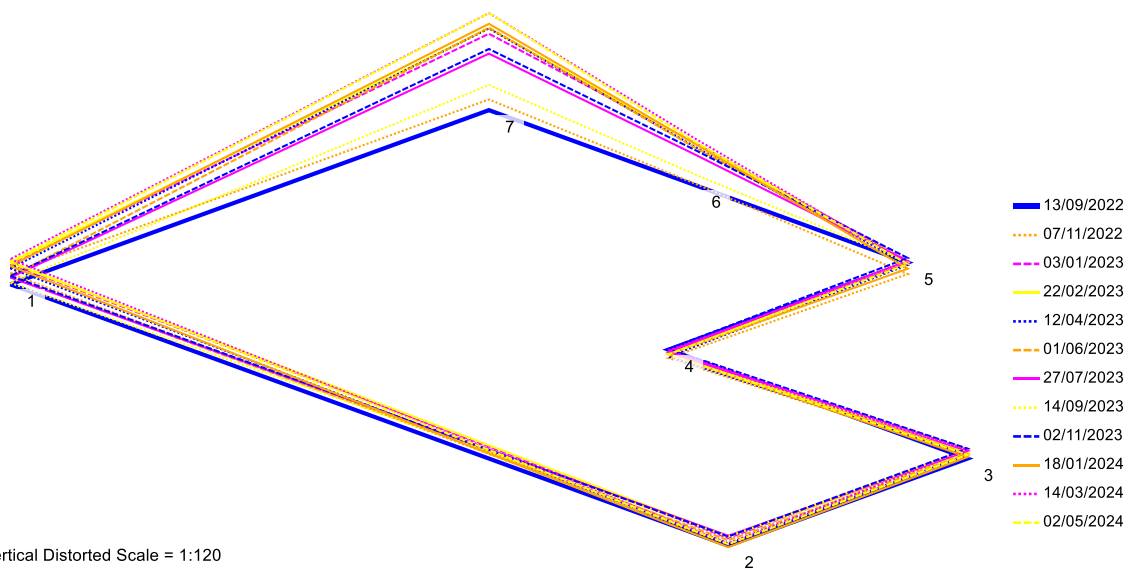
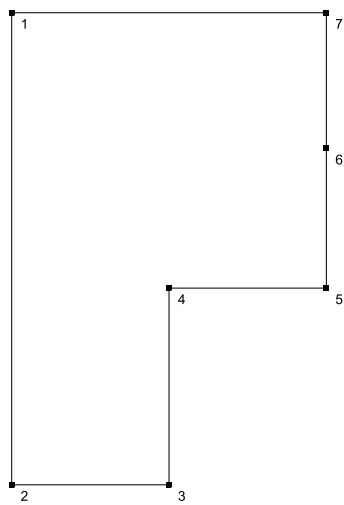
## Level Monitoring Displacement Map

The following image shows an isometric representation of the movement of the property, based on the Level Monitoring Stations that were installed.
