## Bat Emergence and Re-Entry Surveys (BERS)

208 Henley Road, Berkshire, Reading, RG4 6LR

“The construction of a first-floor side extension and rear two-storey extension”

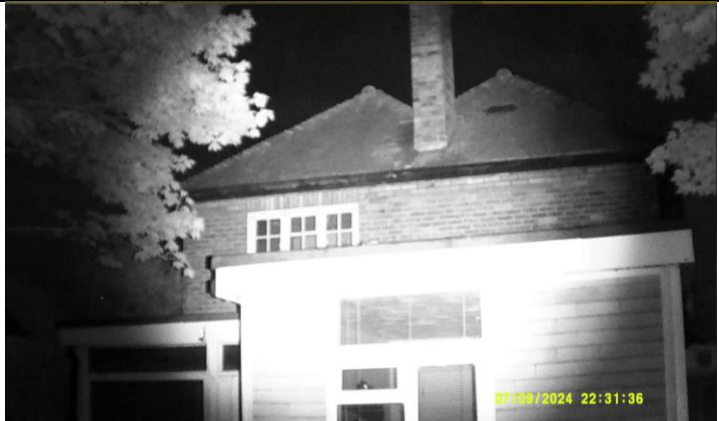
| <i>IR position 1</i> | The footage reflected the view of surveyor 1. <b>No emergences or re-entries</b> observed after review. | <p>Figure 1. Northern elevation – darkest point</p> |

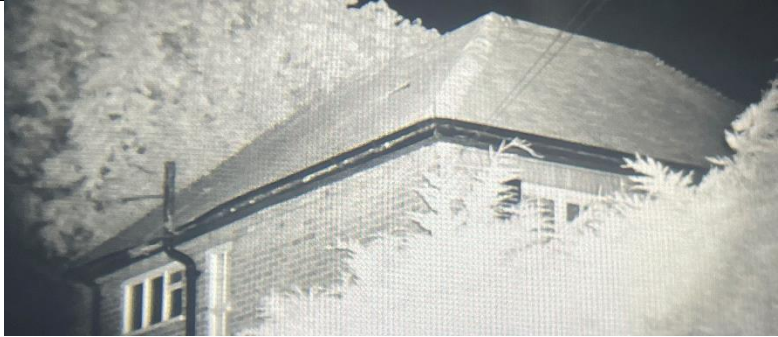
| <i>IR position 3</i> | <p>The footage reflected the view of surveyor 2.</p> <p><b>No emergences or re-entries</b> observed after review.</p> | <p>Figure 3. Southern and western elevations elevation – darkest point</p> |

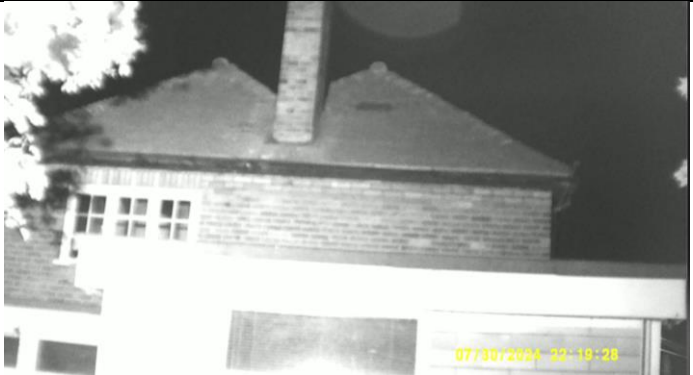
| <i>IR position 1</i> | The footage reflected the view of surveyor 1. <b>No emergences or re-entries</b> observed after review. | <p>Figure 4. Northern elevation – darkest point</p> |

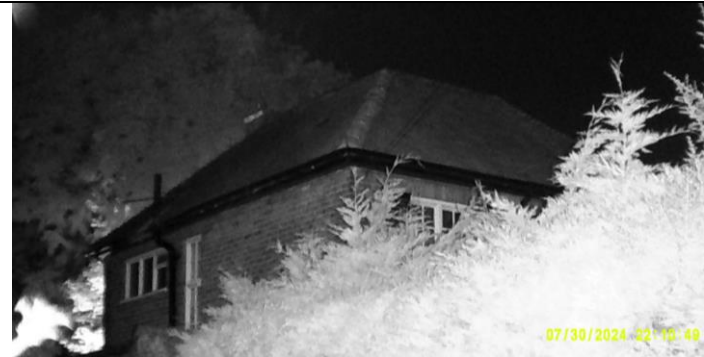
| <i>IR position 2</i> | The footage reflected the view of surveyor 2. <b>No emergences or re-entries</b> observed after review. | <p>Figure 6. Southern and western elevations – darkest point</p> |

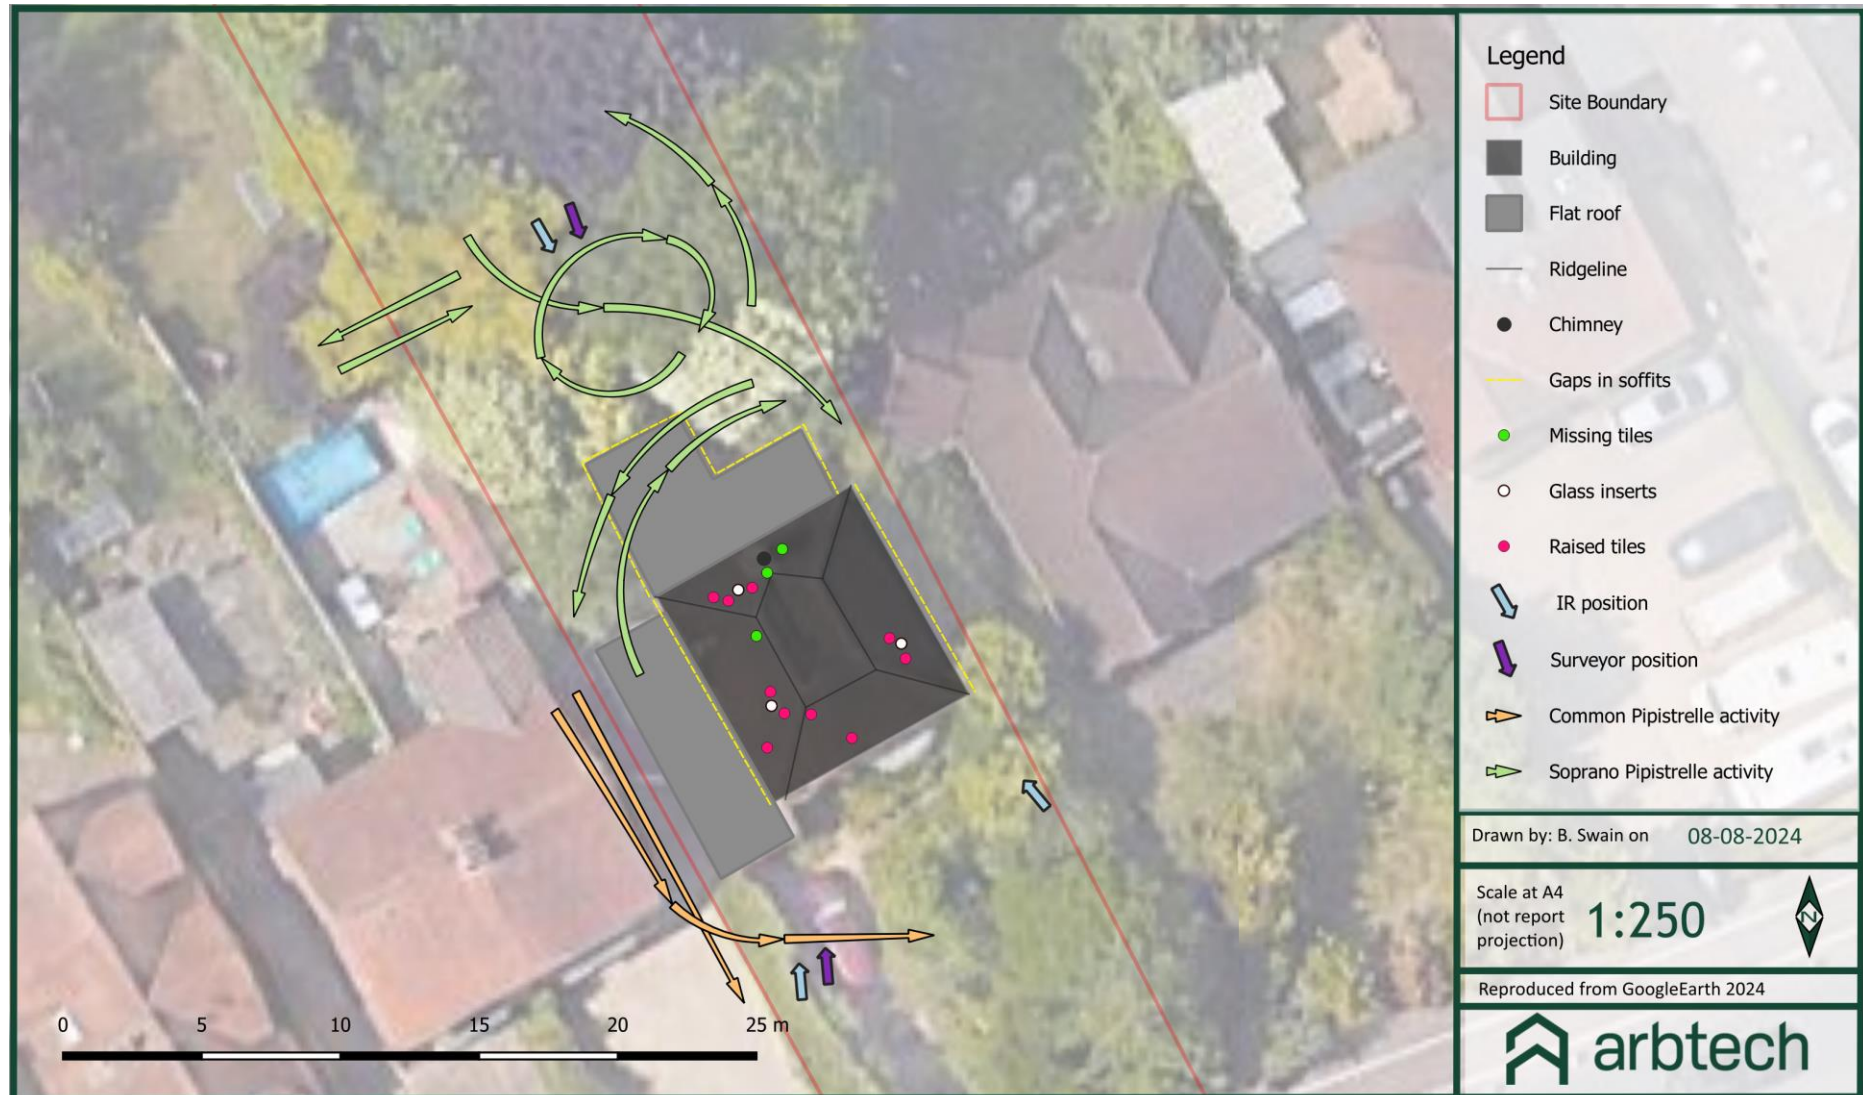
## Appendix 1: BERS plan

| See surveyor locations in the <b>BERS plan in Appendix 1</b> | |
