**Arboricultural Method Statement**

**Mr Visha**

**208 Henley Road,  
Berkshire,  
RG4 6LR**

**07 August 2024**

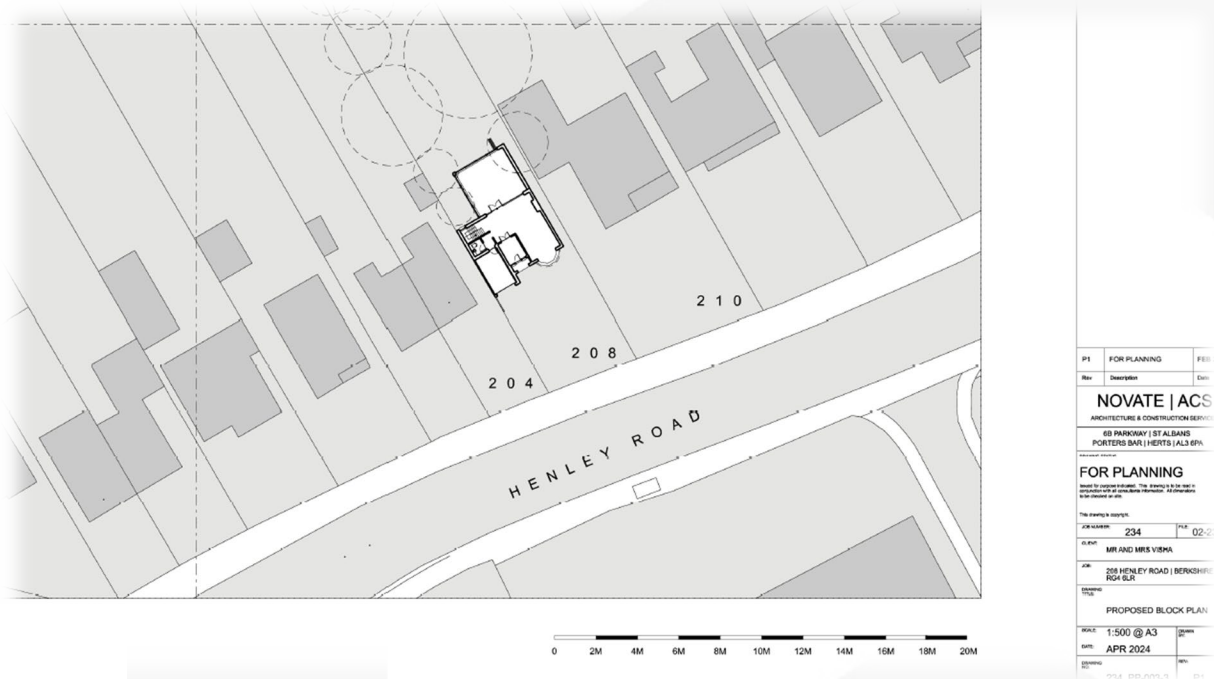
**Figure 3:** Proposed scheme, drawing number 234\_PP-003-3 rev P1 (Novate ACS)

It is proposed to build a two-storey rear extension and a single storey side extension including a loft conversion.
