# Heritage Statement

to assess the impacts and effects of the  
proposed repair and refurbishment

at Number 33 Baker Street, Reading

**Produced by: Archway Heritage**

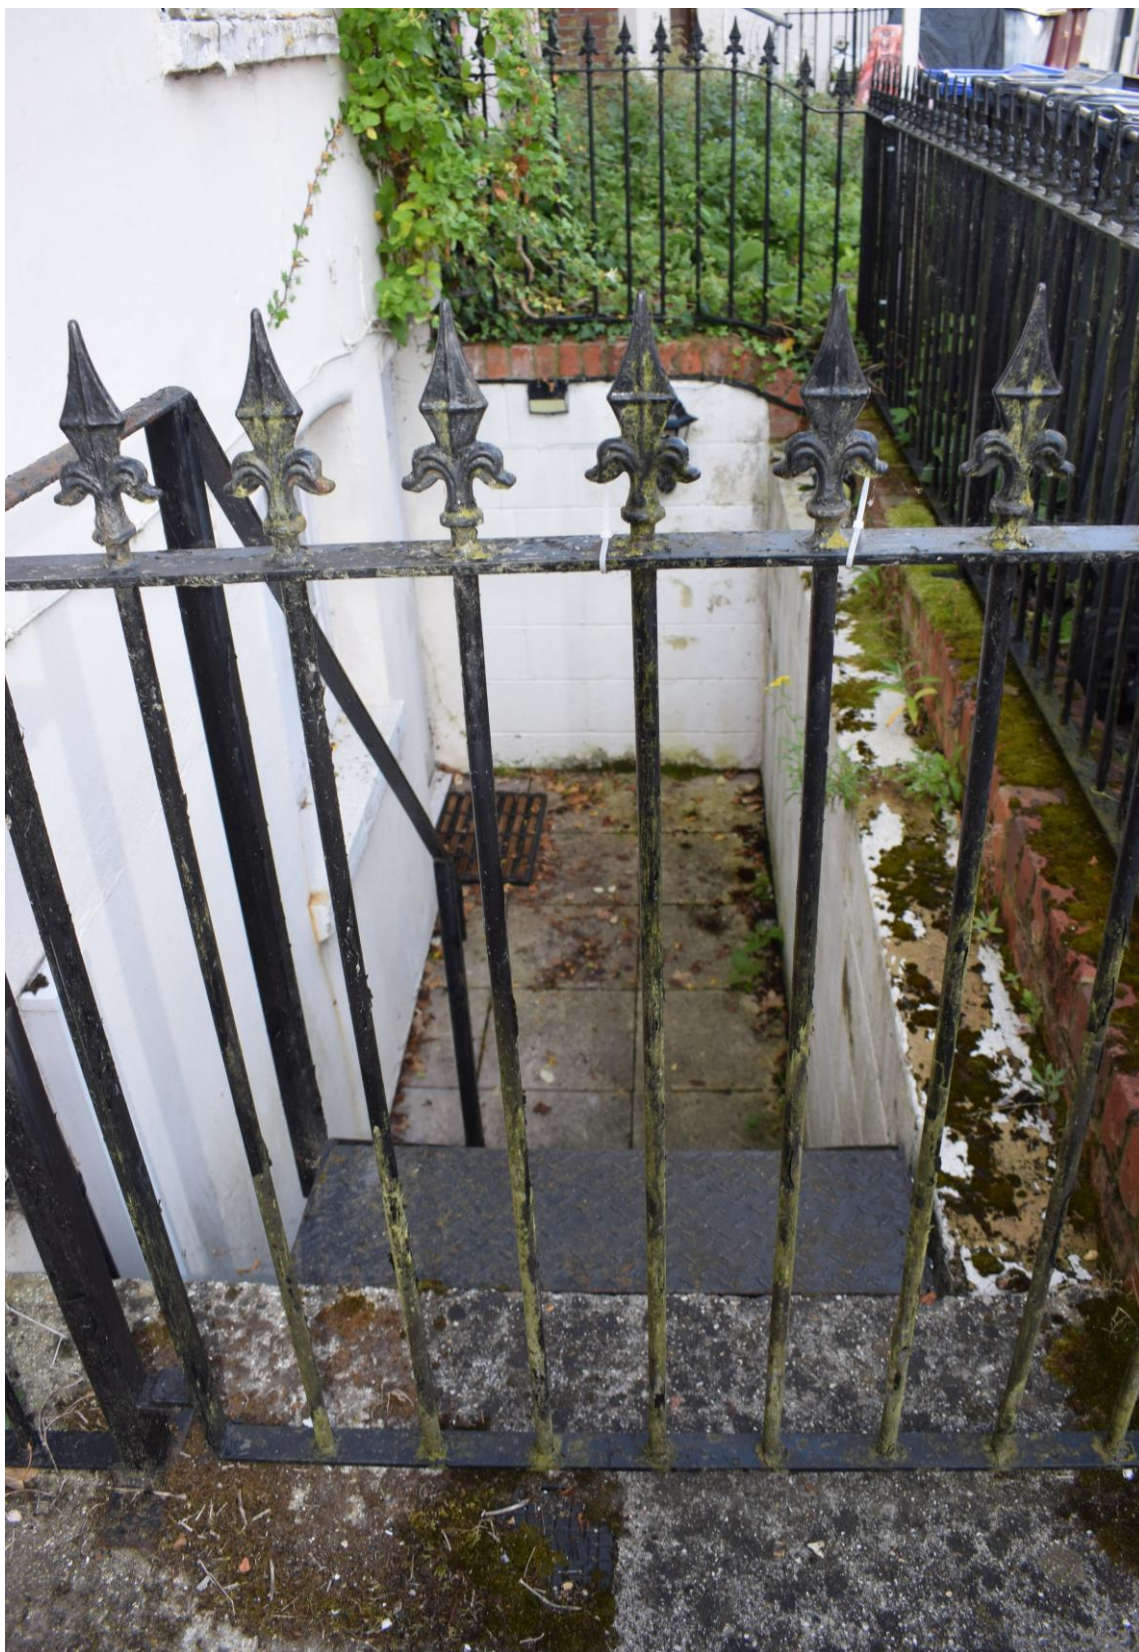
*Plate 1 style of local light wells*

- 2.4.2** Nevertheless, this feature would be in keeping with the street and the introduction of a doorway instead of the window would aid in the readability of this change considered to be of benefit to the overall condition of the house.

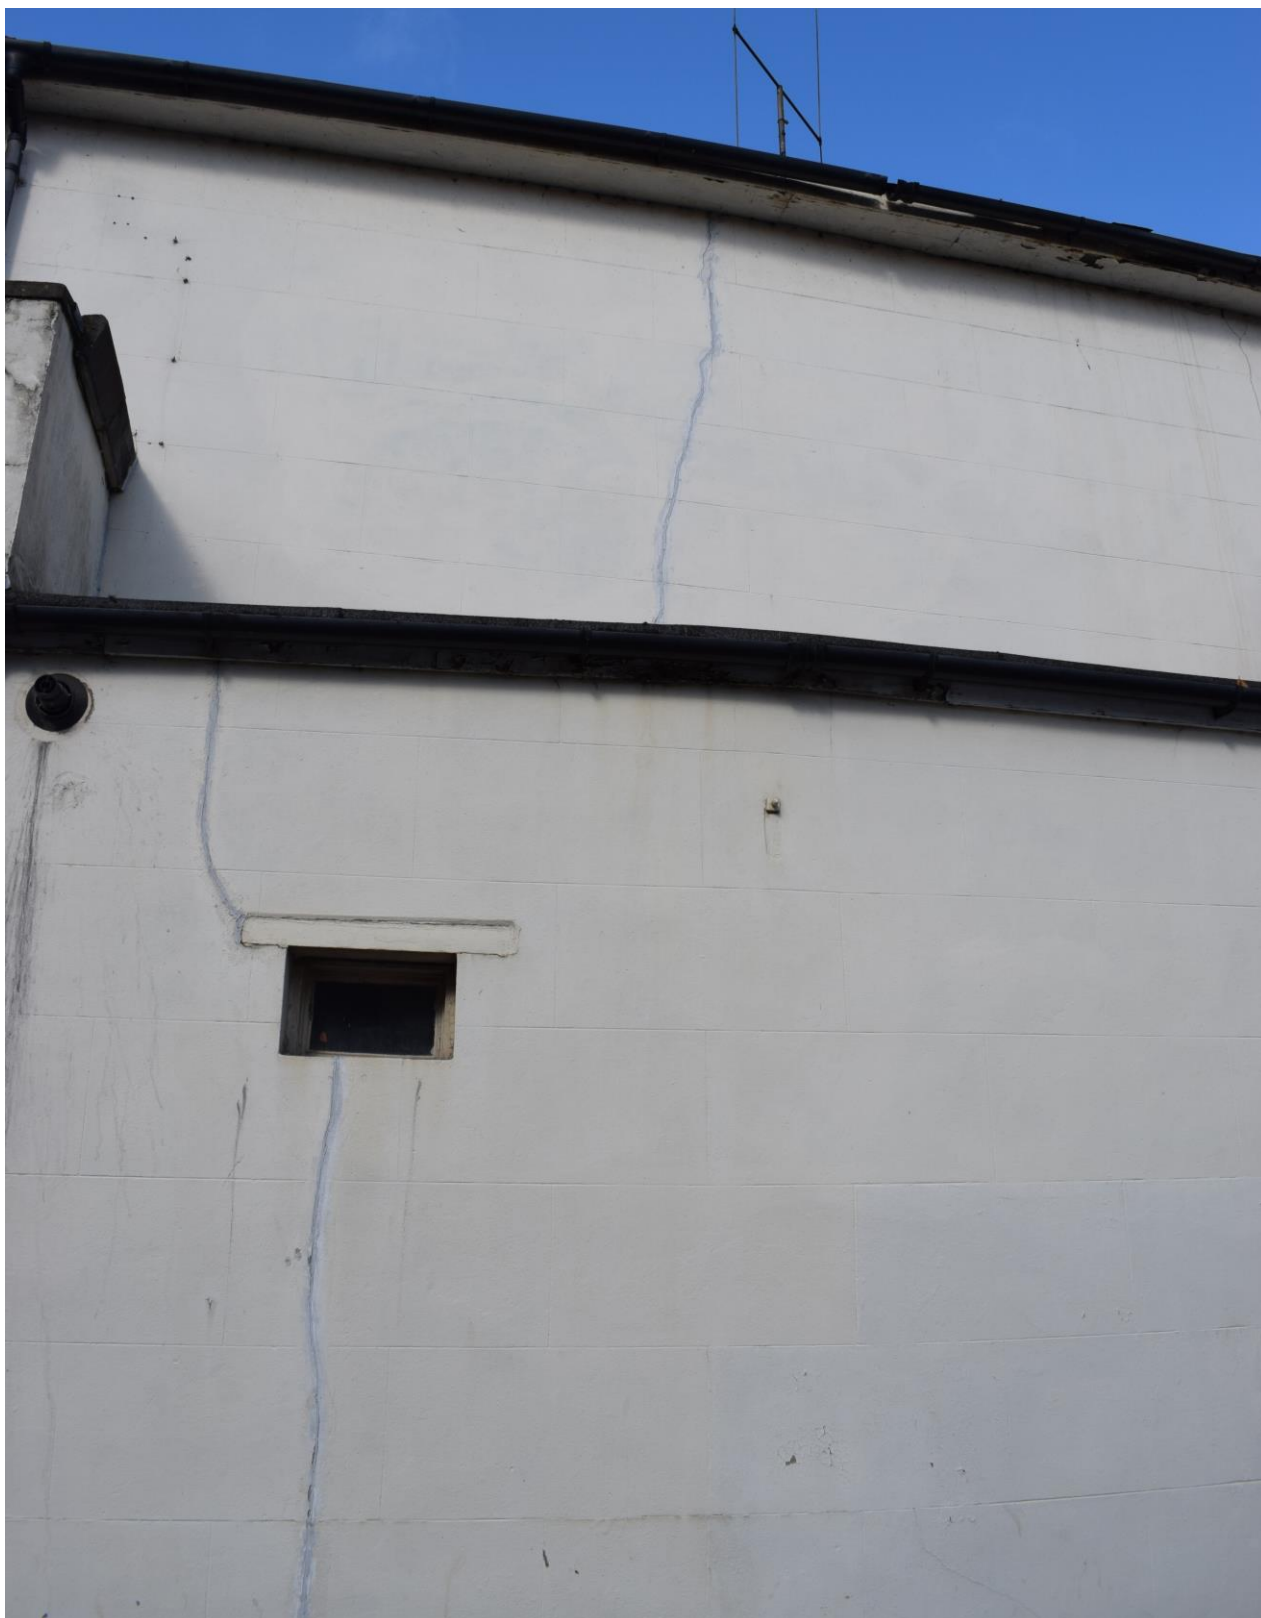
*Plate 2 fractures in the render*

- 2.5.2** Improvements to the side elevation will involve replacing the modern plywood rear entrance door with the period-appropriate door, restoring the building's historical integrity. Visible fractures will be more appropriately repaired than the currently visibly intrusive repairs by re-rendering sections ensuring the re-rendering remains flush with the current facade. Furthermore, improvements to the rear elevation include window repairs and roof and guttering repairs to maintain the appearance of the building.

- 4.5.3** The repair of visible fractures can be beneficial depending on the advice sought, methods and materials used. Once the render is removed (see Section 3.7), then it will be possible to assess whether localised repairs are appropriate. Where doubt arises, then I can recommend a HESPR-accredited structural engineer to investigate the underlying cause of the damage and to identify whether fractures are localised or connected with the whole wall movement. The following provides a guide for repair. Where the movement has resulted in a differential settlement and the pattern of coursing has fallen out of alignment then there are several options.

- 4.5.4** Tying back the external walls to the cross walls using helical stainless-steel bars is a tried and trusted method, which may be inserted below the wall plate. Another option is cutting back the brickwork or rebuilding a section on either side of the fracture, which can be considered.

The cut-back needs to be extended a sufficient distance to allow the mortar jointing to be gradually adjusted.

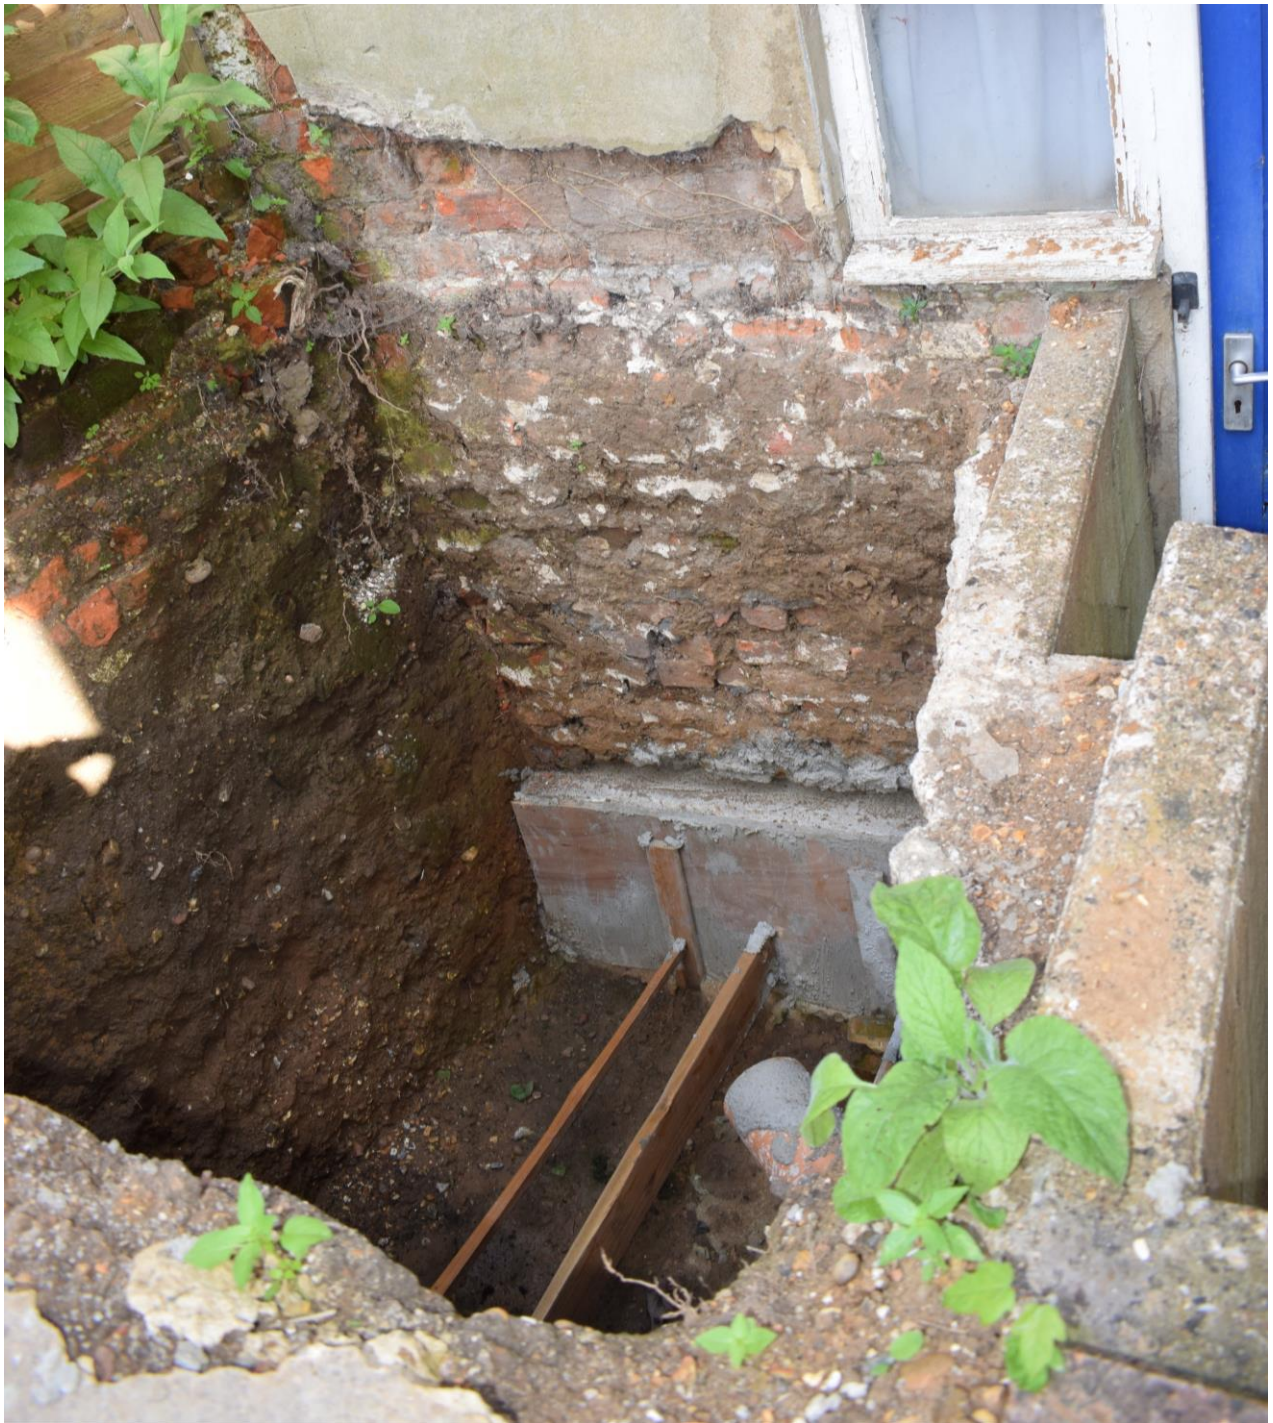
*Plate 3 excavated area to the rear of the building*

- 4.2.1** The urgent works address years of neglect and water ingress. Repair is crucial for the building's long-term conservation. Reinstatement will be done on a like-for-like basis. Like-for-like means using materials and methods suitable for pre-1919 buildings as set out in the maintenance and repair guides published by Historic England and Society for the Protection of Ancient Buildings (SPAB). The methods and materials referenced in the British Standard BS 7913:2013 are suitable for the conservation of historic buildings. However, up-to-date recommendations about specifications and methods should be provided by a heritage expert. This may be reviewed with the conservation officer where incorrect or compatible materials and methods have been used previously.

**4.2.2** Excavated areas allow air to circulate, diverting drainage away from the elevations to improve the structural integrity of the building. Localised brick replacements to match age and size may be necessary after checking for defective or damaged bricks. The proposals include the replacement of any defective wall vents to be set within lime mortar. Repair can then continue by removing any defective pointing or jointing using lime mortar (see Section 5.3.1). The colour and texture match is relatively unimportant as re-rendering with lime is

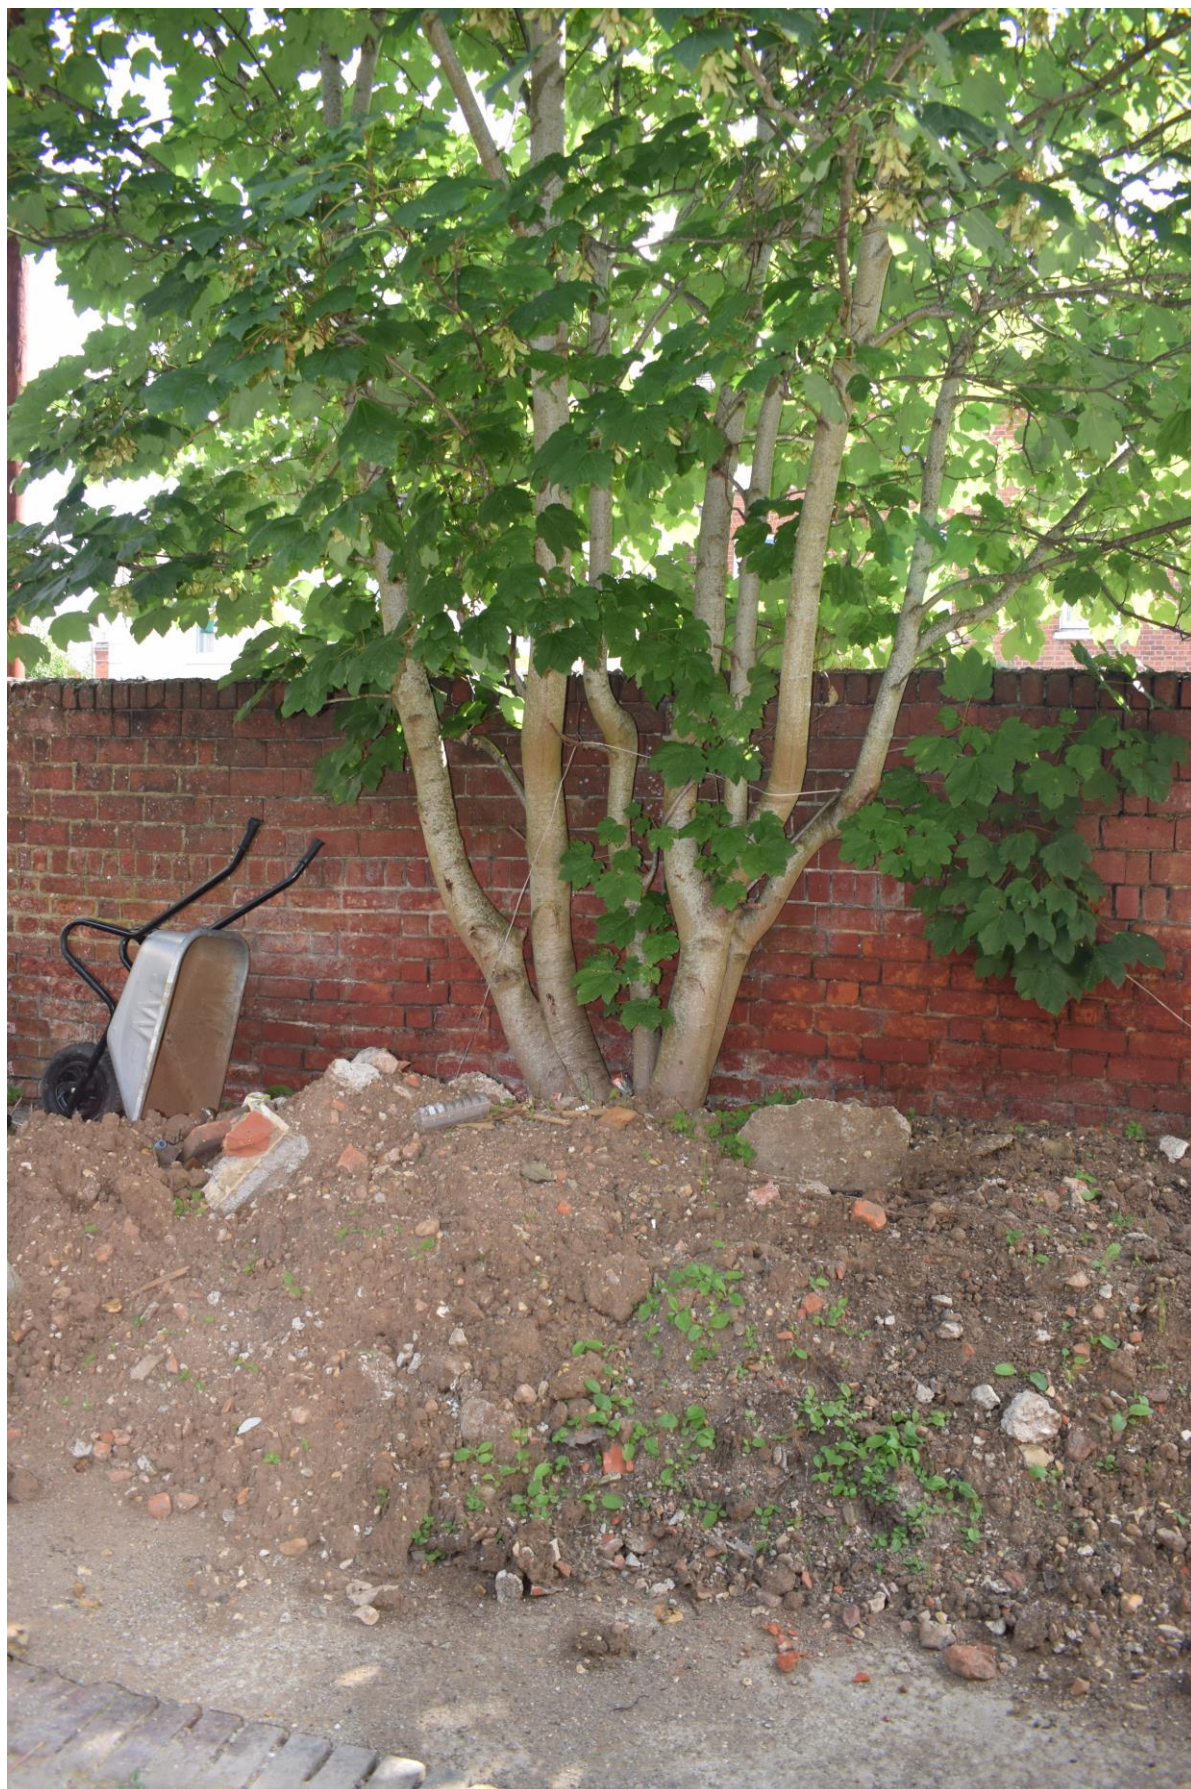
*Plate 6 tree growing adjacent to the garden wall*

**4.3.13** Tree Issues: The tree is causing several problems. There is a risk it is damaging or blocking nearby drainage and it is pushing the garden wall out of alignment. It is essential to notify Tree Officer Sarah Hansen about this issue. If the tree continues to grow, is uprooted during a storm, or causes subsidence through soil shrinkage, it could further displace the wall. The wall’s current location and height pose a significant risk of collapsing onto the public highway, which could have serious consequences if it fails structurally.

**4.3.14** Potential Solutions: With the necessary permissions, it may be possible to remove the later

brick construction that was added to increase the height of the original wall for safety reasons. However, it is crucial to ensure that the original brickwork remains watertight by using brick capping stones, the brick bond repaired and is repointed using lime mortar. If the drainage system should be surveyed and if damaged, repaired and potentially rerouted. Root barriers are not effective in stopping root growth but can deflect it. One recommended course of action is to cut, manually remove, and treat the stump with targeted chemical control to prevent the tree from regenerating. This work should be carried out by a suitably qualified specialist.

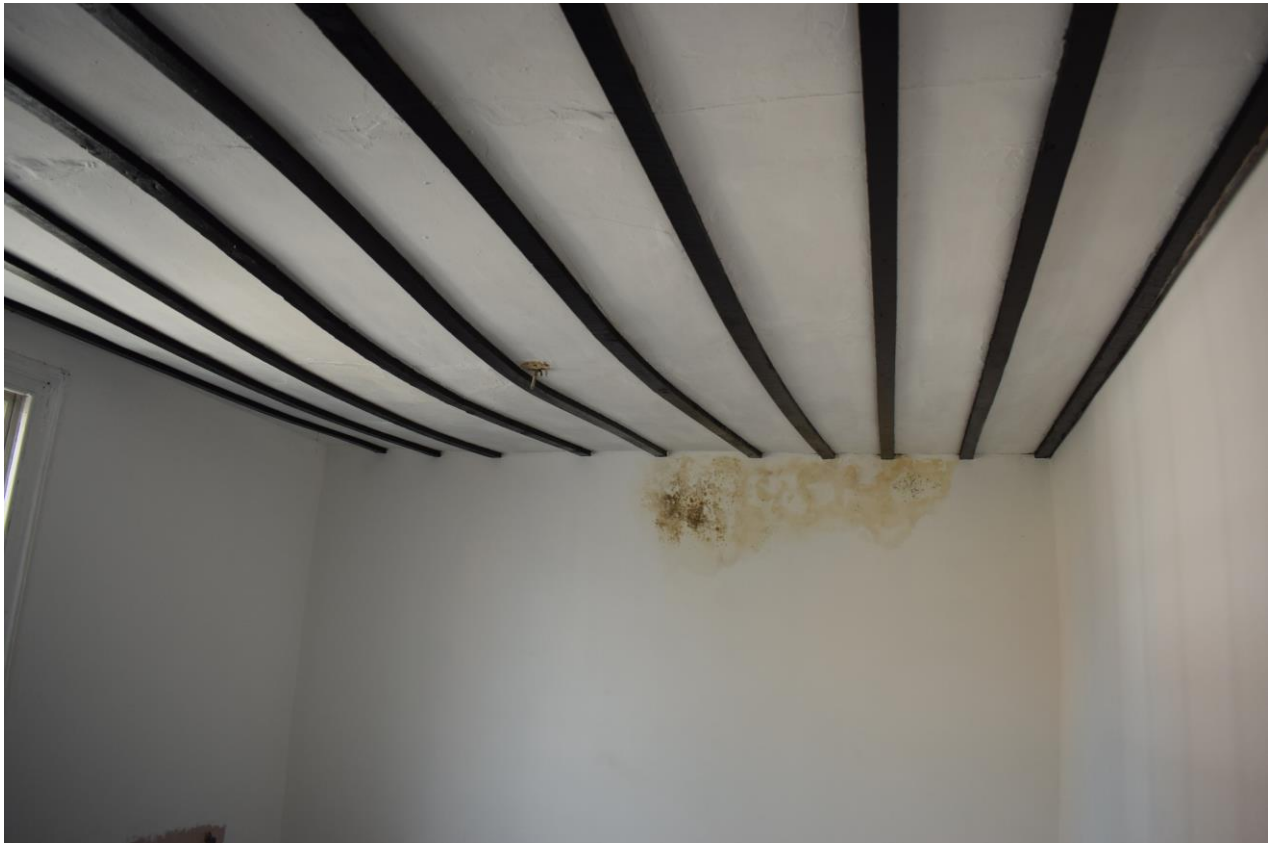
*Plate 8 sagging first-floor ceiling*

**4.3.15** Distorted plaster, laths, joists and beams may have achieved an equilibrium which can be undermined by attempts to alter it so the aim is to support it rather than lifting it. Temporary supports may be provided by plywood sheets secured on acrow props that can be carefully adjusted locally to avoid added pressure against the propped support. It is important to avoid added pressure, which can lead to the plaster detaching.

**4.3.16** Stainless steel restraints secured by short lengths of stainless steel dowels or washers have been used to safely secure historic ceilings. Holes are drilled at irregular intervals to minimise the impact. The washers are countersunk, approximately 2mm into the surface and tensioned using a thin wire. The thin wire is passed through a hole drilled in the plaster and secured to the flexible metal strap. The flexible metal strap bridges the joists or studs. Lime putty or similar will mask the washers along with other patch repairs. Securing the ceiling allows for the retention of the building's historic fabric.

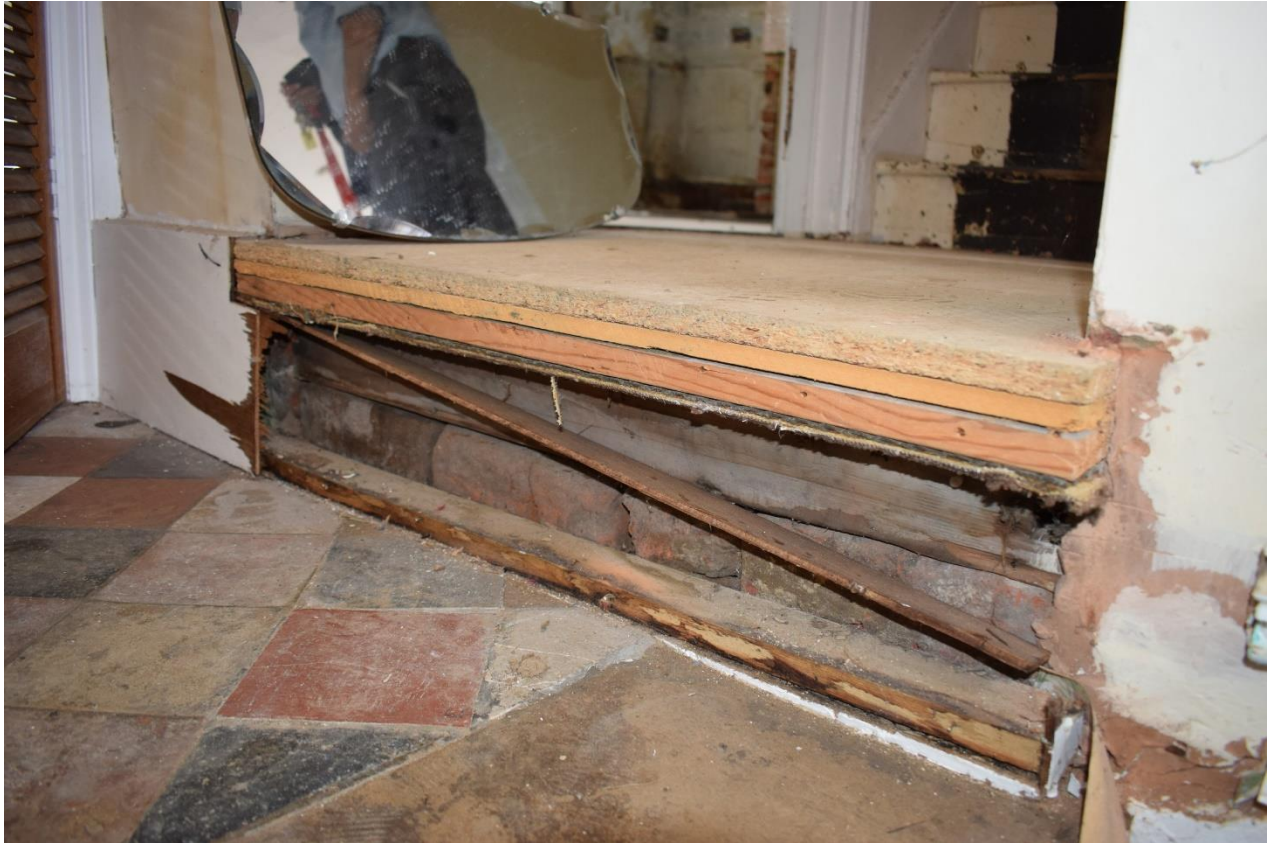
*Plate 9 mixture of historic and modern fixtures and fittings*

- 4.3.17** Much of the historic fabric in the basement and ground floor was removed when in previous ownership (confirmed by Jeff Asemi during the site visit). Decorative harmony and legibility of the original authenticity would be achieved by replacing those lost internal fixtures and fittings with modern alternatives using an appropriate period style.

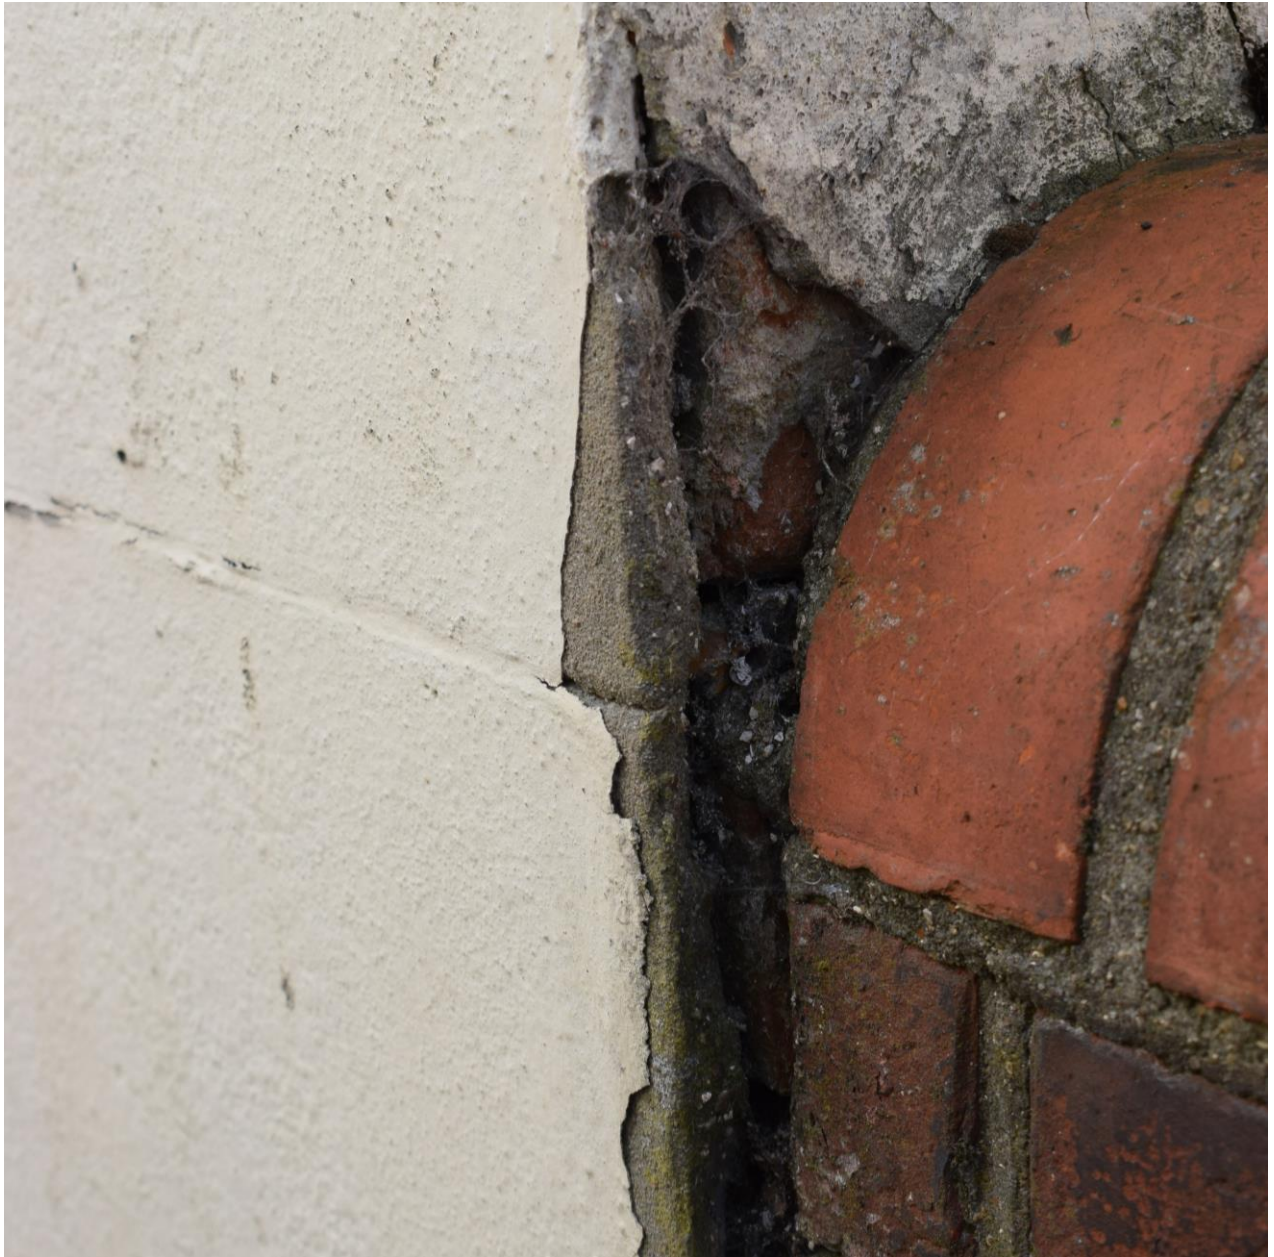
*Plate 11 cementitious render*

- 4.3.6** Re-rendering with cementitious render is not recommended, though this has occurred in the past on the upper floors of the rear elevation and possibly the extension wall. Removal of cementitious render is not necessarily recommended because it can deface the fire surface of historic bricks. However, this work may be advisable where the cementitious render has already detached the brick repaired, and then rendered with lime.

**4.3.19** Ideally internal lime plaster would be applied to the walls where repairs are needed and impervious modern plaster removed. If time and finances need to be focused elsewhere, a temporary fix may be considered appropriate. The possibility of introducing vents and installation of a lime hemp plaster applied to reed or wool wood-backed boards on the lower ground floor walls with a ventilated air gap between the wall and the plaster-backed board has been discussed though this may need to wait for future works, when possible.
