| Project | 27-32 Market Place |
| Drawing Title | Ecological Enhancements Plan |

| Date | August 2024 | Drawing No. | CSA/6255/110 |

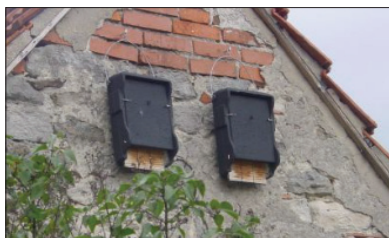
**Schwegler 1FF bat box** (such as those available at [www.wildcare.co.uk](http://www.wildcare.co.uk) as above)  
Material: Woodcrete  
Dimensions (mm): 270 x 430 x 140  
Entrance dimensions (mm): 120 x 240  
Weight (kg): 9

Two Schwegler 1FF bat boxes will be installed at the top northern corner of the western exterior of Building A, to provide opportunities for larger groups of common pipistrelle bat (e.g. a maternity roost) to make use of the Site.
