# **St Joseph's College, 64 Upper Redlands Road, Reading RG1 5JT**

## **A Heritage Statement**

**Project No: RHC 2024-33**

**Date: 14/08/2024**

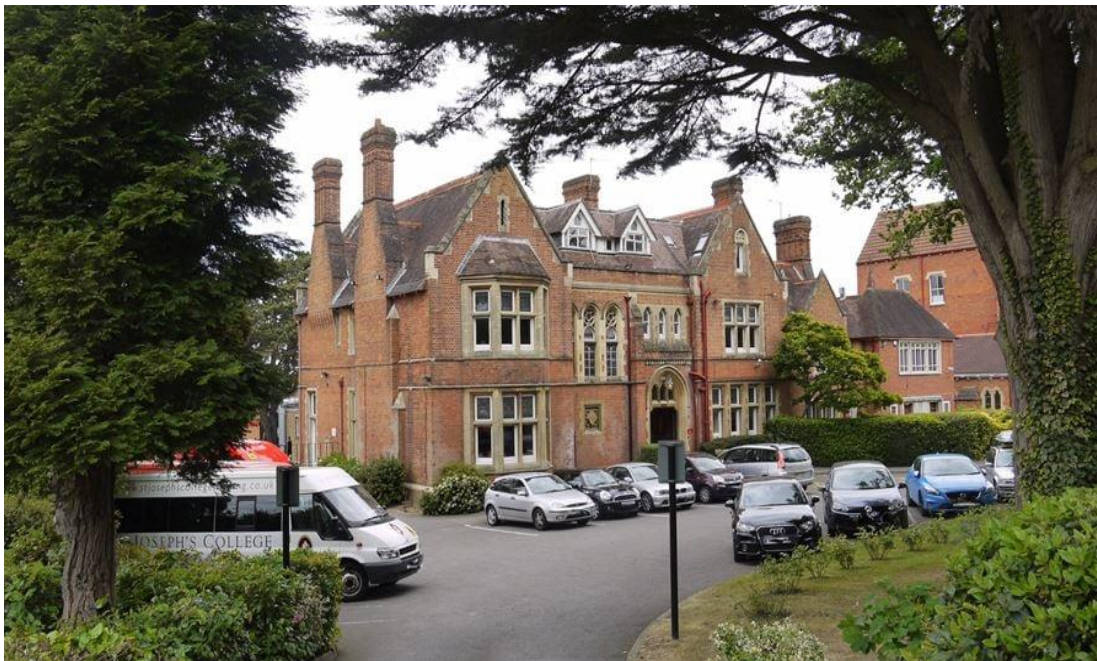
Fig. 4: View, looking north-east, of the front elevation of Broad Oak House, with the later buildings of St Joseph's College to the right (Historic England).

- 1.3 The Grade II-listed house of Broad Oak House was constructed in c. 1870-80, and comprises an imposing, detached red-brick house of two and a half storeys and five bays (NHLE 1157100) (Figs. 4 and 7). Its architectural interest is enlivened by stone dressings and detail, and by a highly articulated, asymmetrical front elevation, with its mix of gables and window forms. The adjoining brick-built ranges of the College partly reflect the material palette and architectural style of Broad Oak (Figs. 10-14), and have a close functional and historical association with this listed building. On this basis, they are deemed to be curtilage-listed.

- 4.11 The buildings, including B Block, comprise part of an integrated scheme, which is distinguished by its consistency of form and detail, in which the component ranges collectively comprise an imposing and aesthetically satisfying composition. While the buildings themselves are of a somewhat austere and institutional character, they are enlivened by their bold and highly regular fenestration. The buildings are therefore associated with design aesthetic heritage values of some importance, which partly relate to the architectural interest of Broad Oak House (Figs. 4 and 7).

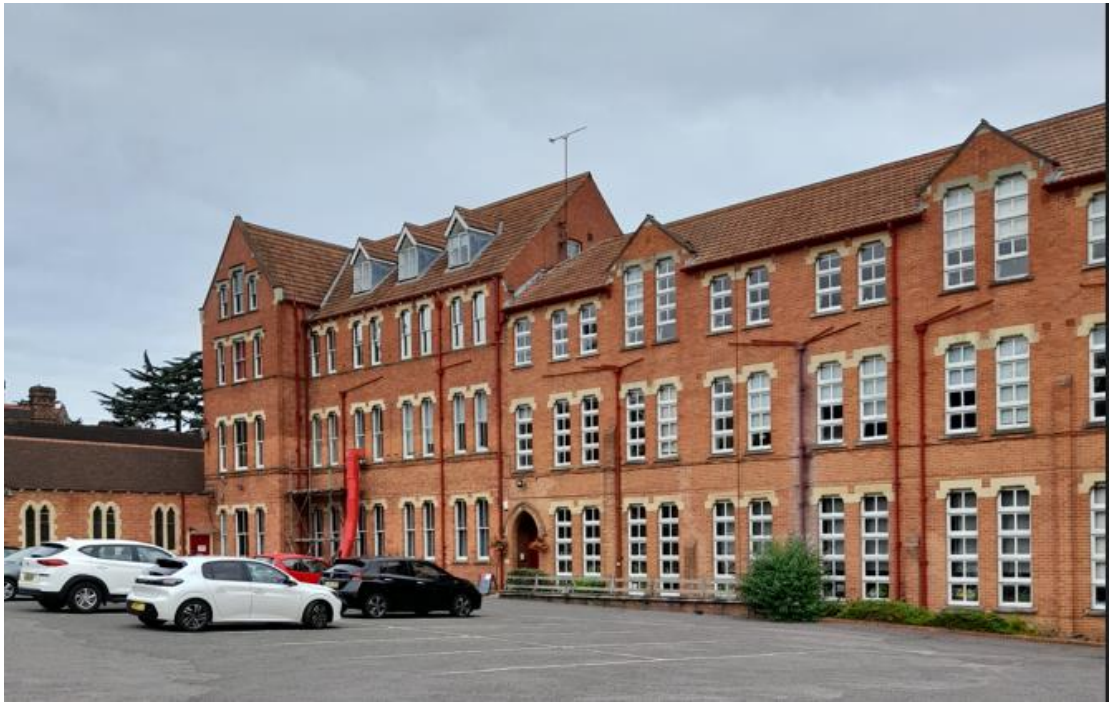
**Fig. 10: View, looking north-west, of the western and middle ranges of early twentieth-century school buildings to the east of Broad Oak House.**

- 4.6 The series of imposing brick-built ranges to the east of Broad Oak House represent a sequence of early twentieth-century phases of construction, which appears to have been completed within a relatively short time-span, and before the Ordnance Survey map of 1933 (Fig. 8). These comprise three principal blocks, which progressively diminish in scale

from west to east (Figs. 10-14 and report front cover). The earliest and most westerly of these is of three storeys, with an attic stage, and is distinguished by a gabled cross-wing and three attic dormers on the south elevation (Figs. 3 and 10). Immediately to the east of this, the middle range is of notably lower roof-ridge height, and is of three storeys, with no attic level. B-Block, the furthest to the east, beyond the former hall, is of only two storeys, but in a comparable architectural style (Figs. 11-13).

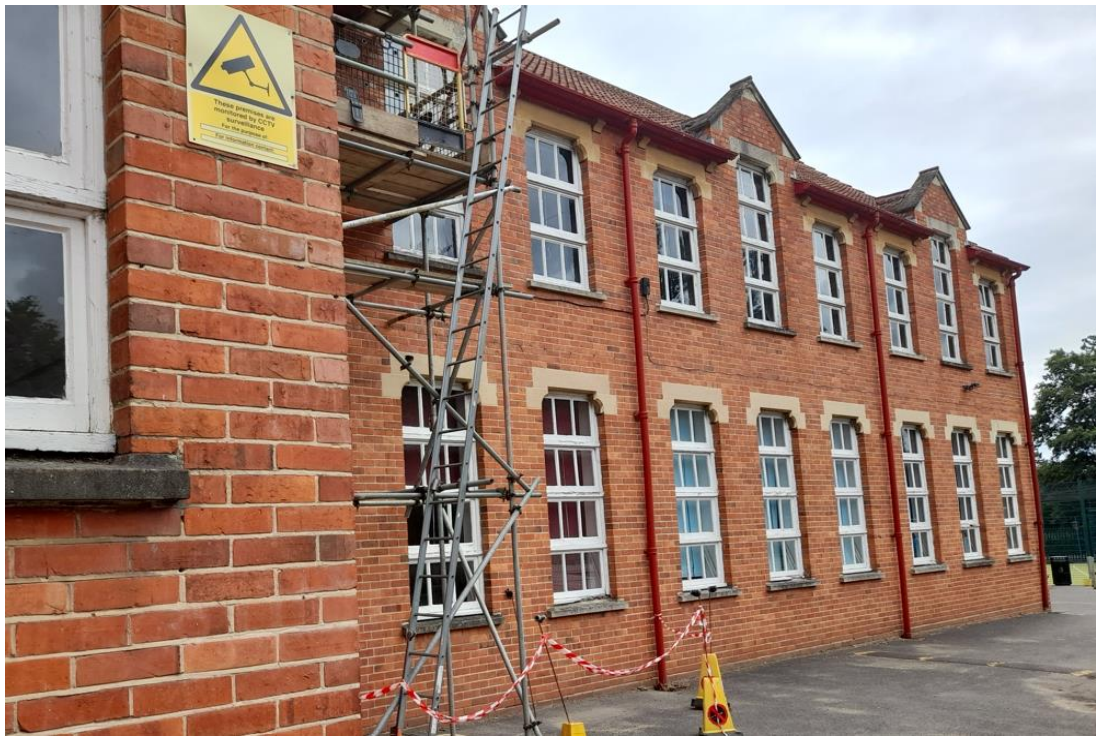
**Fig. 11: View, looking north-east, of the south, front elevation of B Block.**

- 4.7 The three principal ranges display remarkable consistency of form and detail, implying the work of a single architect. Facades are in plain, unornamented red brick, with prominent fenestration providing a defining feature. Windows throughout feature stone cills with identical stone lintel beams which are flush to the brick façade and supported on embedded corbels with scalloped profiles. The slightly earlier western block has simple four-pane sashes, whereas the middle and B blocks have complex multiple-hung, timber-framed awning windows, of unusual type (Figs. 10-15 and report front cover). The windows of B Block have four multiple-hung awnings at the ground floor, and three at the first floor (Figs. 11 and 12). The tall, closely-spaced windows are arranged in groups of two on the middle block, and groups of the three on the B Block. These arrangements provide a sense of rhythm and form within what are otherwise plain, institutional facades.

- 4.8 Additional interest is provided by the regular spacing of gabled forms at eaves-level, within which first or second-floor windows are of greater height. The heights of window openings diminish proportionally from ground floor to first or second-floor level on each block. The middle block features a pointed-arch, 'gothic' doorway with roll-mouldings, to the left of the south elevation (Fig. 10), which adds an ecclesiastical touch, although the B Block has a plain doorway opening to the west of the front elevation. The eastern end of B Block is of plain brick, with no fenestration, whereas the rear elevation is of less imposing character, with wide, camber-headed window openings on both floors which incorporate pairs of the same multiple-hung awning windows found on the front elevation (Fig. 13). This elevation is partly obscured by fire-escape stairs, and other later accretions.

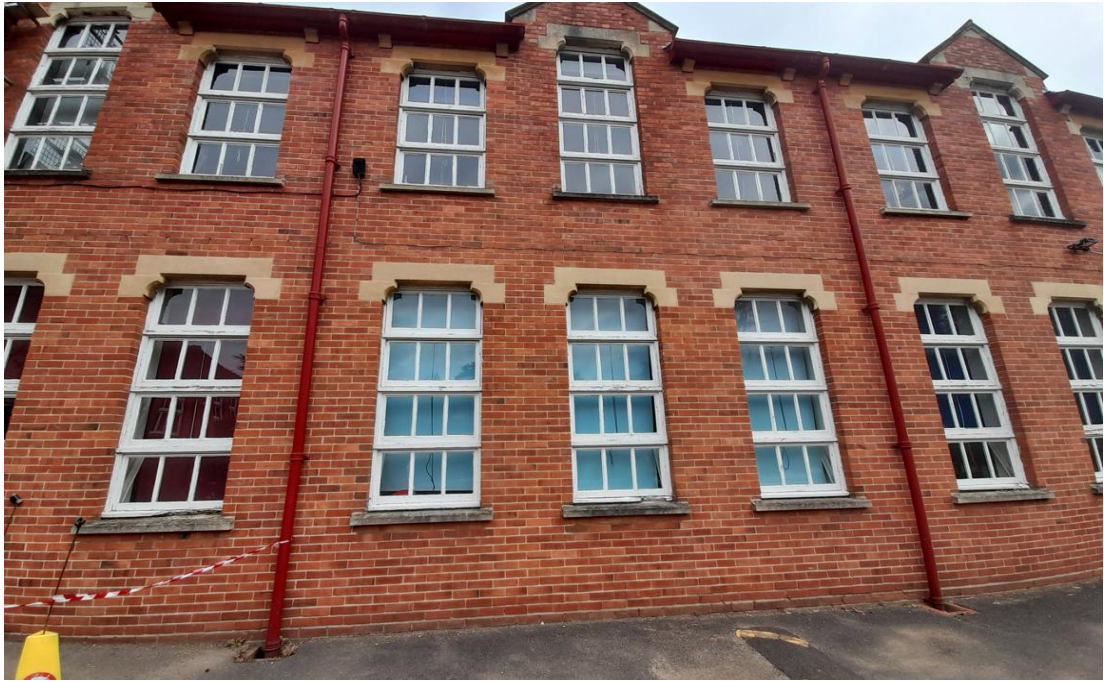
**Fig. 12: View, looking south, of the south elevation of B Block, with details of fenestration.**

- 4.9 The highly regular and consistent fenestration design across the south elevations of both middle and B Blocks, with white-painted frames and glazing bars, makes an important contribution to the character and architectural interest of the college buildings. The existing windows appear to be original features, but are of a complex form, and in an exposed location, which is not conducive to their preservation. A number appear to be incapable of being opened, and others display advanced decay of timber frames (Figs. 12 and 17).

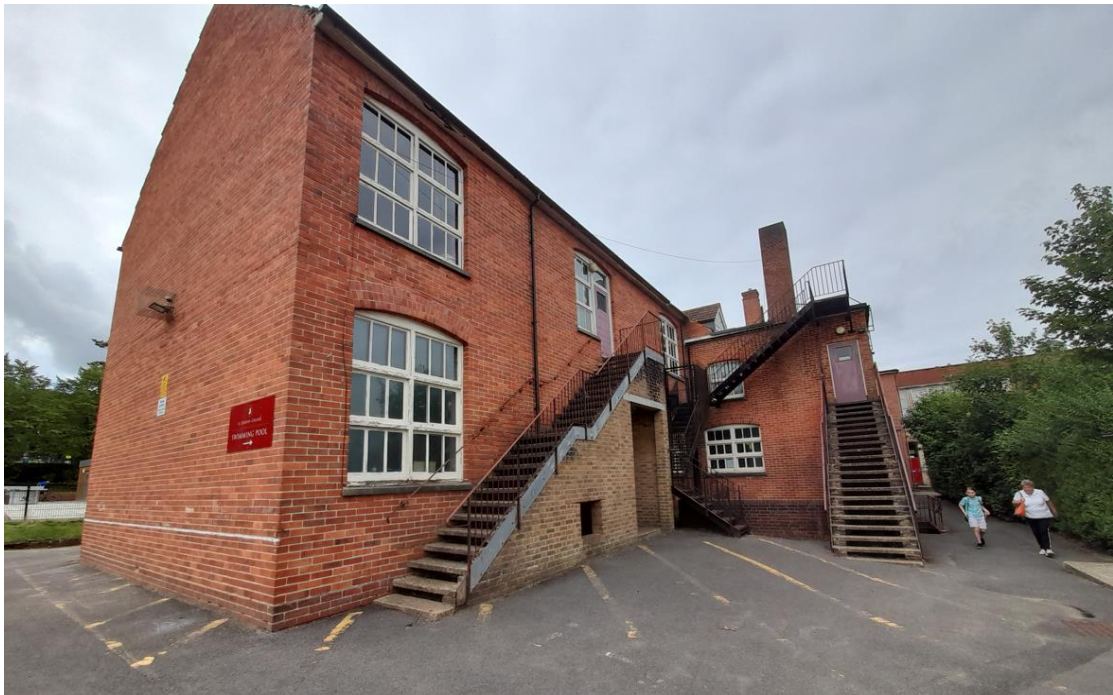
**Fig. 13: View, looking south-west, of the east and north, rear elevations of B Block.**

- 4.10 There is some variation in roof forms, with the middle block and adjoining former hall featuring hipped roofs, while the western and B blocks have gabled roofs of simple type (Figs. 10 and 14, and report front cover). Roof-lines throughout are enlivened by upstanding gable forms and the use of dormers. The general consistency of architectural treatment is strengthened by the use of Bridgewater tiles throughout, which add texture to the overall composition.

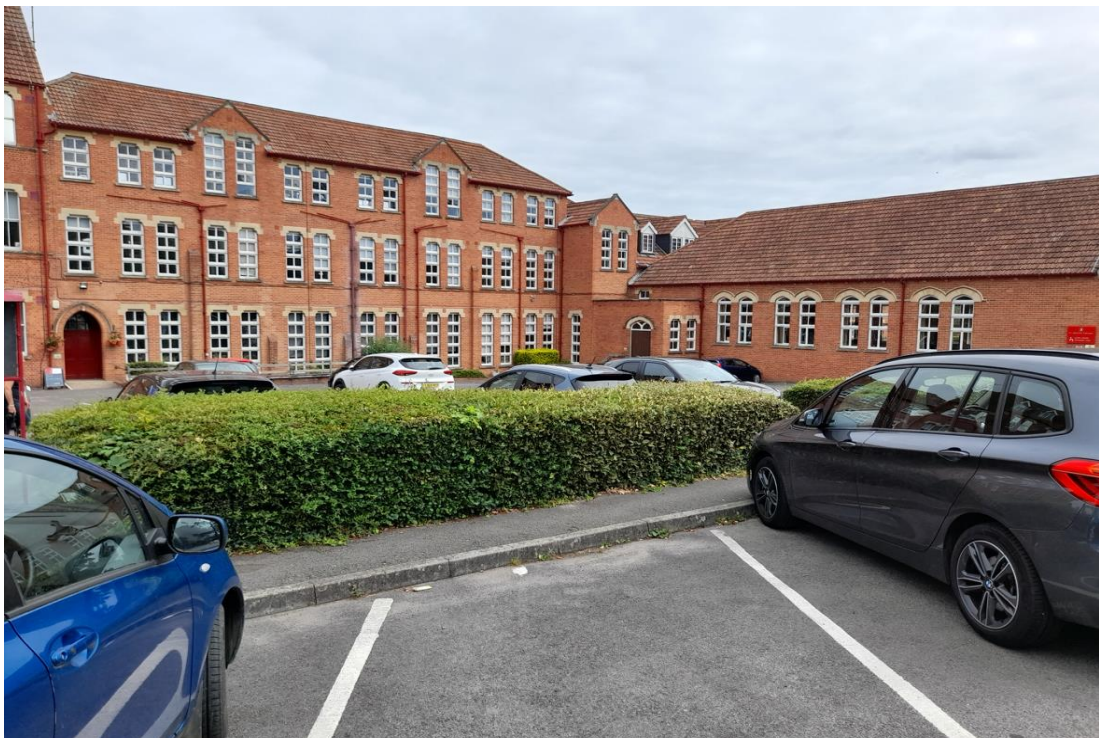
**Fig. 14:** View, looking north-east, of the middle range of school buildings and the adjoining former hall.

- 5.4 The original roof-tiles are of Bridgewater 'Roman' type throughout, and these contribute to the appearance and character of the school buildings (Fig. 14). A significant number of tiles have become broken, or have deteriorated due to the effects of weathering, and

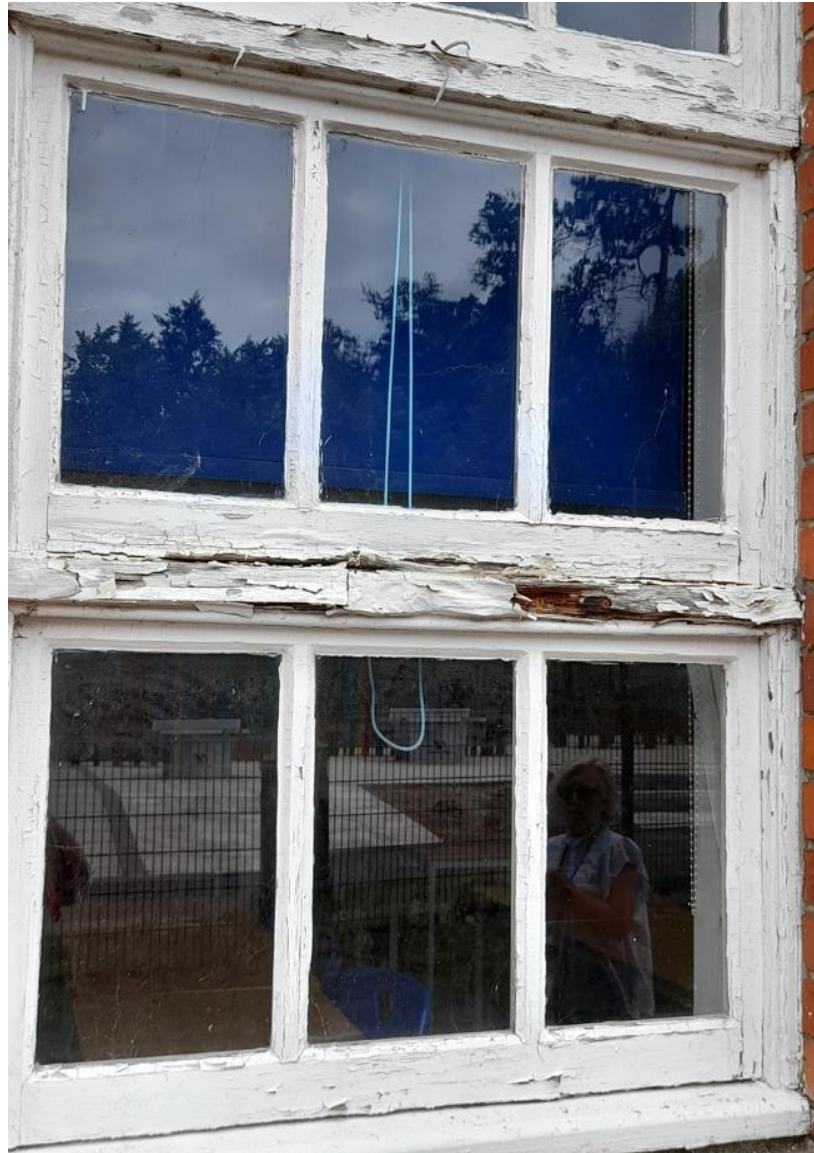
**Fig. 17: Detail of ground-floor window of B Block, with evidence of advanced decay of window frames.**

- 5.3 It is proposed to install UPVC-framed, triple-glazed windows, with glazing bars and detail of appropriate historic pattern, to match the existing fenestration on the school buildings (Figs. 12, 13, 15 and 16). The proposed replacement windows would considerably enhance the energy efficiency of the building, while maintaining its external appearance and character.

- 5.6 The current condition of window frames on B Block is such that they now represent a serious defect which has implications for the long-term use and conservation of the building (Fig. 17). Their replacement is therefore urgent and necessary. The replacement of the existing timber-framed windows with UPVC-framed examples of appropriate design, with individual awning frames and glazing bars, would retain the current external appearance and character of the building (Fig. 20).

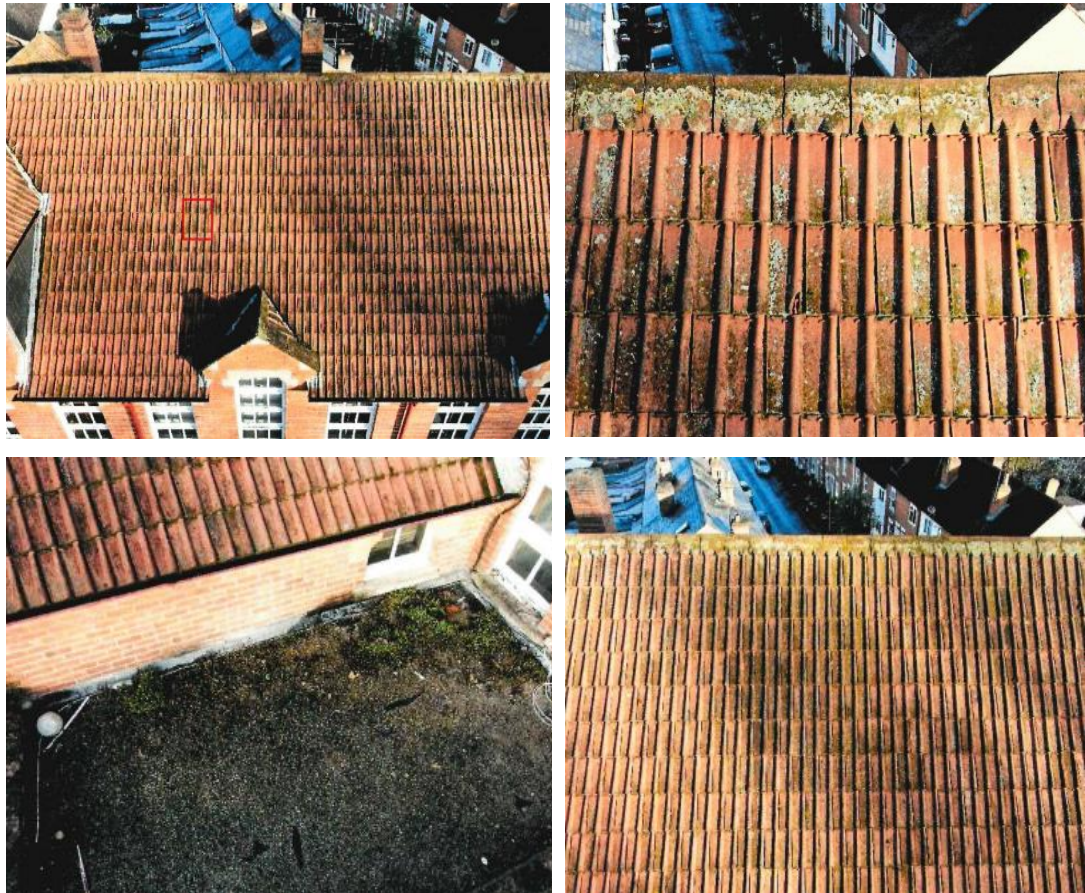
Fig. 18: Photographs of defective areas of tiled roof on B Block (St Joseph's College).

some are missing (Fig. 18). These tiles are no longer manufactured, and it is not possible to replicate their precise historical pattern on an economic basis. Similarly, sourcing salvaged historic tiles would not be economically feasible. Accordingly, it is now proposed to re-roof B Block with modern replacement tiles of similar type, which would provide an acceptable substitute for the originals. In conjunction with the re-roofing of B Block, it is proposed to improve the thermal performance of the roof-space of this building, and to further enhance its energy efficiency.

deteriorating condition of the tiled roof of B Block, with a number of tiles broken, displaced and missing, with important implications for underlying fabric. It is therefore proposed to replace the existing tiles with modern examples of appropriate pattern, as tiles of the historic Bridgewater pattern are no longer available. Replacement of roof tiles would be undertaken in conjunction with improvements to the thermal properties of the roof-space of B Block, thus further enhancing the energy efficiency of this building. It is also proposed to install an array of photovoltaic panels on the south-facing roof of B Block, to provide a source of renewable energy.

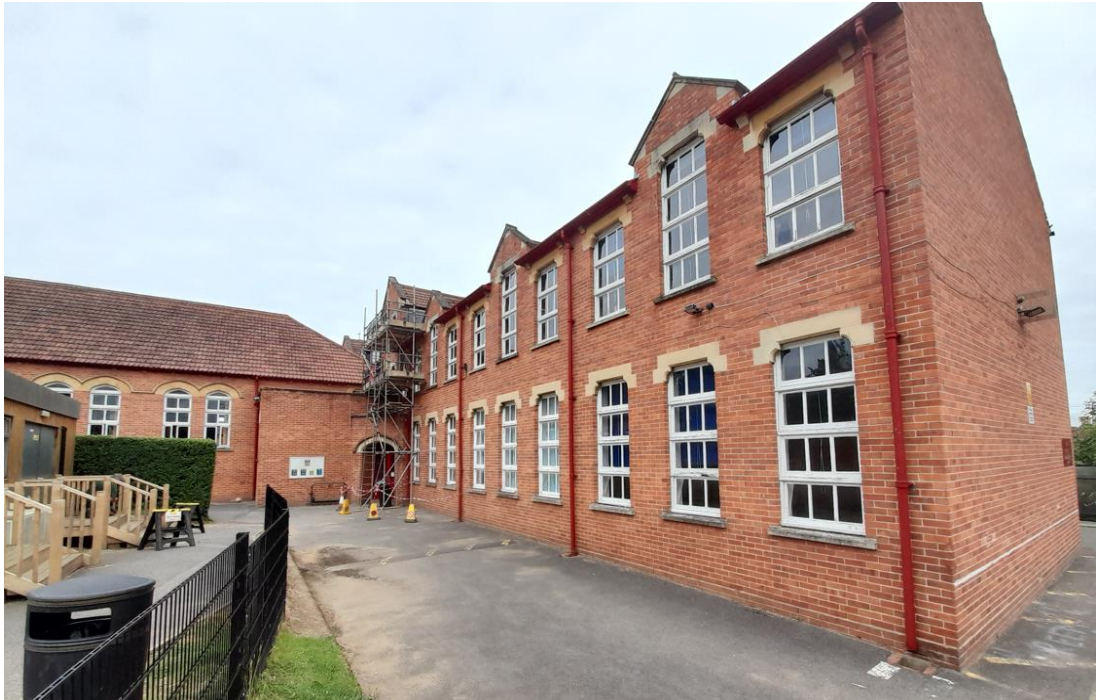
Fig. 19: View, looking north-west, of the south elevation and south-facing roof of B Block.

- 5.8 The proposed installation of photovoltaic panels on the south-facing roof of B Block would affect the external appearance of the building in northward views from Upper Redlands Road (Fig. 20), but would have comparatively little visibility within the school complex, due to the intervening built form of the former hall on the western side of B Block (Figs. 14 and 19). The photovoltaic panels would not be visible from Grade II-listed Broad Oak House, and would therefore not result in any impact to its wider setting or significance. Similarly, the proposed window replacements and re-roofing of B Block would have a minimal effect on the setting and significance of Broad Oak House. The proposed repairs would not affect the settings or significance of any other heritage assets, including Grade II-listed No. 11 Elmhurst Road, located 160m to the south-west. It is argued that any harm resulting from the installation of roof-mounted photovoltaic panels in this case would be balanced by the public benefit of establishing a source of renewable, carbon-free energy.
