## Preliminary Roost Assessment

85 Hamilton Road, Earley, Reading RG1 5RB

A new single storey garage in addition to a three-storey rear extension including basement level following the demolition of an existing extension

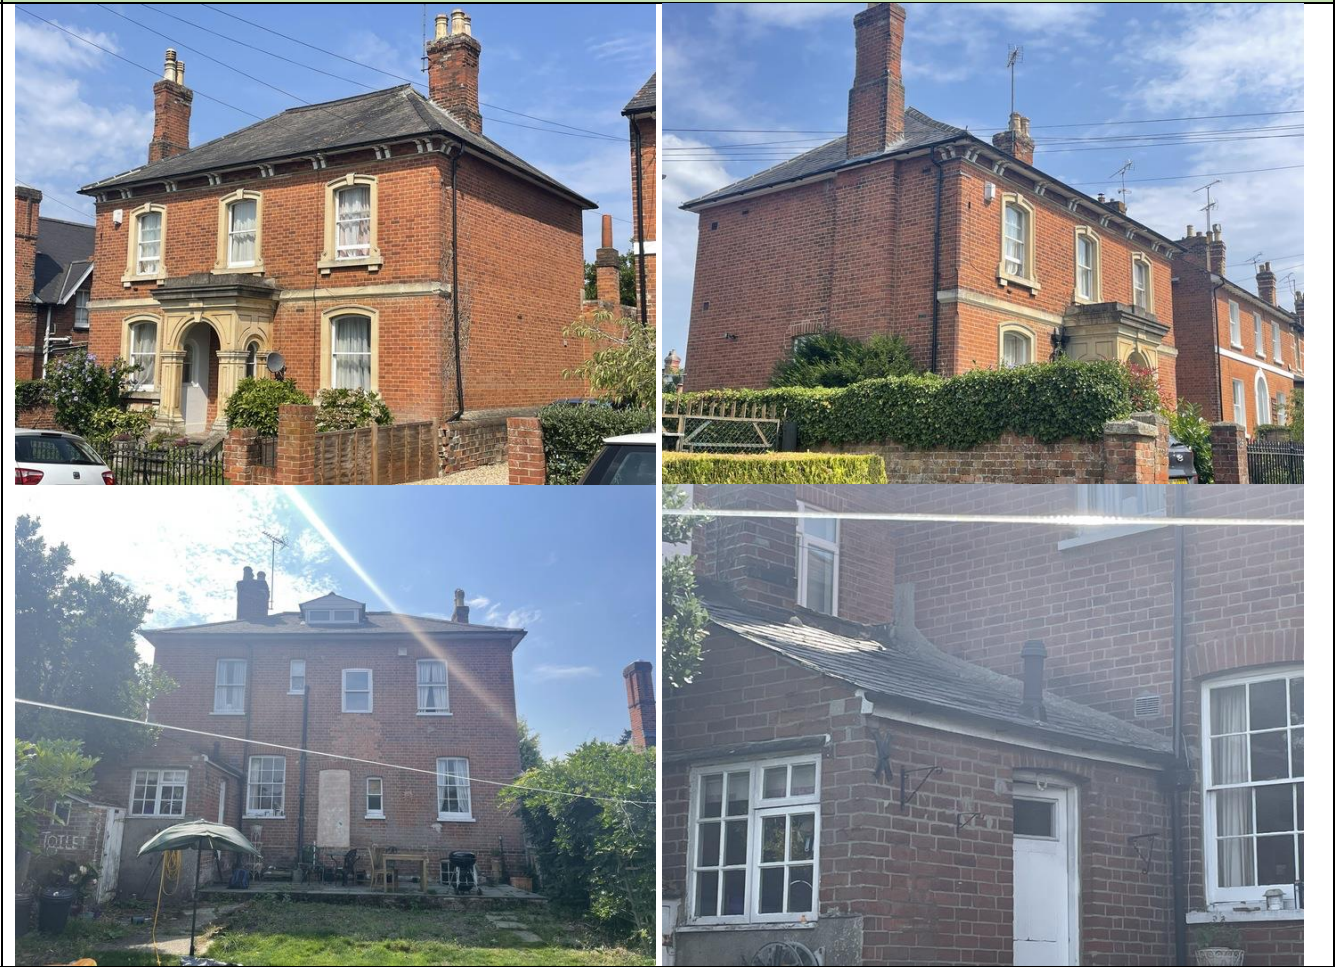
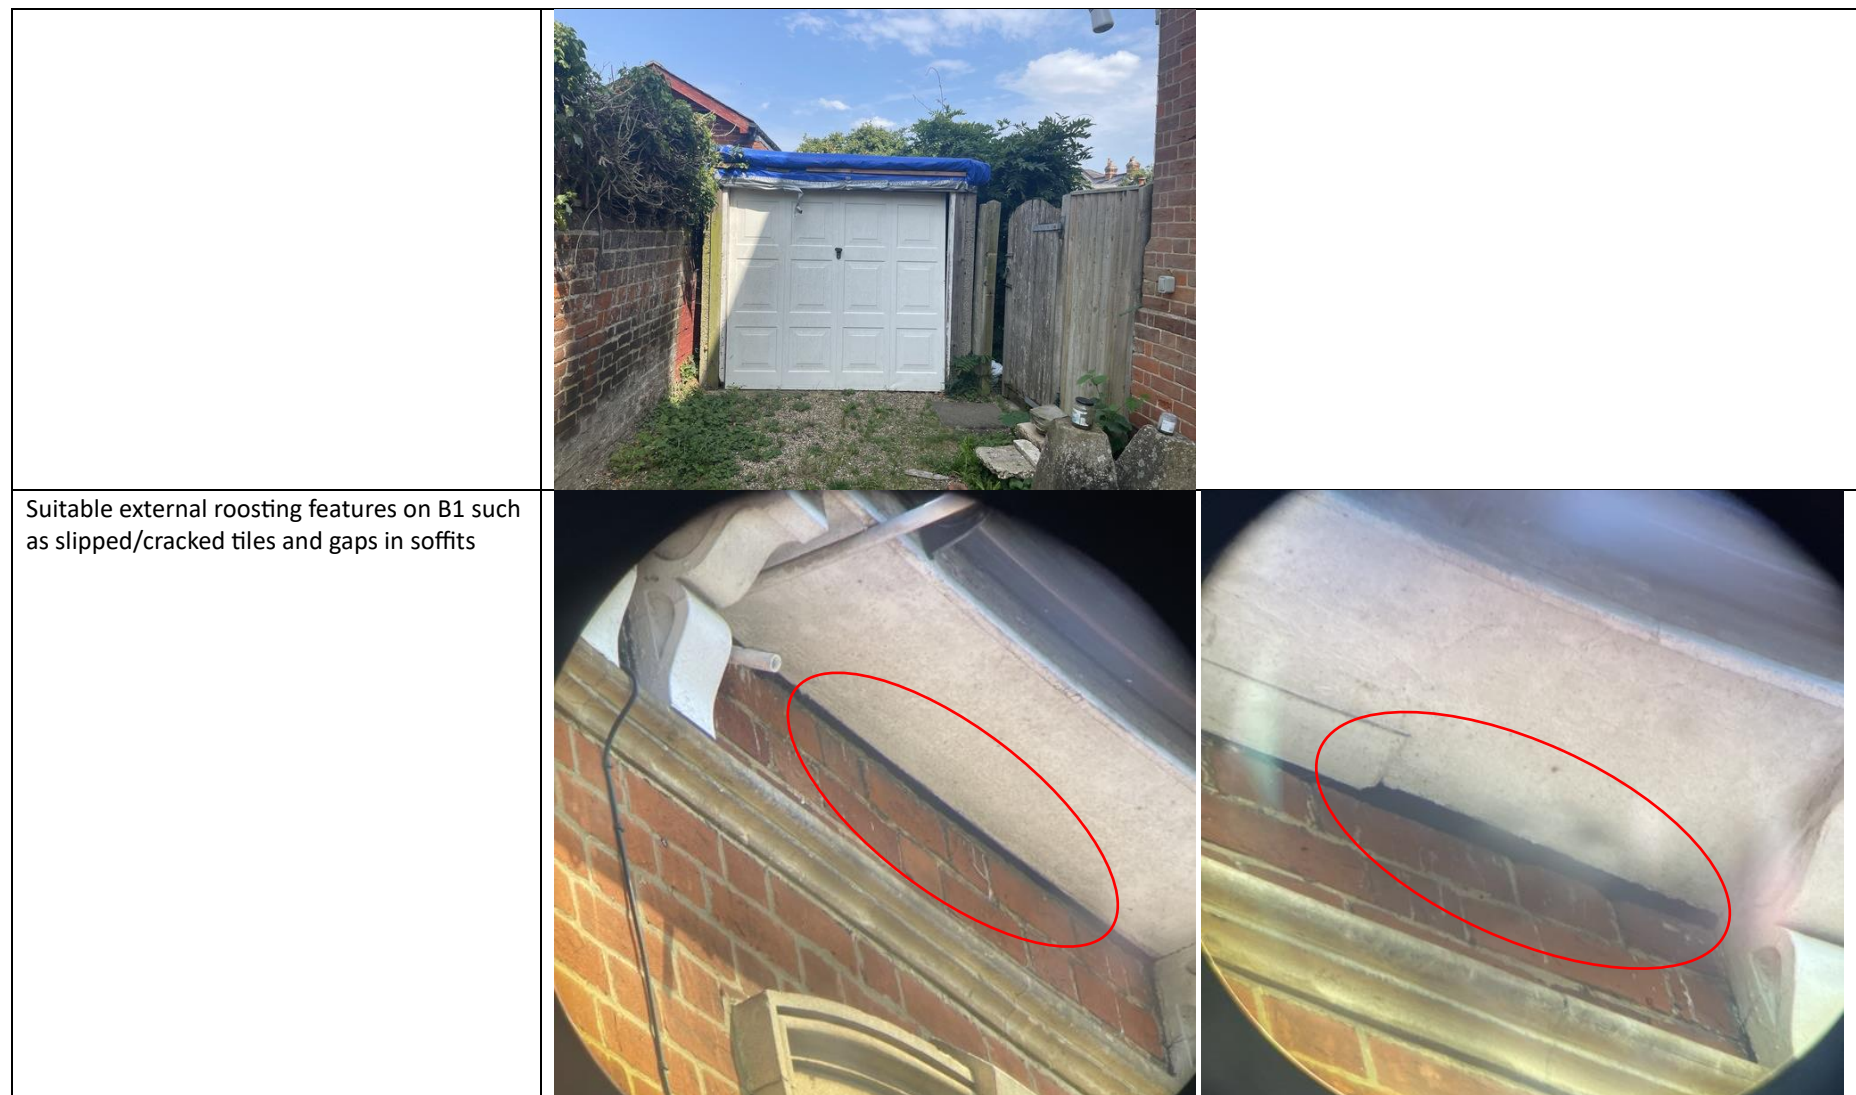
| Description | Photos |
|---|---|
| Overview of the building exterior | |

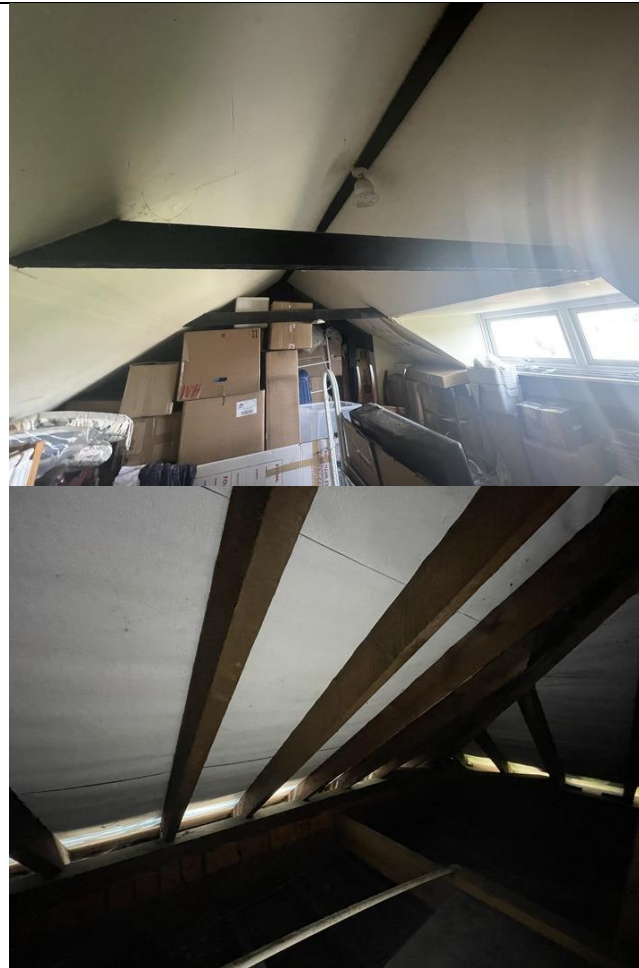
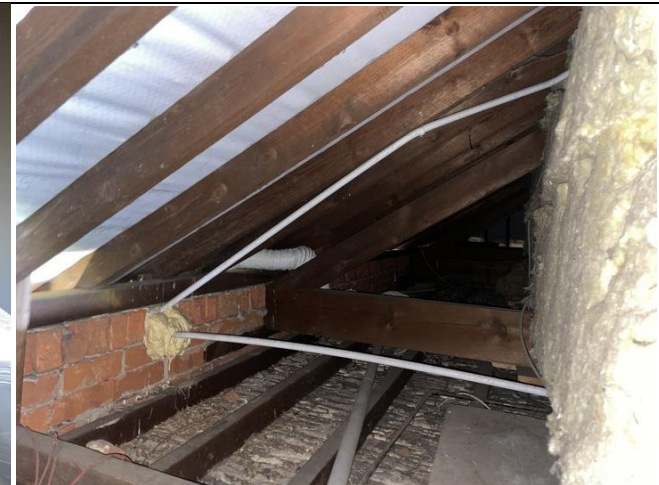
### Overview of the interior and eaves space in B1

Photographs show the lack of loft space in B1, with the ridge beam present in the upstairs rooms, and the roof membrane present lining the roof inside the eaves space, the lack of hard flooring to be able to stand on, and daylight entering the eaves space through the gaps in the soffits.

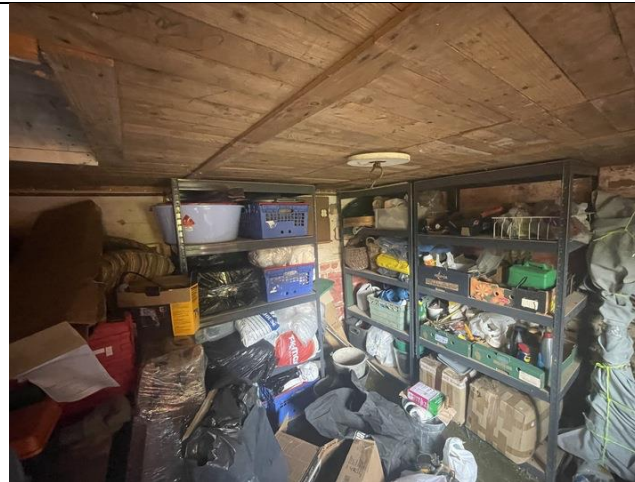
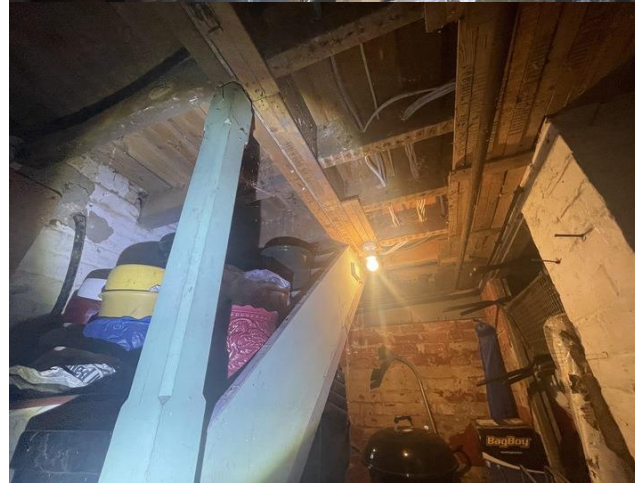
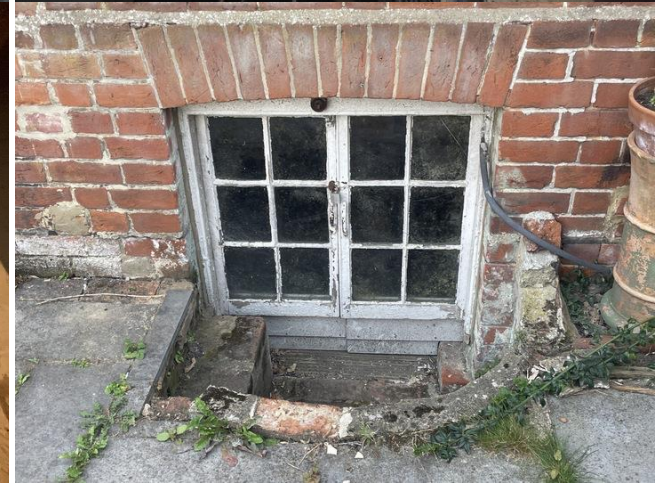
Overview of the interior, as well as the window on the exterior of B1 leading into the basement.

The photos show dense cobwebs present and lack of entry and exit ways from the basement, indicating a likely absence of any bats.
