**REDEVELOPMENT OF  
234 SOUTHCOTE LANE  
READING  
BERKSHIRE**

## **STRUCTURAL DEMOLITION SPECIFICATION**

**TB/466523/djb**

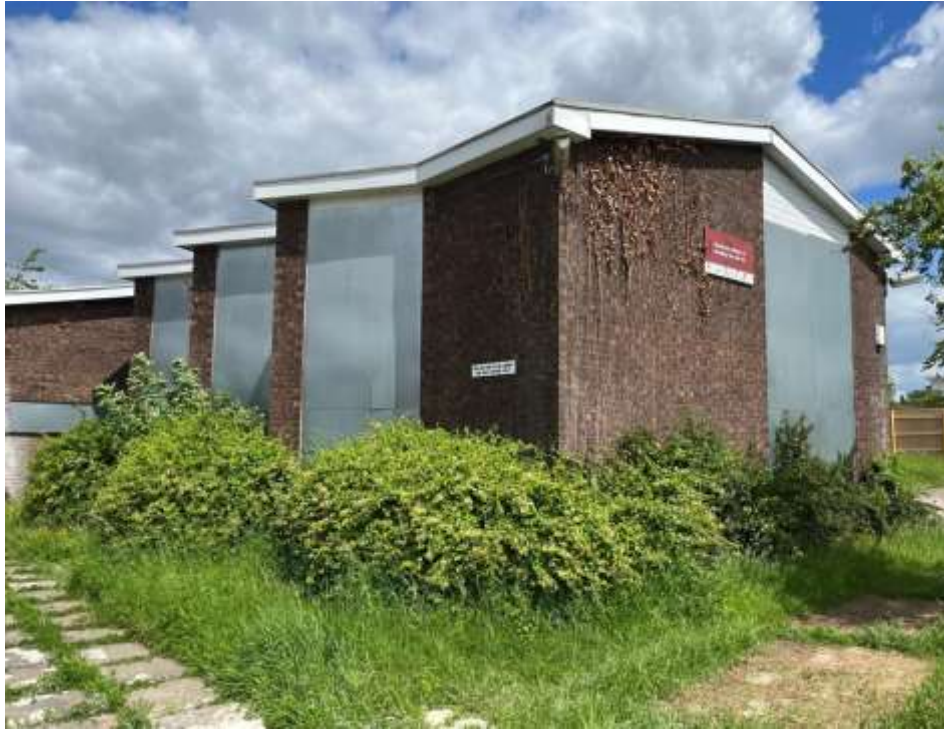
**Figure 1:** Existing building looking from the south east

The affected building is believed to have been constructed in C. 1980. The building is detached and single storey, varying in height, with a mixture of pitched roof and flat roof areas. The construction is of traditional masonry construction with timber trussed rafter roof, with metal profile sheet coverings, to the pitched roof areas and timber flat roof joists, with bitumen coated strawboard coverings, to the

flat roof areas. I believe that the west elevation of the building, has steel frames around the full height glazing units. The ground floor of the building is believed to be a concrete ground bearing slab.

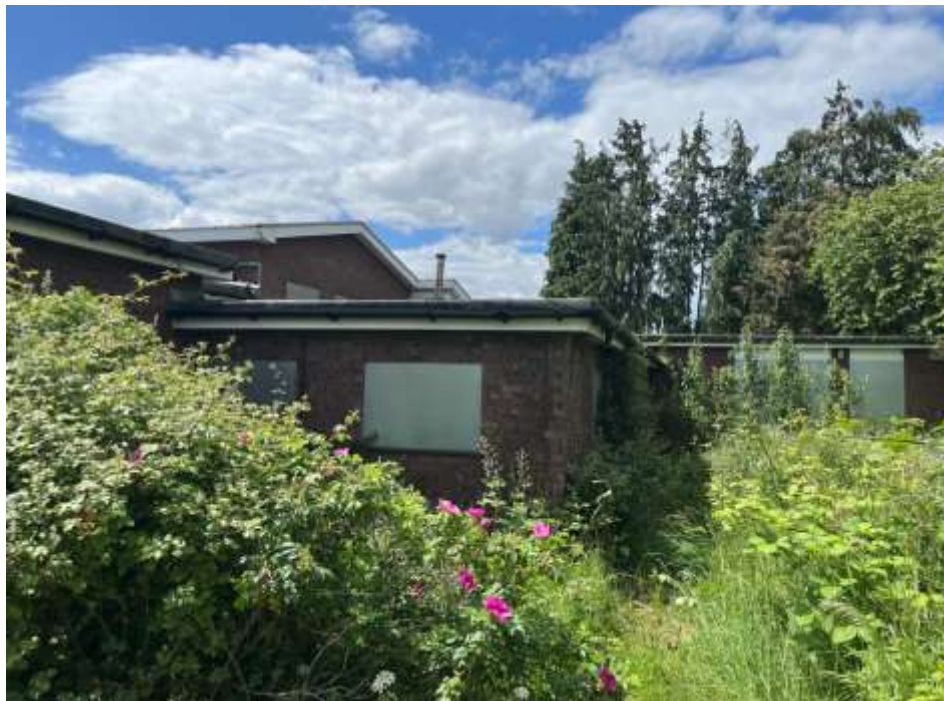
**Figure 2:** Existing building looking from the north east
