# Biodiversity Enhancement Plan

**Site:** 1-15 Queen Victoria Street and 145-148  
Friar Street, Reading

**Client:** Thackeray Group

**Date:** October 2024

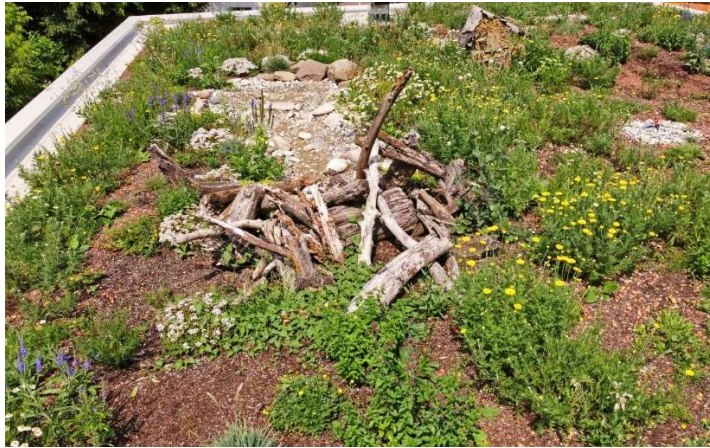
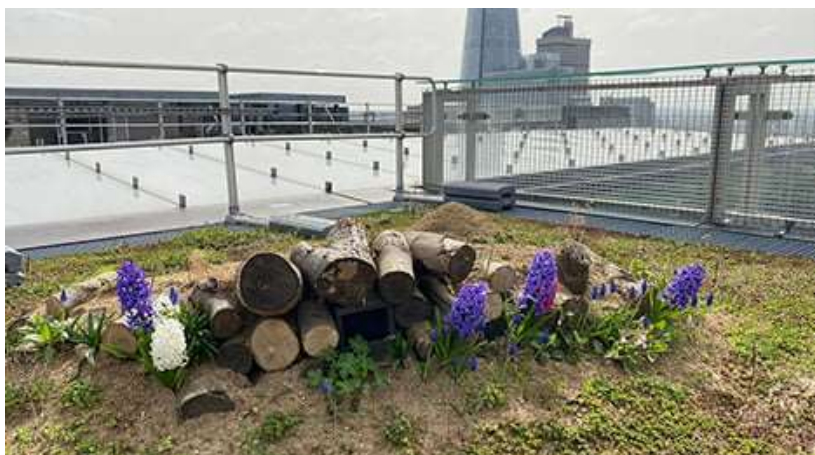
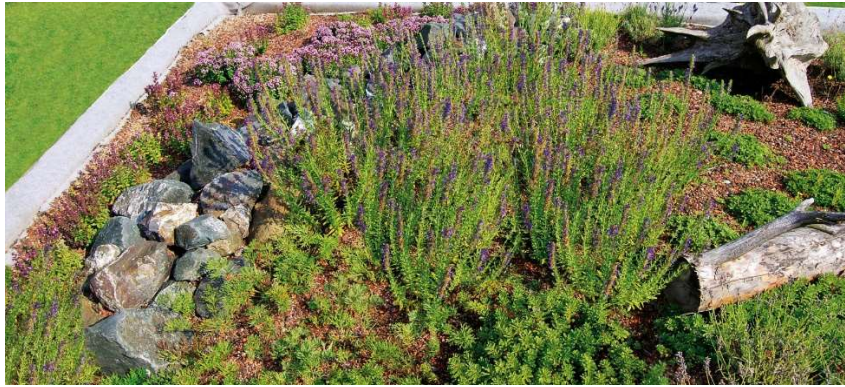
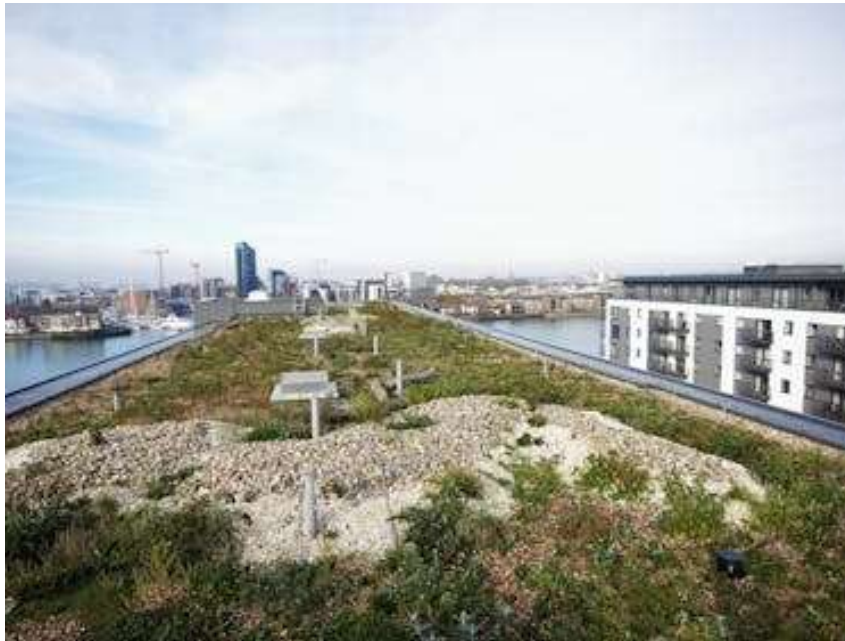
**Figure 1: Habitat Feature Examples**

- 3.4** The log pile will be created using logs from native broad-leaved trees with bark retained. Different log girths (greater than 10cm diameter) and lengths (5-100cm) should be used with the lower logs buried into the substrate. The log pile can be secured in place through the placement of wooden stakes on either side of the logs. Plants should be allowed to grow around and over the log pile to facilitate moisture retention and shade for invertebrates and to increase the structural diversity.

- 3.5** Areas of rocks, boulders and larger aggregate (small rocks/pebbles) will also be provided within the green roof in addition to coiled rope. These features will be set out within the brown roof under the instruction of an ecologist.

- 3.6** The provision of such habitat features will increase the structural diversity across the brown roof, providing enhanced conditions for a variety of flora and increased habitat diversity for invertebrates (in particular). Examples of these habitat features are provided in Figure 1. A plan showing the suggested locations of these features is provided in Appendix 3; final locations will be subject to confirmation of loading allowances and under the direction of an ecologist.

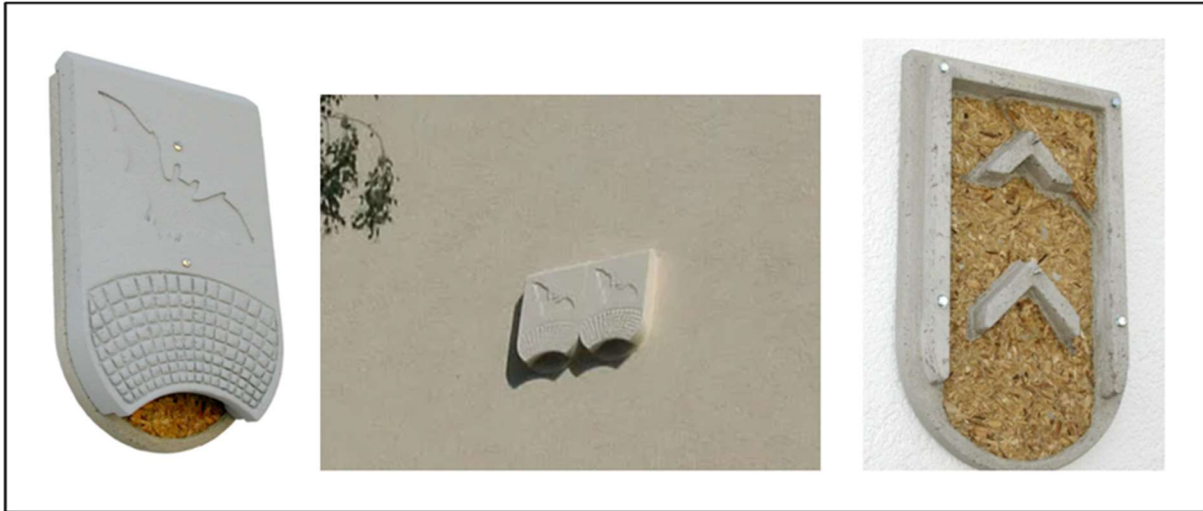
**Figure 2: 1FQ Schwegler Bat Roost (For External Walls)**

- 3.11** Based on the above requirements the boxes would be best placed on the available southern façades as shown in Appendix 4. Whilst the PEA specified the bat boxes to be used should be Bat Brick by Bird Brick Houses, it will be necessary for the bat boxes to be externally mounted<sup>1</sup> and therefore the 1FQ Schwegler Bat Roost (for external walls), Beaumaris Woodstone Bat Box or Lela Bat Box (or similar approved) will be installed (shown in Figures 2-4 below).

- 3.13** The bat box examples provided above do not require any management or maintenance; the design and construction of the boxes ensure longevity and enables bat droppings to fall out, so no cleaning is required. Annual checks on fixtures and fittings will be required for safety purposes.

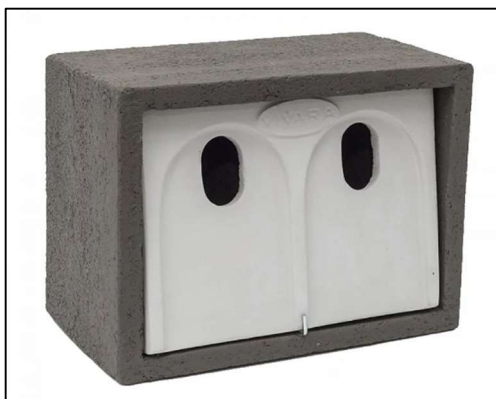
**Figure 5: Vivara Pro Woodstone House Sparrow Nest Box**

- 3.16** Whilst the PEA specified that the Ibstock Swift brick should be used, this is an integrated feature and it will be necessary for the swift boxes to be externally mounted<sup>1</sup>, therefore a suitable alternative will be to use the Vivara Pro Woodstone Swift Nest Box (or similar approved). The bird boxes to be used are shown in Figures 5 and 6 below and will be installed as per the manufacturer's installation specifications.

- 3.17** The bird box examples provided above require minimal management and maintenance; the design and construction of the boxes ensure longevity. Annual clearing of nests (during the autumn, once nesting is finished but before winter) will be required. Annual checks on fixtures and fittings will also be necessary for safety purposes.
