## Reading Civic Centre RBCO24 Geoarchaeological Watching Brief 30/10/2024 to 04/11/2024

A geoarchaeological watching brief was conducted on boreholes drilled at planned pile locations for assessment of asbestos contaminations. The site is located on Bridge Street Reading, Berkshire, RG1 2LR (NGR: SU 71448 73150).

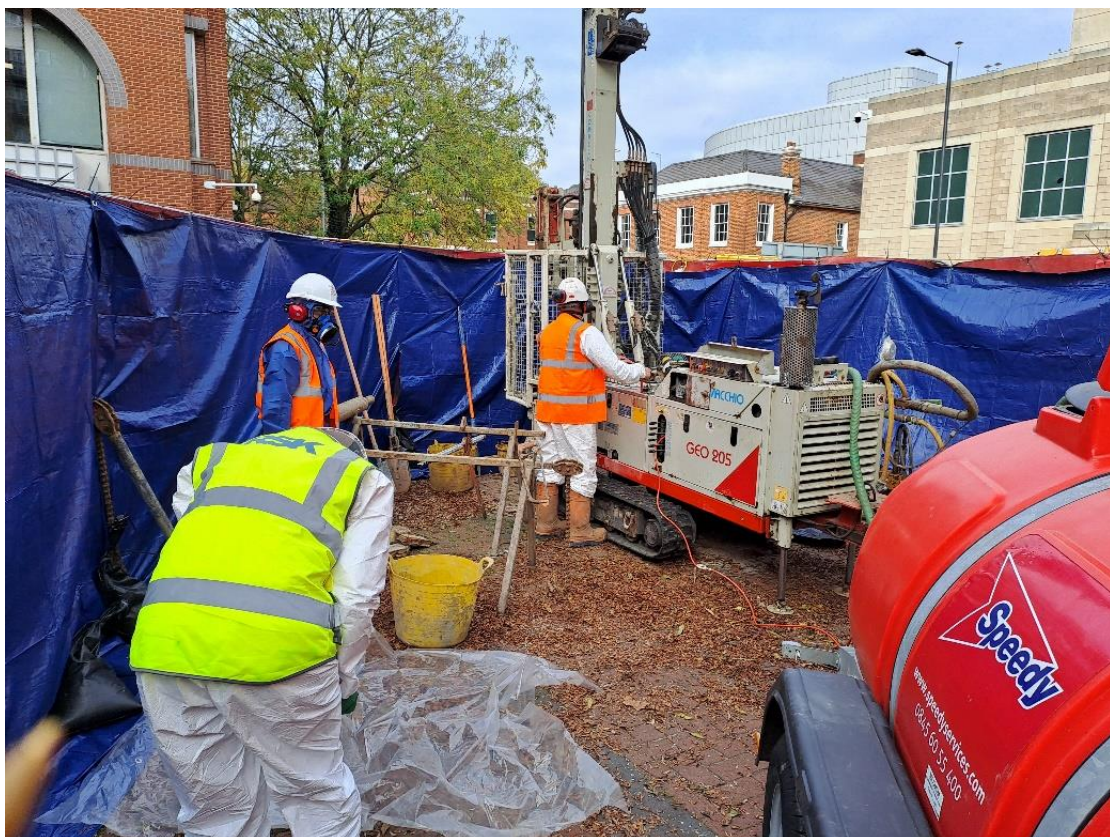
*Figure 1: Working shot of BH203*

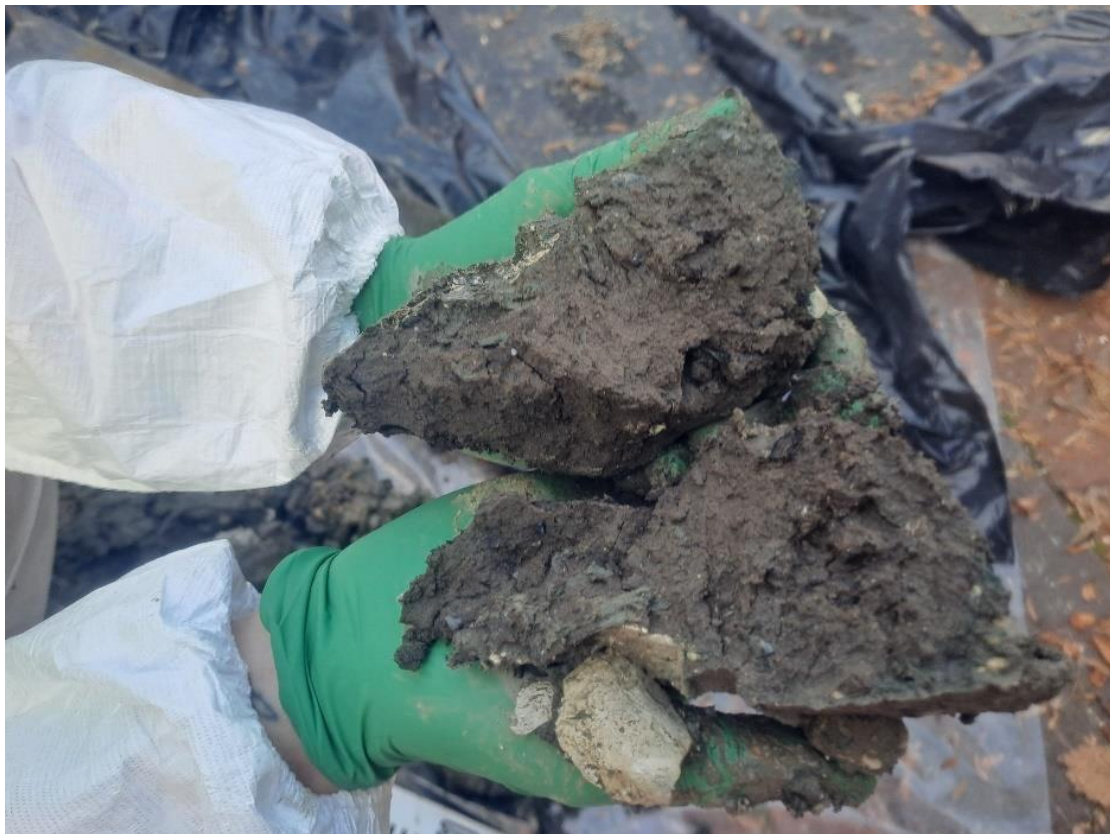
The basal deposit (4.80-5.00 m below ground level) in BH201 was a soft dark reddish brown slightly organic silty clay with root fibers and a mixed structure. This deposit likely represents an area of trample forming prior to the dumping of made ground at the interface with the river terrace gravels.

*Figure 2: BH201 4.80-5.00m bgl putative mixed organic clay trample*

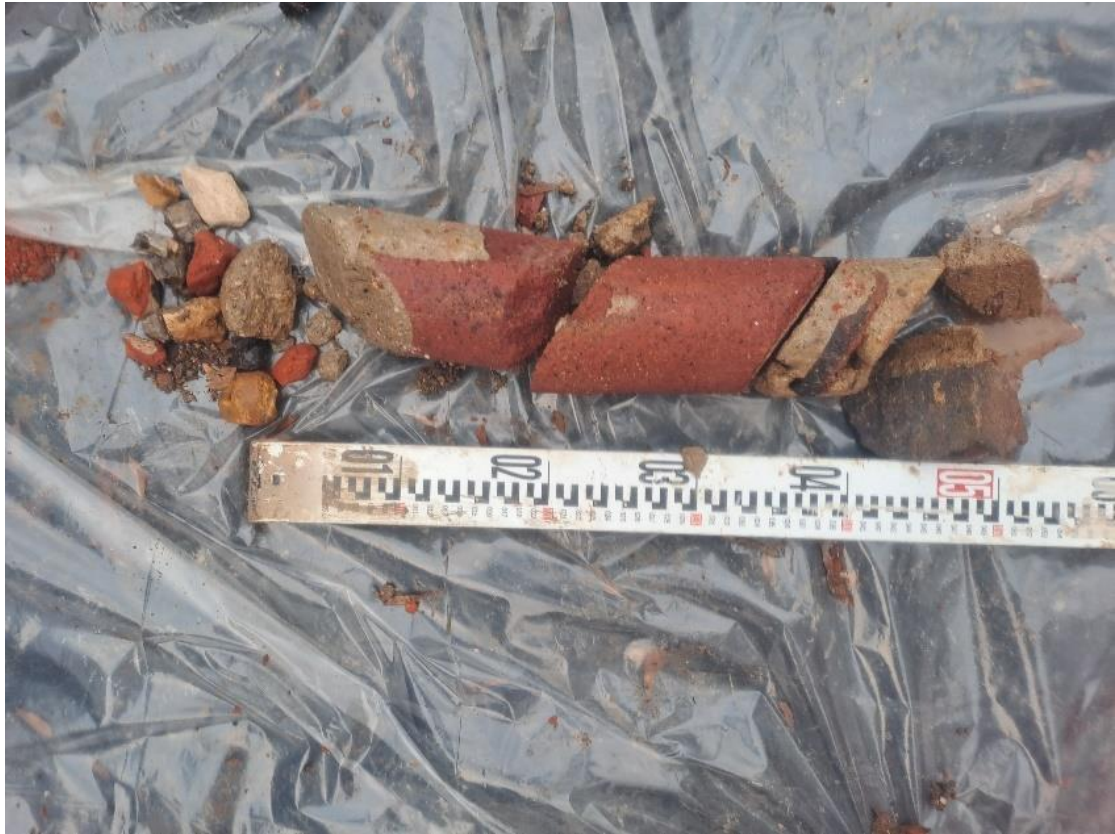
Figure 3: Remains of a redeposited brick footing in made ground. 2.00-2.48m bgl

| 2.00 | 2.48 | 37.90 | 37.42 | Redeposited brick footing - dark reddish pink brick with a sandy shelly grey mortar with brick fragments within and black bricks | Modern made ground – demolition make up | - |
