# ROOT DNA FINGERPRINTING TEST REPORT

**22 Russet Glade, Emmer Green, Reading, RG4 8UJ**

Our Ref: SUB190402-4095 – DNA Test  
Client: Crawford & Company  
Client Reference: SU1901097 / 1779439

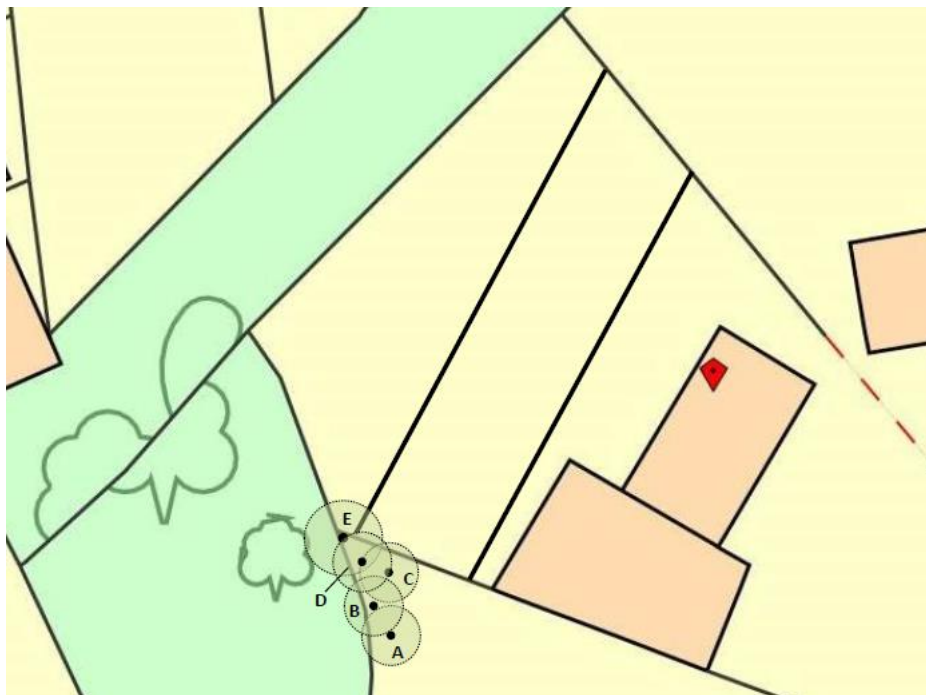
## Site Plan – TG2 breakdown

Tree TG2 C generated the same DNA fingerprint as the roots and so can be considered to be the source of the roots.

**Approximate areas of damage**

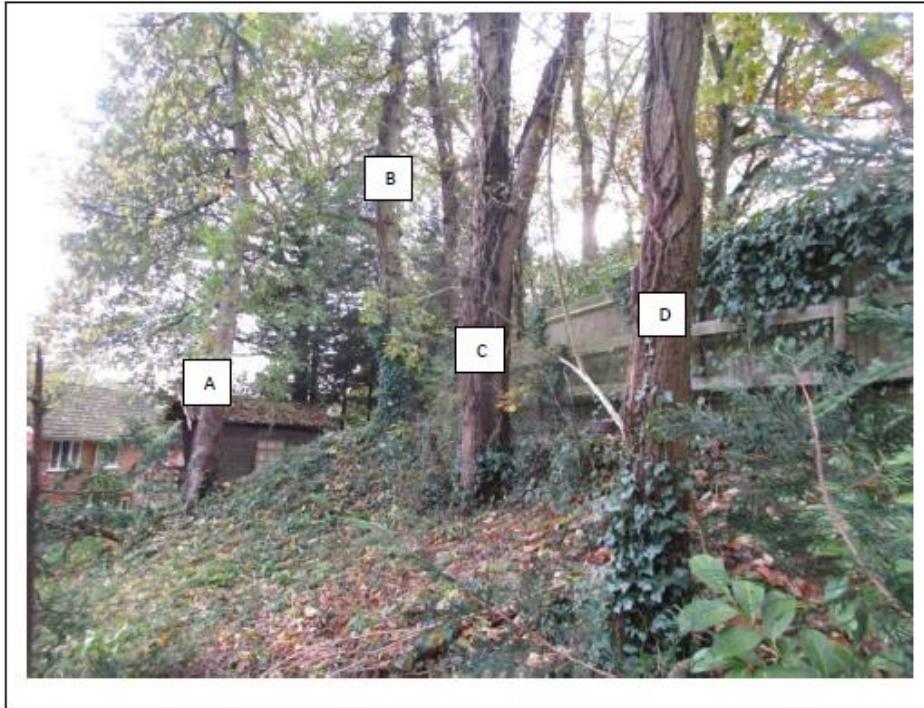
View of TG2
