An Arboricultural Impact Assessment (AIA) was subsequently undertaken to identify the potential impact of the development on the existing trees surveyed during the PAA in accordance with British Standard 5837:2012 '*Trees in Relation to Design, Demolition and Construction - Recommendations*' (hereafter referred to as BS5837).

**Application Number:** 230613 - Condition 27, and to cross reference with comments for PL/24/0838 (remediation) and PL/24/0978 SuDs / drainage strategy condition 26.

Following completion of the approved demolition phase, this Arboricultural Method Statement has been compiled to meet the conditions above and adhere to BS5837 and provide the information specified in RIBA Stage 5 including:

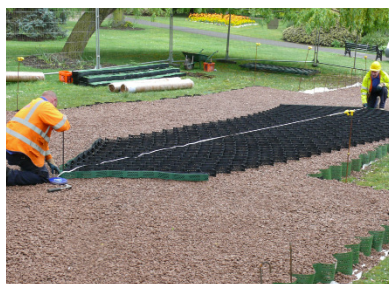
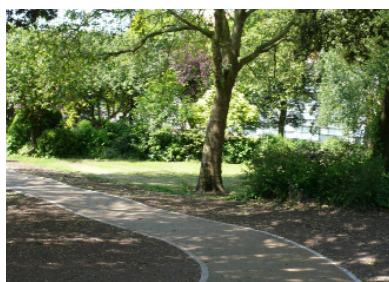
## Castle Gardens, Leicester

| Project details: | This project was undertaken by Leicester City Council in 2015. The aim of the project was to create a new access and footpath from St Nicholas Circle in the centre of Leicester down into the Castle Gardens. This would create improved access to the Castle Gardens and enable the public to pass through the gardens to access other parts of the city. The project required thoughtful design to overcome significant changes in levels within the root protection areas of several mature trees and utilise Cellweb®TRP as a no dig solution. A full case study is available on this project. |
