**FIELD HOUSE, LEIGHTON PARK SCHOOL, READING**

**PRELIMINARY BAT ROOST ASSESSMENT & BAT ACTIVITY SURVEY REPORT**

Document Ref: E24123301/DOC 01 – DECEMBER 2024

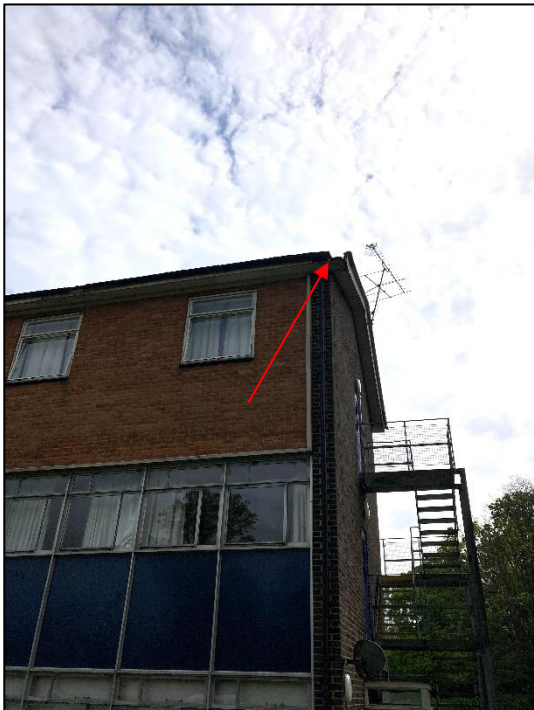
| PRF | Description |
|---|---|
| 1 | <p>Damaged/missing fascia and soffit boards at south-west corner of the main building. Potential bat access into loft space and beneath roof tiles. The building also contains a number of small crevices at the gable end.</p> |

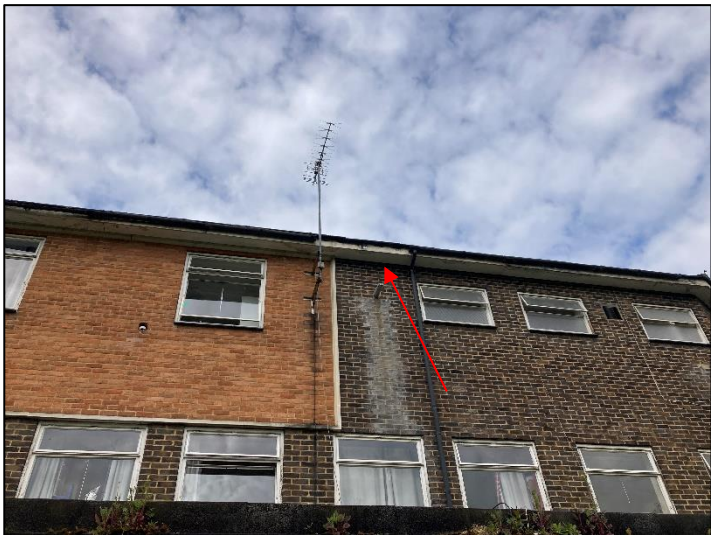
| PRF | Description |
|---|---|
| 2 | <p>Missing guttering and damage to fascia, leading to access under roof tiles. Located along eastern elevation of southern wing.</p> |

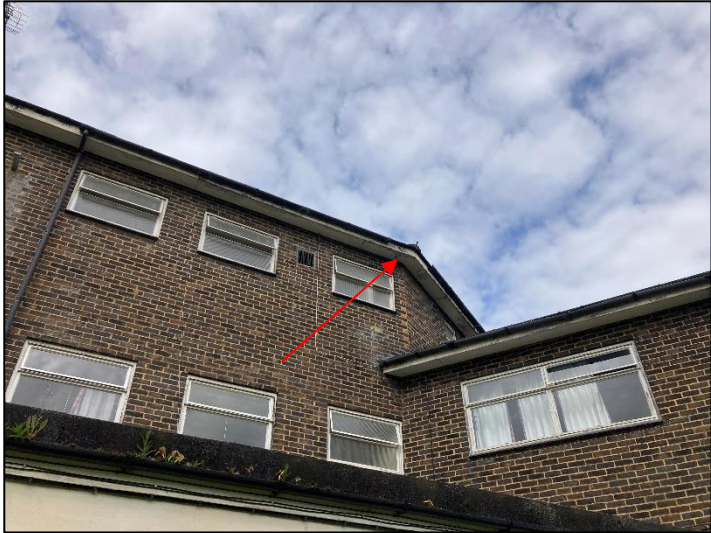
| PRF | Description |
|---|---|
| 3 | <p>Similar to PRF 2 above, missing guttering and fascia leading to access under roof tiles.</p> |

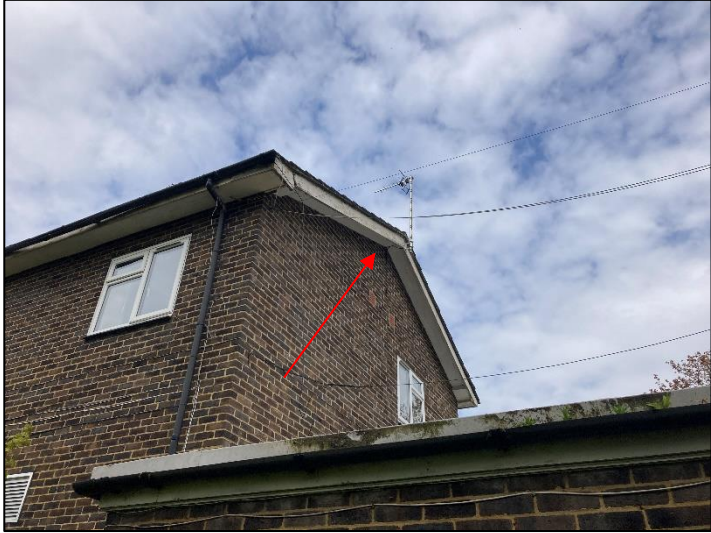
| <p>4</p> | <p>Minor damage and wear to barge boards on gable end of eastern wing of the main building. Small gap on gable end at apex with potential bat access into loft space.</p> | |

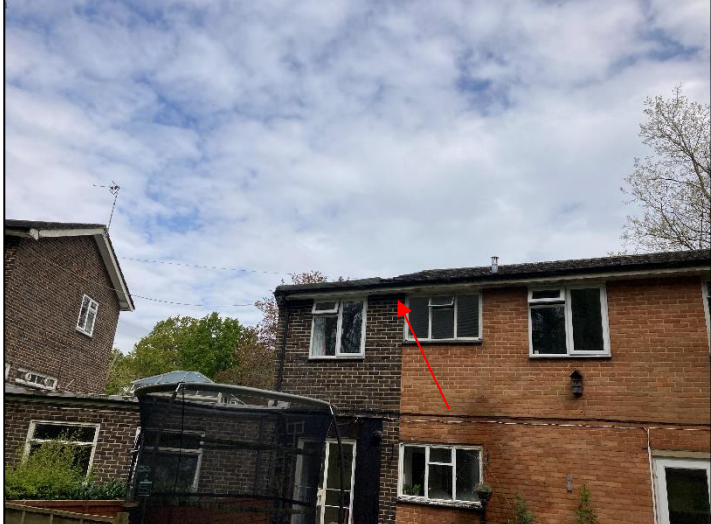
| <p>5</p> | <p>Raised roof tiles where bitumen felt flat roof has been installed. Located on south-western corner of residential unit connected to field house.</p> | |

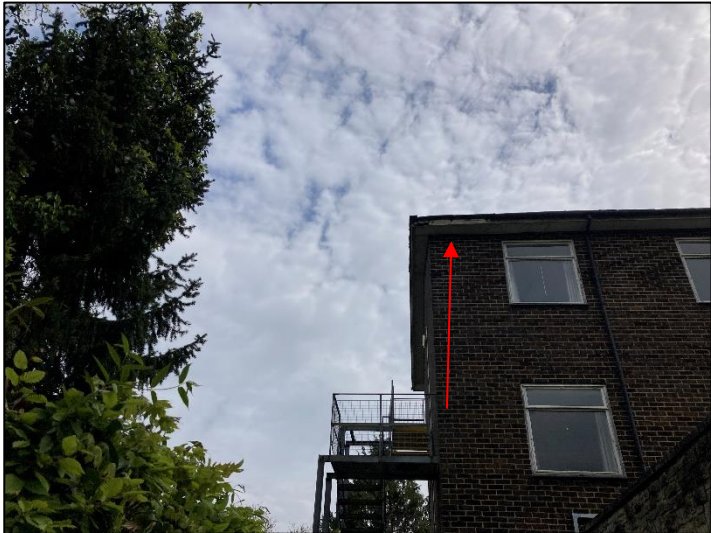
| 6 | <p>Similar to PRF 1, damaged/missing fascia and soffit boards at north-west corner of the main building. Potential bat access into loft space and beneath roof tiles.</p> |

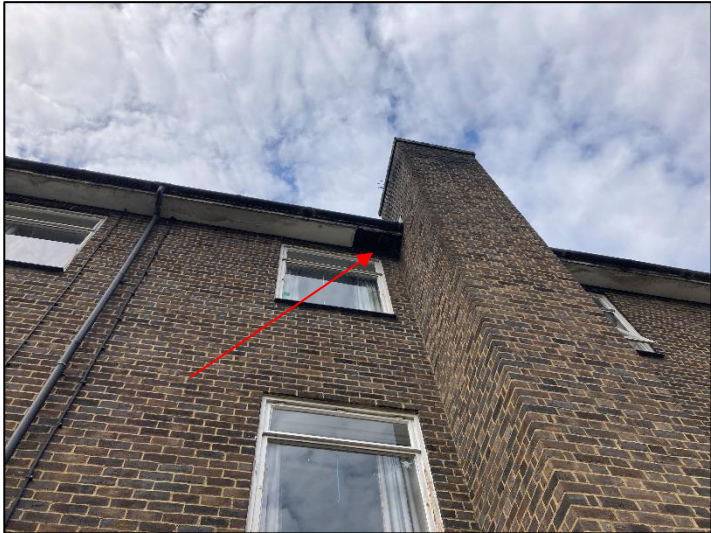
| 7 | <p>Missing soffit board located along eastern elevation next to chimney stack. Direct access into loft space (confirmed by internal inspection). Old wasp/hornet nest in loft near access point.</p> |

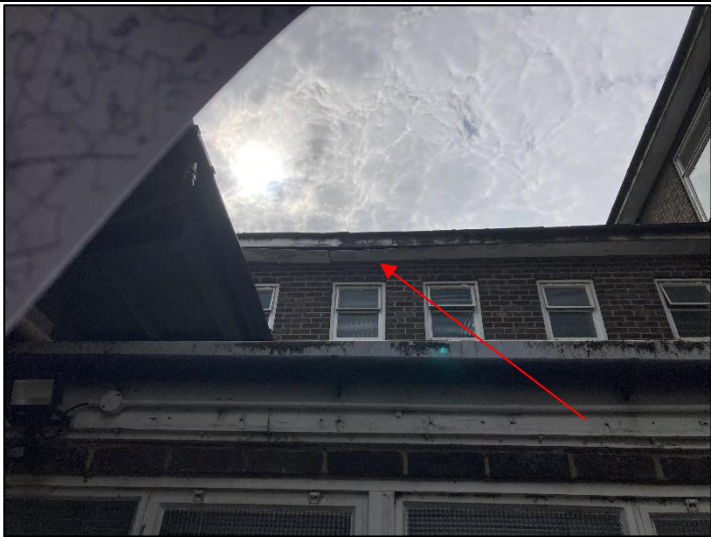
| 8 | <p>Damaged soffit board located on northern elevation of eastern wing of the main building. Board is dipping revealing potential bat access into loft or eaves.</p> |

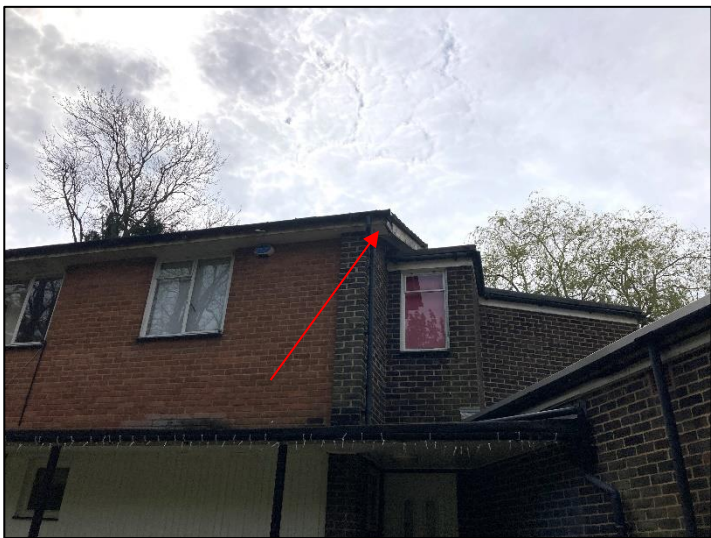
| 9 | <p>Minor damage to fascia board at north-west corner of residential unit. Potential bat access into eaves.</p> |

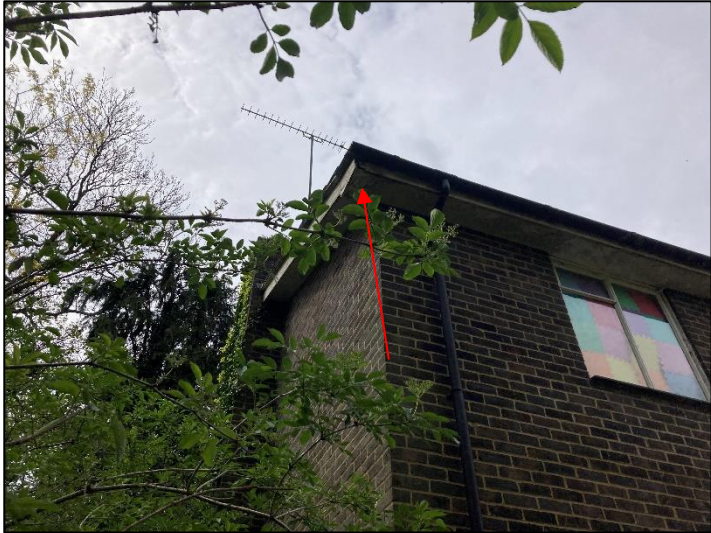
| 10 | <p>As above, minor damage to fascia board at north-east corner of residential unit. Potential bat access into eaves.</p> |

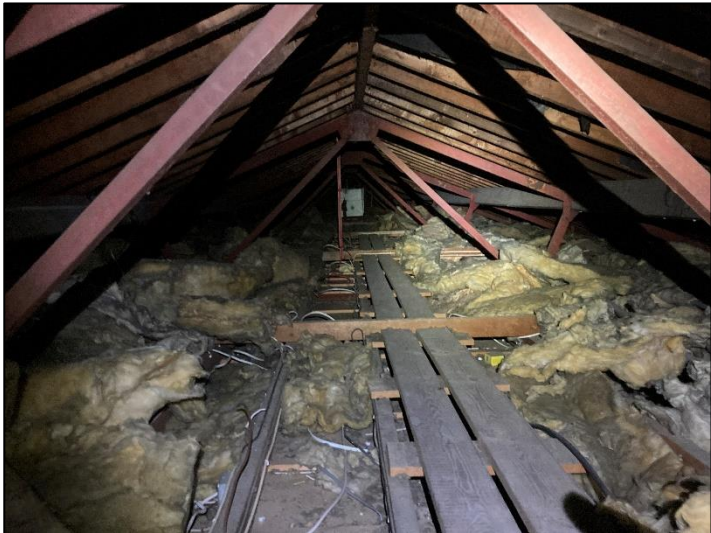
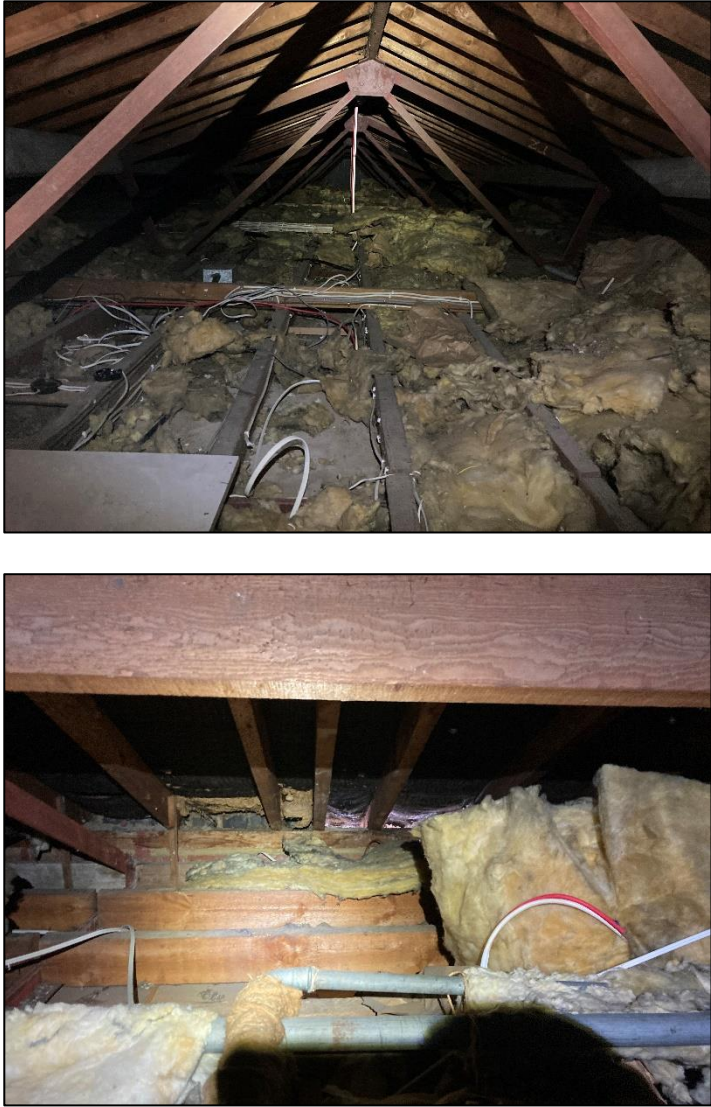
| | |
|---|---|
| 1 | <p>Loft space of three-storey section of main building. Northern and southern wing connected via continuous loft space. Loft space comprises of timber and metal roof beams with bitumen felt and fibrous insulation. Access only possible to northern wing, neither gable end were reached during the internal inspection. Access point at PRF 7 was identified – old wasp/hornet nest in loft near access point. No evidence of roosting bats was found (e.g., live/dead bats, droppings or feeding remains).</p> |

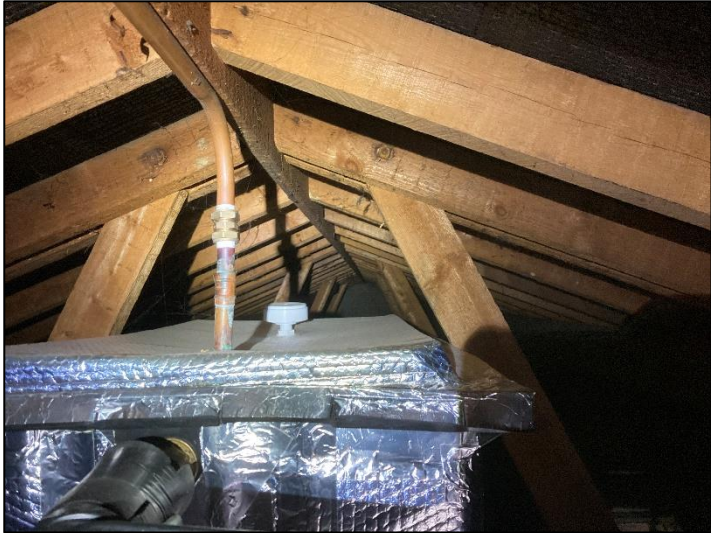
| 3 | Loft space of connected residential unit. Eastern gable end of loft only visible during current survey as location of water tank blocked access into loft space. Loft comprises of timber roof beams with bitumen felt and insulation, as well as water tank. No evidence of bats found. |

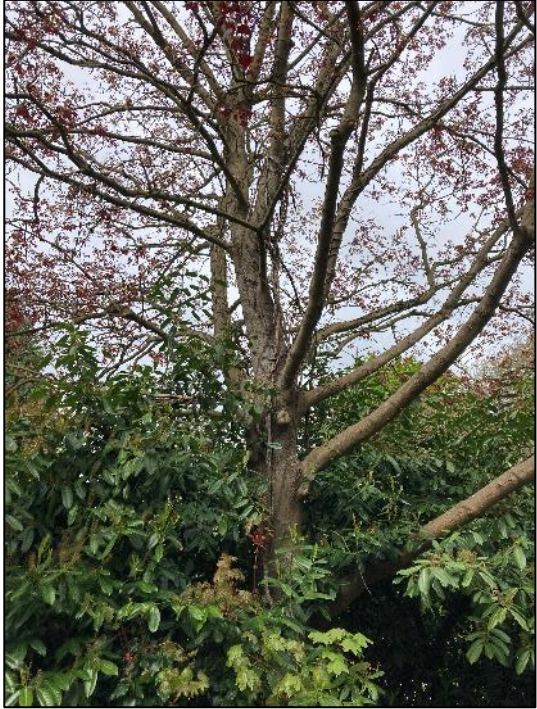
| | |
|---|---|
| T10 | <p>Purple Leaf Maple (T10) located at entrance to Field House from Pepper Lane. Tree has no obvious PRFs. Assessed to be of Negligible potential to support roosting bats.</p> |

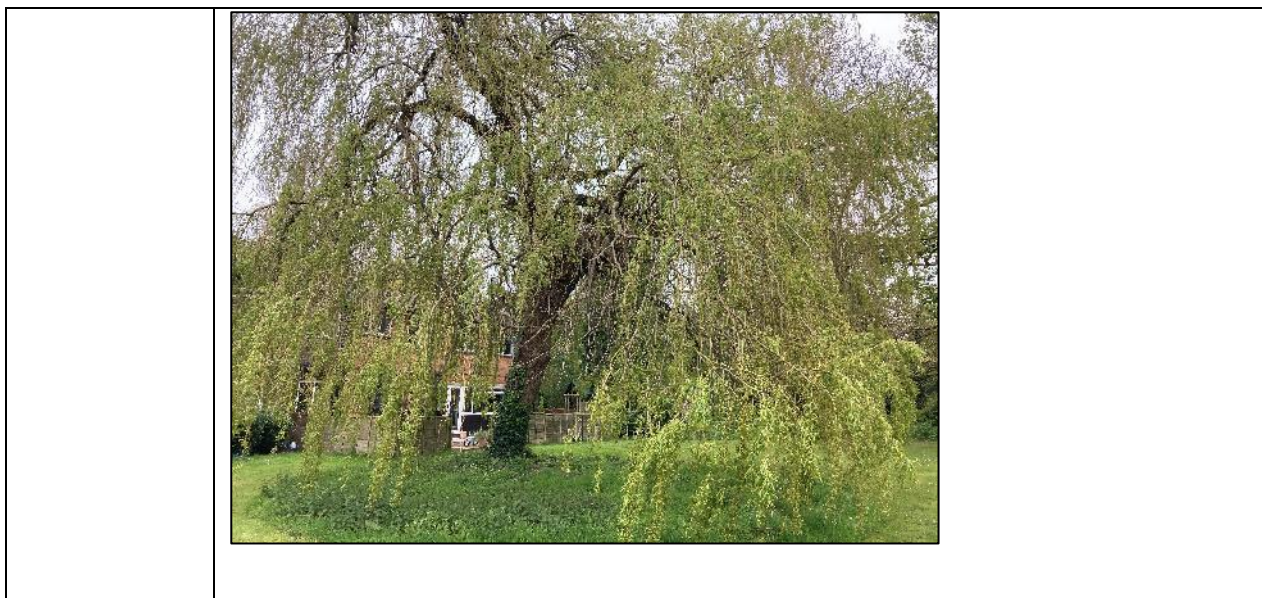
| | |
|---|---|
| T15 | <p>Mature Weeping Willow (T15) located within school grounds. Tree is a large specimen and contains shallow bark fissures and one shallow knot-hole. Assessed to be of PRF-I potential to support roosting bats.</p> |

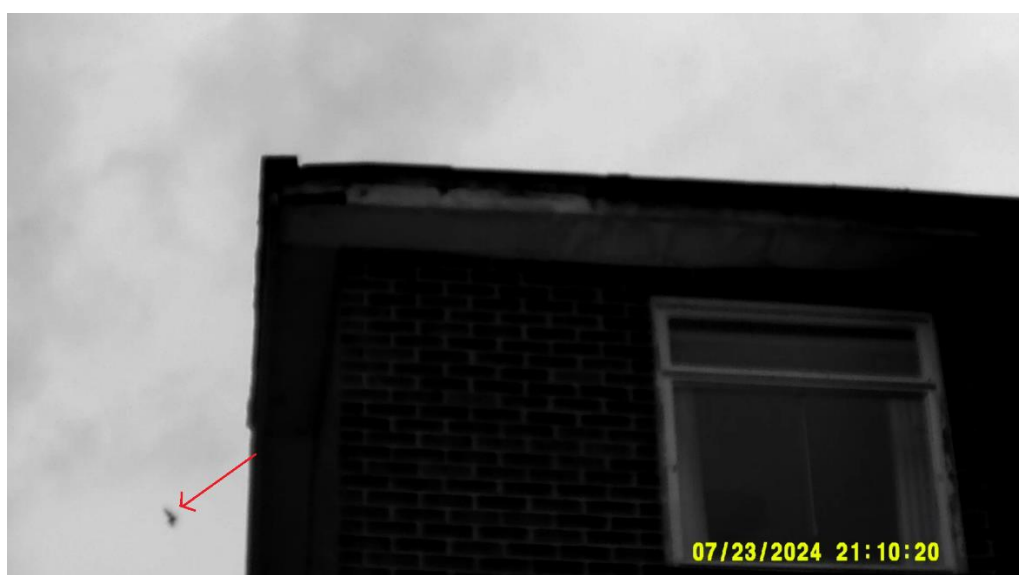
**Figure 1 – pipistrelle emergence on 23<sup>rd</sup> July from north-western elevation.**

3.14 During the second survey visit the surveyor at position 2 identified a potential pipistrelle bat emergence from the gable end of the building's north-western elevation at 21:10 (5 minutes following sunset). Following a review of the infra-red footage this was considered likely to have emerged from the building, either from an edge roof tile or under the soffit (see Figure 1). No other emergences were seen during the survey.

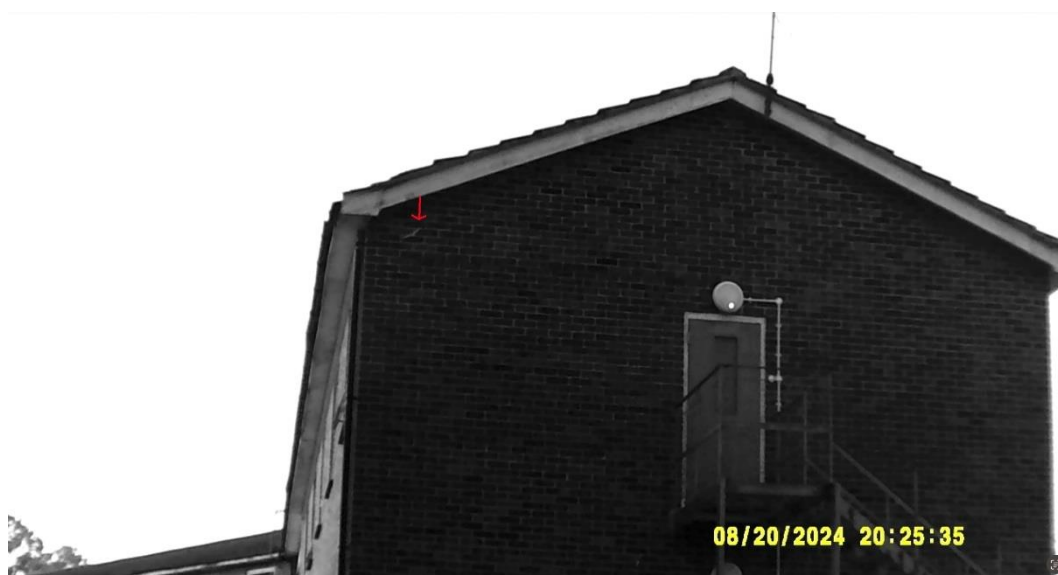
Figure 2 – common pipistrelle emergence on 20<sup>th</sup> August from under soffit on south-western elevation.

- 3.16 During the final survey visit the surveyor at position 1 identified two separate Common Pipistrelle emergences from the gable end of the building's south-western elevation – see Figures 2 and 3. The first emergence at 21:25 and the second at 21:35 (10 and 15 minutes following sunset, respectively). No other emergences were seen during the survey.
- 3.17 The level of bat activity recorded was lower than during the previous two survey visits. As before, bat activity was focused around survey positions 1 and 3. This included passes by Common and Soprano Pipistrelle, Noctule, Myotis and Brown Long-Eared bat.
