## Waterfront Square, Reading Berkshire

# River Condition Assessment Survey Report

Document Reference: 10179.008

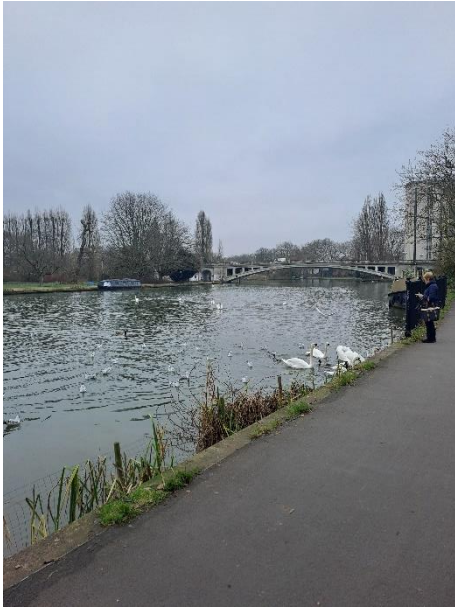
*Figure 1: MoRPh5 Subreach Looking Downstream*

- 3.13 At the location of the site, the River Thames is subject to high levels of riparian zone encroachment on both sides. There are established footpaths on both sides, and in accordance with the metric user guide, these are exempt from encroachment if recorded in the baseline. However, irrespective of this, on the right bank >25% of the riparian zone comprises buildings and hardstanding (not including the footpath). Additionally, on the left bank, there is encroachment at the eastern end associated with the bridge over the river. This is within 0 to 4m from the bank. As such, major riparian zone encroachment was assigned to both banks.
- 3.14 At the location of the site, the banks of the Thames are almost entirely engineered. As such, major watercourse encroachment has been assigned.
