## **Historic Building Record**

**71 – 73 Caversham Road,  
Reading, Berkshire.**

December 2024  
Reference: 24915

**Historic Building Record**

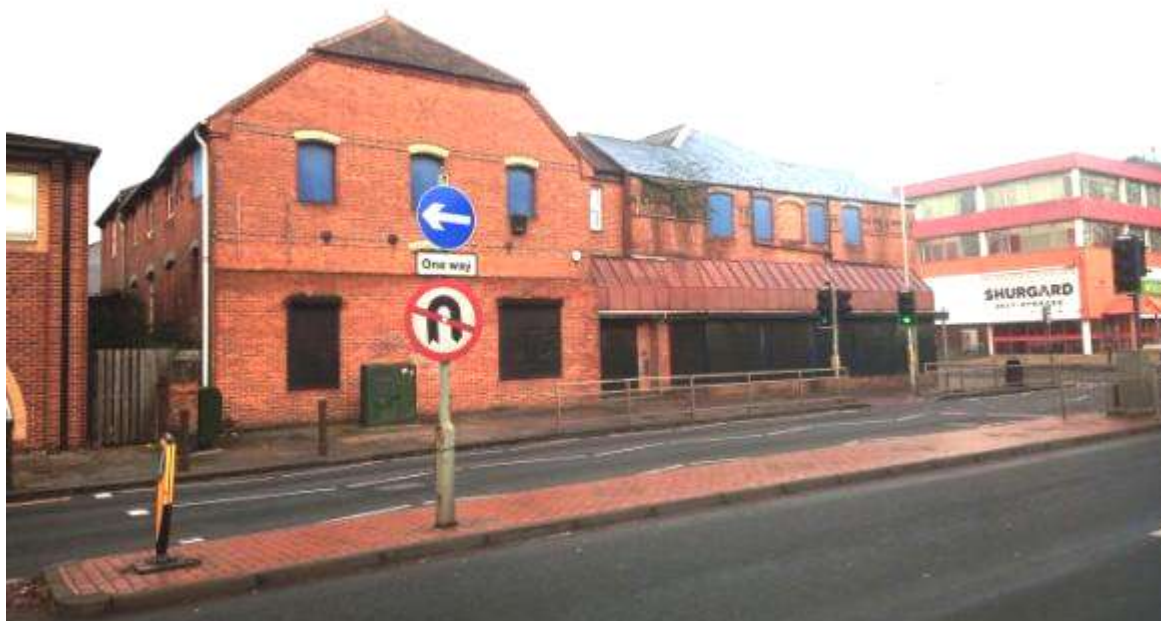
Fig 2.1.1: 71 – 73 Caversham Road from the southeast (71 left)

- 2.1.1 The site is rectangular on plan, where this is on the west side of Caversham Road in the junction to Northfield Road that runs along its north side. To the south and west of the site is another commercial site that wraps around this one.

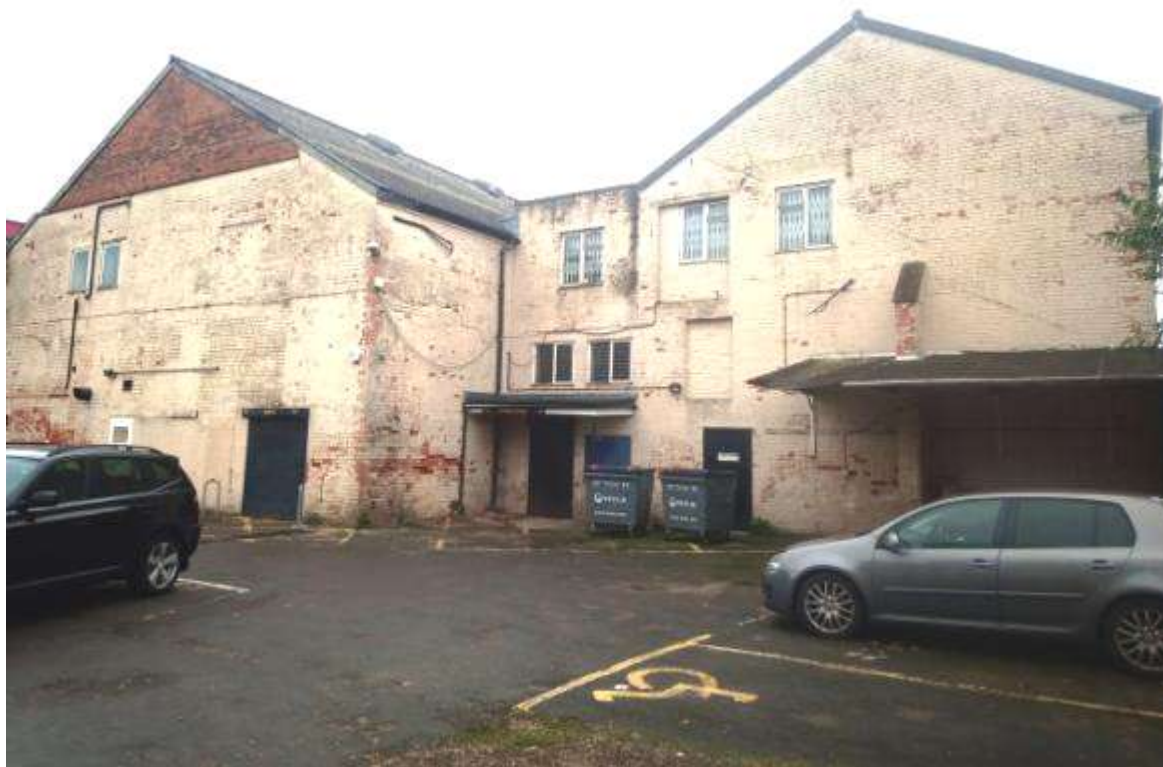
Fig 2.2.2: West end of building from the southwest (71 left)

- 2.2.2 The north and south blocks are gable ended at the west end and then have ridges that run from there to the east, where the south roof finishes with a half hip. This runs through from front to back, although there is upward step in a position approximately two thirds of the length of the roof towards the back where the form changes. On the west end wall there is small mono pitch canopy roof towards the south side, which is attached to the gable
- 2.2.3 The roof to the north block runs in to, and above, the back of what can be considered a cross roof to the front that is parallel to Caversham Road and is gable ended to Northfield Road. The resultant configuration of the north roof produces a T shape on plan, where the west end gable is the foot and the head is the front cross roof over that range. As the main rear ridge of this block is higher

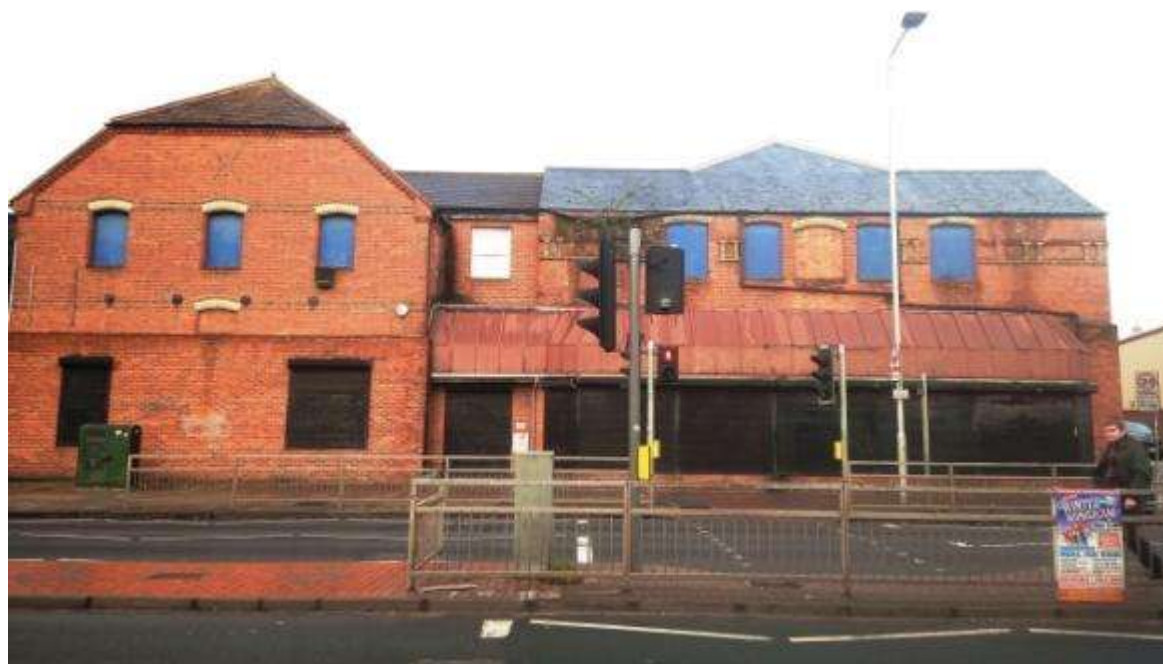
Fig 2.2.5: Front cross range to N° 73 (left) and new infill against south block (71)

- 2.2.6 The whole of the front cross range to N° 73 is set back from the frontage of the site and the south block it abuts. This has been levelled-up to the back of the present pavement with a single storey extension to the front with a metal roof over what could almost be considered as a large bay containing retail shop windows behind roller shutter security grilles.
- 2.2.7 The infill block between the south and north buildings now runs from the west end to the back of an extension to front cross wing as a two section flat roof where that over the west end is higher than the other. As with the south block this has a

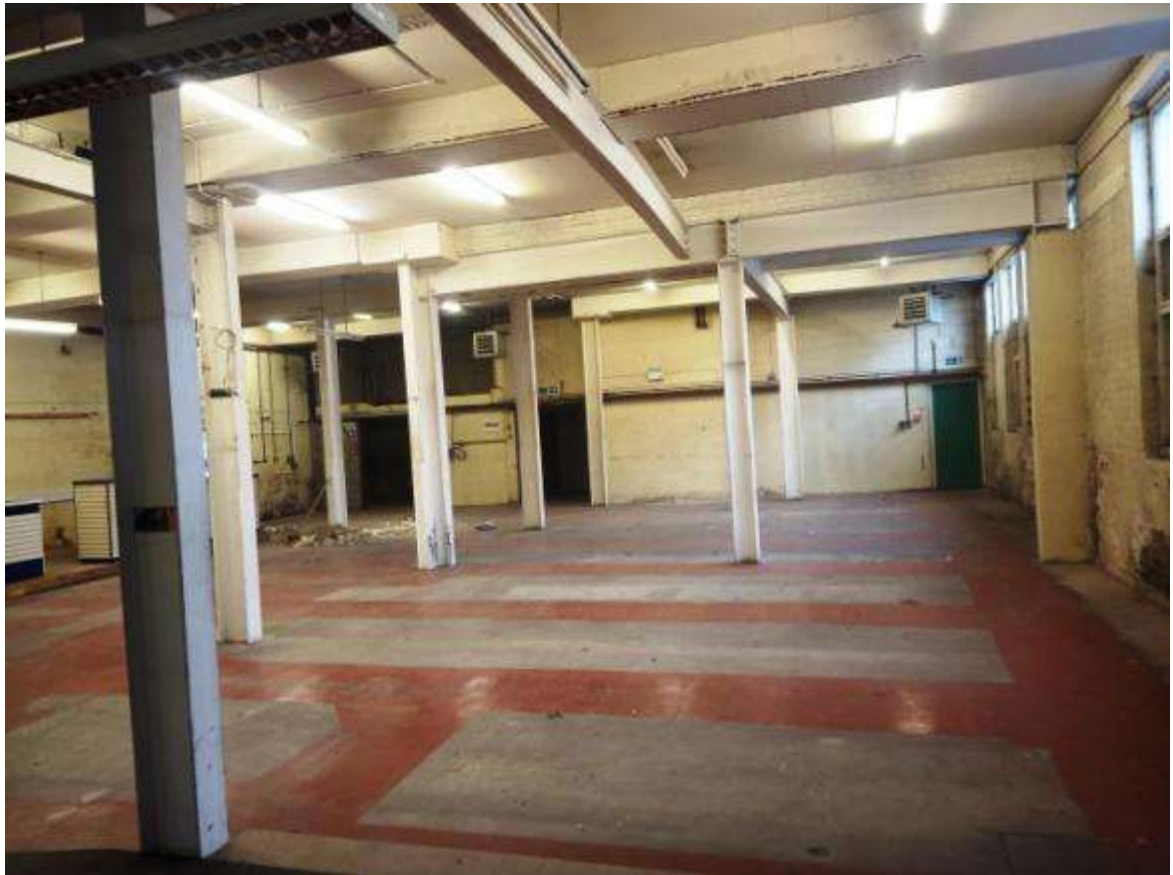
Fig 2.2.8: Ground floor to north block (73)

- 2.2.8 Internally the north block contains two stories where the ground floor extends through in to the shop window type extension to the back edge of the pavement to Caversham Road. Against the west gable there are late 20<sup>th</sup> C structures that contain store rooms and a goods lift to the upper floor. The first floor on the north side is similar to the ground floor and largely open from front to back

- 2.2.9 On the south side it can be seen how the floor and wall layout reflects the roof structure over this block, with a change in floor level as well as an internal dividing wall on the junction between the two parts. This is also of two floors, where there are the remains of offices to the front as well as the back on the first floor.
- 2.2.10 The infill block between the north and south blocks was evidently adapted, when this was retail premises, to act as the main distribution space to the floors on

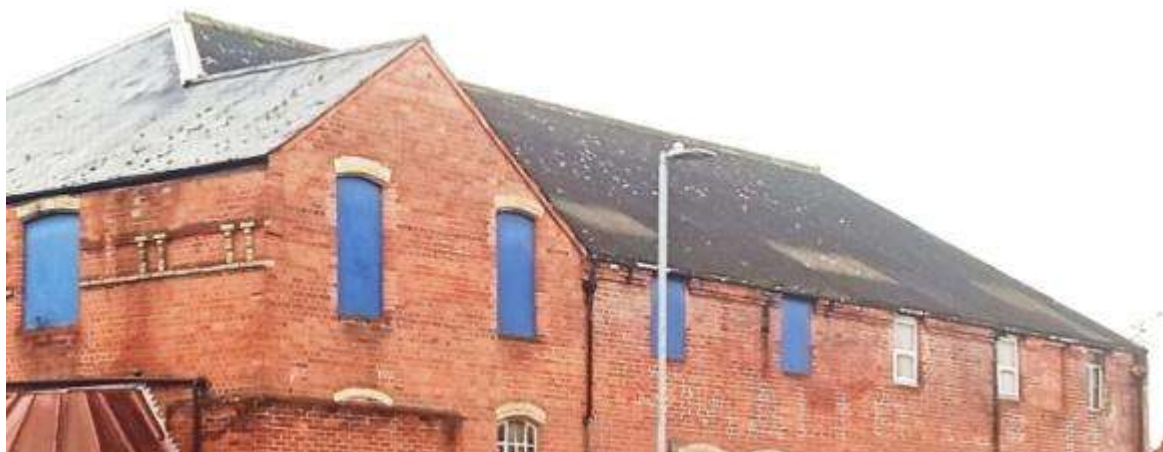
Fig 3.1.1: Roof to north block (73)

- 3.1.1 The roof of the north block (73) from the west gable to the front cross ridge is a single structure that is covered with big six profile corrugated asbestos cement sheeting with some panels of translucent sheeting set in the surface. The top is capped asbestos cement ridge units and the west verge is finished with wrap-over asbestos cement barge boards to the head of the gable. This has a pitch of approximately 40°.

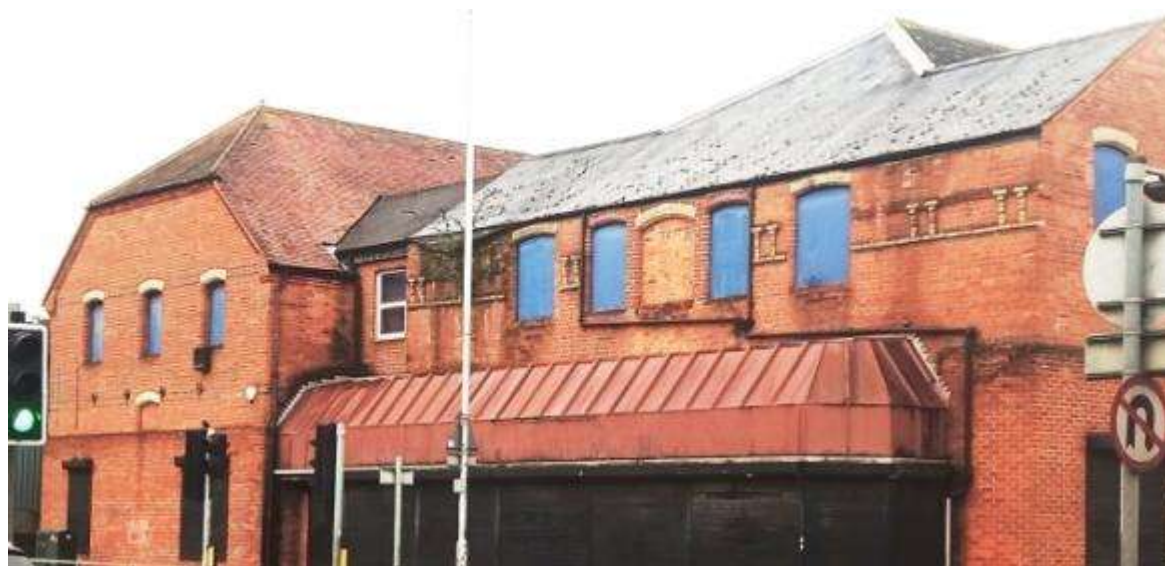
Fig 3.1.7: Front roofs with low level zinc roof

- 3.1.7 Across the front of the north block (73) and abutting the forward projection of the south range is a type of shop front that is covered with a modern form of mansard roof where this a fascia over the windows which then becomes a backward sloping lower section below a flat top that runs back to the front wall of the building. This is all faced and covered with copper coloured zinc sheeting with a box profile roll to the sloping and flat top part. At the abutment to the walls this has stepped flashing to the sloping side and cover flashing to the back upstand all formed in zinc sheet.

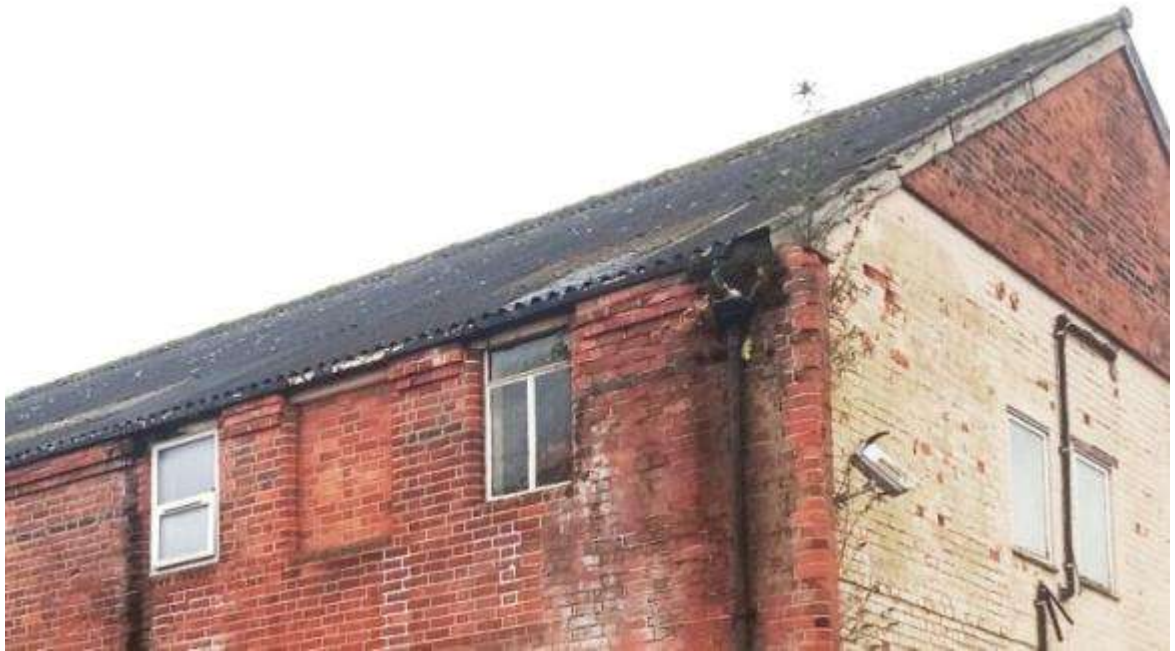
- 3.2.6 Along the north side of the building there is a three course projecting corbel course to the head of the wall that terminates with sideways corbels on either side of the first floor windows heads. This corbelling supports box section cast iron guttering

that empties into hopper heads at each end of the block on top of circular section cast iron downpipes.

Fig 3.2.6: Eaves to north block (73)

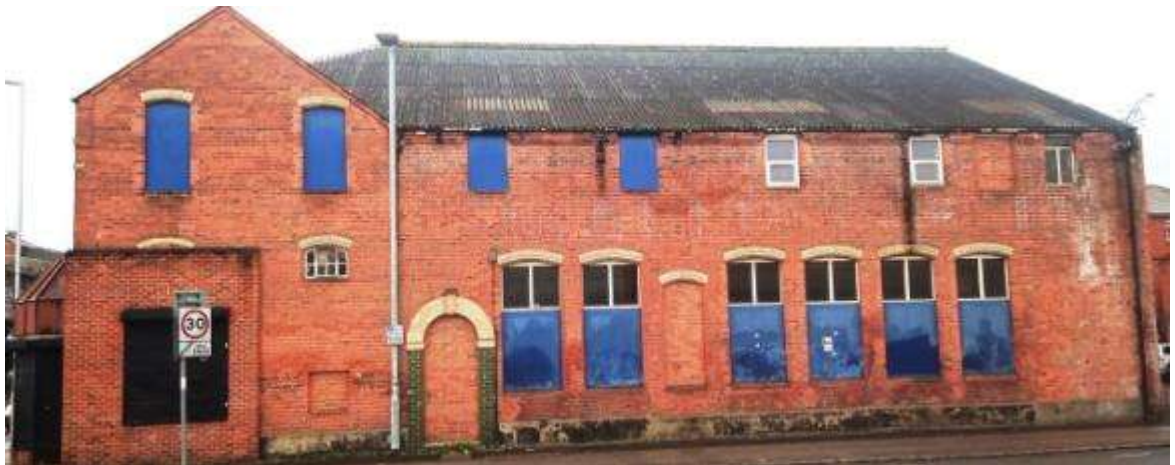
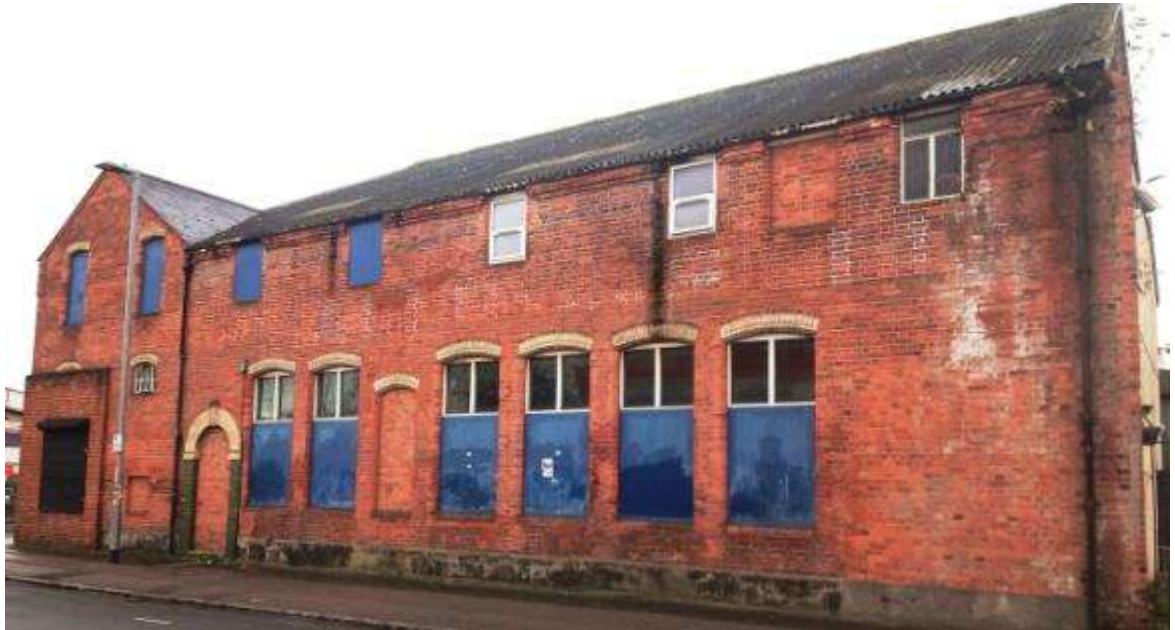
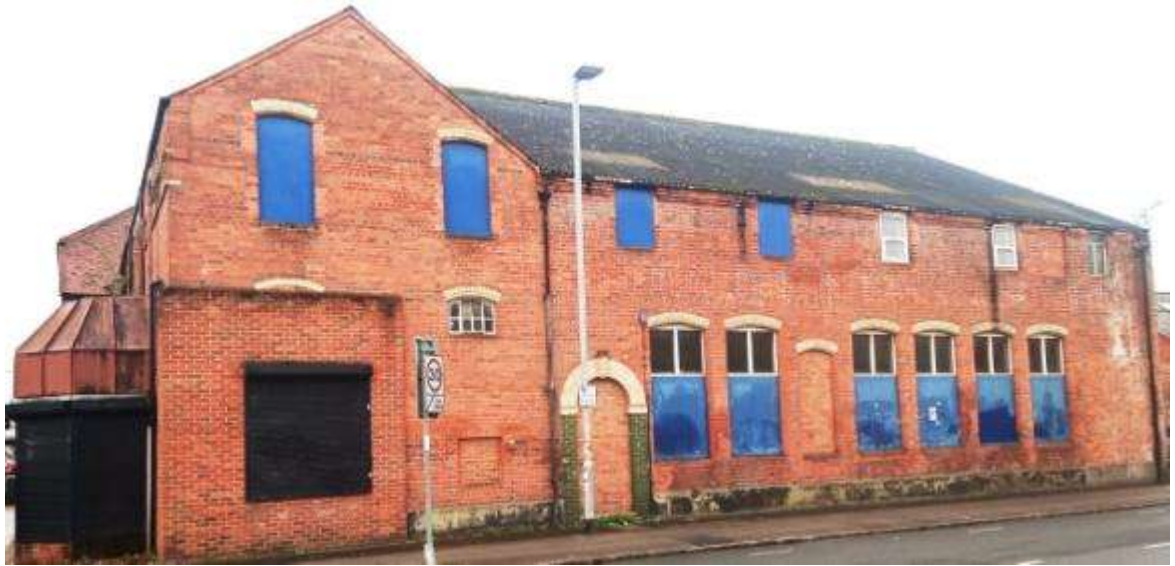
Fig 3.3.1: North elevation

- 3.3.1 The north wall of the block is all built in a reddy orange brick and is about one and half bricks thick that is laid in English bond up to about the head of the ground floor window arches when it changes to Flemish garden wall bond. Four courses below the bottom of the top corbel eave is a header course of dark red brown bricks that extends from the west gable to just under the bottom of the rear roof slope to the front cross wing roof where it meets the eaves on this side. This is all pointed externally with a slight struck joint of orangey buff coloured mortar and along the bottom of the wall to the pavement there is a painted rendered plinth band.

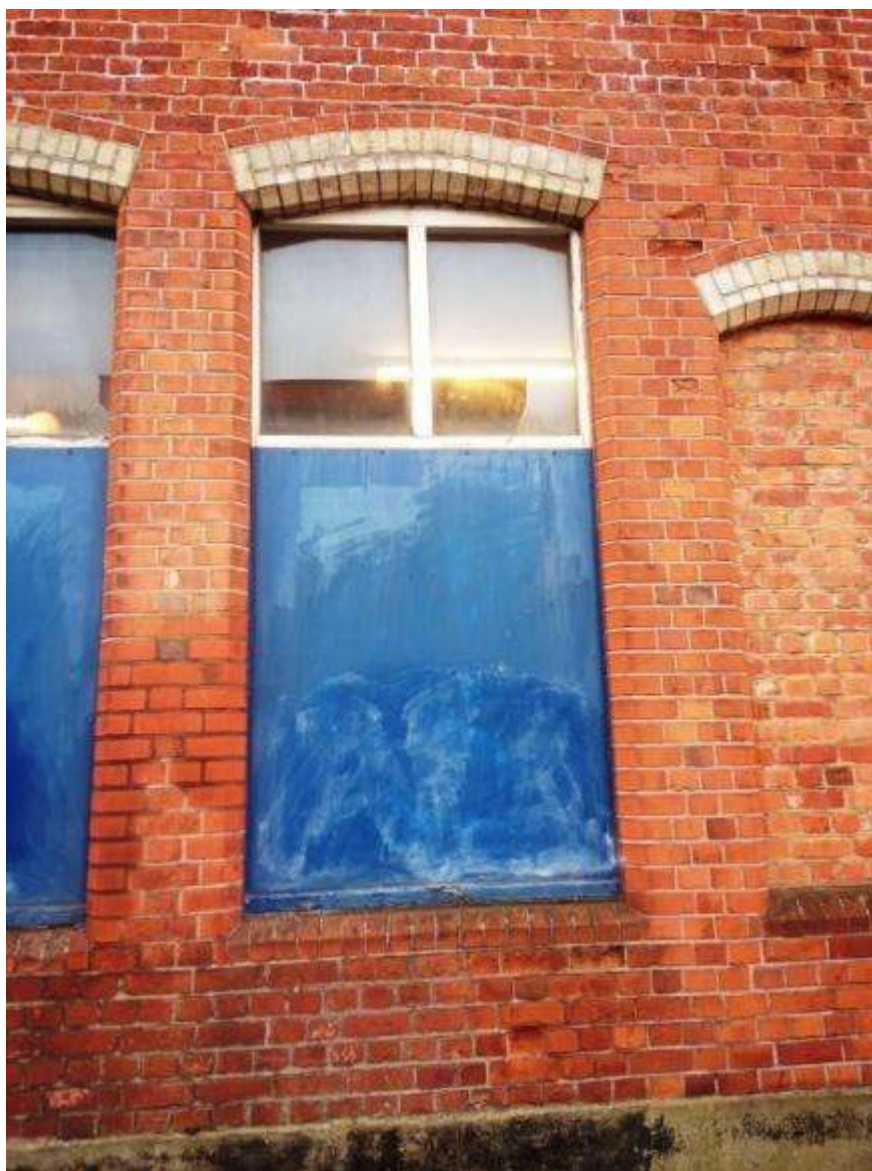
Fig 3.3.2: Ground floor north windows

- 3.3.2 The ground floor windows along the north wall are effectively one and a half storey high set within opening single splay bricks to the reveals and on edge to form the cills. Over these are brick cambered arch arches with a double course of pale buff coloured brick header on edge topped with a course of header bricks of the same colour as the main wall, where the bottom course is of squints. The first floor window openings have similar squint cills and reveals, but no decorative head (below).

8.1.4 The windows to what is now the ground floor are of a size that would not be expected for this a malthouse as they would have cut across internal floor levels, which would have been lower than now found. Their grouping does not reflect those at the higher level, as could be expected for a maltings and there is not the same amount of obvious alteration as noted to the higher level. This could suggest that there was substantial re-ordering of this wall subsequent it no longer being used of its original purpose.

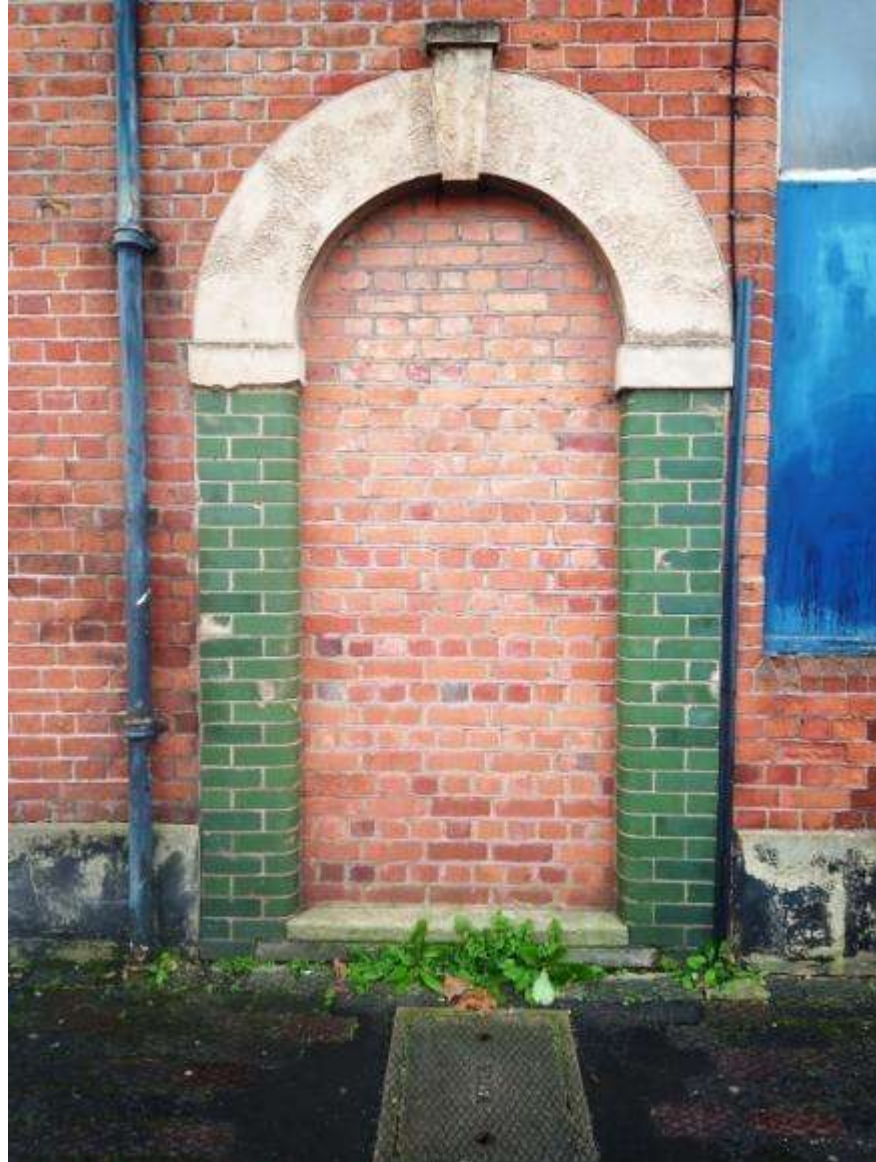
Fig 3.3.4: Closed-up door opening

- 3.3.3 Between the second from the east ground floor window and the centre east window there is what would seem to be a narrow bricked-up door opening that has

a cill just below that of the windows, but a lower head. This is formed in a similar manner to the window openings.

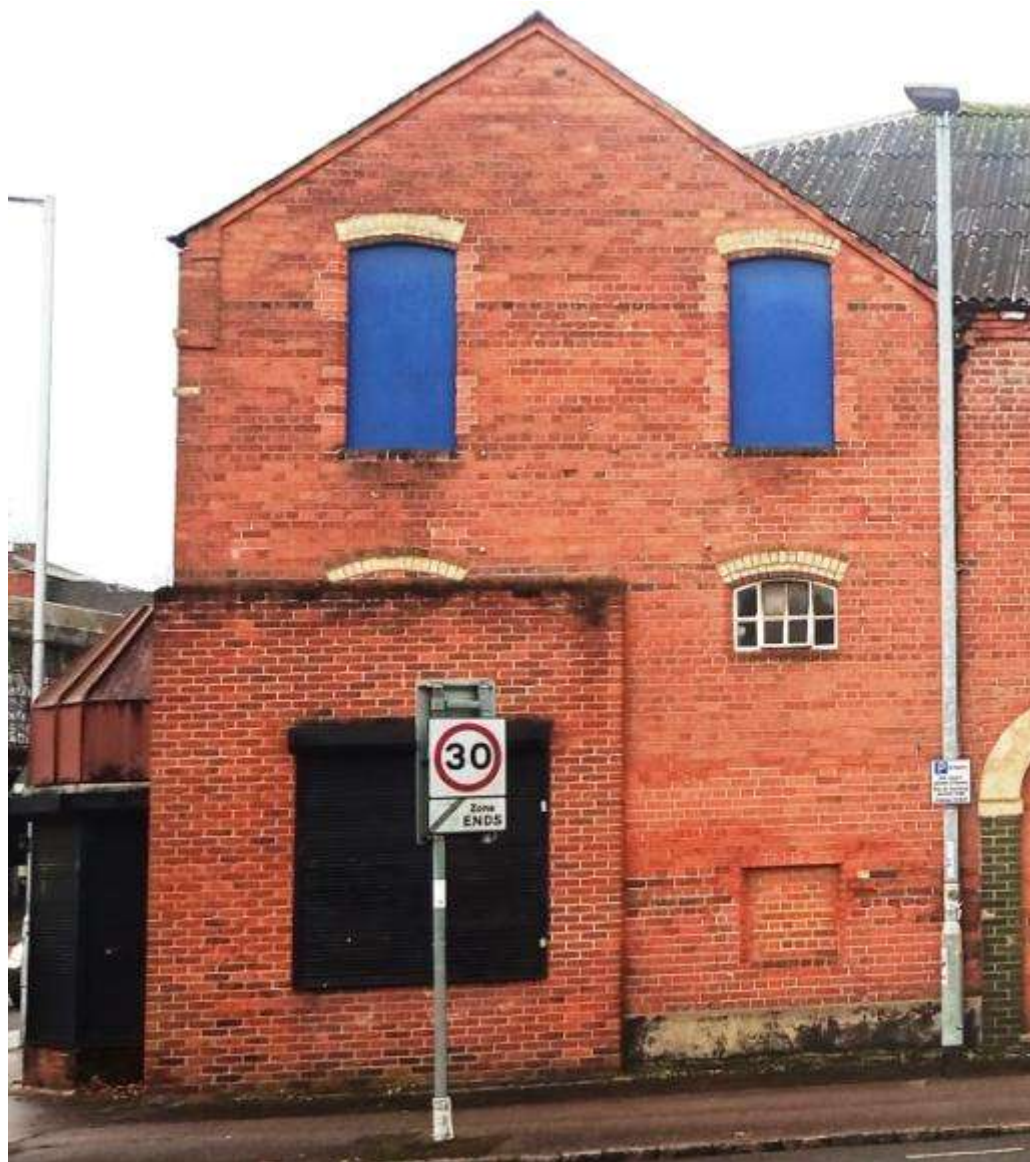
Fig 3.3.5: Front cross wing north gable

- 3.3.5 There is no obvious construction joint between the north end wall to the cross front wing and the main north side wall, where this is all generally as the other part. However, the brickwork is laid entirely in English bond for the full height. Within this there are windows with storey height openings to the upper floor and small windows at a lower level, where these are of similar appearance as to those in the main north side, but without the plain header course over to the upper openings.

- 3.3.6 Running across the gable, from the lower eaves level to the rear roof is heading course of dark red brown bricks, as those in the main north wall below the eaves.

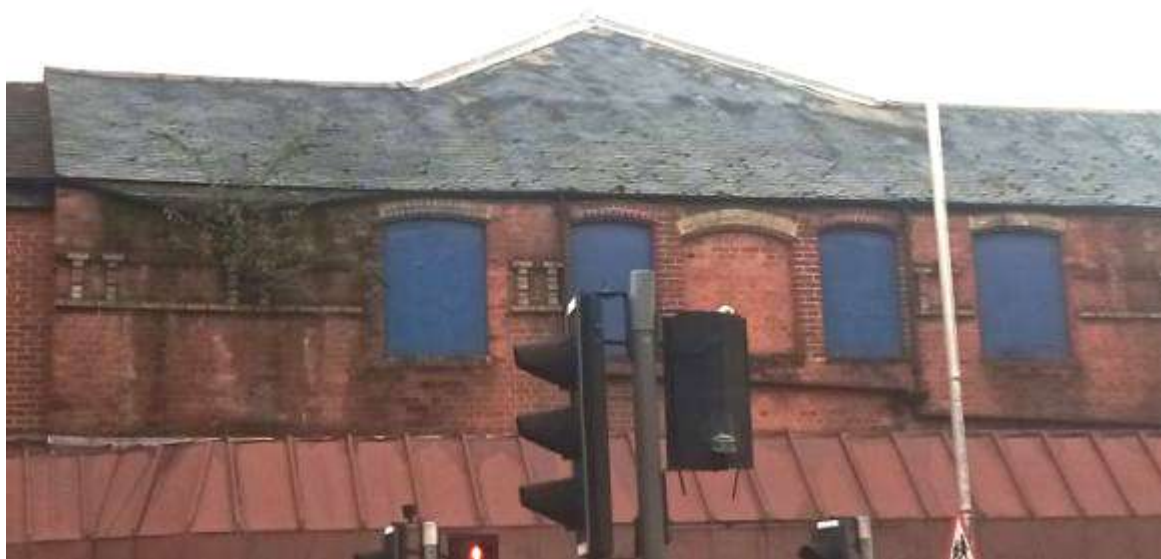
Fig 3.3.9: First floor front windows

- 3.3.9 At first floor level to the street face of the original front cross range there are five windows that have been either boarded or bricked-up. Of these the outside and centre have openings, with dressings, similar to those seen in the north wall of the building, but where the two on each side of the centre are plainer and are modern inserts as indicated by the change in brickwork around them.

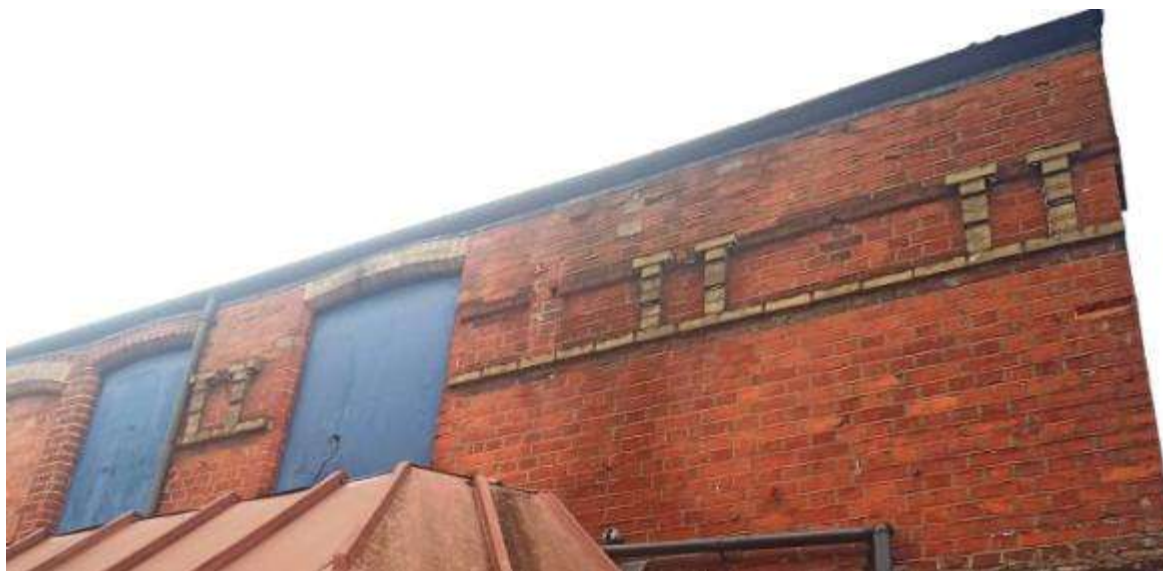
Fig 3.3.10: Decorative brickwork to front of 73.

- 3.3.10 Across the front range elevation to Caversham Road, in an almost central position to the height of the first floor windows there is projecting decorative banding of yellow buff brickwork between two courses a forming an arcature pattern with vertical pairs of pilasters of projecting yellow buff header bricks topped with a single stretcher of the same colour in a double course of dark red brown bricks. Where the new windows have been formed this feature has been lost in the centre of the wall.

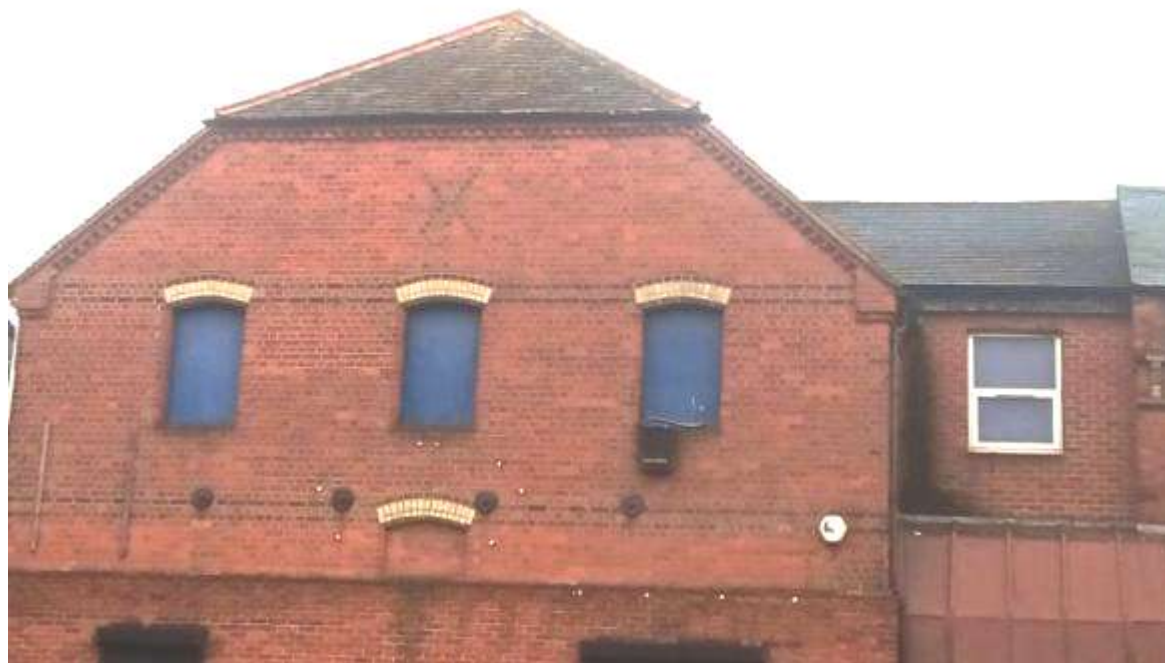
Fig 3.3.12: Upper east gable to N° 71

- 3.3.13 In the head of the east gable there a decorative X formed by a single set of dark red brown header bricks.
- 3.3.14 Over the heads of the east gable windows, at both ground and first floor levels, are cambered arches of buff bricks as noted on the north side, but here the top header course is a contrasting dark red brown colour and single splay bricks to all the

arises and cills. Running between the window heads at both level levels are parallel courses of dark red brown bricks as noted on the front range north gable.

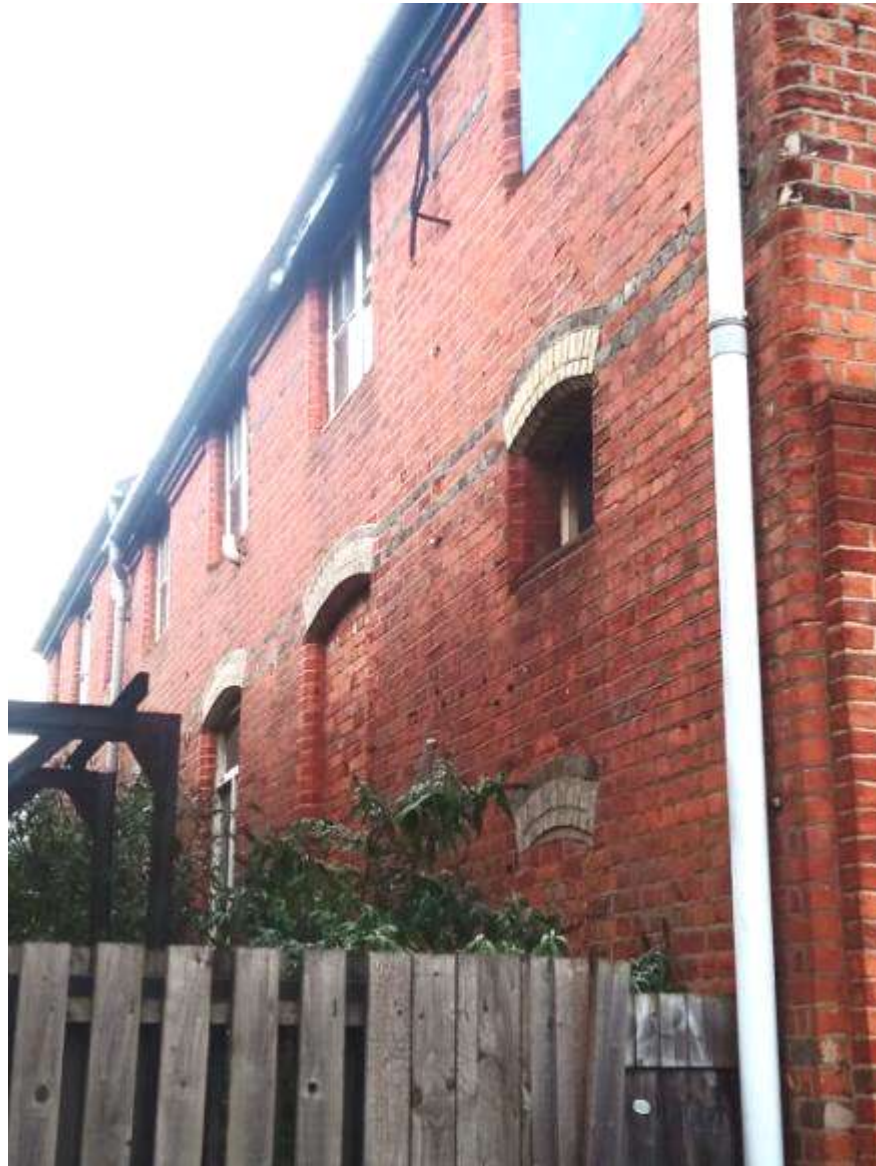
Fig 3.3.17: Restricted view of south elevation, showing eaves level change

- 3.3.17 Due to the position of the west section of the south block relative to the adjoining boundary and buildings on the neighbouring site we could not gain any realistic view of the south wall. Therefore we can make no further comment on its construction apart a very general one of it being similar to the east part, but with as much decorative brickwork.

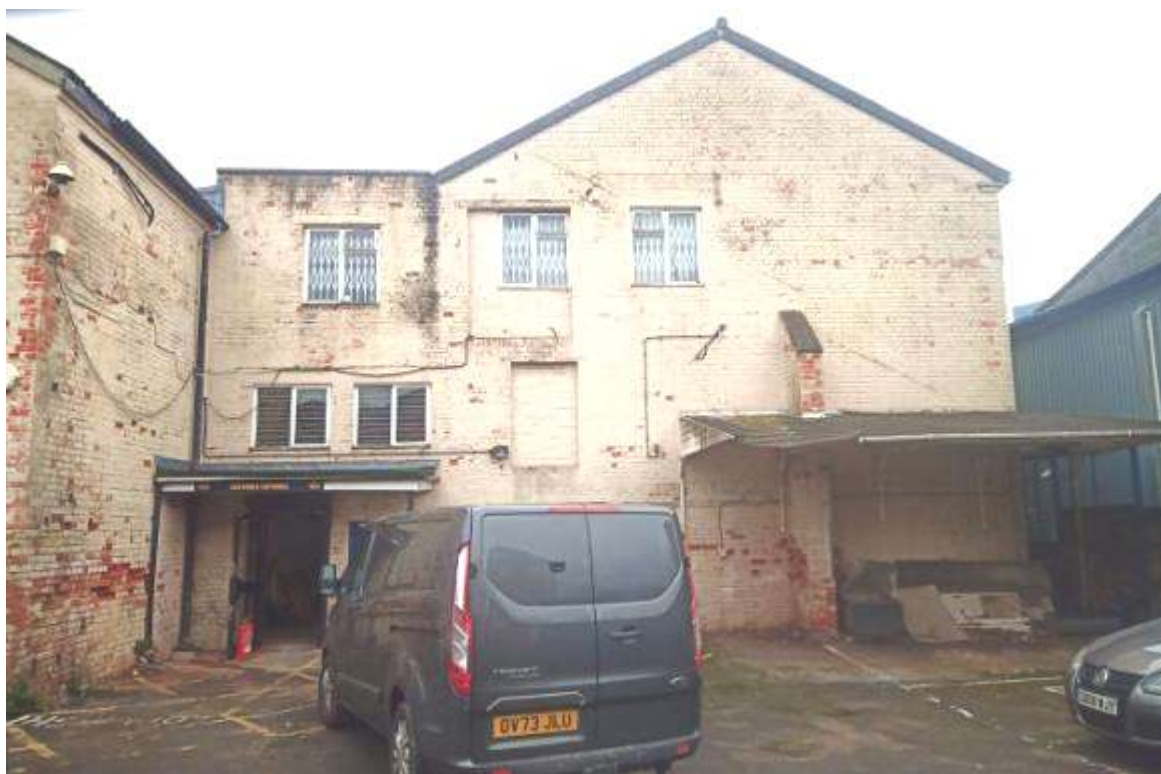
Fig 3.3.19: West end of N° 71 (left) and infill blok

- 3.3.18 The rear gable ends and infill section of the building is all in brickwork, mostly laid in English bond that has been painted, with the exception being the gable peak to the west end of the north block with is in Flemish bond and unpainted. At the bottom of this latter section of wall there is what appears to be the remains of a flashing across the whole of this face, which could mark where an adjoining roof previously abutted. There is a slight step in the roof slope and covering to the main roof where this runs out over the gable to support this suggestion.
- 3.3.19 In the both the west gable ends there are many signs of where alterations have taken place with door and window openings having been closed-up, altered and adjusted. Window heads are very simple with either concrete or timber lintels over

them and are of a type typical of former internal openings. These walls have much the appearance of where other building and structures have been removed in the past and then adapted in more recent times.

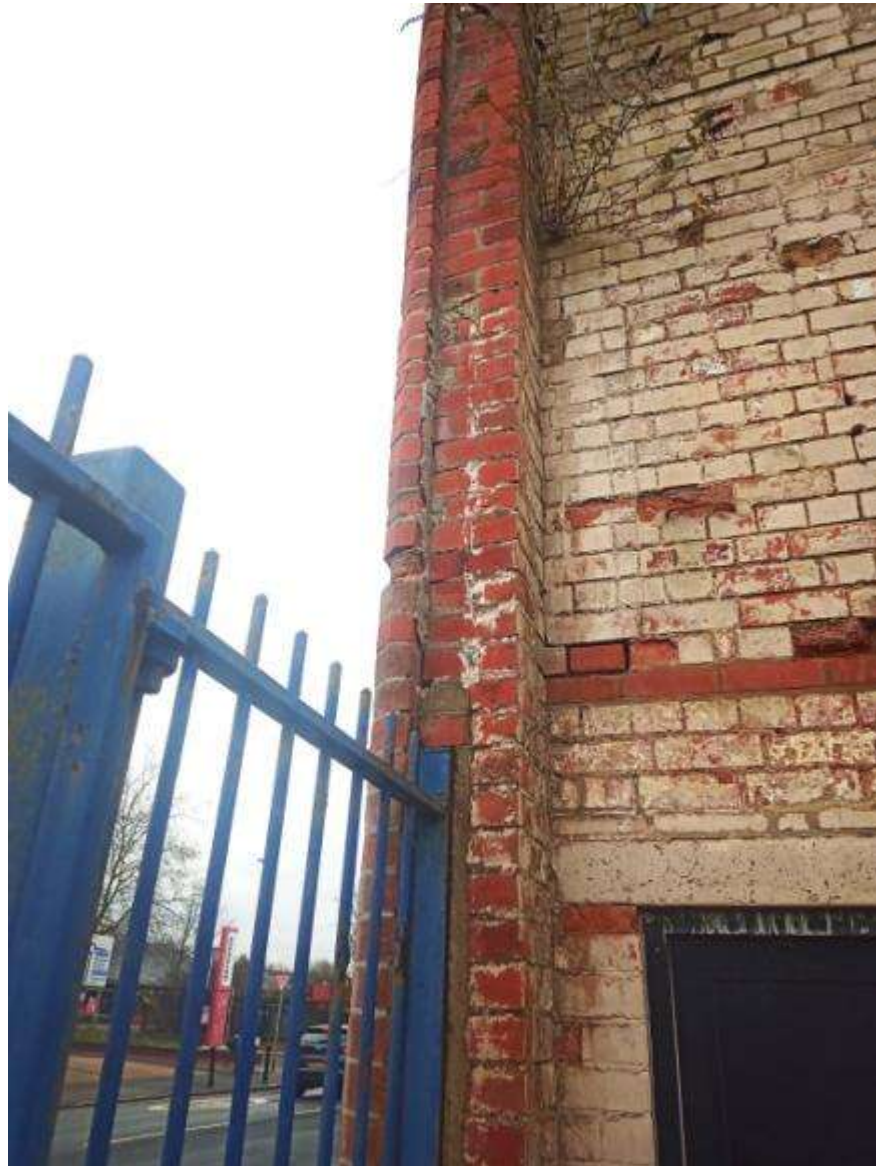
Fig 3.3.21: Link nib on northwest corner to removed building

- 3.3.20 On the north elevation of the building, between the heads of the ground floor and cills of the first floor windows there are patches of what seems to be historic paint. This is possibly the ghost of signage that the name of the building or the owner at some time in the past and has either weathered away or more likely deliberately removed. Because of its condition it is not possible to suggest what it may have read.
- 3.3.21 On the west corner of the block the end of the north wall protrudes slightly, almost forming a buttress type element from the end to that flank. This finishes with an outer face of projecting column of single splay brick on the outer face where the ends are about half a brick (110 mm) beyond the face of a one brick thick nib. It would seem that another wall, possibly timber framed, finished against the nib and over which the outer brick face lapped.

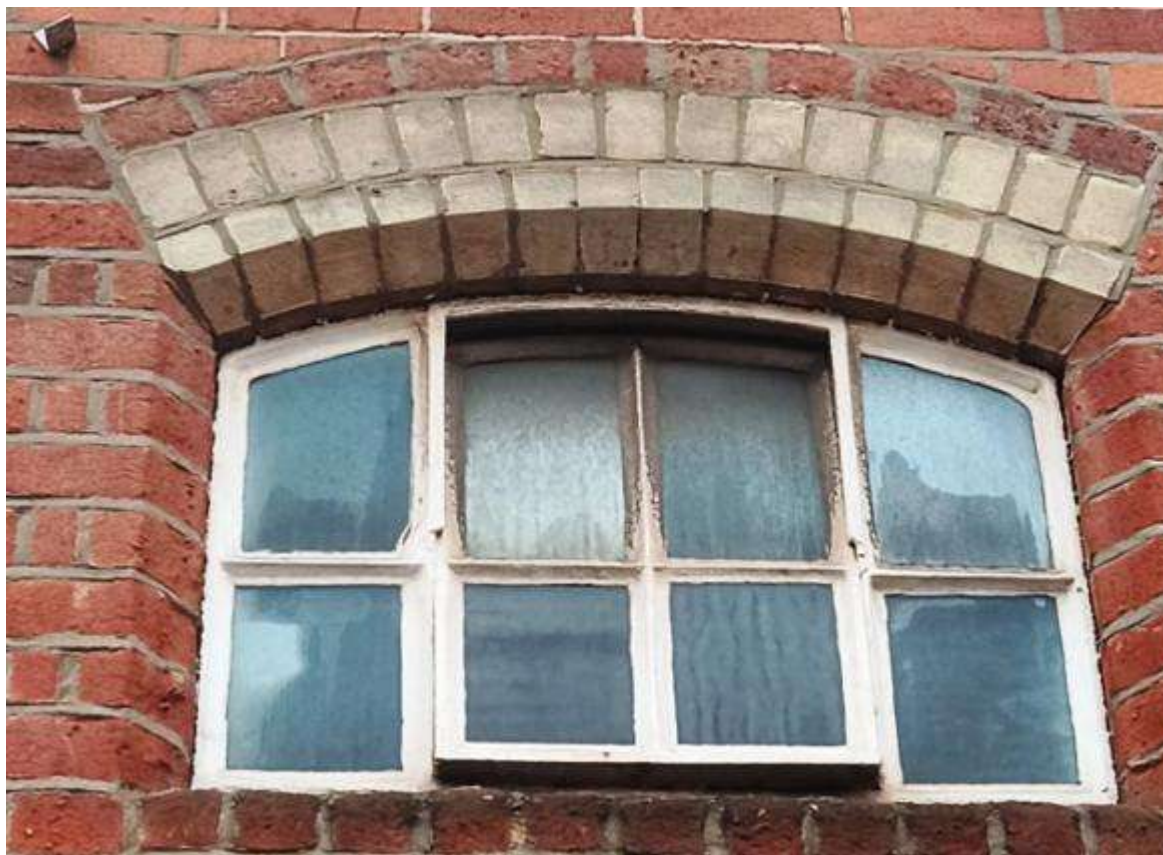
Fig 3.4.2: Cast iron window

- 3.4.2 In the north gable to the front cross wing there is a small cast iron centre pivot casement window with fixed lights on either side. This may be a survival of the malthouse fenestration pattern.

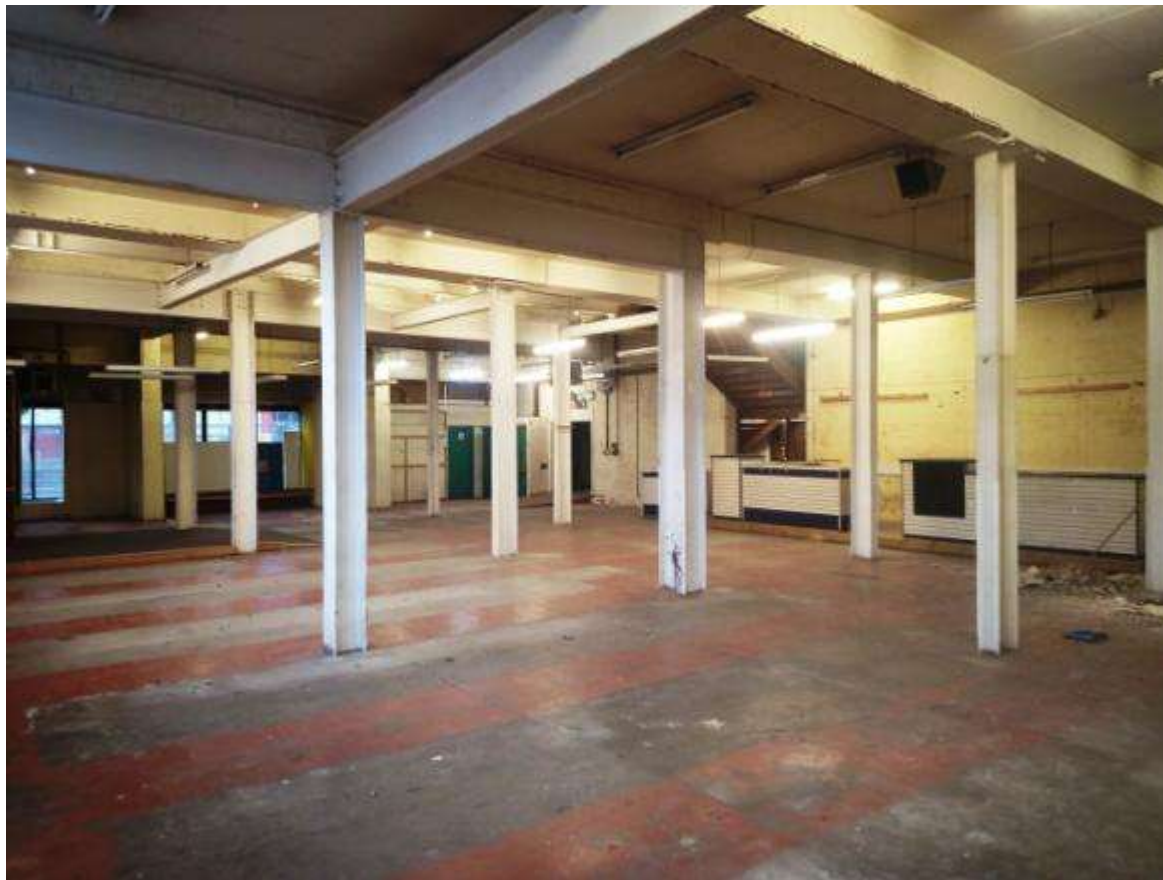
Fig 4.1: North block ground floor looking from back to front

- 4.1.1 Throughout the north block ground floor is a reinforced concrete structure as could be seen where this has been opened up for inspection. This is a modern concrete slab, approximately 200 mm thick, over a polythene damp proof membrane and then scalplings and hard core underneath that.

- 4.1.2 On the north side, the inner face of the external wall has a painted finish and apart from that it is much as that noted on the outside face, but with square reveals and sills to the windows. Over the windows there appear to be some form of steel beams as lintels that are set within the brickwork with timber facings to them.

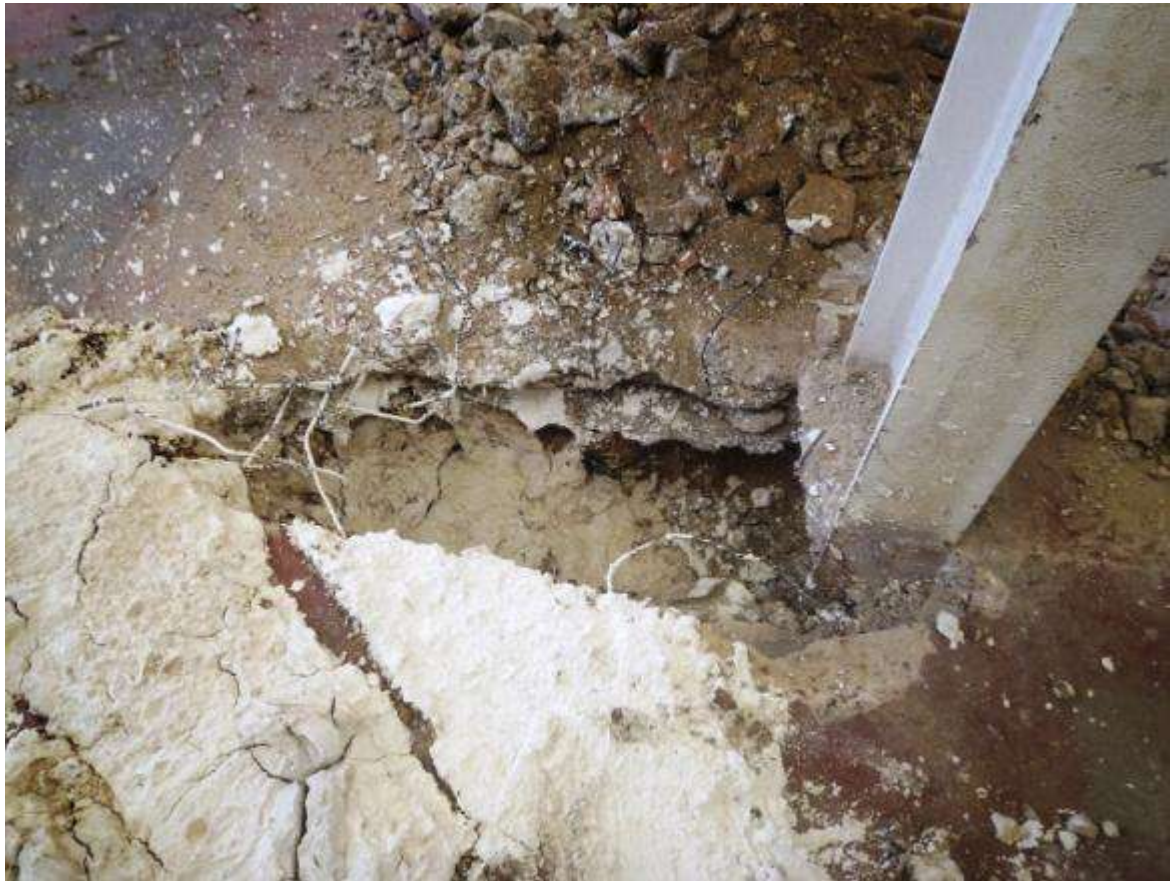
- 4.1.4 The south wall to the north unit is all in brick work that has been painted and is much as that to the north wall. Within this there are large cut-through openings for doorways, stair access etc, to link to the central section for travel between internal areas.
- 4.1.5 Within this part of the building is a mid - late 20<sup>th</sup> C inserted steel framed structure of large H section columns supporting cross beams between them and a concrete deck at high level. This rises up to just over ground floor window head height on the north side. The deck and beams are underlined with what s likely to be some form of fire insulation board.

Fig 4.1.5: Column with opened-up floor
