## **Historic Building Record**

**71 – 73 Caversham Road,  
Reading, Berkshire.**

December 2024  
Reference: 24915

**Historic Building Record**

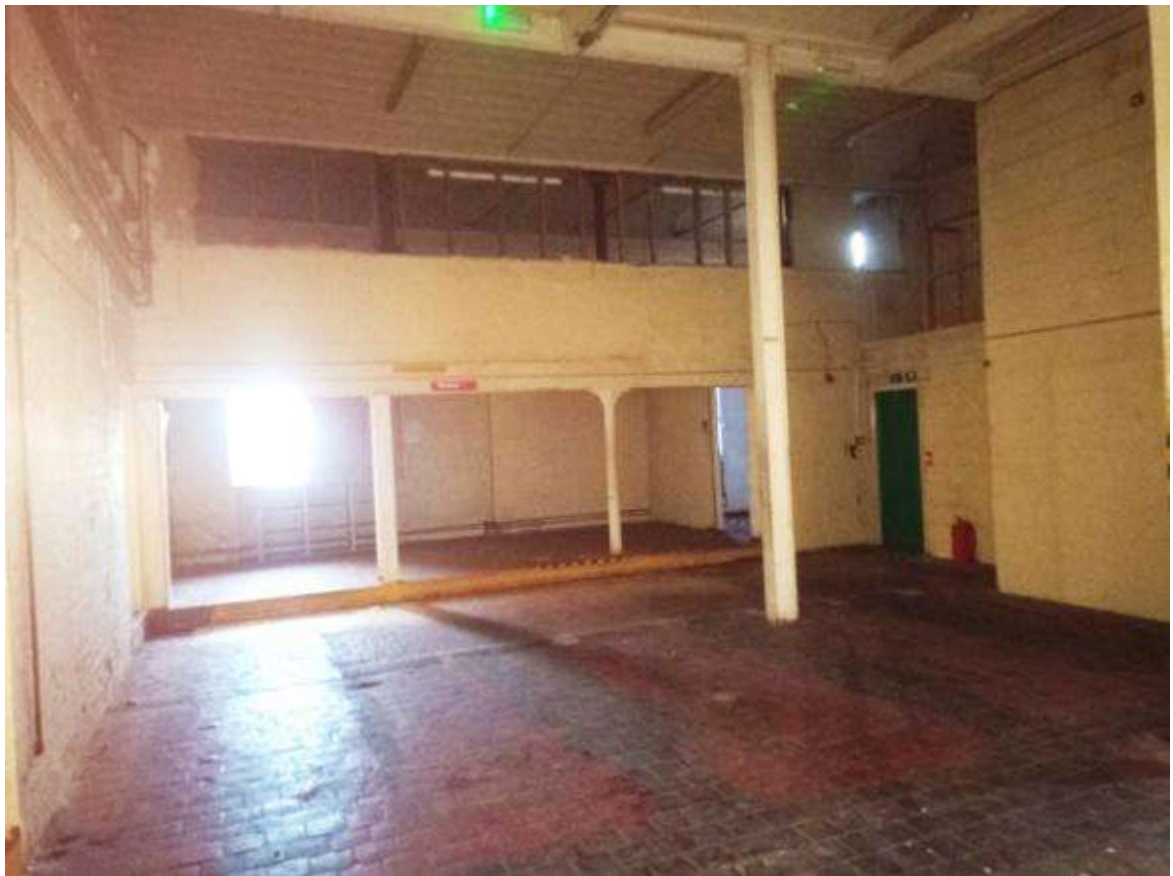
Fig 4.3: South block looking towards former offices to front

- 4.3.1 Across the front of this section there is a step-up in the floor of approximately 200 mm to the former office section of this part of the block. The floor is of solid construction with a painted finish.

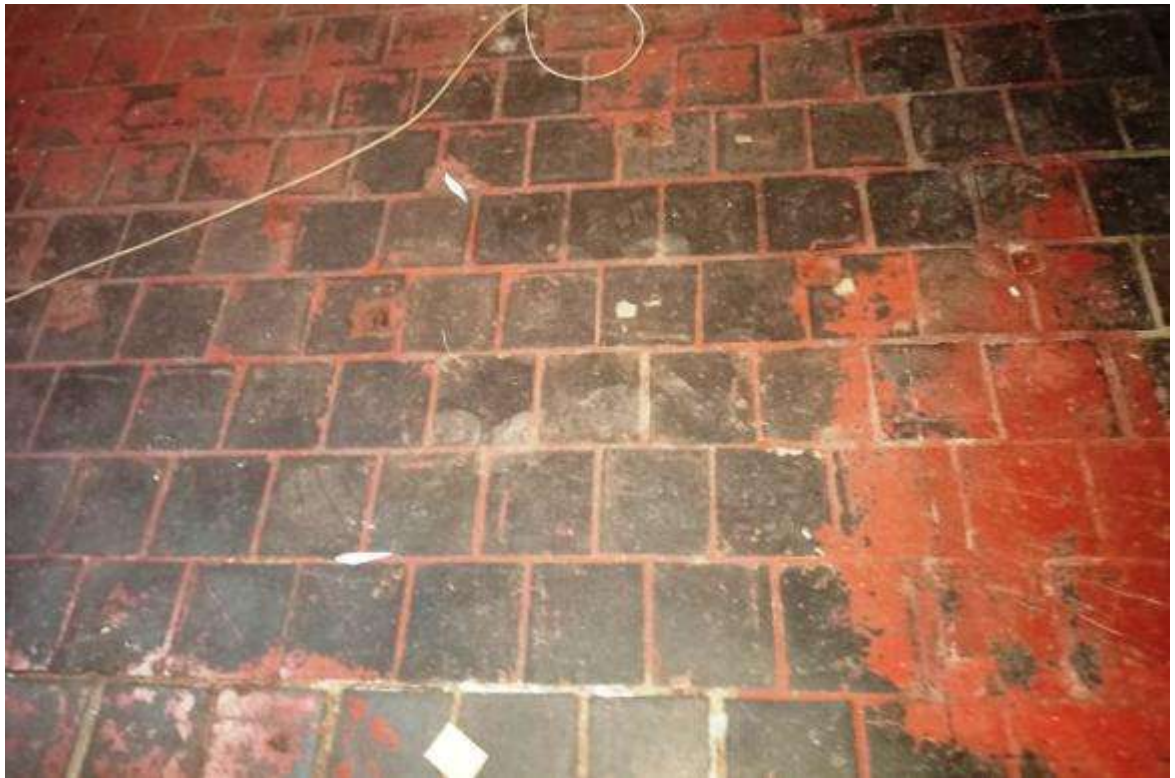
Fig 4.3.: Floor tiling

- 4.3.2 The former wall between the front office and the area to the rear has been cut through on the line of the floor level change. This is supported by a steel beam with on H section column and a circular cast iron post with a splayed support top.
- 4.3.3 The floor to the main part east section of the south block has solid floor covered with a dense square black coloured quarry tiles that are approximately 150 x 150 mm and 19mm thick and are bedded in mortar on a concrete slab. In the west part there is a concrete floor that has been painted.

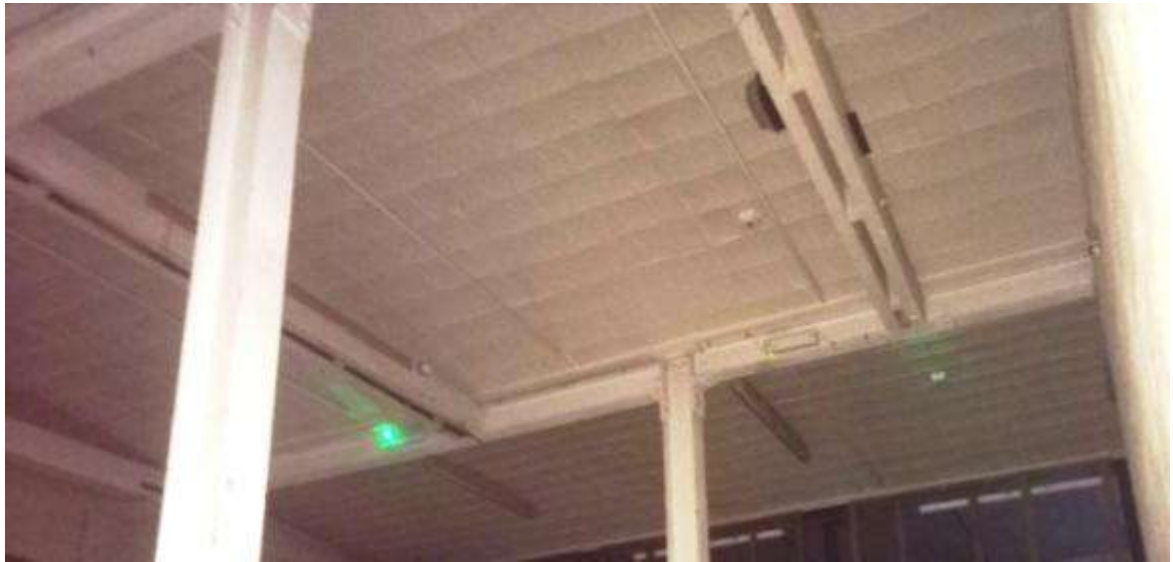
Fig 4.3.5: Underside of brick upper floor

- 4.3.4 Along the south side of the east section there is modern walling of concrete blockwork that encloses a fire escape staircase from the first floor.
- 4.3.5 At high level over the main body of the east section there is what appears to be the underside of a brick floor that arches between beams that span across the building. This would appear to be typical of solid suspended solid floor construction of the late 19<sup>th</sup> C.

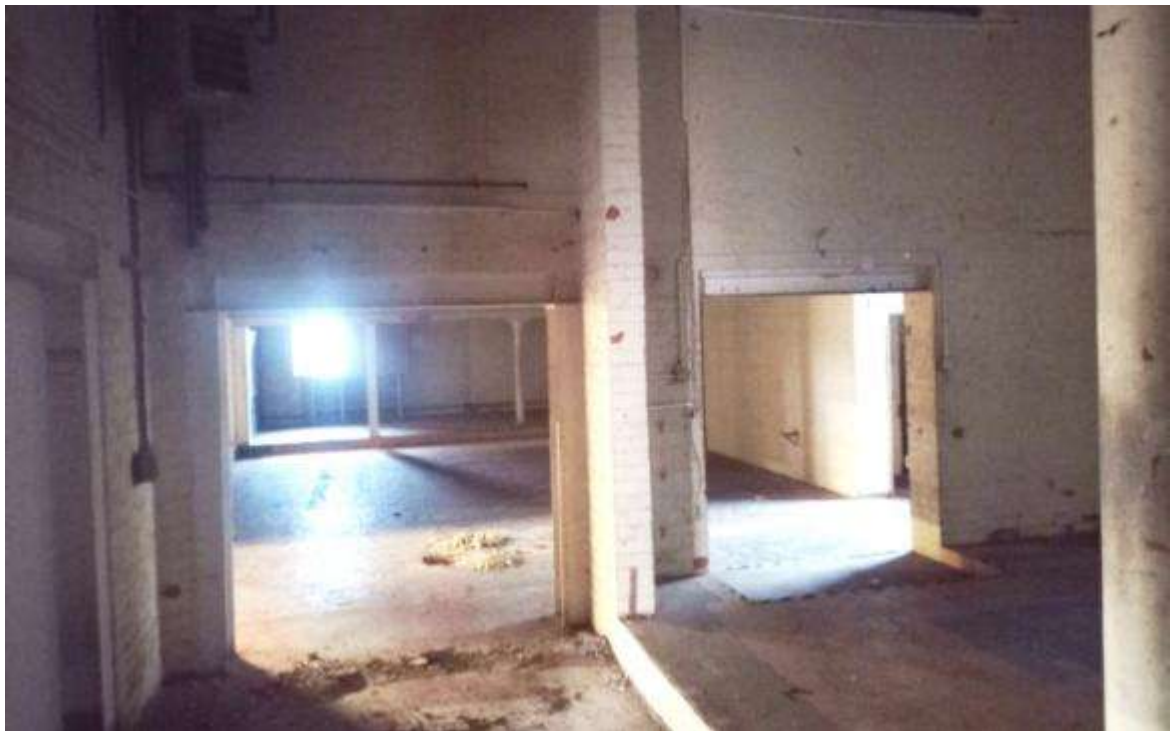
Fig 4.3.6: Dividing wall between front and rear section of south block

- 4.3.6 At the back of the east section there is a brick dividing wall that is a brick and half thick (320 mm), laid in English bond and has been cut through for door openings with steel H section lintels over the heads in to the west part. In the west section the walls are painted fairly plain brickwork.

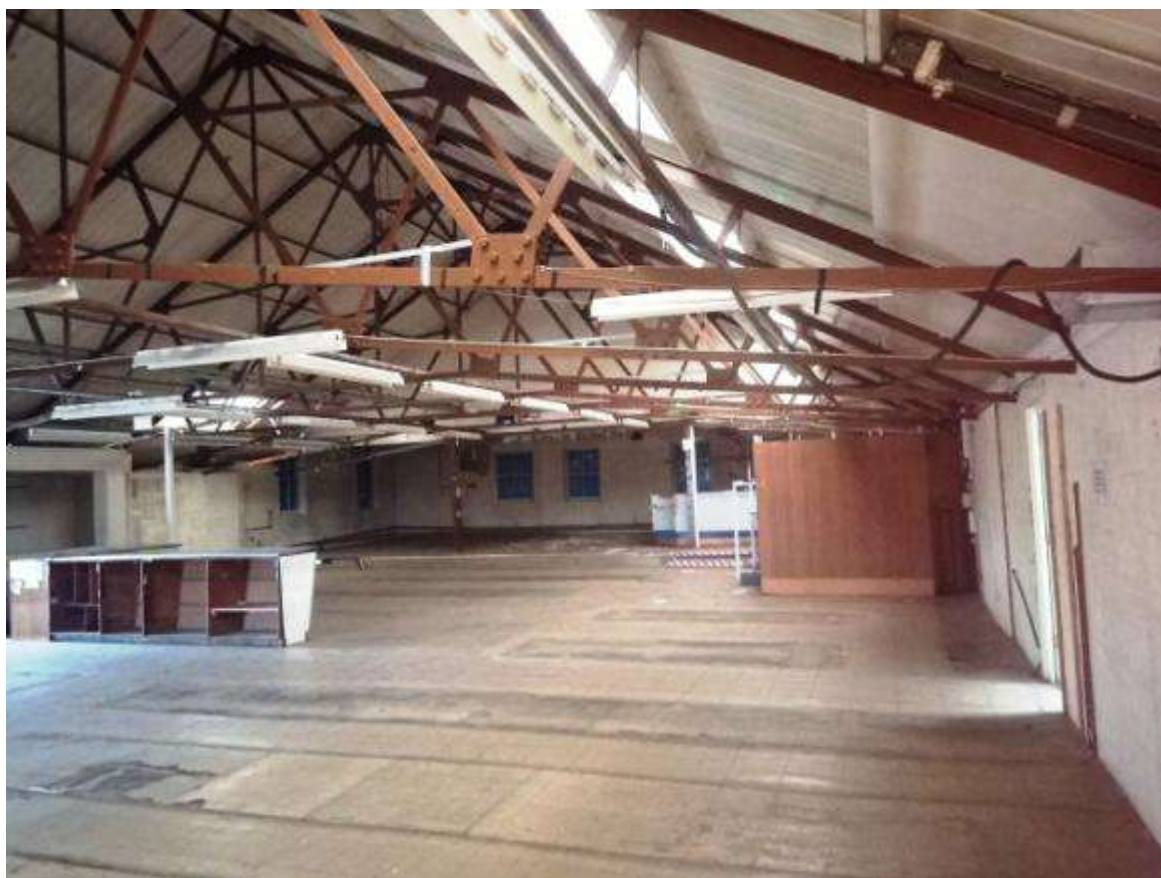
Fig 4.4: North block first floor looking towards the front

- 4.4.1 The north block first floor has a top that is a suspended timber structure covered with what appears to be vinyl asbestos floor tiles that are stuck to some form of boarding below, over what would seem to be timber joists.
- 4.4.2 The walls to the exterior are painted brick work, generally as that noted on the ground floor.
- 4.4.3 At the west end modern there is a modern concrete block housing for a set of fire escape stairs and the lift shaft.
- 4.4.4 The roof over this block from the back of the front cross range to the west wall is supported on a series of steel framed trusses at approximately 1.5 m centres. These are of a late 19<sup>th</sup> C fink pattern truss with a slightly raised centre section

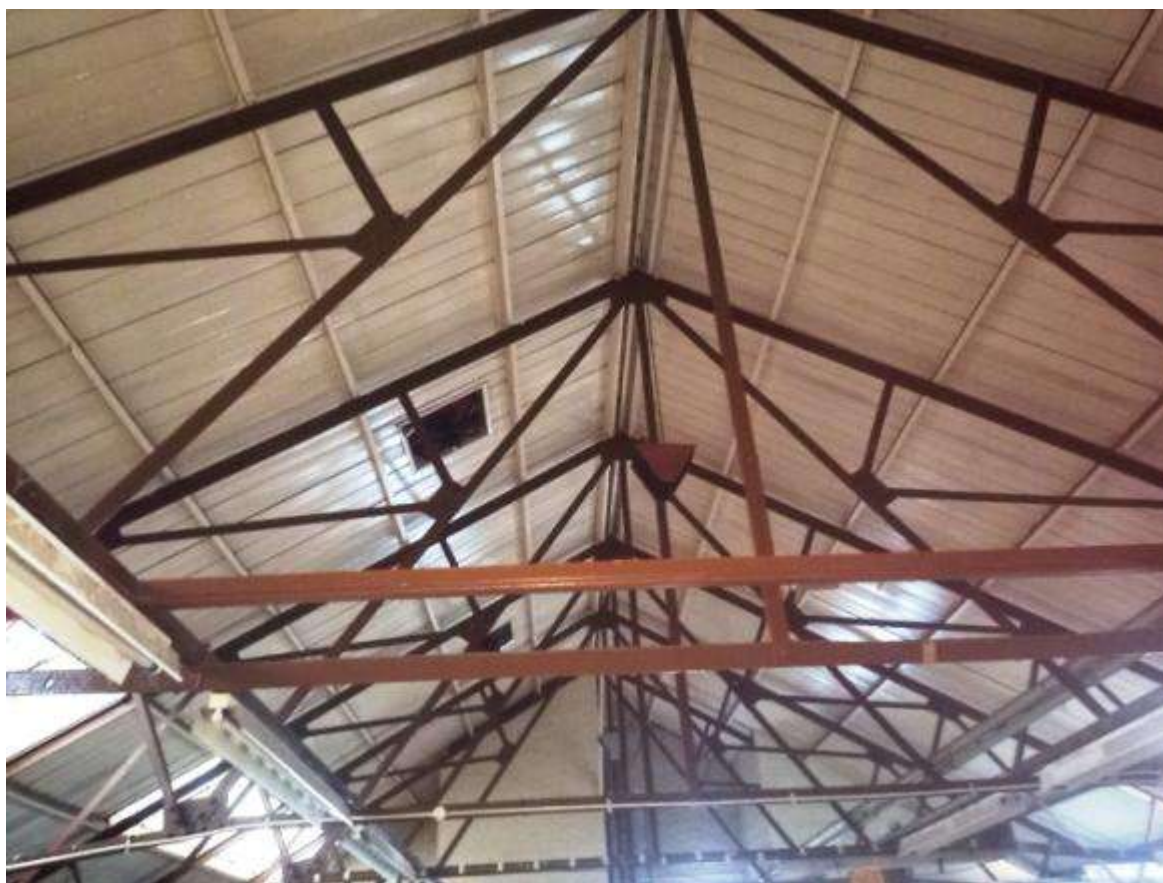
Fig 4.4.4: Roof trusses to north block man roof

and the outer bottom cords angling down on either side to the eaves level. It is comprised of angle iron principal rafters and struts simple plain bar cords and ties. The trusses have bolted gusset plate connections on all the joints and a vertical tie rod in between them and then additional bracing added to the side sections. These all have a paint finish.

- 4.4.5 The trusses support timber purlins where there are eight per side, including the eaves purlin, and a ridge board at the top. There are painted timber sarking boards, over the purlins, which run up from the eaves to the ridge. In the upper purlin bays along the south slope there are large extractor fans mounted under cowl hoods mounted over the external roof sheeting.
- 4.4.6 Over the front section of this section that is a flat soffit of plasterboard over the former office area and under the front cross range roof. On the junction between the former office area and the main part to the rear there is a beam against the east end truss that is supported on posts.

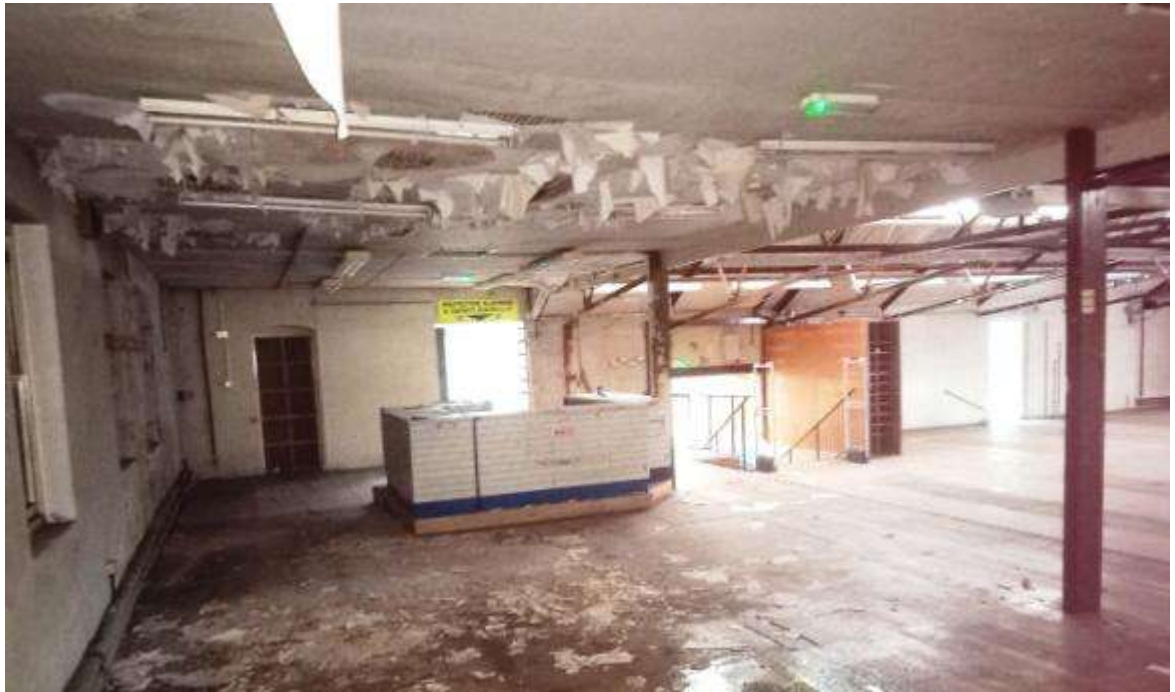
Fig 4.4.6: Lower ceiling to former office area to front of first floor north block (73

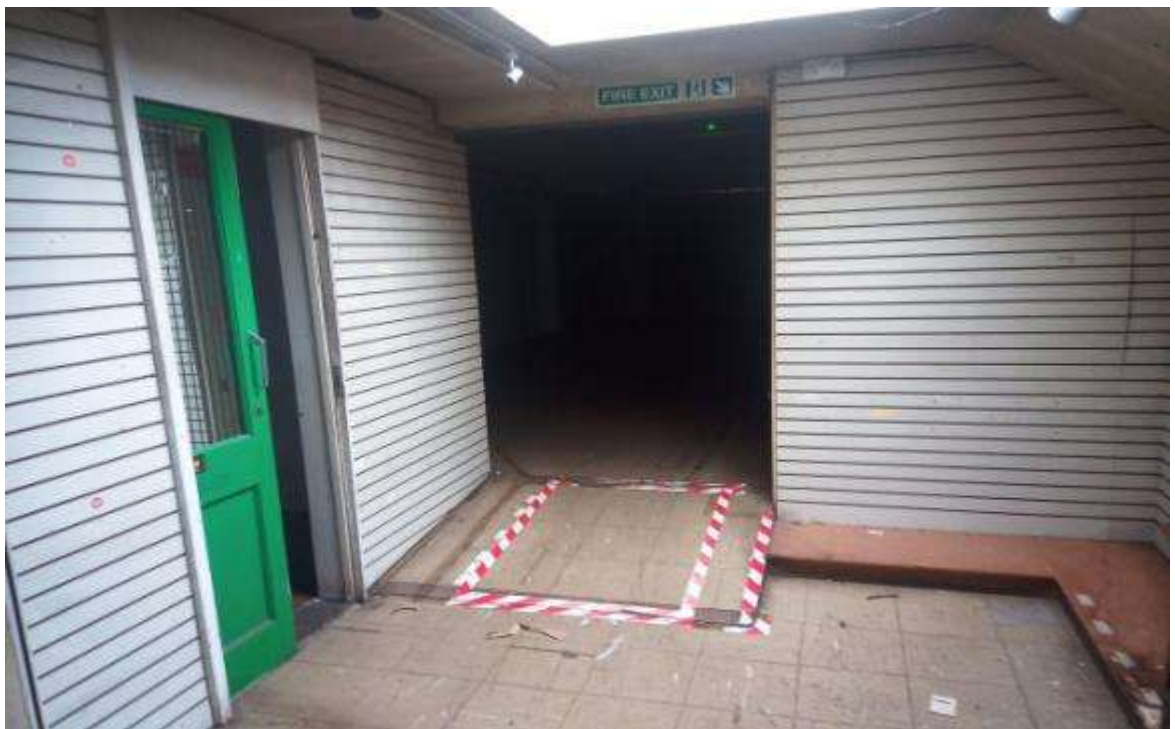
Fig 4.5: Infill link block at front with connection to south block

- 4.5.4 Over the front part to this section is the pitched roof for the front link block into which a Velux type roof window is set in the rear slope.

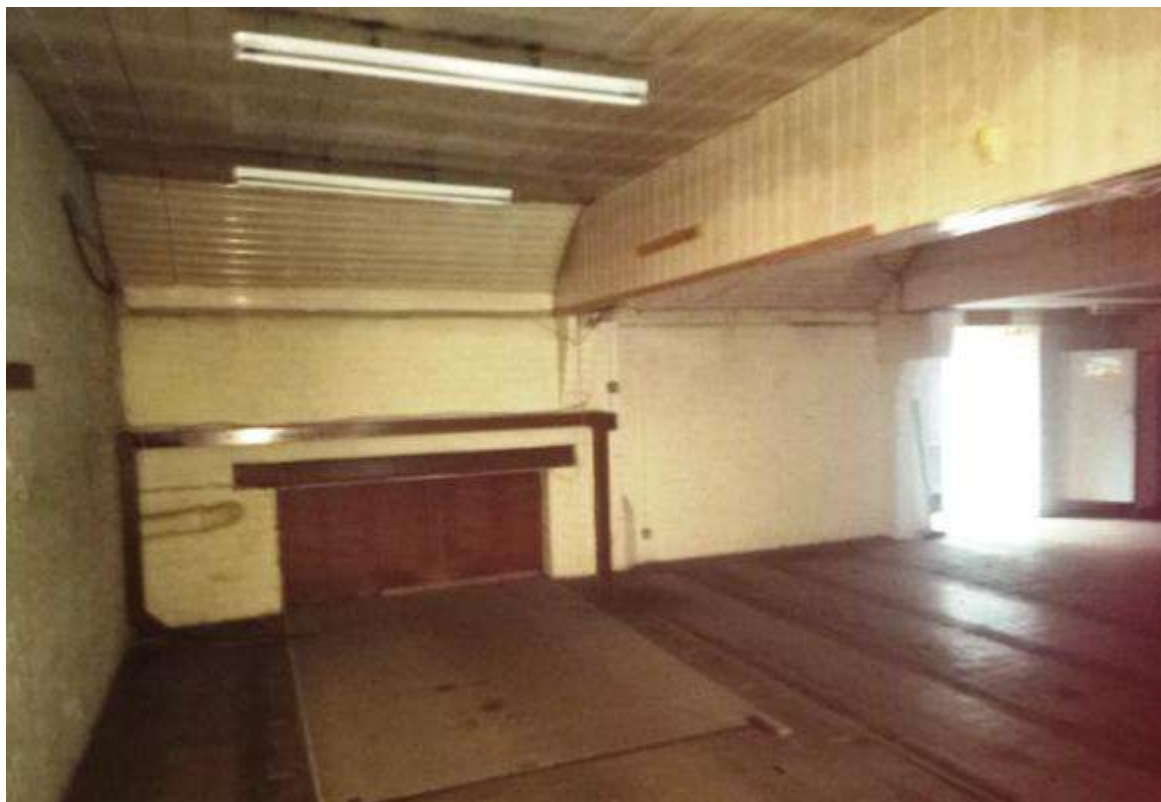
Fig 4.6: South block first floor first at east end

- 4.6.1 The front section of the east end of the south range has a suspended timber floor where this is to the former office section and then changes to solid floor, where the underside is seen below, and is all covered with vinyl asbestos tiling similar to that in the north range. It is slightly higher, by approximately 200 mm, to the link from the infill.
- 4.6.2 The floor of the rear section of the south block is a suspended timber structure covered with carpet.

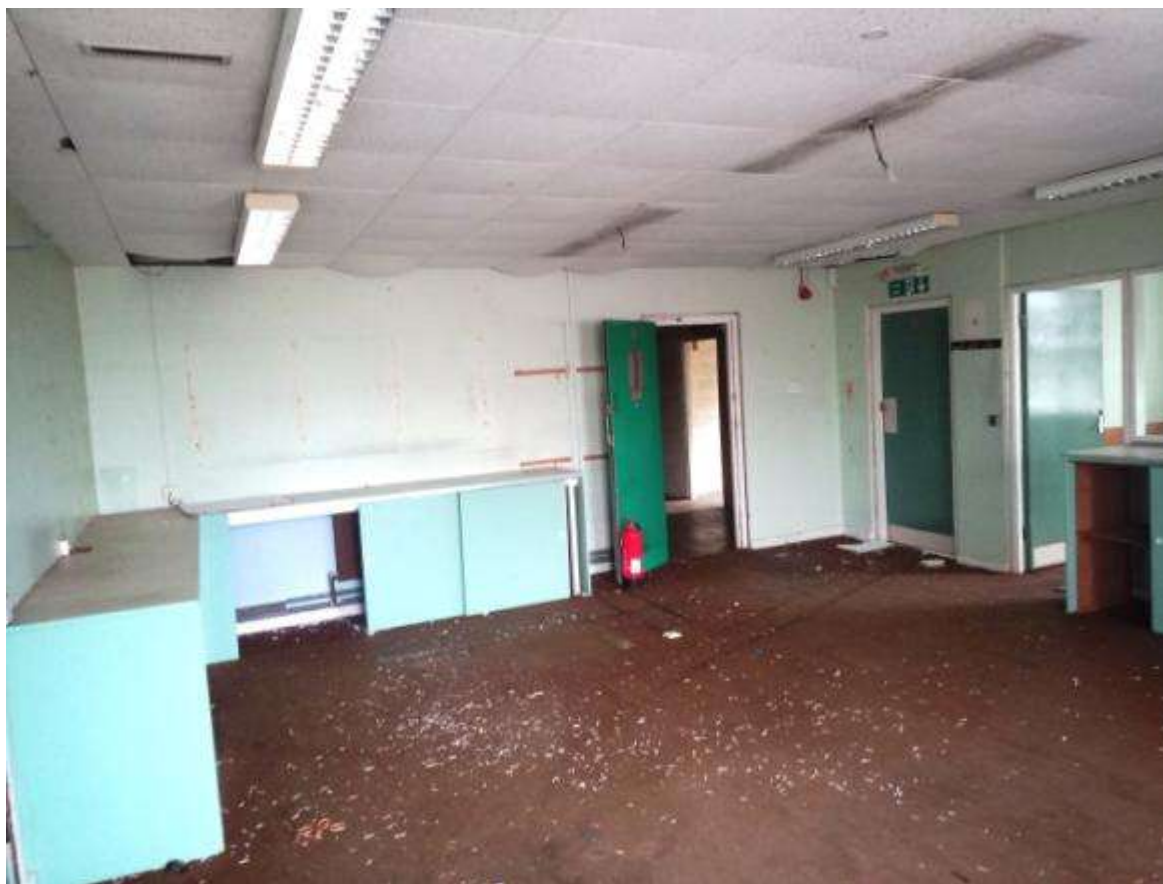
Fig 4.6.3: South block first floor west end office

- 4.6.3 All the external walls have been plastered and painted and then the room divided up with modern concrete block partitioning to form offices and storerooms. Over this is a fibrous laying grid suspended ceiling system below steel trusses generally similar to that noted for the rest of the building.
- 4.6.4 Where seen, the external walls are of painted brick work, generally as those described for the structure externally.

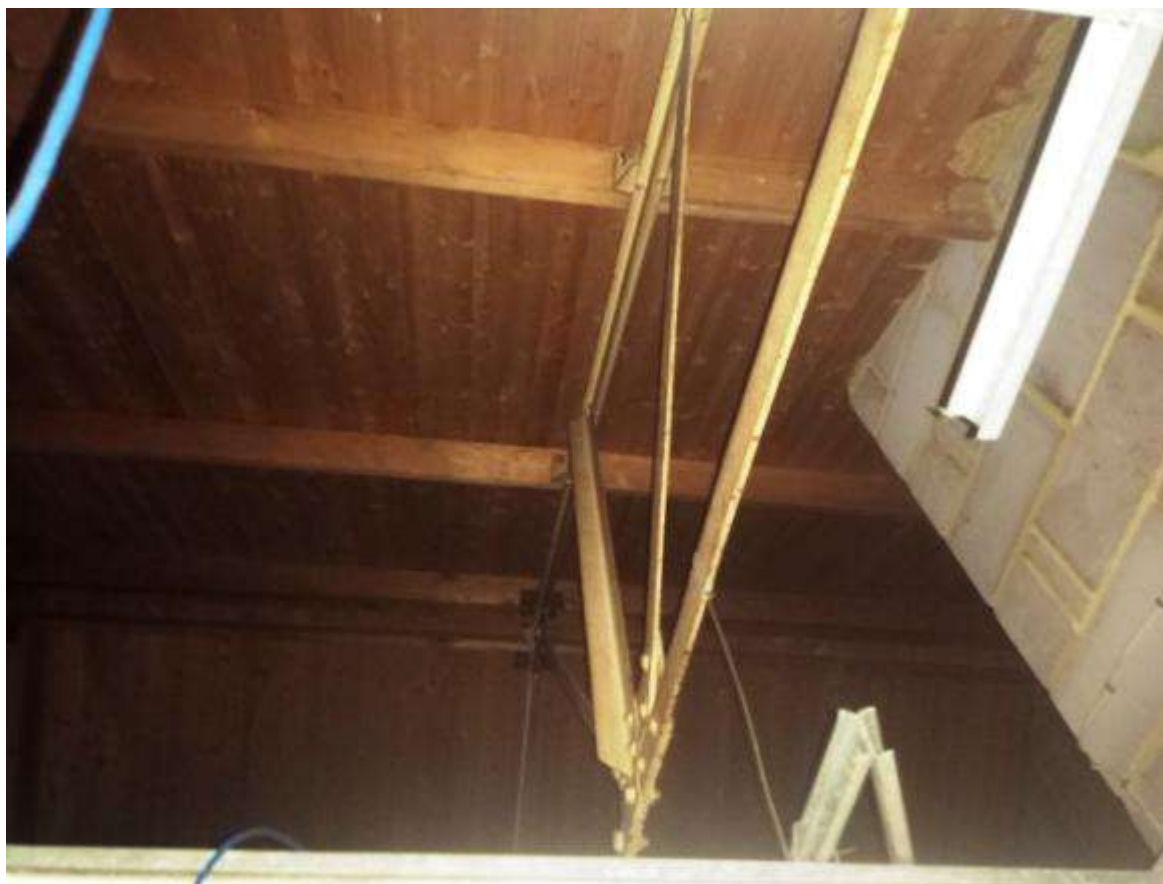
Fig 4.6.7: South block roof truss at west end above suspended ceiling

- 4.6.7 The trusses supporting the roof structure over this area are similar to those over the main part of the north block, where these are iron plate and angle iron fink trusses. , However, these are supported on nibs to the inner face of the walls on both sides that corbel out to give support to the truss ends. In the western section of this block the bottom sides of the trusses are clad with timber boarding with a raised flat soffit between them of painted timber boarding.

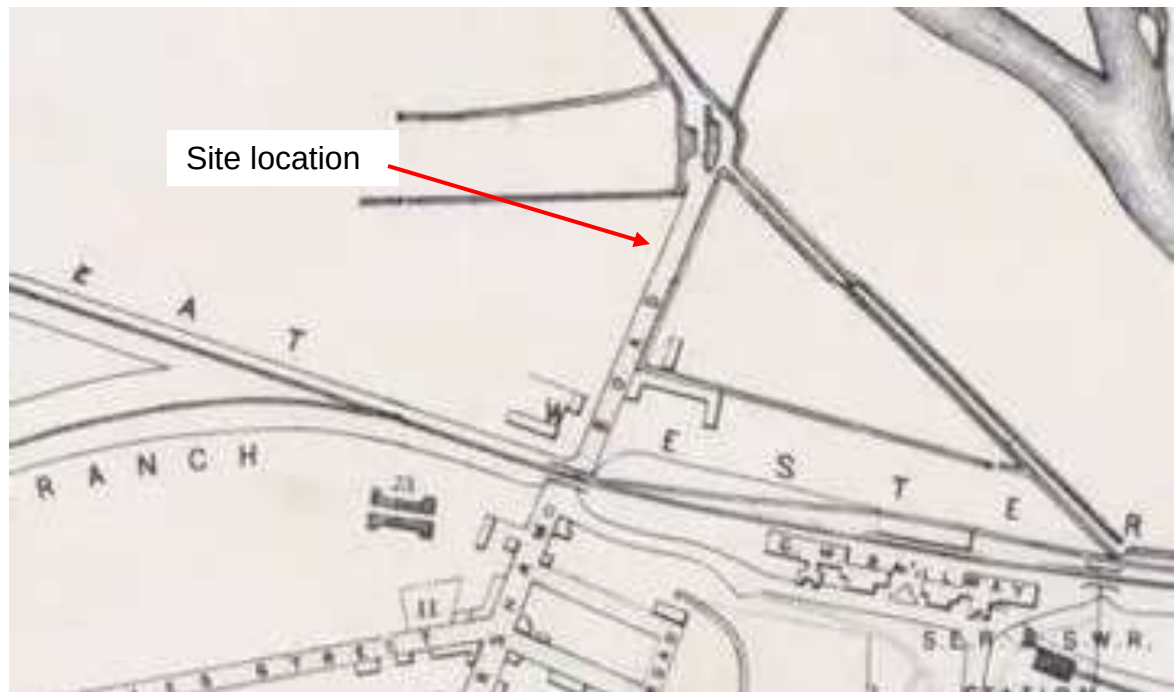
- 6.1.1 A map of Reading date 1840, even though it is quite a large scale, does not show any form of development in the region of this site.

Fig 6.1.1: Map of Reading circa 1840

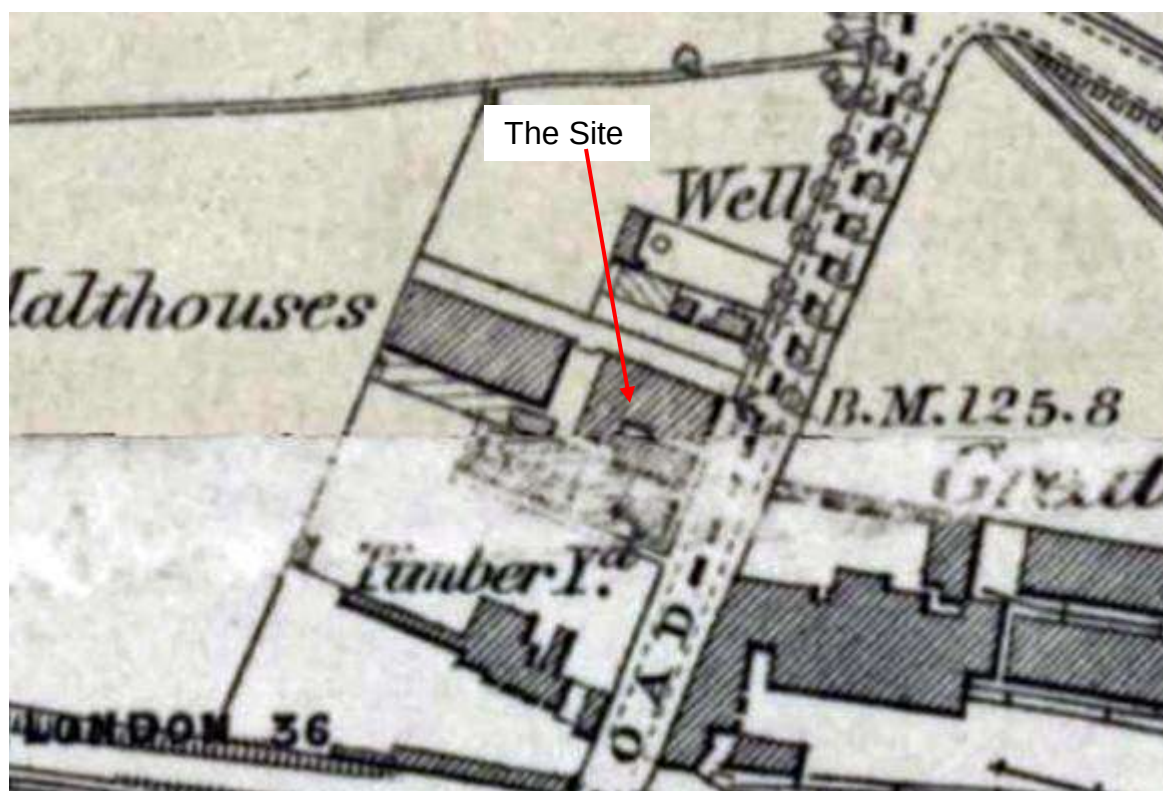
Fig 6.1.3: 1882 edition OS map extract

- 6.1.2 The first edition of the 25" to the mile scale Ordnance Survey (OS) map, published in 1878, shows there to be two buildings on this site that are labelled as malt house. There is a building against the south boundary that would appear to be about the same size and length of the present east part of the south block. Between the south and north blocks there is a gap, and then the north block wraps around part of the west end of the other.
- 6.1.3 Along the north side of the side of this site Northfield road is only shown as a narrow piece of land the depth of the site on the 1882 edition, but it is shown as Northfield Road by 1912.
