**EASTERN BOUNDARY (SCREEN) WALL, BELOW GROUND VAULTS & LANDSCAPING  
CAVERSHAM COURT GARDENS  
CAVERSHAM  
READING**

**STRUCTURAL REPAIR AND CONSERVATION WORKS**

**HERITAGE STATEMENT**

Morse Webb Architects  
The Byre  
Lantern Courtyard  
The Street  
Bramley  
Tadley  
RG26 5DE

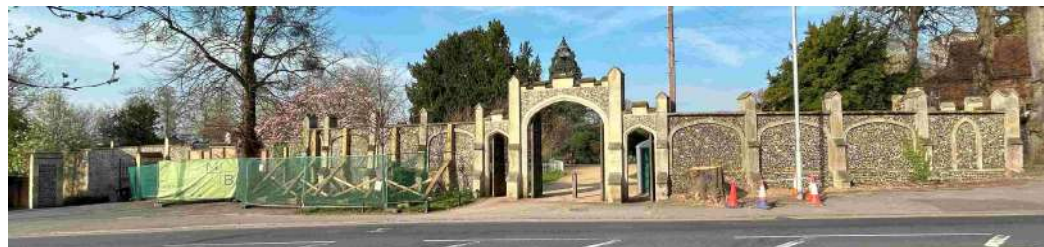
Eastern boundary (screen) wall (part): outer east elevation facing public realm

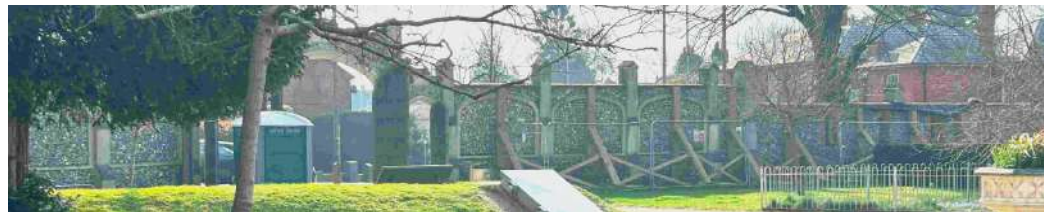
Eastern boundary (screen) wall (part): inner west elevation facing into Caversham Court Gardens

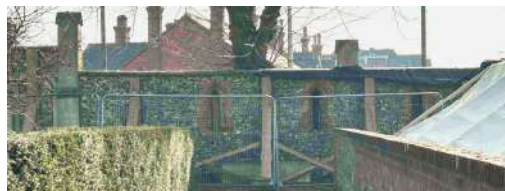
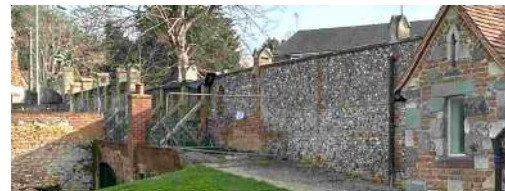
Eastern boundary (screen) wall (part): inner west elevation facing into Caversham Court Gardens

*Eastern Boundary Screen Wall – west elevation (garden side) photographs – Photos by KRP Engineers*

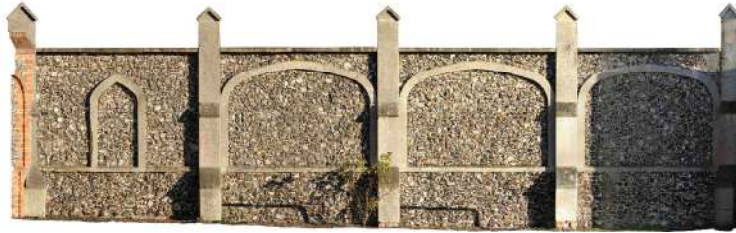
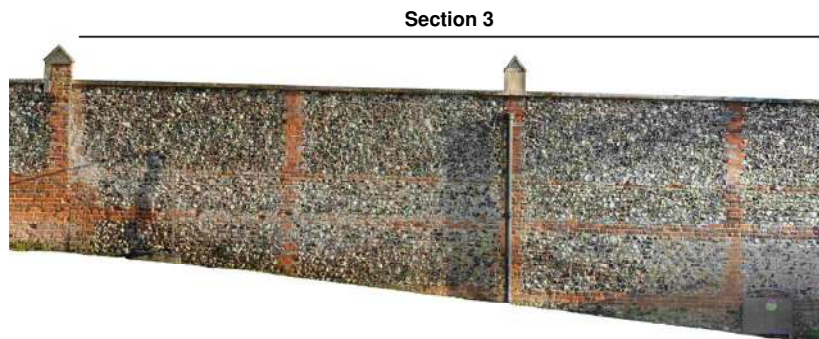
*Eastern Boundary Screen Wall – east elevation (Church Road side) photographs –  
Photos by KRP Engineers*

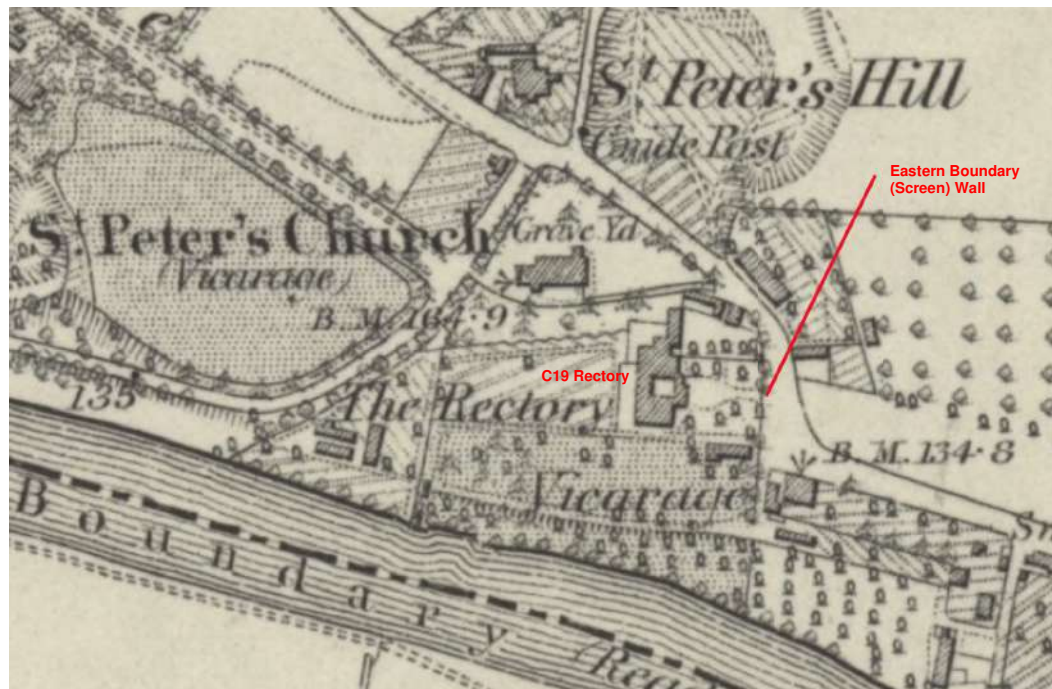
Historic map 1: 1877 – extract. Caversham Court showing the mid C19 rectory attributed to A W N Pugin within the garden inside the boundary wall. Ordnance Survey Historic Maps
