# Land West of Kidmore End Road: Land Quality Desk Study

P25033\_R1  
March 2025

Land West of Kidmore End Road: Land Quality Desk Study

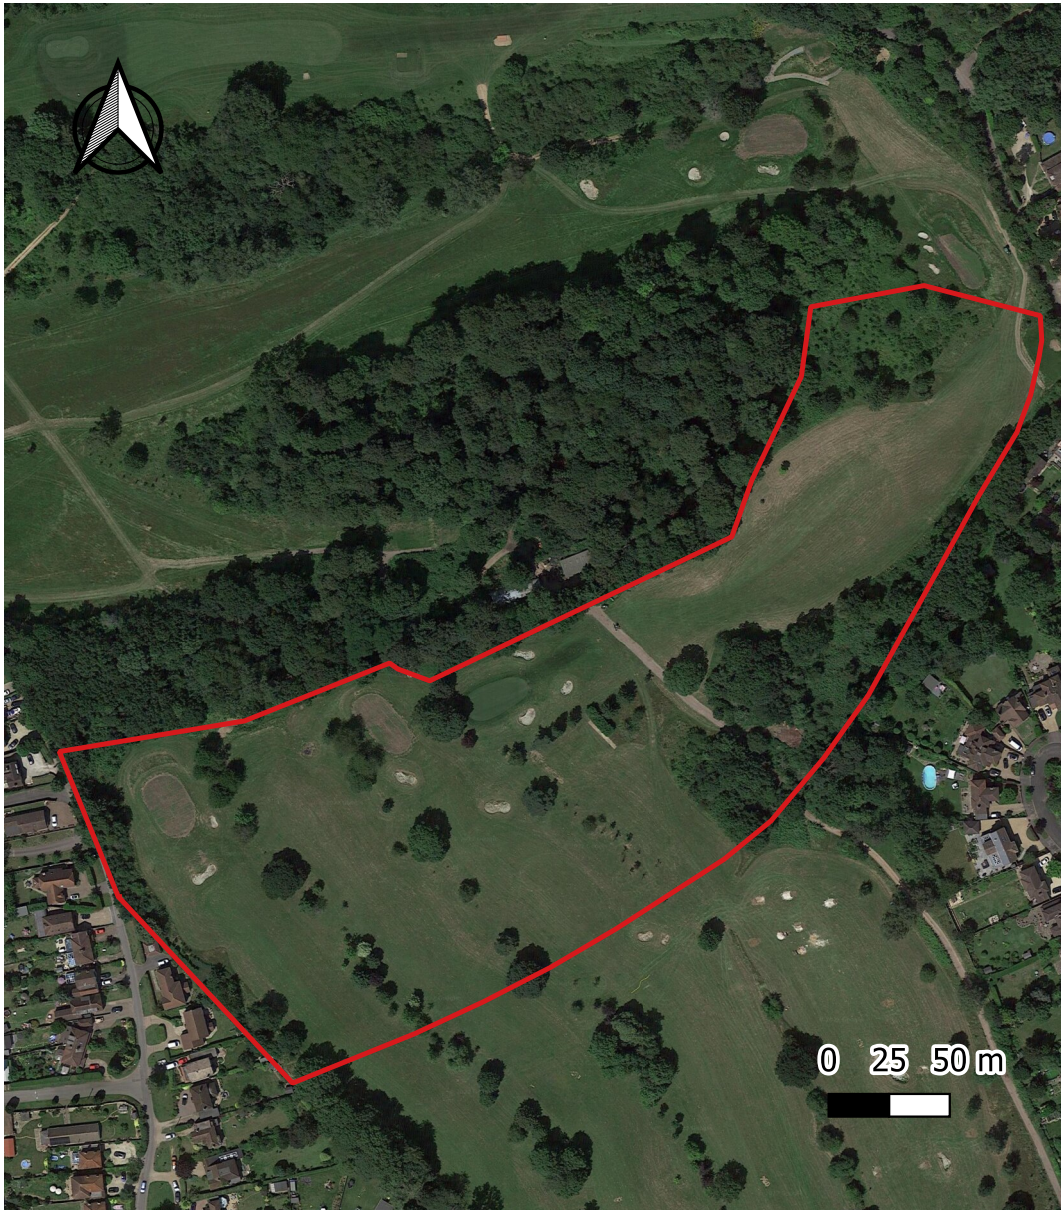
| | Figure Title<br><br>Site location, Reading Golf Course | Client<br>Fairfax (Reading) Limited<br>and RGC (SODC) Limited | Date<br>08/09/22 | Drawn<br>RLW | <br><b>AQUA TERRA</b><br>CONSULTING |

A Site Location plan is presented as drawing P25033\_R1\_D01. The Site address is as follows:

The Site area (taken from the red line boundary presented in Appendix B) is approximately 5.9Ha and the British National Grid Reference at the centre of the Site is: 471460, 177140.

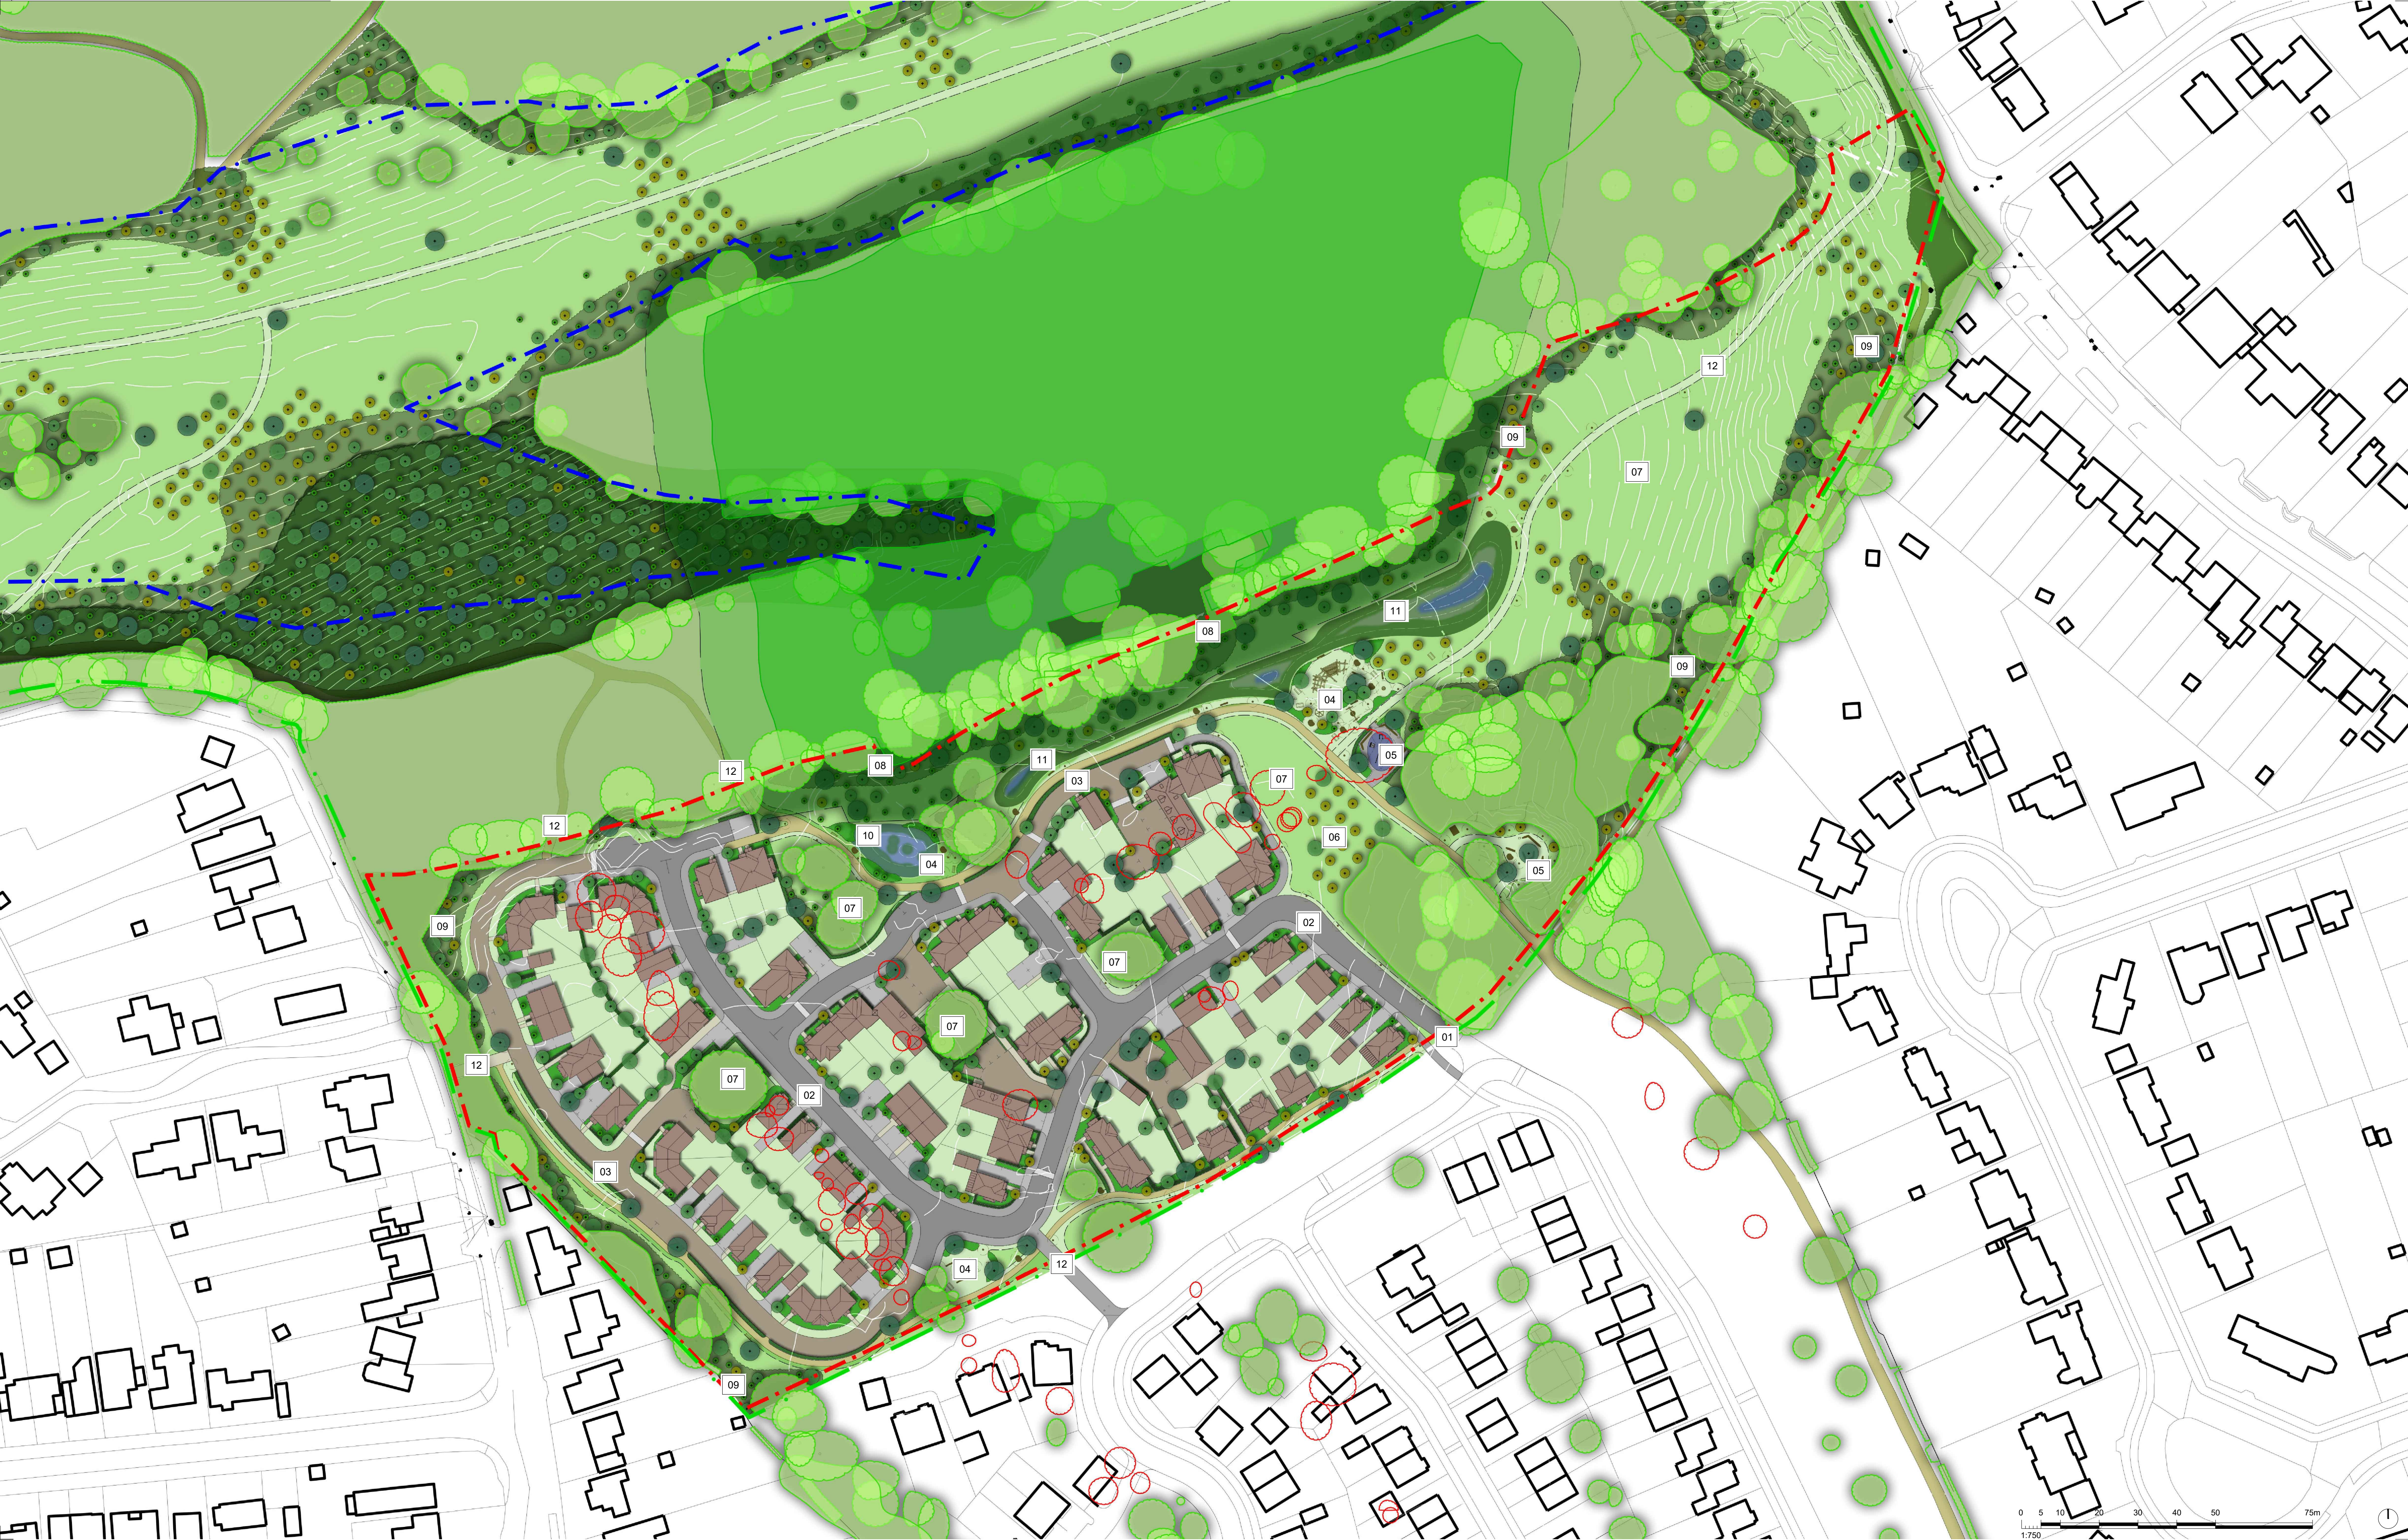
Drawing Title: Colour Masterplan

1. Main site access points
2. Main street
3. Edge / secondary streets
4. Play spaces - LAP / LEAP
5. Youth and young adult spaces
6. Community orchards
7. Open space
8. Woodland planting

9. Woodland edge
10. Attenuation basin
11. Swale
12. Footpath links
