## Mews Cottage

### Bat report

June 2025

**Mews Cottage**  
**Ecology 8721**  
**Version 03**

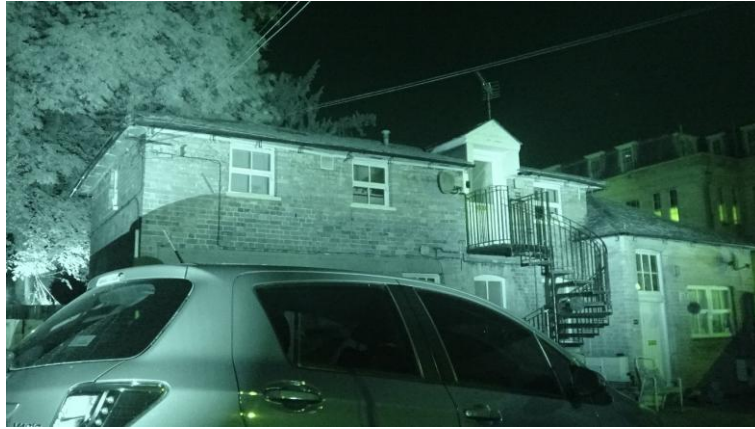
**Figure 1:** Still from camera on the Southwestern corner

- 3.7 The surveyors were equipped with Echo Meter Touch 2 Pros and Canon XA11 with LED Infra-Red Illuminator flood lights as Night Vision Aids (NVAs). **Figure 1 - 3** shows the coverage of the camera during the surveys. The camera was positioned next to the surveyor watching the building, once it became too dark to see the building the surveyor viewed the building through the camera display. Post survey any emergences or suspected emergences were then reviewed using a computer and VLC media player with the motion detector filter activated to aid footage review. Where necessary footage was slowed down and reviewed frame by frame.

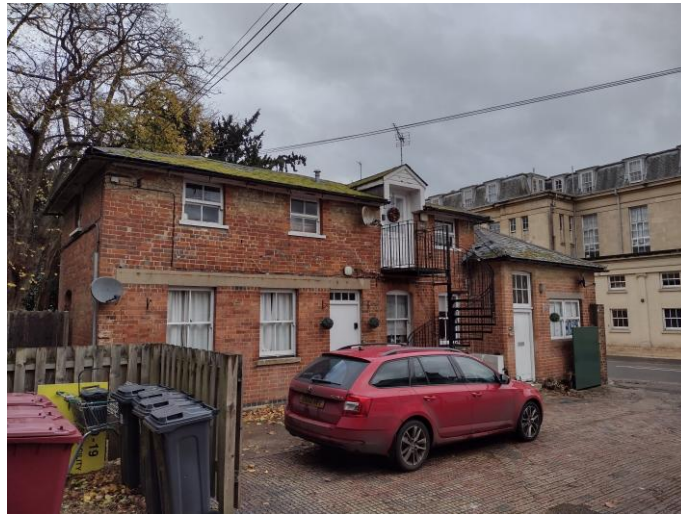
**Figure 1:** Southern elevation of building 1

- 4.4 Building 2A is a two-storey brick building. The roof is pitched and hipped and comprises slate roof and clay ridge tiles. Timber soffits are present which are generally in good condition however some peeling paint and missing soffit grills were noted. Timber doors and windows are present in reasonable condition, as well as uPVC guttering. Two boiler flues and two soil stack/vent pipes are present but well-sealed. The hayloft door entrance to flat three has slate cheeks on western and eastern elevations. The door is flush to the dormer and the timber gable and fascia are in good condition. (**Figure 1**).

- 4.5 Mortar is missing on the corners of hip tiles leading to access points and potential roosting locations. The timber soffits are in poor condition with peeling paint and some missing grills are present over vent holes.

- 4.6 Building 1 is considered to hold **low potential** to support roosting bats due to the presence of access and potential roosting opportunities under the hip tiles from the missing mortar and the missing vents on the soffit grills creating more potential roosting opportunities. These features are considered suitable for low numbers of bats on an opportunistic basis. Due to the presence of suitable roost features in the proposed area of works a further emergence survey was completed on the property.

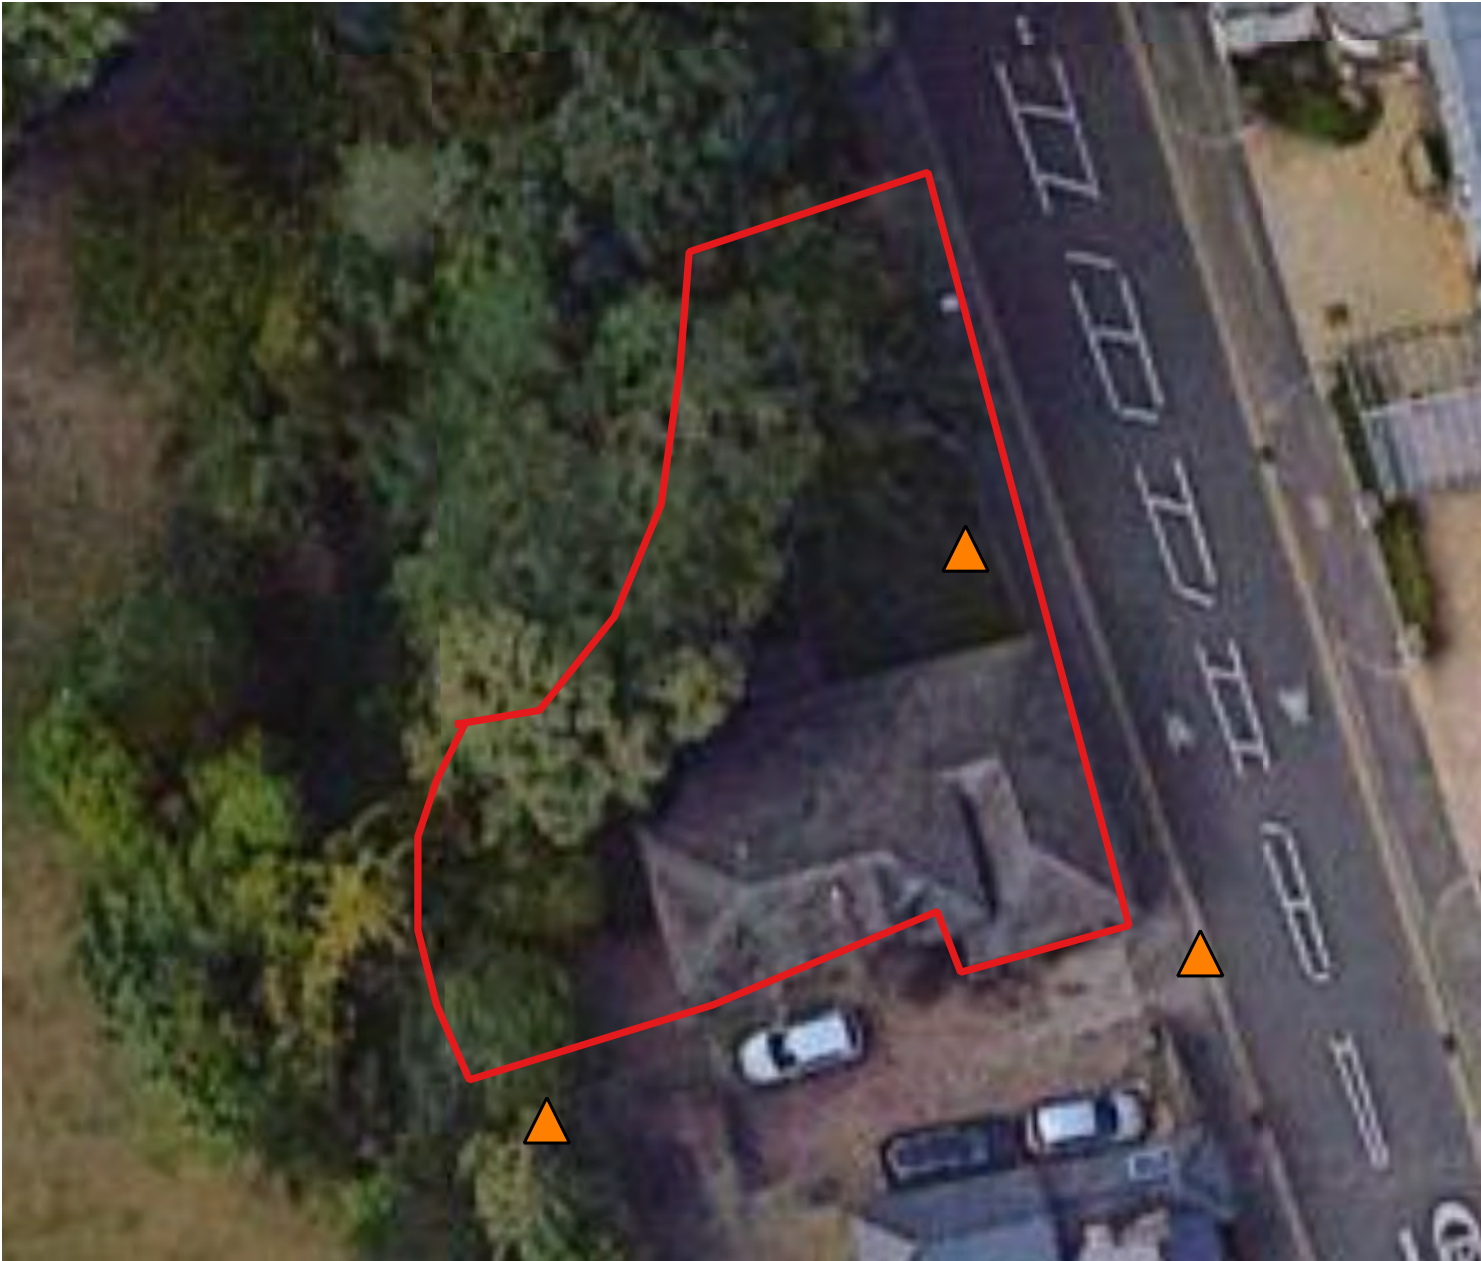
| DRAWING: | Emergence Survey Results | 1:250 | |

- 4.8 No bats were recorded emerging from the building.
- 4.9 Activity was recorded throughout the survey with activity predominately from common pipistrelle bats which were recorded foraging intermittently along the western elevation between 21:08 and 21:54. One noctule pass was recorded at 22:12.

- 4.10 No bats were recorded emerging from Mews Cottage. It is therefore considered this building does not support a bat roost. Therefore, the works will not impact any bat roosts. Bats utilise the site and surrounding areas for foraging and commuting and recommendations for lighting have been made in **Section 5.0**

| 21:07-<br>21:14 | Common pipistrelle | Heard not seen, faint pass intermittently on the northern elevation | |
| 21:12<br>–<br>21:15 | Common pipistrelle | Foraging north of Mews Cottages | |
| 21:12<br>–<br>21:53 | Common pipistrelle | Foraging along the southern and western elevation of Mews Cottages | |
| 21:18 | Common pipistrelle | Foraging north of Mews Cottages before flying south along the western elevation | |
| 21:23<br>–<br>22:15 | Common pipistrelle | Up to two bats foraging in the garden north west of the site | |
| 22:12 | Noctule | Heard not seen to the east of Mews Cottages | |
