# **Preliminary Roost Assessment**

**Land behind 4 Manor House Court,  
Heath Road, Reading RG6 1NA**

27 March 2025

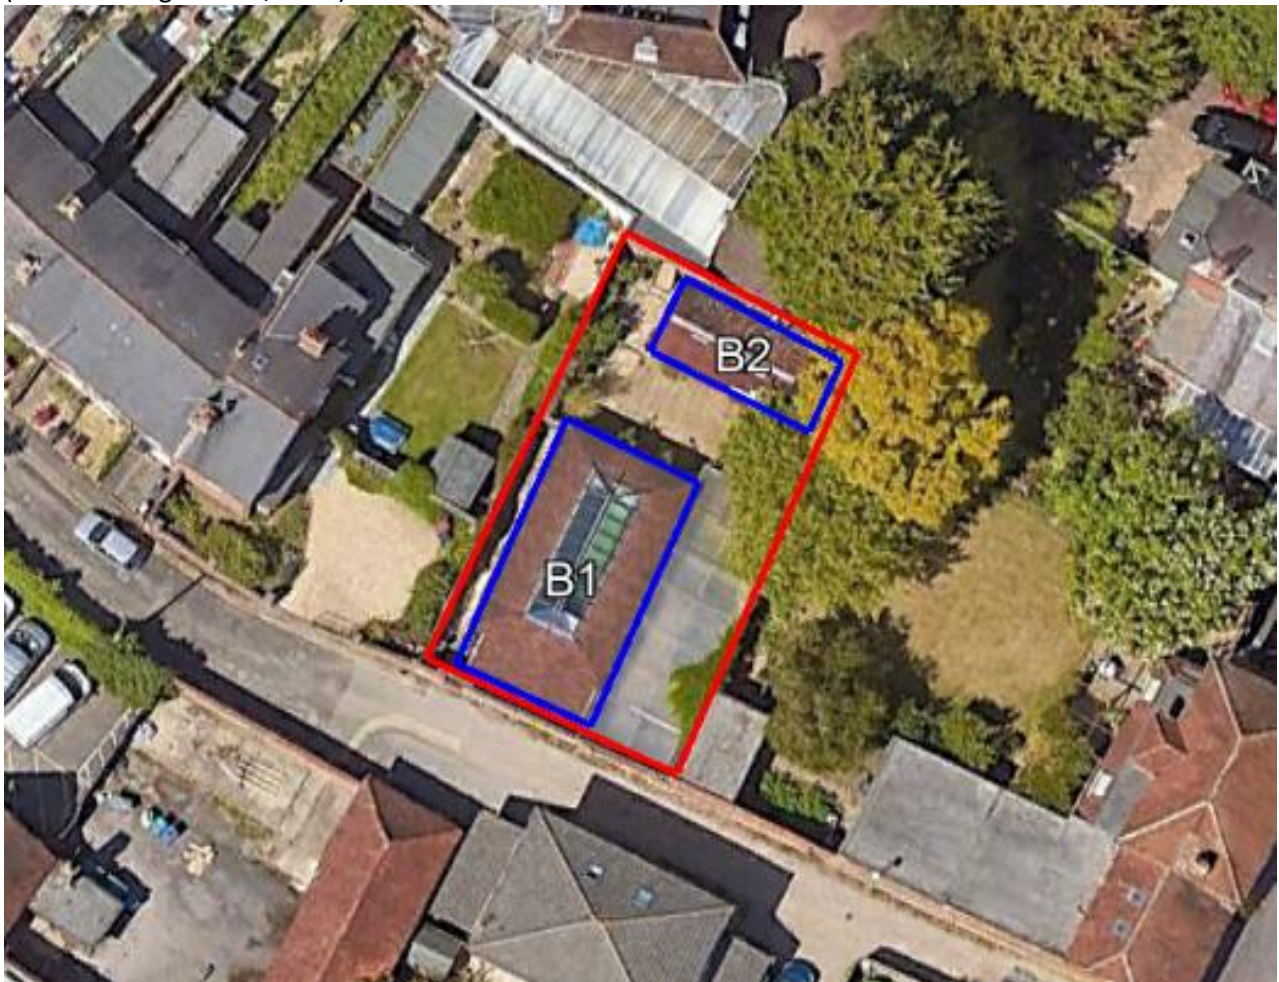
**Figure 1: The approximate site boundary (blue) and structures surveyed (red)**

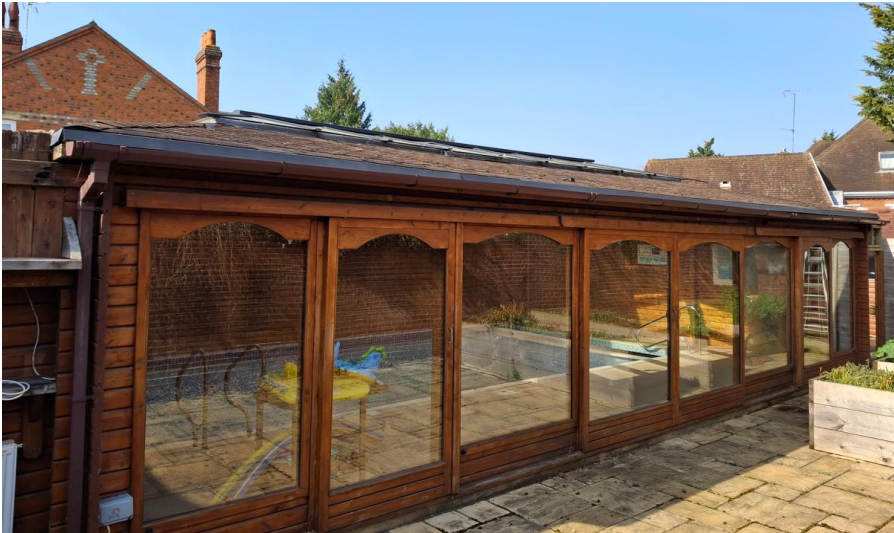
**Figure 3: The east elevation of B1**

Building B1 is constructed with panelised wooden cladding, which was found to be in good condition, with no signs of deterioration such as gaps caused by lifted or rotting wood. There are no soffits or fascias present that could provide potential roosting sites for bats, nor are there any suitable spaces around the uPVC drainpipes. Additionally, the large windows on the east elevation are well-fitted to the structure, leaving no crevices that could serve as potential roosting locations.

The roof has a slight pitch and was challenging to observe from ground level. However, the tiles appear to be composed of a thin felt material, which does not provide suitable habitat for bat roosting.

Due to the proximity of the neighbouring property and boundary wall, the west and south elevations of B1 could not be directly surveyed. However, it is reasonable to assume that these elevations are constructed and maintained to the same standard as those that were assessed.

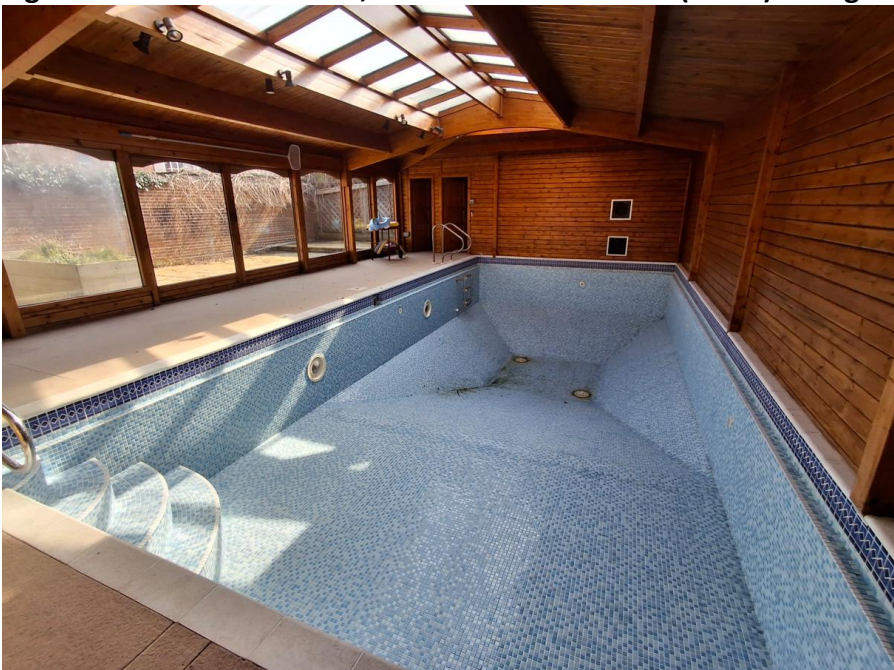
**Figure 4: The internal of B1, as seen from the front (north) facing south**

Due to the presence of the eastern glass wall and the glass window along the roof apex, the internal environment of B1 is well-lit, making it highly unsuitable for bat roosting. Additionally, there are no internal features that could provide suitable roosting opportunities.

Furthermore, B1 does not contain an enclosed loft space.

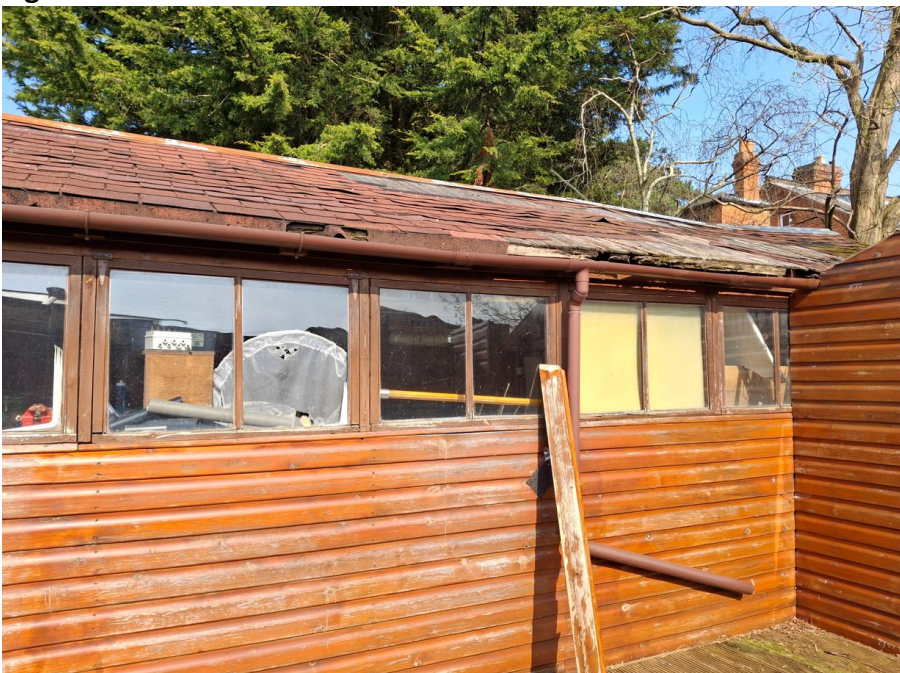
**Figure 5: The south elevation of B2**

B2 is constructed with panelised wooden cladding, which was found to be in good condition, with no signs of deterioration such as lifted or rotting wood. The soffits on the west gable end and south-facing elevation do not provide any potential roosting opportunities for bats.

The roof consists of thin felt tiles laid over a wooden structure, with multiple gaps present. Additionally, lead flashing runs along the length of the roof apex, where further gaps were observed.

The north and east elevations of B2 could not be directly surveyed due to the proximity of the boundary wall. However, it is reasonable to assume that these elevations are of similar construction and condition to those that were assessed.

It is important to note that the surrounding local and wider landscape contains habitats highly suitable for bats. Therefore, it is recommended that caution is exercised when removing the lead flashing from the apex of B2. The area should be carefully inspected beneath the flashing before disposal.

Given the inherent uncertainty due to the unpredictable nature of bats, it is recommended that the lead flashing on B2 be carefully removed and checked for bats before disposal. Should bats, or evidence of their presence, be discovered during development, the advice of a qualified ecologist should be sought.

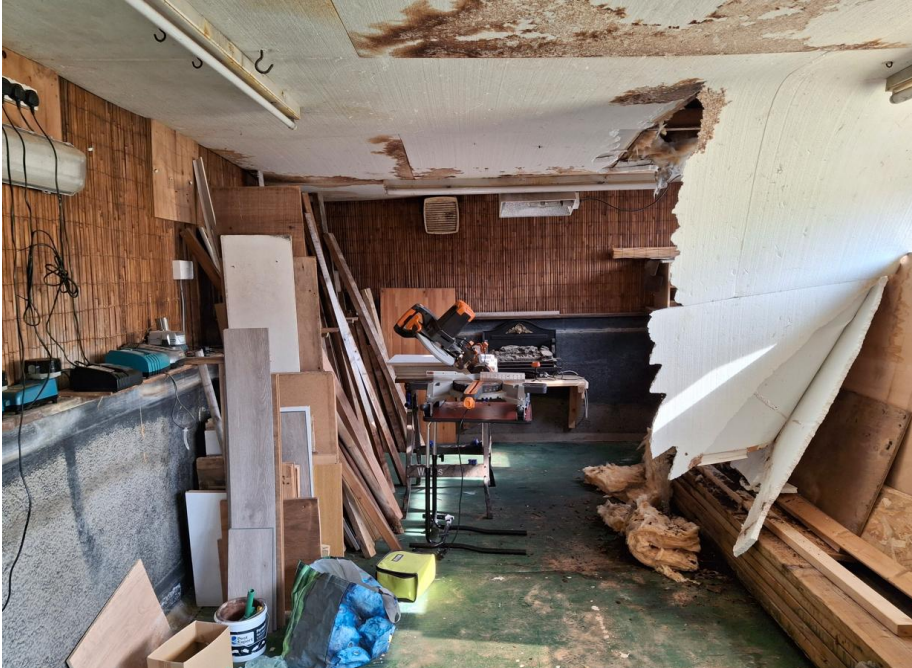
**Figure 6: The internal of B2, as seen from the front (west) facing east**

Due to the presence of windows along the southern elevation, the internal environment of B2 is well-lit, making it highly unsuitable for bat roosting.

B2 contains an enclosed loft space, which was inspected through a hole in the ceiling on the southeast side using a high-powered torch. The loft space has a maximum height of approximately 1m at the apex, and the A-framed timber beams provide minimal, if any, suitable crevices for roosting. Additionally, the void is subject to light spill due to the damaged ceiling, further reducing its suitability as a roosting habitat.

No bats or evidence of bat activity were found within B2, and no internal features suitable for roosting were identified.

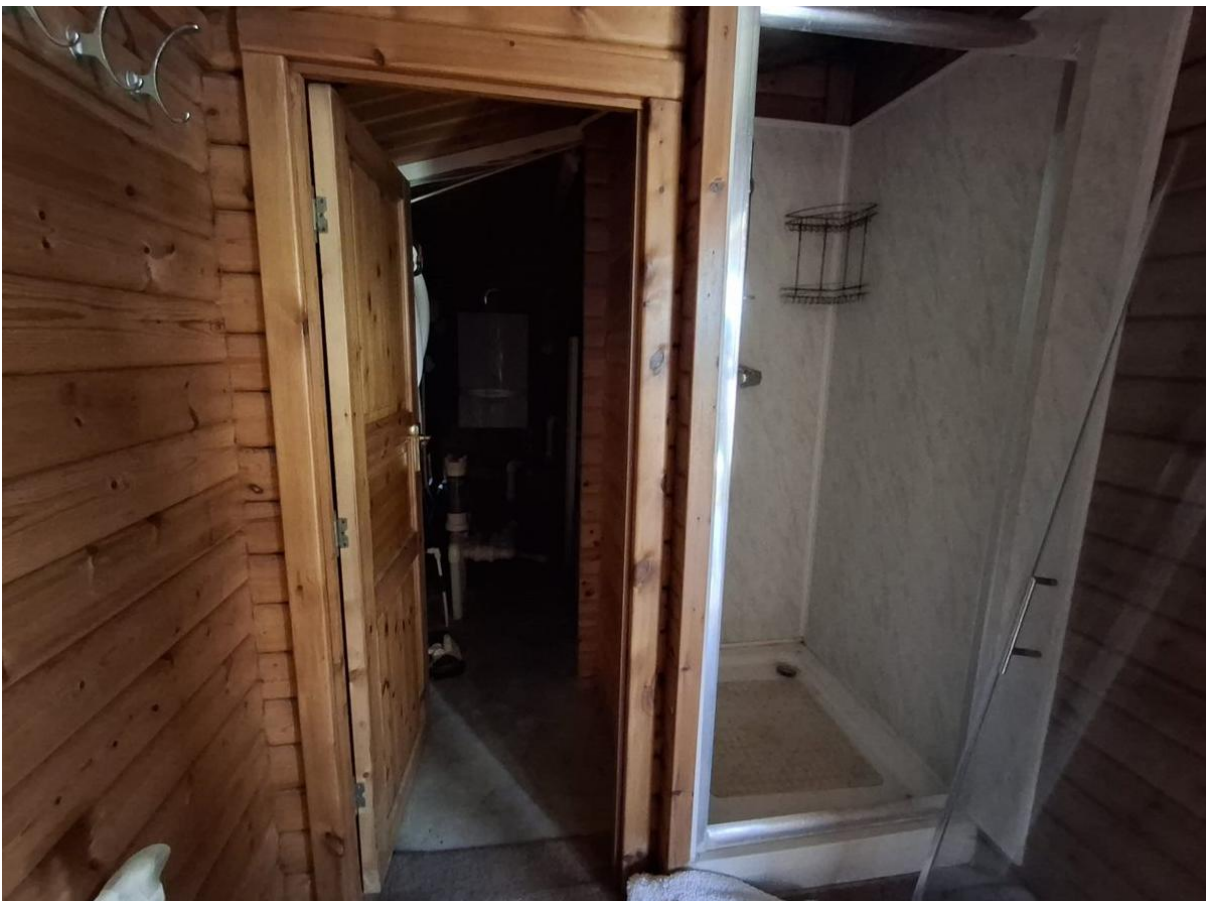
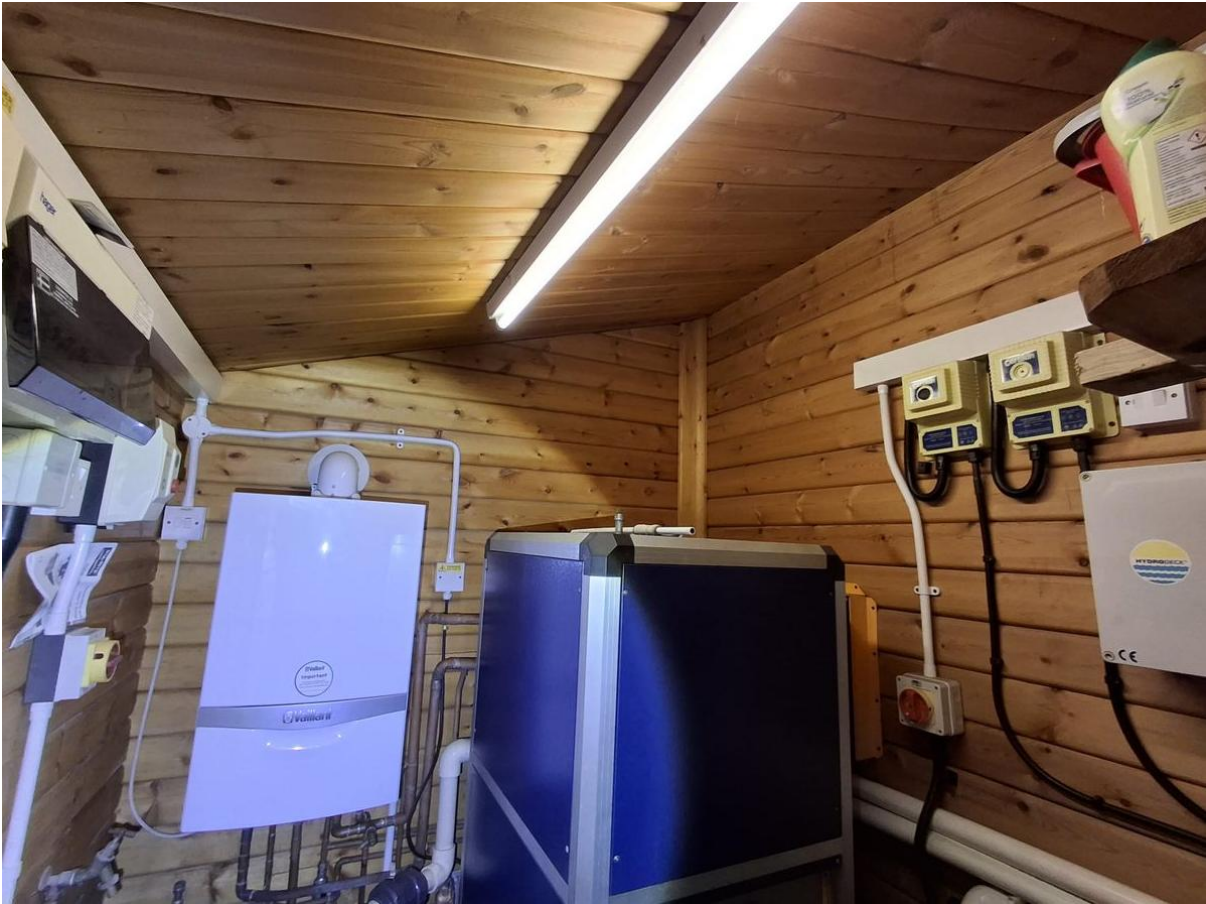
B1: internal

| Feature | Survey Findings | Recommendations |
|---|---|---|
| B1 | <p>Internally there was no bats or evidence of bats and features suitable for bat roosting. B1 is well lit and does not provide bat suitable habitat conditions.</p> <p>Externally, there were no obvious gaps or crevices which could be used by roosting bats.</p> <p>The south and west side of the roof could not be surveyed.</p> <p><b>B1 offers no bat roosting potential.</b></p> | <p>There are no foreseen impacts on roosting bats, and the proposed works will be highly unlikely to cause disturbance, injury or death to bats, nor result in the destruction of a bat roost and/or block bats from accessing their roost.</p> <p><b>No further bat surveys are required.</b></p> |

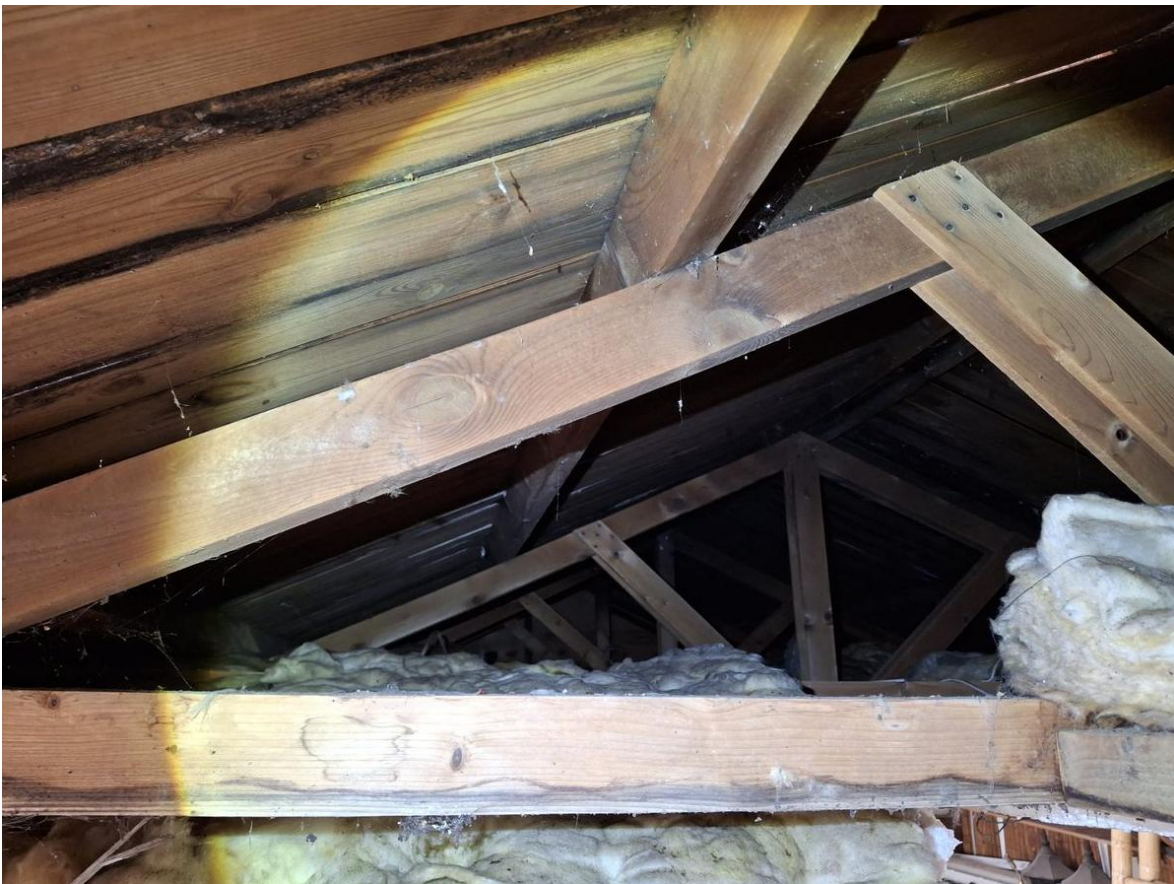
B2: loft, facing north

Internal inspections of B1 and B2 identified unsuitable roosting conditions, primarily due to significant light spill from windows and a lack of suitable roosting features. The loft space within B2 is not sufficiently tall to accommodate void-dwelling bat species, which require adequate space to drop from their roost positions to gain flight. Additionally, the space is likely too bright to be suitable for crevice-dwelling bats.

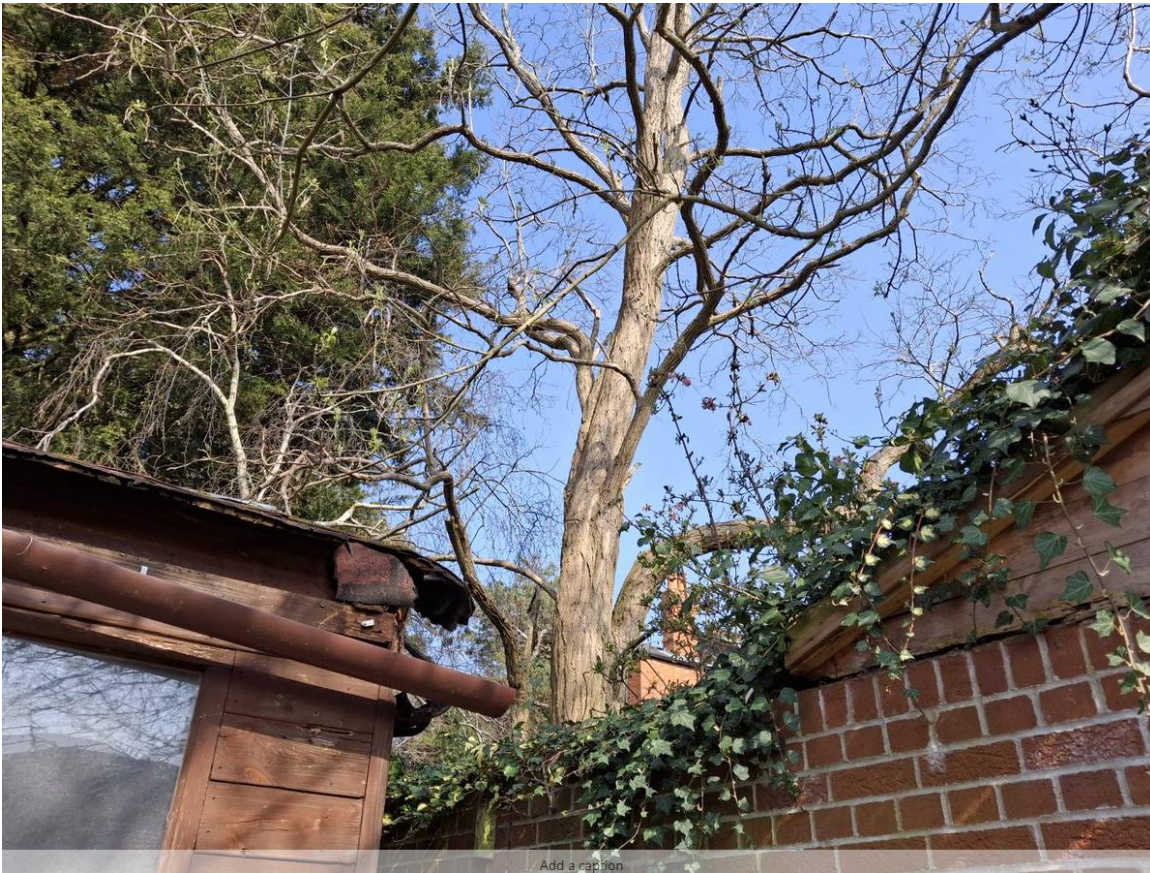
Trees to northeast of site

| Feature | Survey Findings | Recommendations |
|---|---|---|
| Other habitats and considerations | <p>The site is located within a local and wider landscape that provides high-quality habitat for bats, but the site itself has low biodiversity value.</p> <p>There are six known bat roosts within 2 kilometres of the site, with the closest record relating to a known common pipistrelle roost 400 metres west of the site (2014).</p> <p>No trees will be impacted by the works.</p> <p>Birds could begin nesting on site at any time.</p> | <p>Lighting recommendations have been made to reduce impacts on bats which may be using the treelines to the northeast of the site.</p> |
