85 Watlington Street

Design and Access Statement  
July 2025

## 1.1 Description of Works

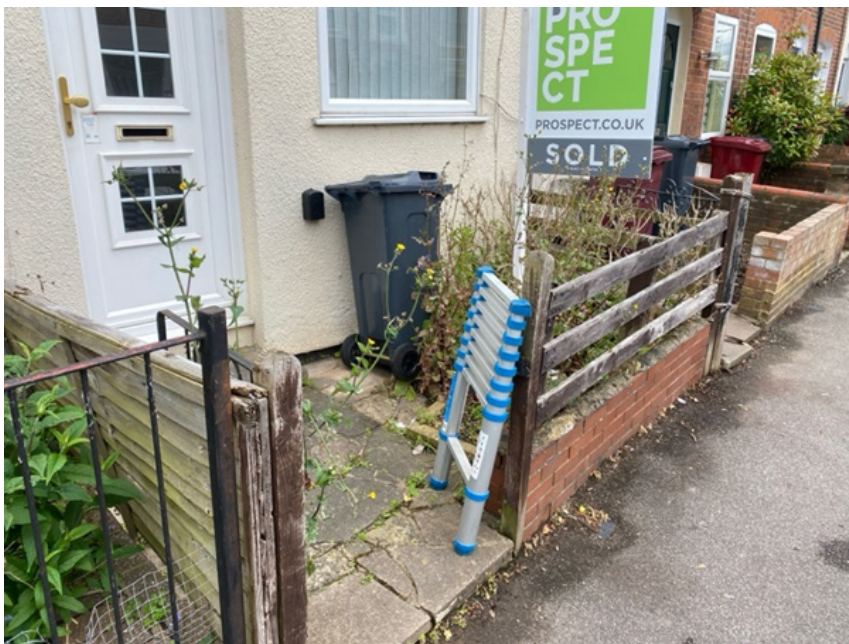
Figure 3: Existing front garden with poor condition paving, wall and railings

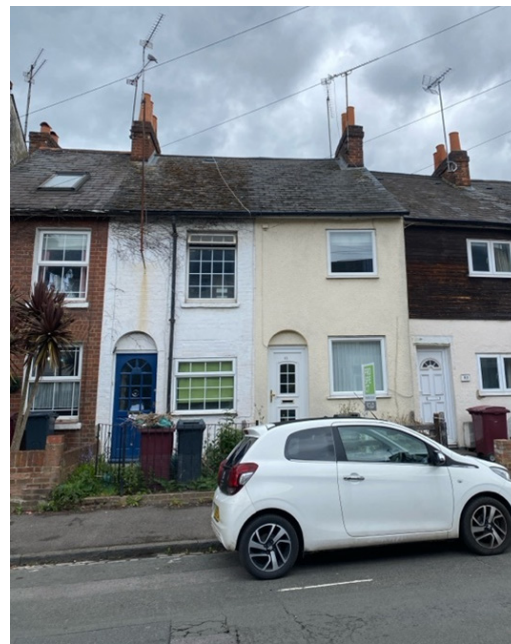
Figure 6: Existing front garden with non original beige render

Exploration is to occur if the existing concrete render can be removed to reveal original brick work and remedy damp issues on the internal wall face. If not possible due to poor brick condition a new render with matching colour will replace the existing but in traditional lime to allow breathability.

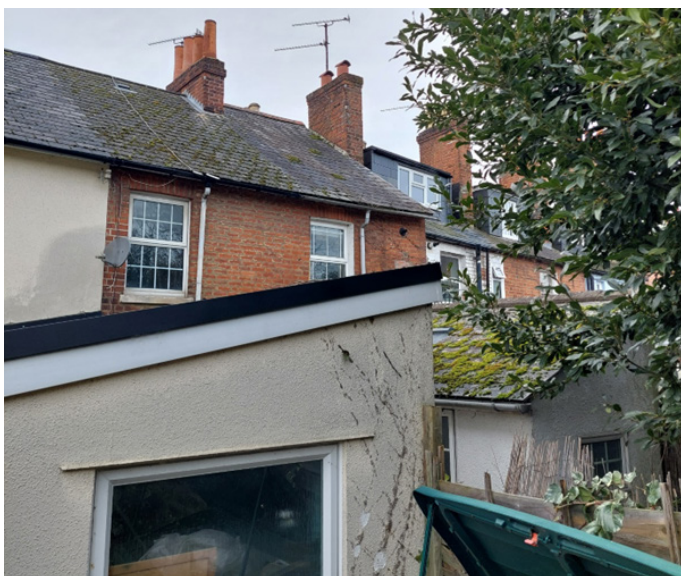
Figure 4: View from 85 back courtyard garden: existing dormer lofts north along Watlington Street

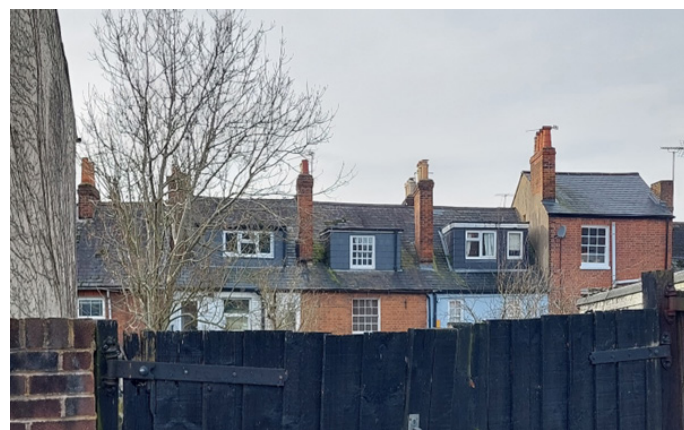
Figure 5: View from Princes Street towards existing dormer lofts at rear of properties along Watlington Street

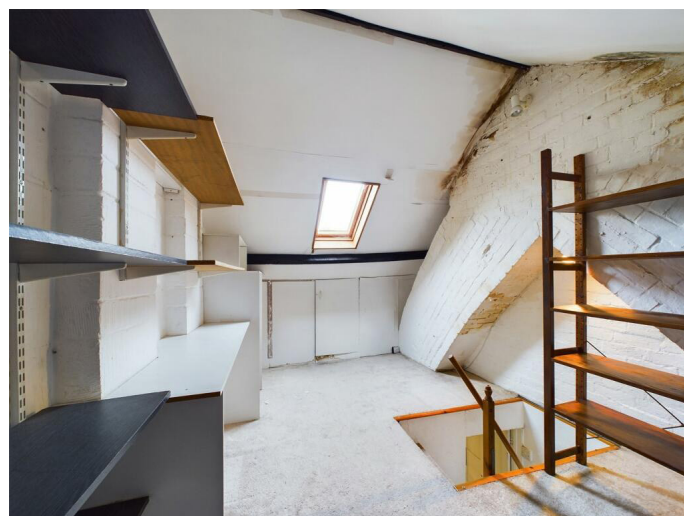
Figure 7: Existing converted loft with ladder stairs and velux window. Roof water damage to chimney surrounds also evident.

The existing loft space is had been converted into a office space with flooring, velux window and furniture. It is currently accessed through the bedroom via a steep ladder staircase.

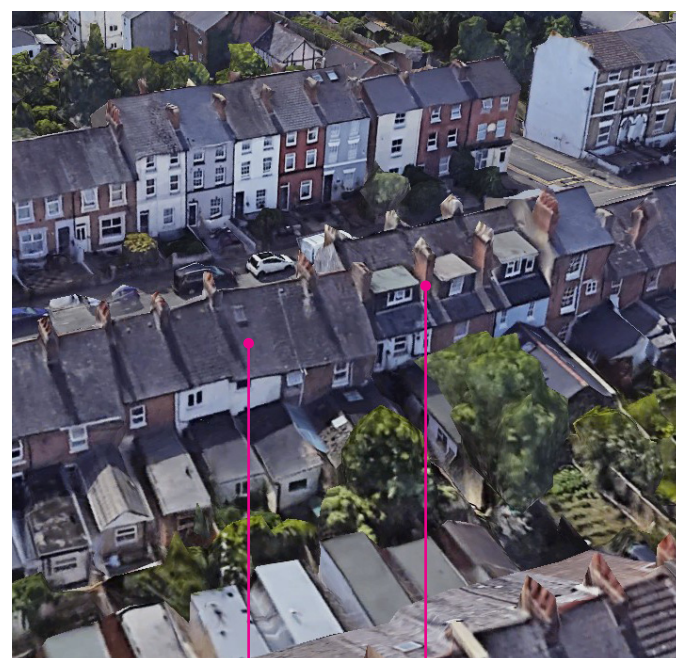
Flat roof  
dormers at  
neighbouring  
properties

There are however examples in and around the conservation area where dormers have been used on rear pitched roofs, away from the sight lines of the streetscape. dormers with gabled tops are more appropriate than flat roofs.

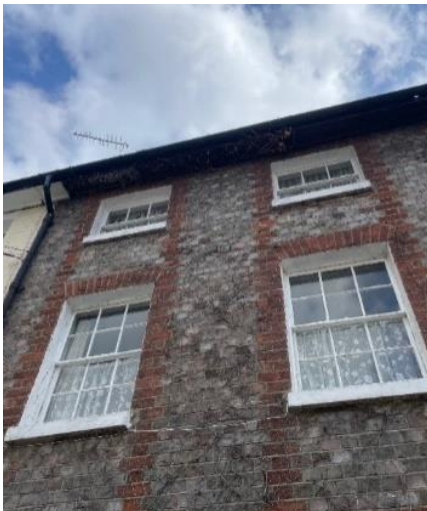
Figure 14: Example of six over six window as proposed

The proposals make a number of improvements to the streetscape and will reinstate some previously removed historic elements to the existing house including correctly proportioned windows to match the context.

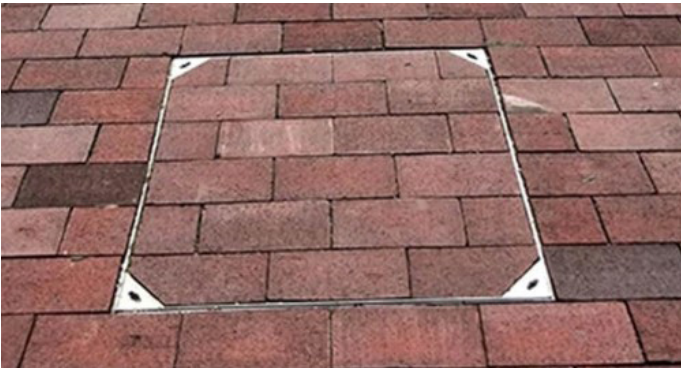
Figure 12: Proposed inspection chamber inset cover with paving to match surrounding (brick)

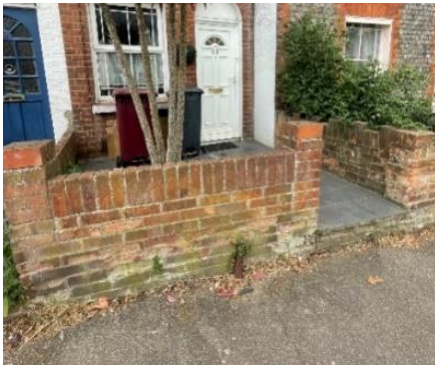
Figure 13: Example proposed brick wall

Replacing the brick wall in front of the property with walling similar to adjacent property will help tie the street together.

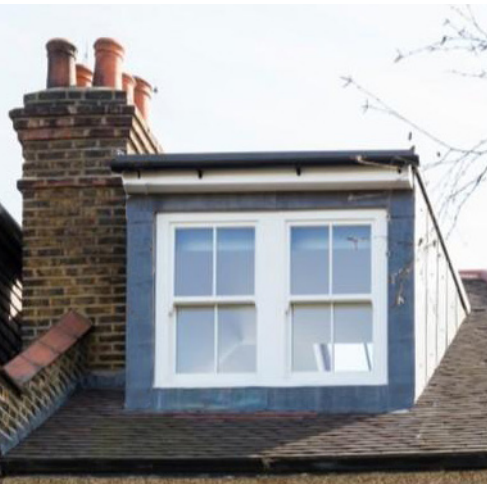
Figure 20: Example of appropriately sized dormer with conservation windows

The proposed dormer will have gabled roof with tiles to match existing roof. The cheek and face walls would also be a similar colour to the roof tiles. White coloured conservation windows would also provide quality.

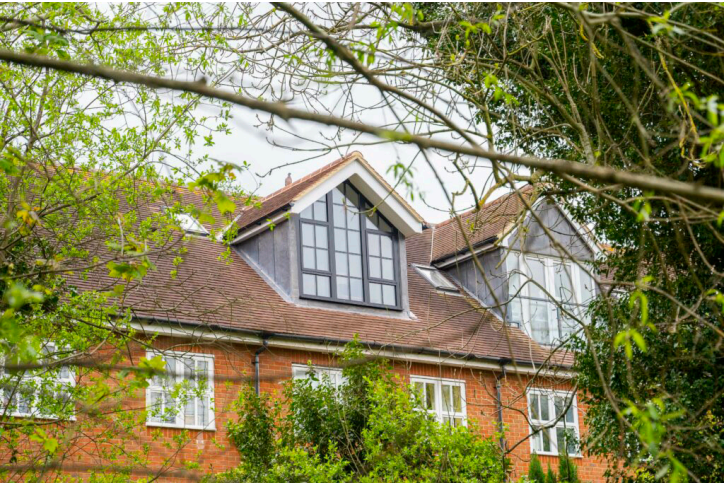
Figure 19: Example of gabled top dormer

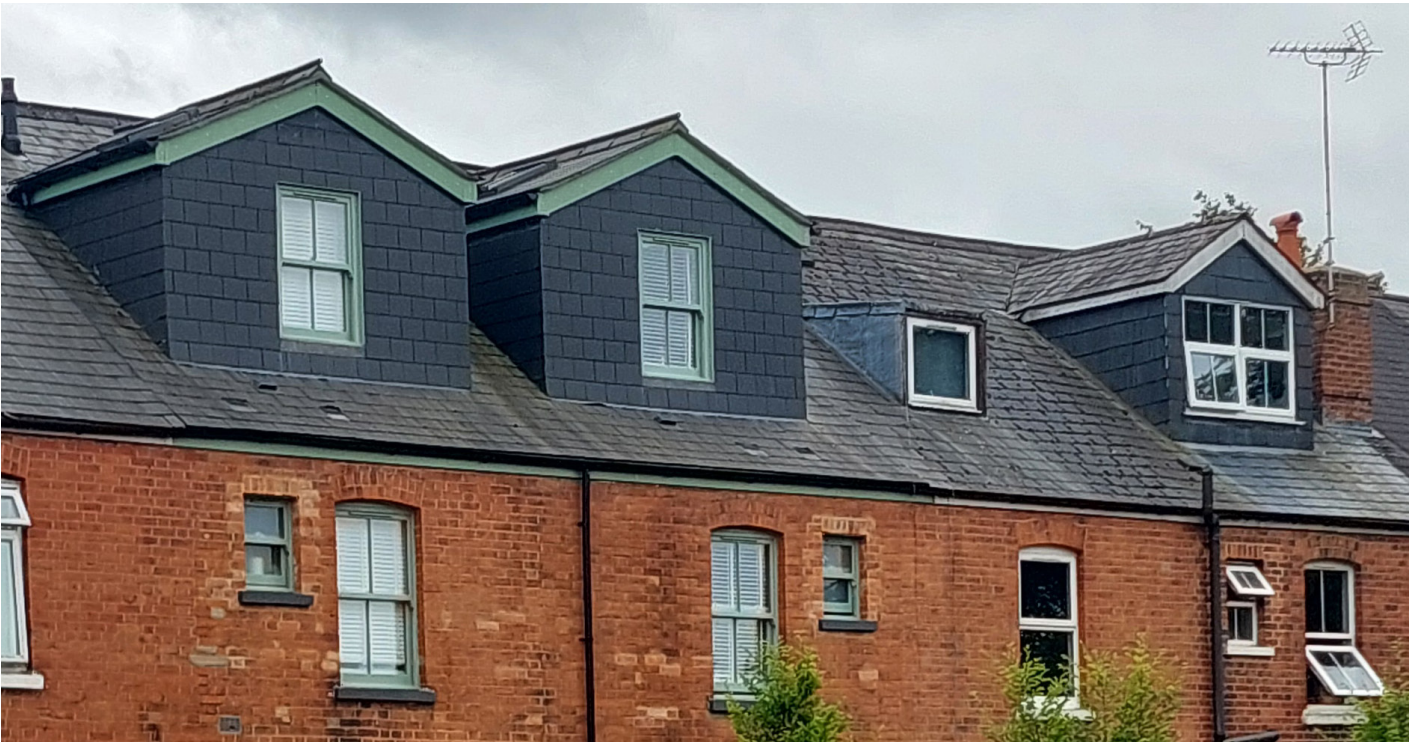
Figure 18: Examples of dormers on rear properties in Reading
