# ARCHITECTONICS

CIAT Chartered Architectural Practice  
& Historic Buildings Consultancy

SUPPORTING IMAGES

August 2025

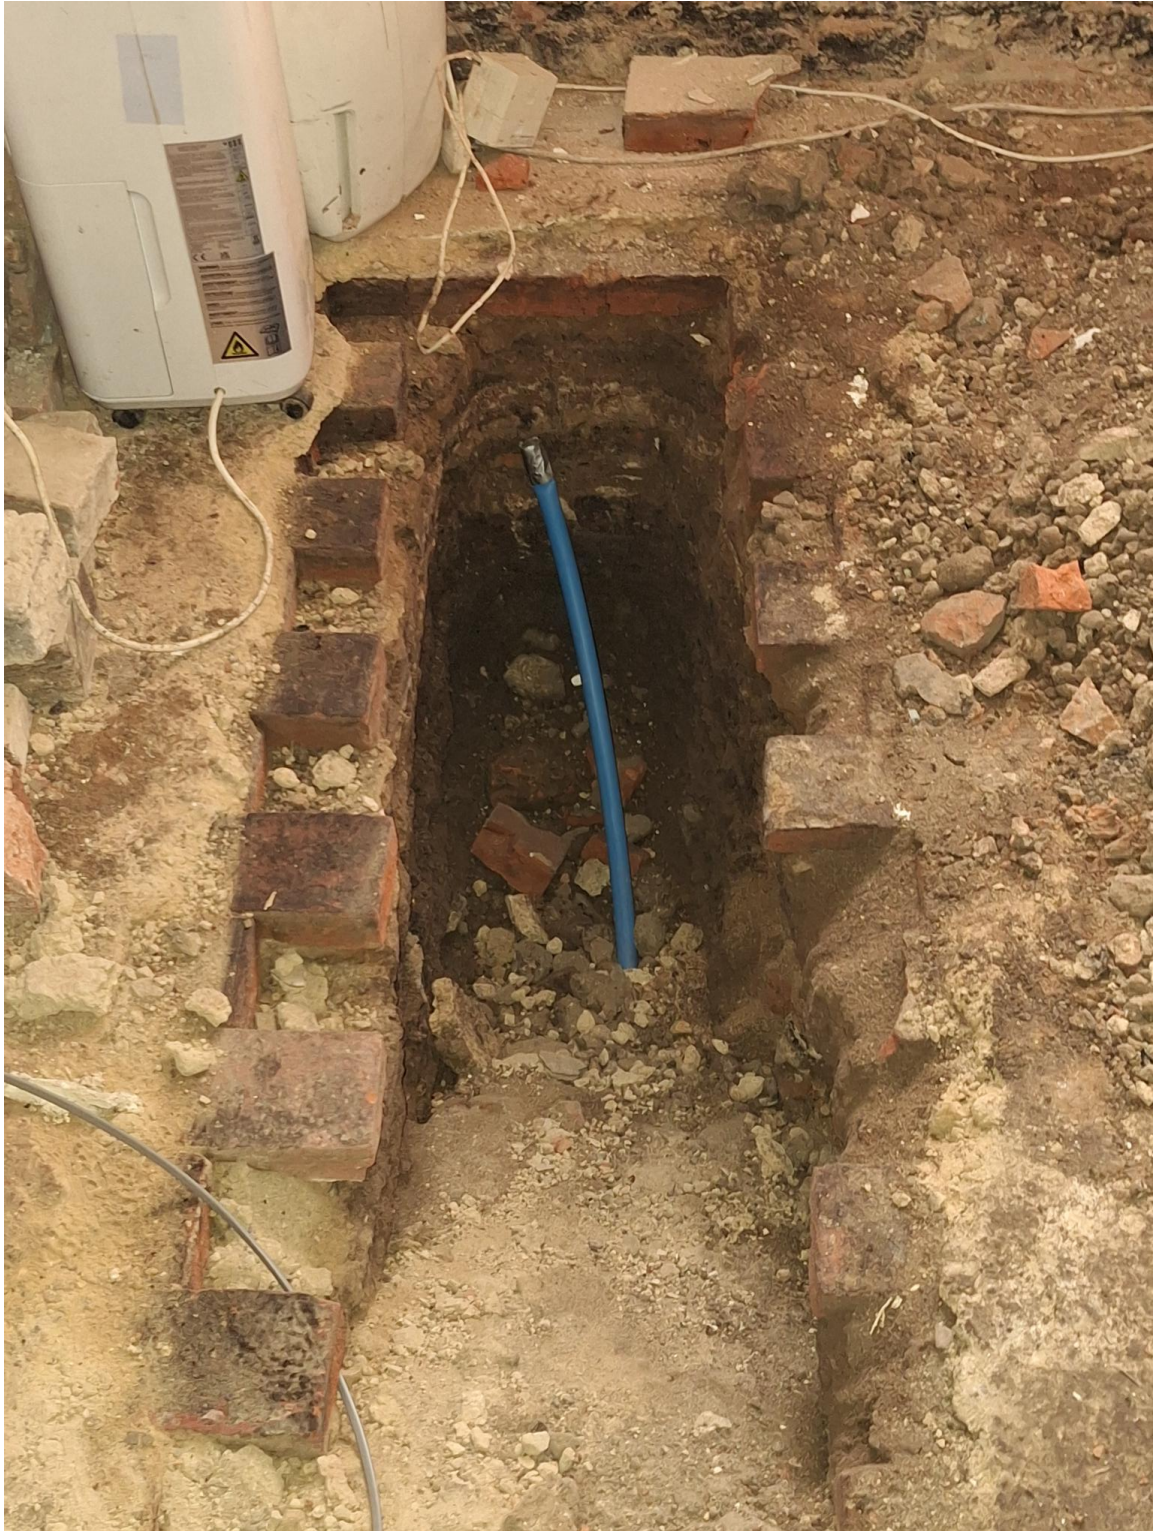
*Figure 1. Image showing the installation of the 25mm diameter MDPE water supply pipe in a 457mm wide trench through the existing Dining Room floor refer to Construction Detail A.*

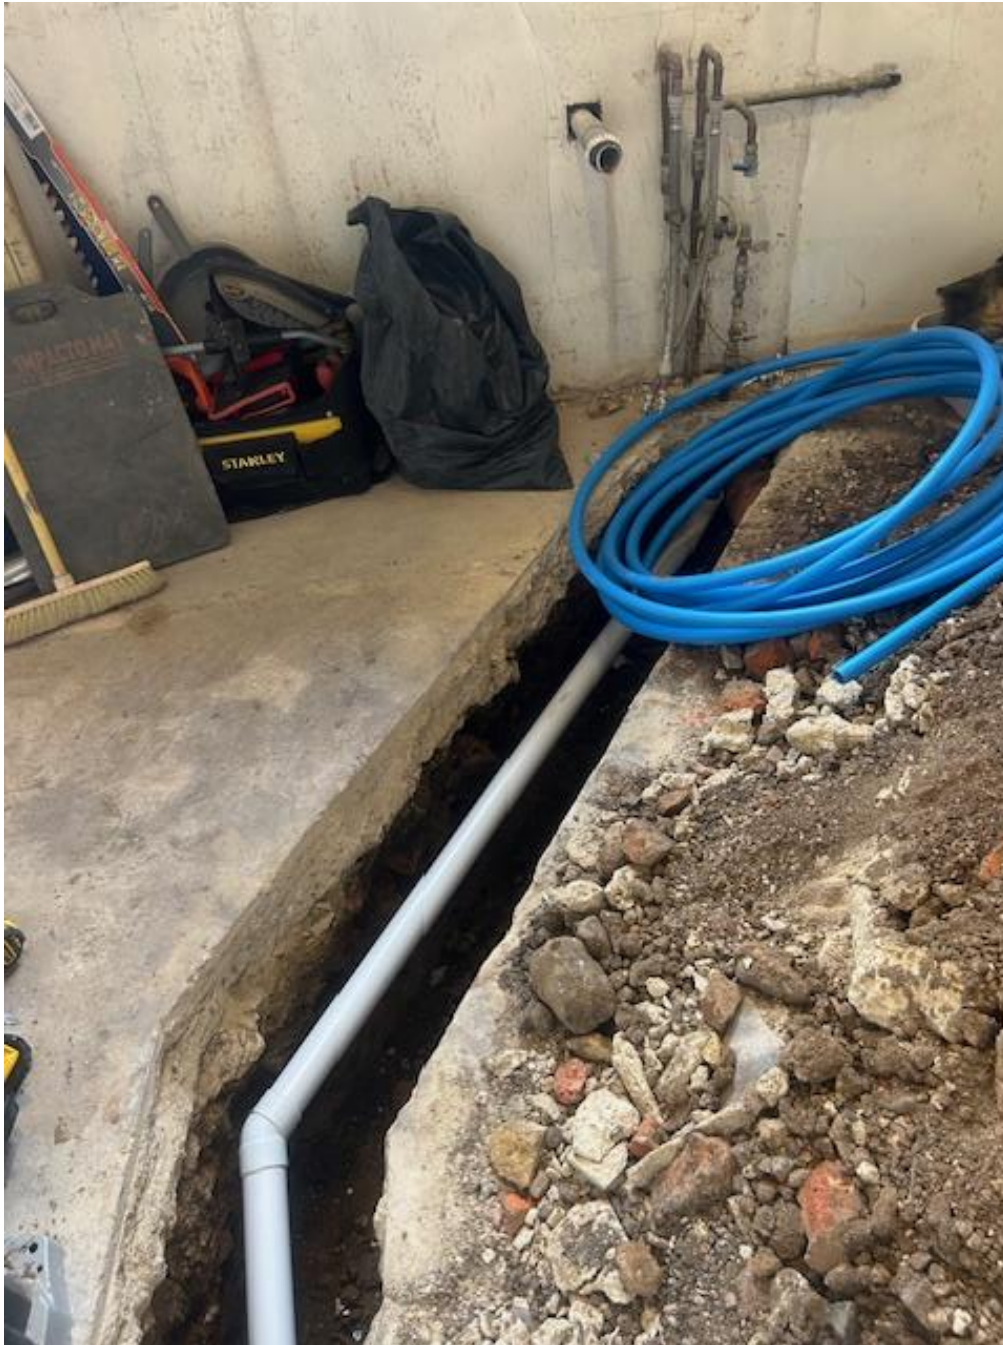
*Figure 2. Image showing the installation of the 25mm diameter MDPE water supply pipe in a 225mm wide trench through the existing Kitchen floor to be connected to the existing stop cock refer to construction Detail B.*

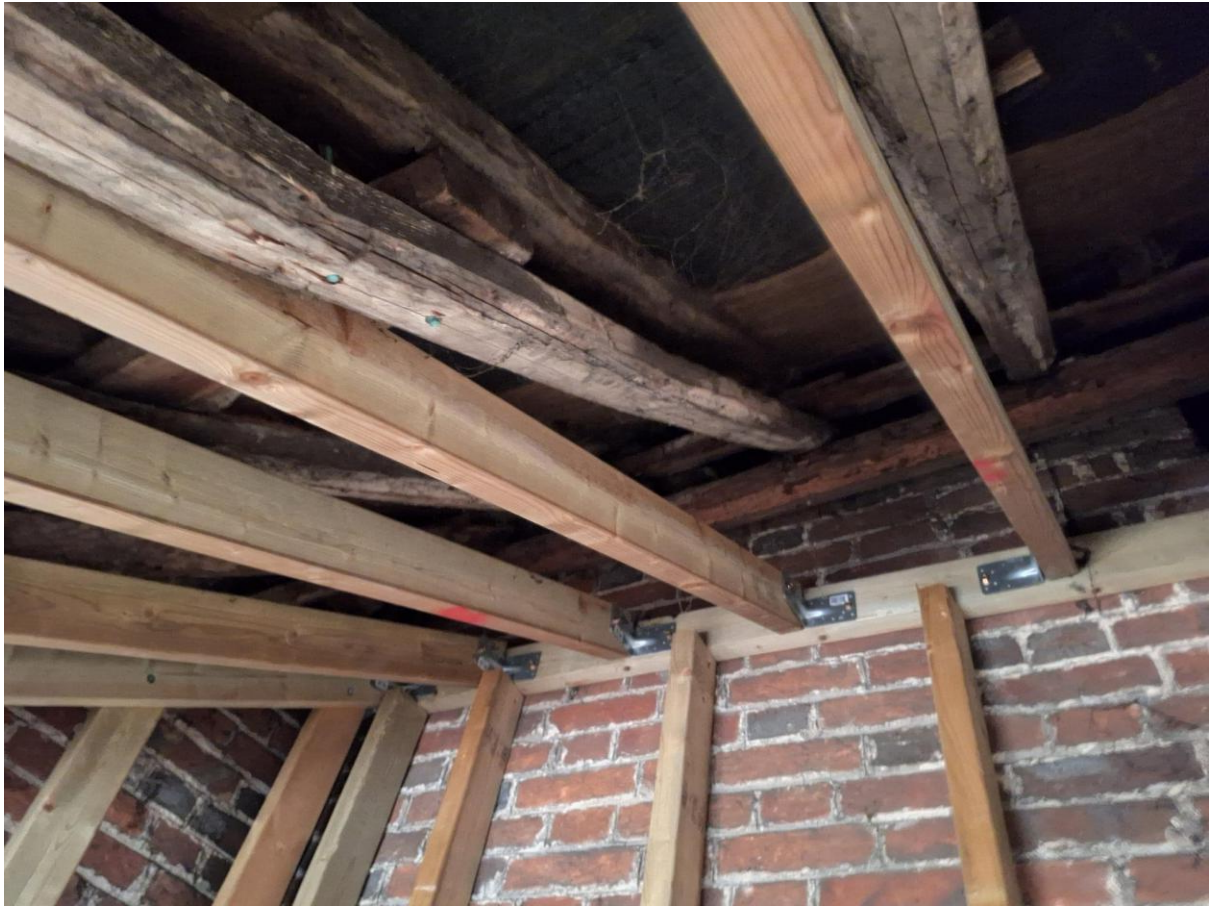
*Figure 3. Image showing the existing C20 plasterboard ceiling & wall finish removed exposing the existing walls and roof rafters. The existing rafters have been inspected and are in good condition, no replacements or repairs are required.*
