## **Historic Building Record**

**71 – 73 Caversham Road,  
Reading, Berkshire.**

December 2024  
Reference: 24915A

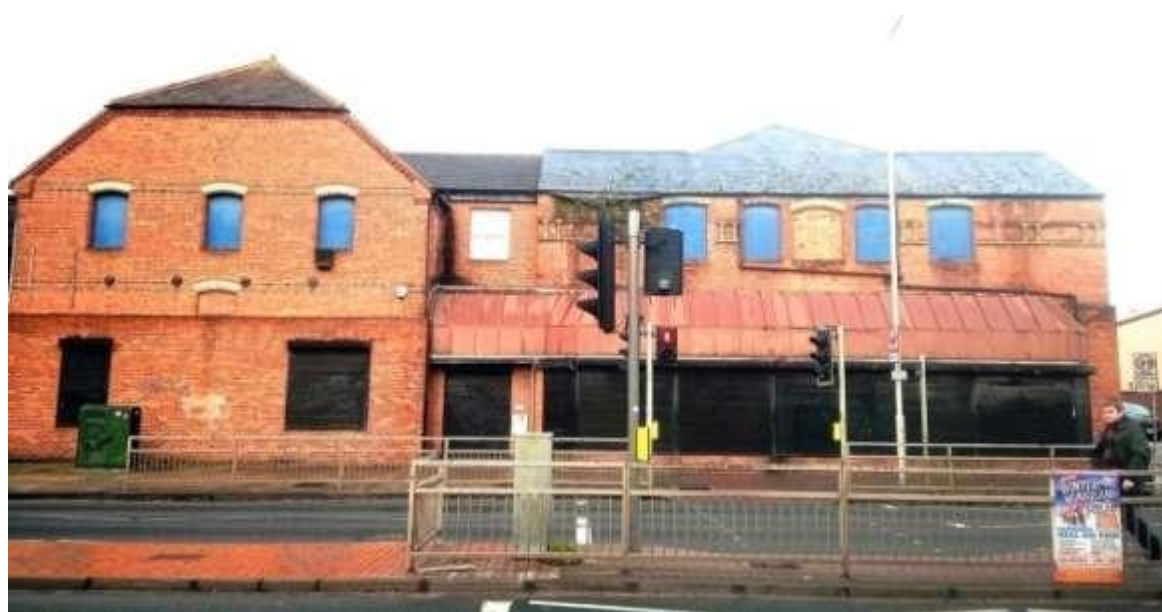
Fig 2.2.1: Caversham Road elevation (71 left)

- 2.2.3 The two main blocks were built as part of a set of malting buildings where these may have contained the germination floors and then the kiln and malt stores may have been at the west end and now demolished. Due to the various internal alterations in the 20<sup>th</sup> C there is scant noticeable evidence of the use of the buildings for malting purposes.

- 2.2.4 Between these the two main blocks an infill block was created in stages from the early - mid 20<sup>th</sup>C. This enabled the two parts to be linked so that this had become a single unit by the fourth quarter of the 20<sup>th</sup> C.

- 2.2.5 The north and south blocks roofs have gables at the west end and then have ridges that run from there to the front. The central infill block has a simple plain wall with a parapet headed top to a flat roof behind at the west end and then a recessed brick facade at the front between the adjacent structures.

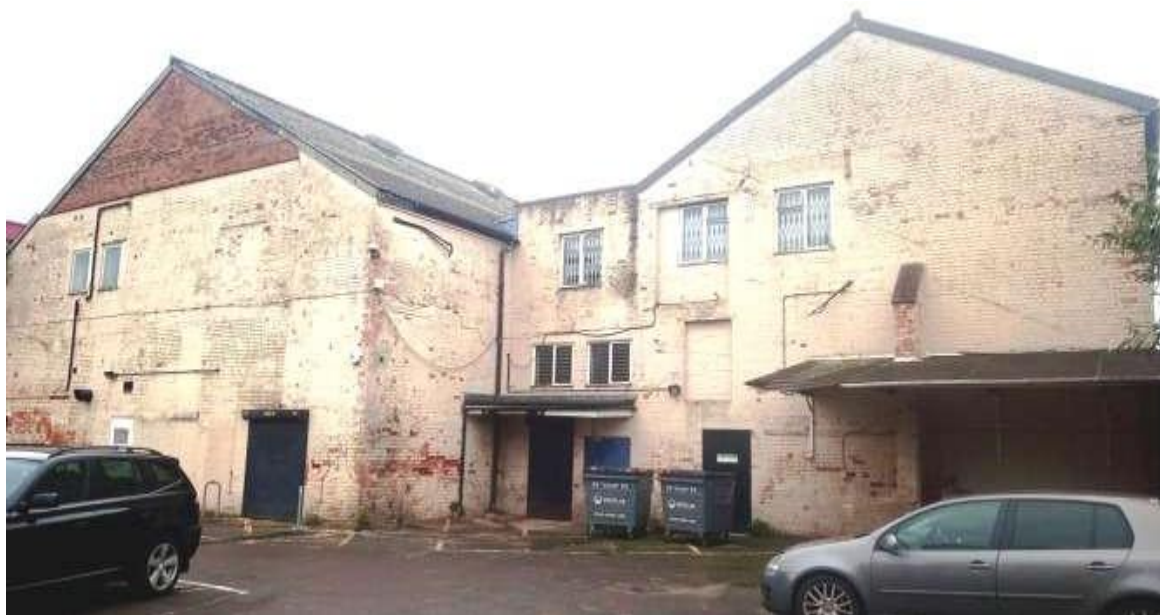
Fig 2.2.4: West end of building from the southwest (71 right)

- 2.2.6 The south roof has a step-up in the slopes and ridge in a position approximately one third of the length of the roof from the back and this corresponds with a change in the internal floor arrangement, possibly related to a change in the building structure. At the front the south roof finishes with a half hip.

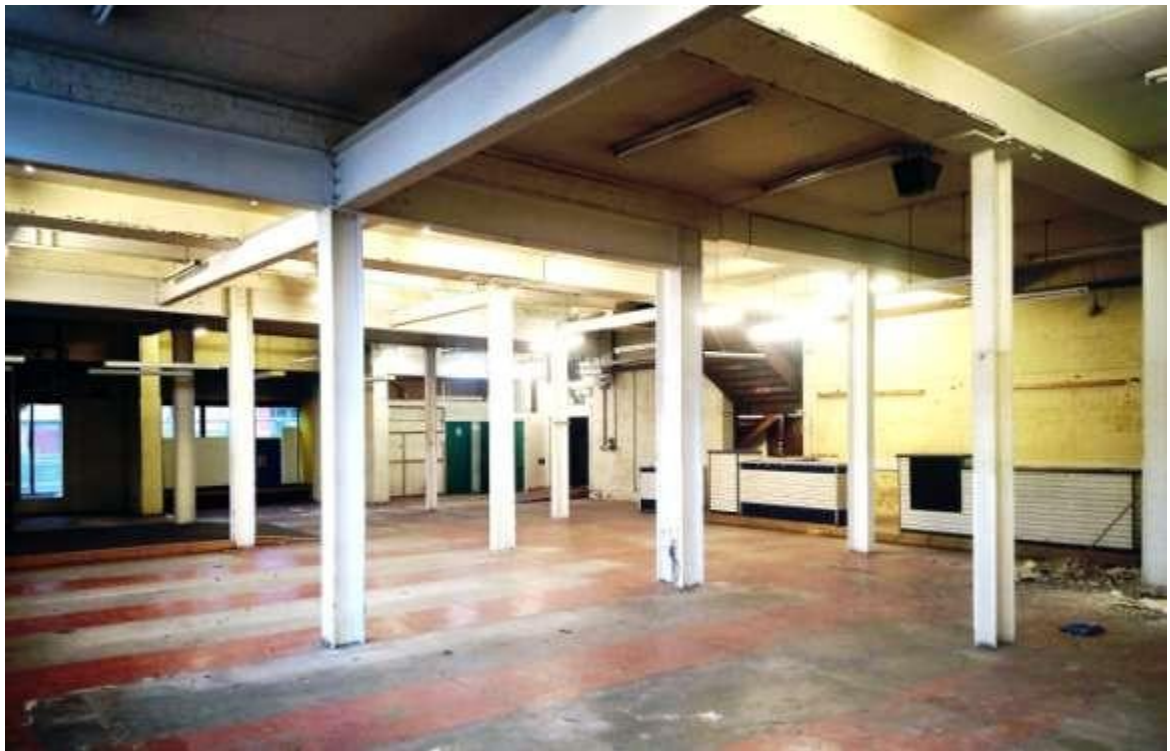
Fig 2.2.12: Ground floor to north block (73) looking to the front

- 2.2.12 Internally the north block contains two stories where the ground floor extends through in to the shop window type extension to the back edge of the pavement to Caversham Road. Against the west gable there are late 20<sup>th</sup> C structures that contain store rooms and a goods lift to the upper floor. The first floor on the north side is similar to the ground floor and largely open from front to back

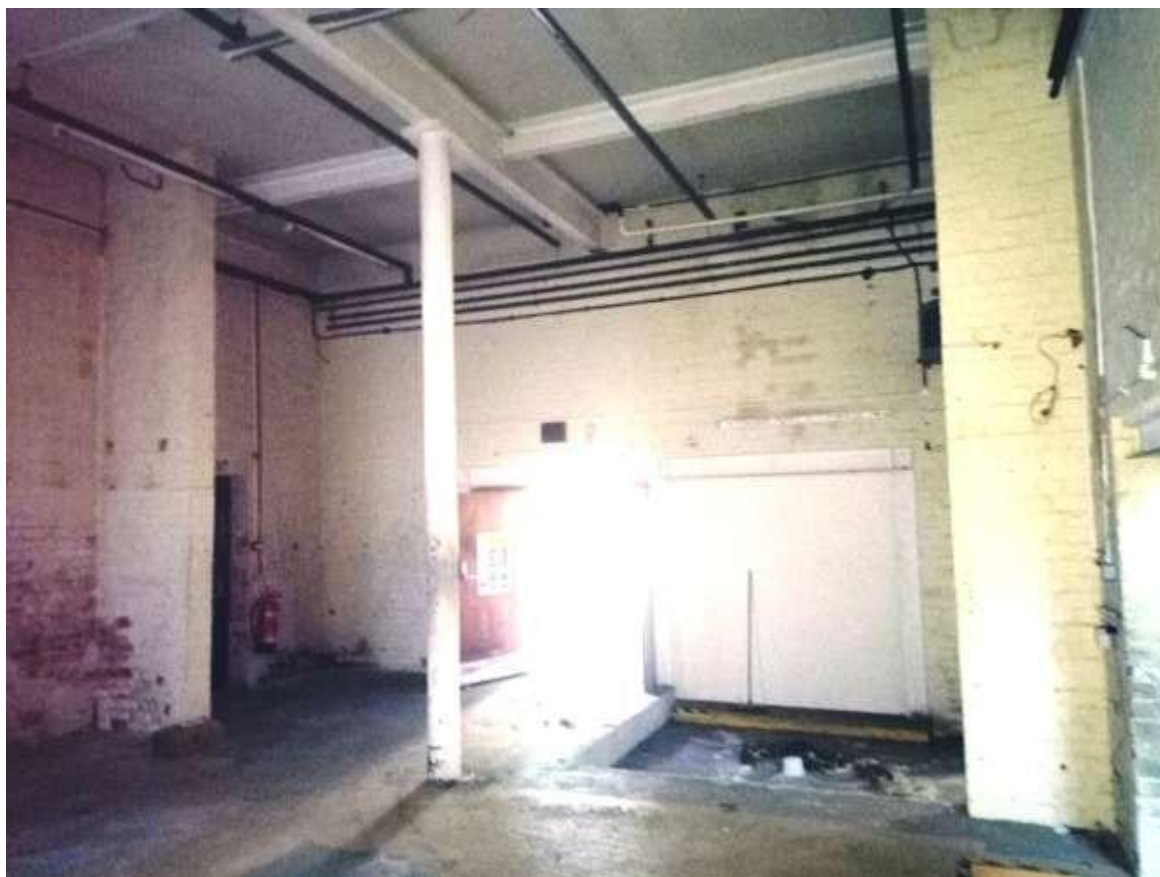
Fig 2.2.13: West end of south block

- 2.2.13 On the south side it can be seen how the floor and wall layout reflects the roof structure over this block, where internally there is a change in floor level as well as an internal dividing wall on the junction between the two parts. This part is also contains two floors, where there are the remains of offices across the front as well as the other offices in the back area of this on the first floor.

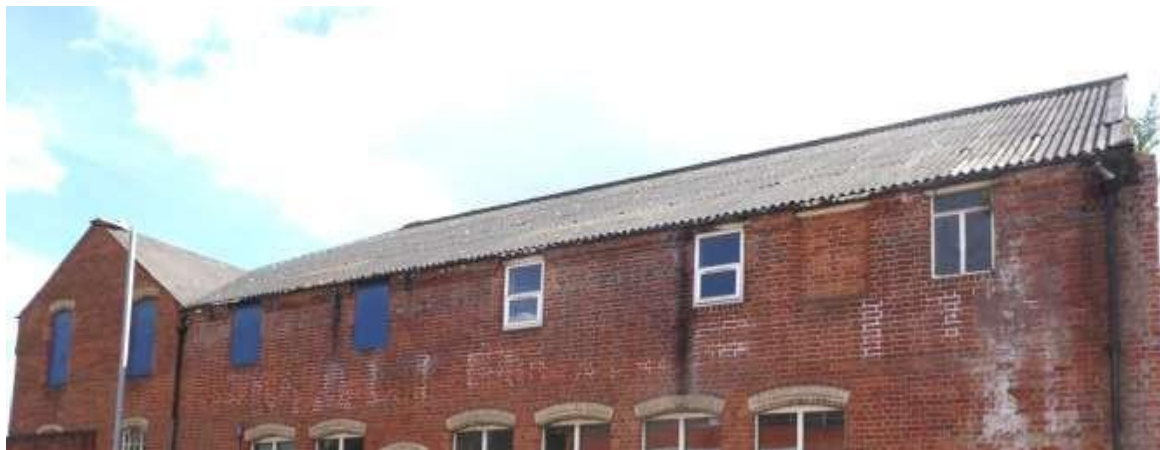
Fig 3.1.1: Roof to north block (73) from west gable

- 3.1.1 The roof of the north block (N° 73) from the west gable to the front cross ridge is a single structure, with a pitch of approximately 40°, which is covered with big six profile corrugated asbestos cement sheeting with some panels of translucent sheeting set in the surface. The top is capped asbestos cement ridge units and the west verge is finished with wrap-over asbestos cement barge boards sitting flush to the head of the west gable wall.

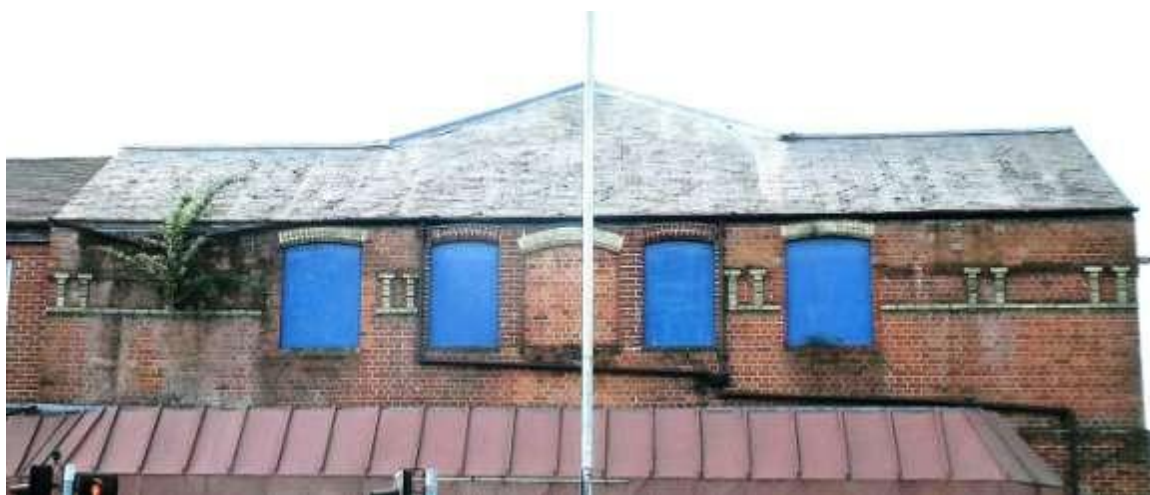
Fig 3.1.2: Front roof of north block (73)

- 3.1.2 At the front (east) end of the north roof, where this runs down and meets the top of the cross roof there is a partial hip down to front roof slope. This part, as well as

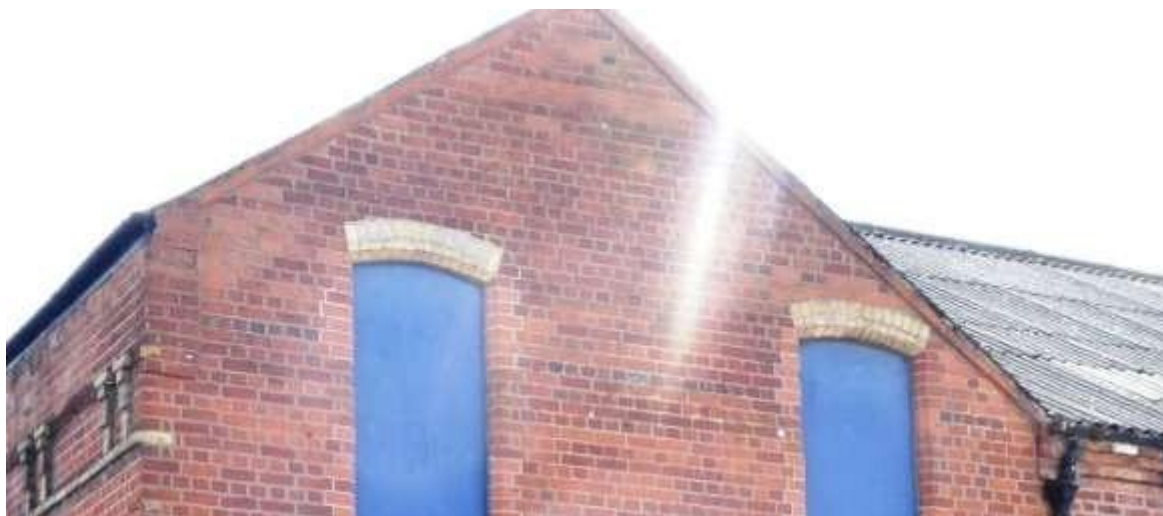
Fig 3.1.3: Eccentric eaves height to the north gable of front wing

- 3.1.3 The front cross range to the north block has an eccentric arrangement with pitch of approximately  $42\frac{1}{2}^\circ$ , where the front eaves is higher than at the back where it is as that for the main rear part.

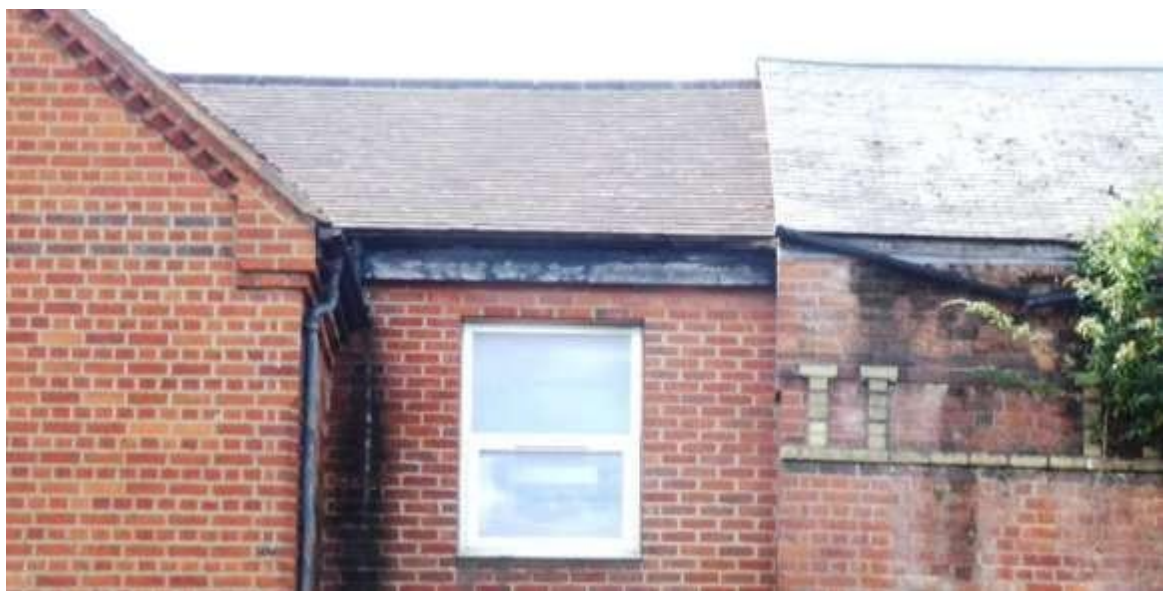
Fig 3.1.4: Front range infill block roof

- 3.1.4 Over the infill south section of the front cross range roof is built below that to the northern block, both to the eaves and ridge. This is covered with brown coloured machine made very regularly shaped and even clay plan tiles of a „Rosemary“ type. This runs up to the top which is capped with concrete ridge tiles of a dark grey colour and are mortared together.

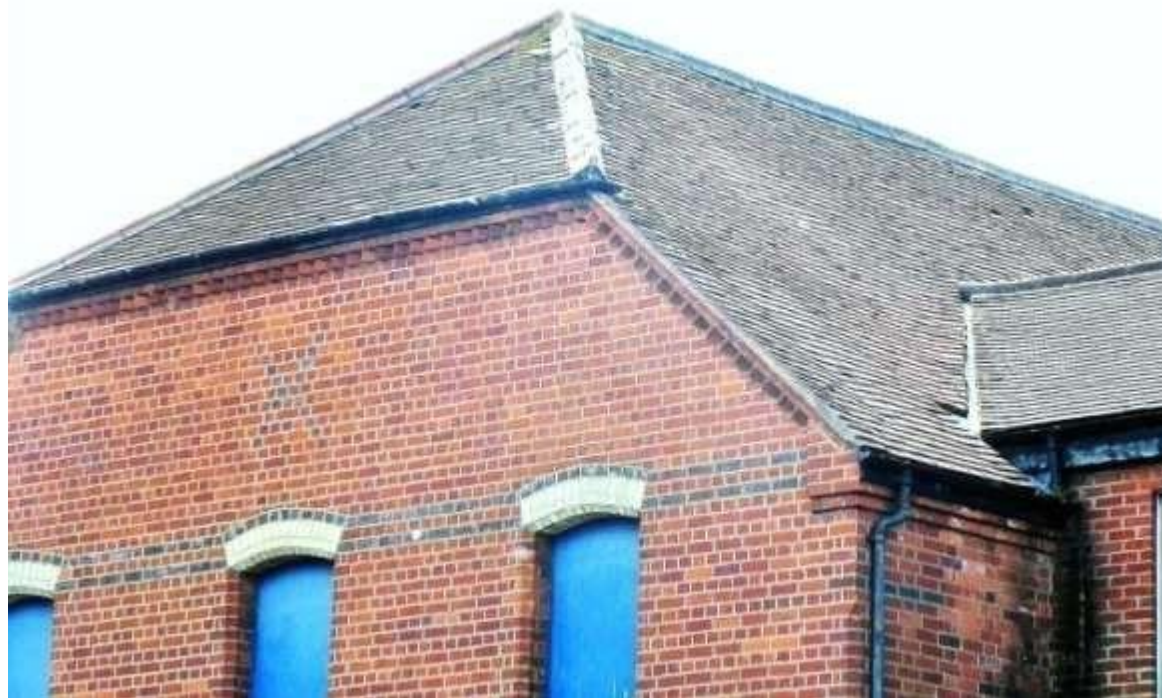
Fig 3.1.6: Front section of south block (71) roof

- 3.1.6 The main east end of part of the south range, including the half hip to the front, has a pitch of approximately 45° and is covered with machine made plain clay tiles of an orange colour of a „Rosemary“ machine made type, with roll top hip and ridge tiles fitted to this. Where this finishes above the rear section of the south block roof the upstand is finished with vertical hung plain tiles.

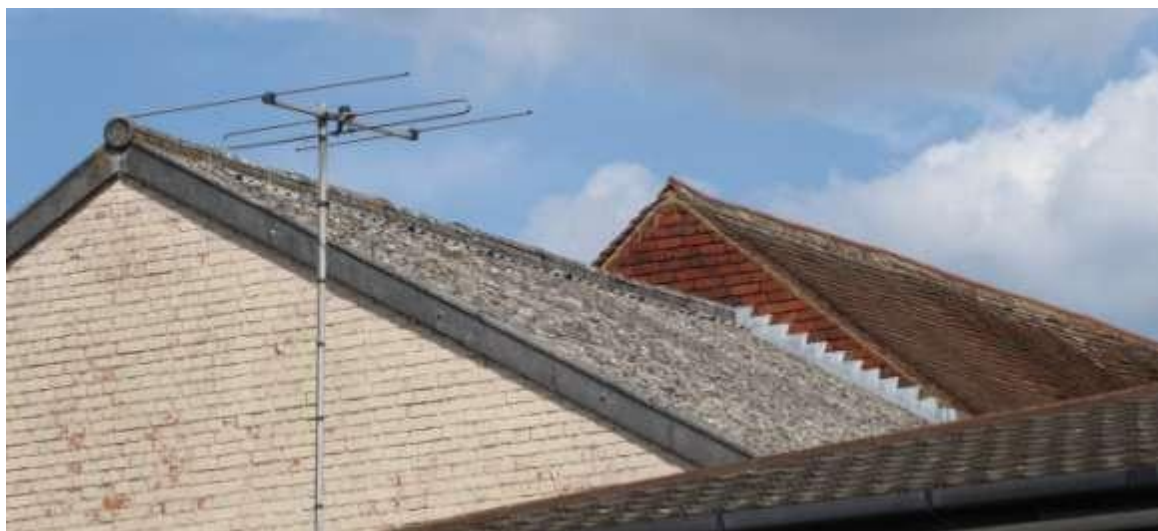
Fig 3.1.7: Rear south block roof

- 3.1.7 The roof to the rear section of the south block is covered with corrugated asbestos sheeting of a profile and fittings as noted for the north block roof and similar comments apply and this is laid to a lower pitch of approximately 35 - 37½°. This has a lower ridge height compared to the east section, but where there is an increase in eaves height on the south side and above the main east part. It has lead stepped flashings to the junction between this roof and the front part.

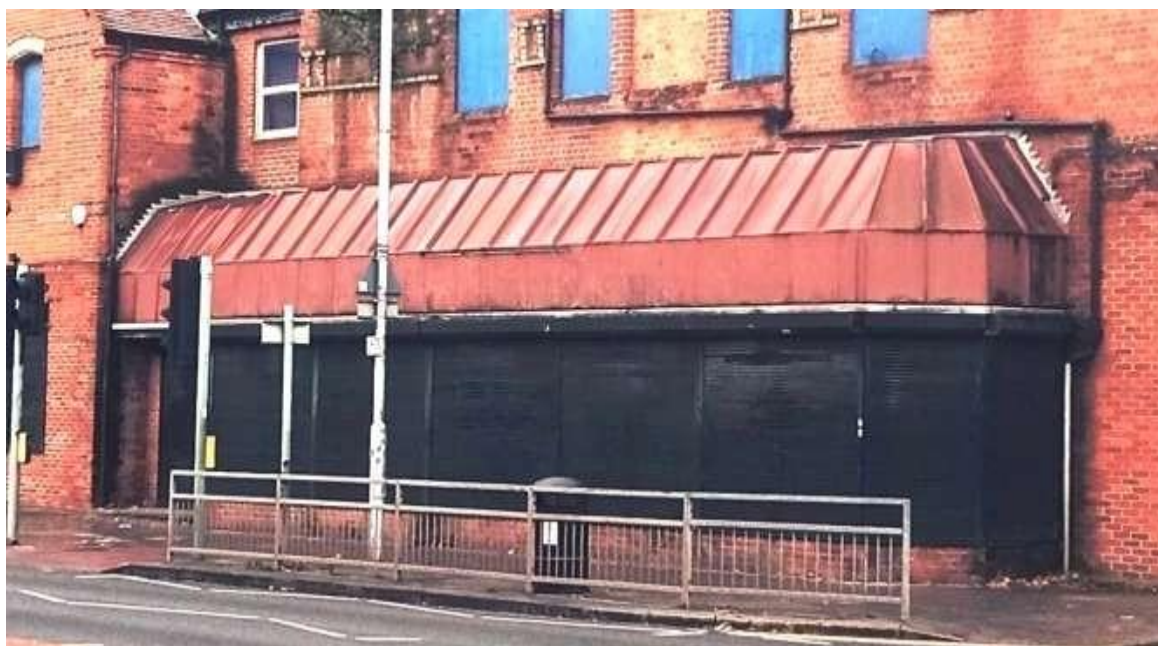
Fig 3.1.8: Shop front canopy

- 3.1.8 Across the front of the north block (73) and abutting the forward projection of the south range is a shop front, with large display windows, which are below a form of canopy roof. This is of standing seam copper coloured zinc sheeting with a shape similar to a mansard roof, with a vertical fascia over the window heads, which then slopes backwards and then becomes a flat top that closes to the front wall face. At the abutment to the walls this has stepped flashing to the sloping side and cover flashing to the back upstand all formed in zinc sheet.

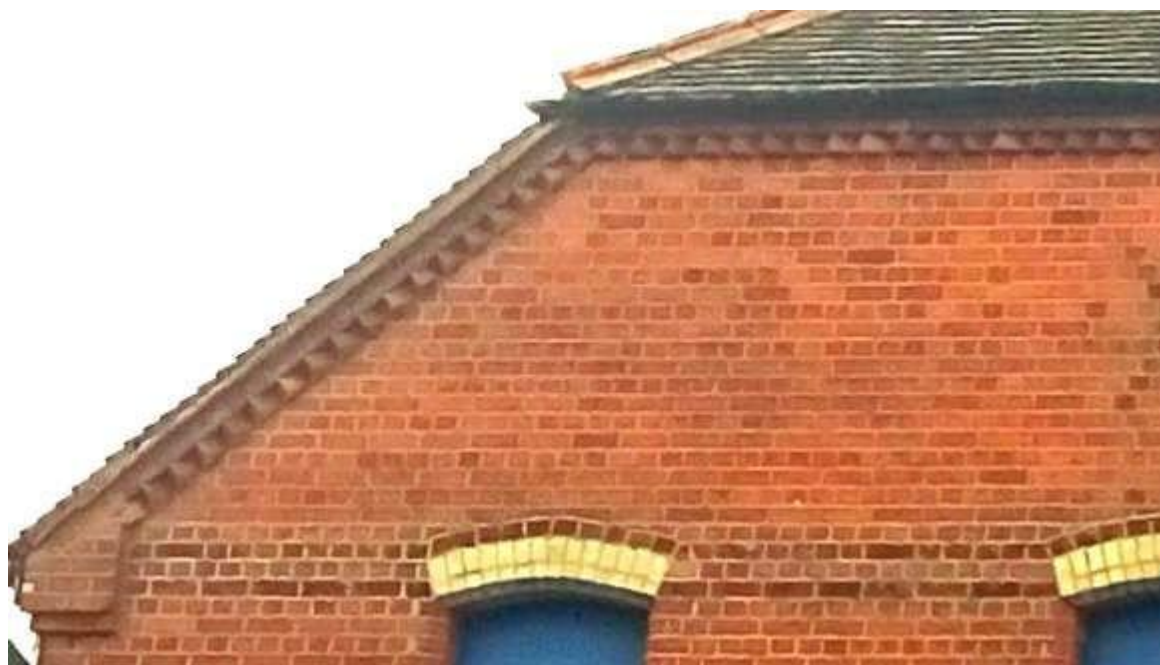
Fig 3.2.1: South block east gable

- 3.2.1 To the front of the south block the head of the wall, below the pointed verge to the tiles, there is a course of bricks laid stretcher over decorative a course of diagonally set bricks to form a hounds tooth dentil course. This rises from a slightly corbelled block on the junction with the eaves to the south side of the roof. Under the half hip to this part of the roof the guttering is supported on brackets below the drip

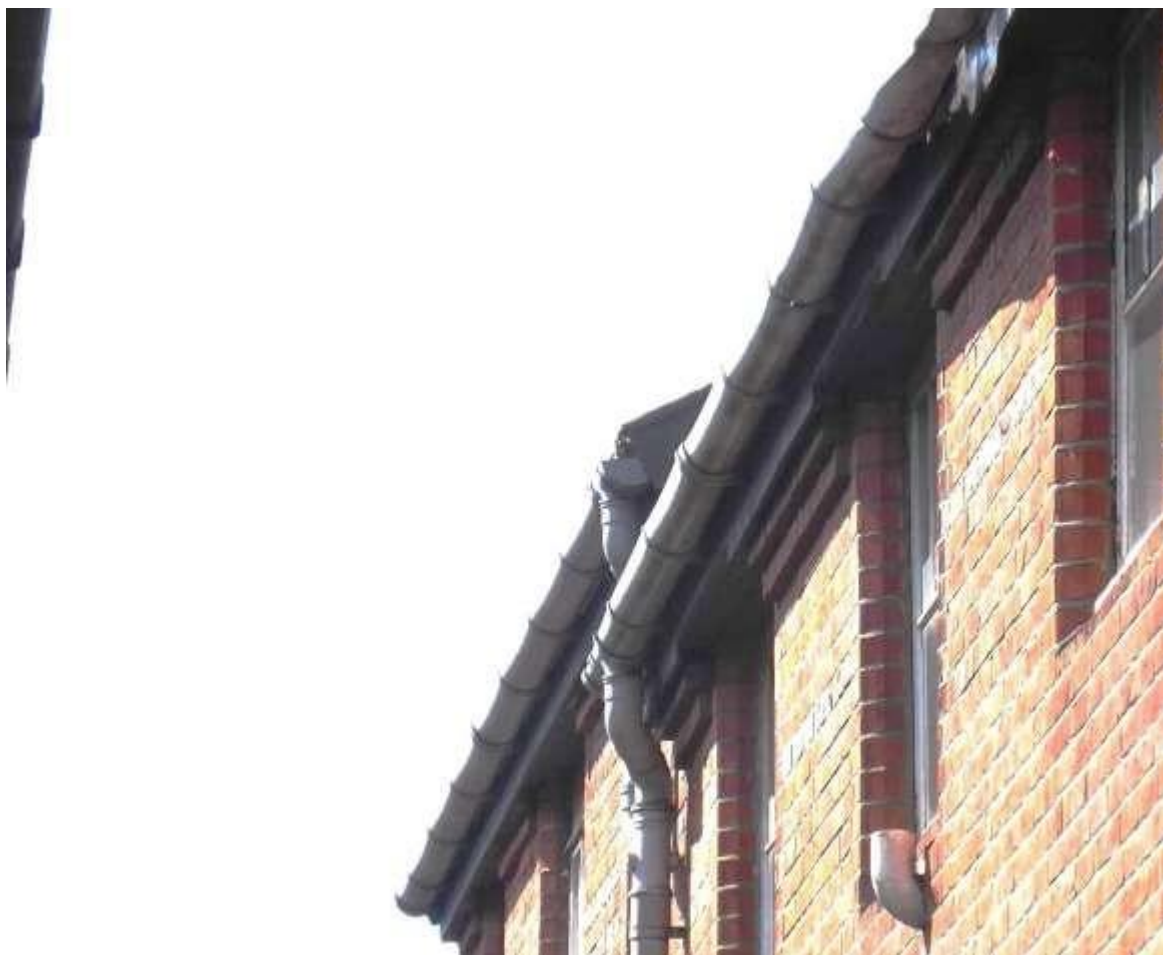
Fig 3.2.2: South wall eaves to south block (71) at east and west part junction

- 3.2.3 At the head of the wall to the west end eaves on the south side of the south block are approximately 600 mm or four courses of brick above that to the east part. The wall head is formed with two courses of rowlock brickwork set flush to the face of the wall. Over that is a single corbelled rowlock course of bricks that support the projecting ends of the rafter feet extending of the head, where there is boarding above and to the underside of the roof coverings. The ends of the rafters support a timber fascia board that in turn supports rainwater goods as at the east end. The head of the west gable is dressed over with .

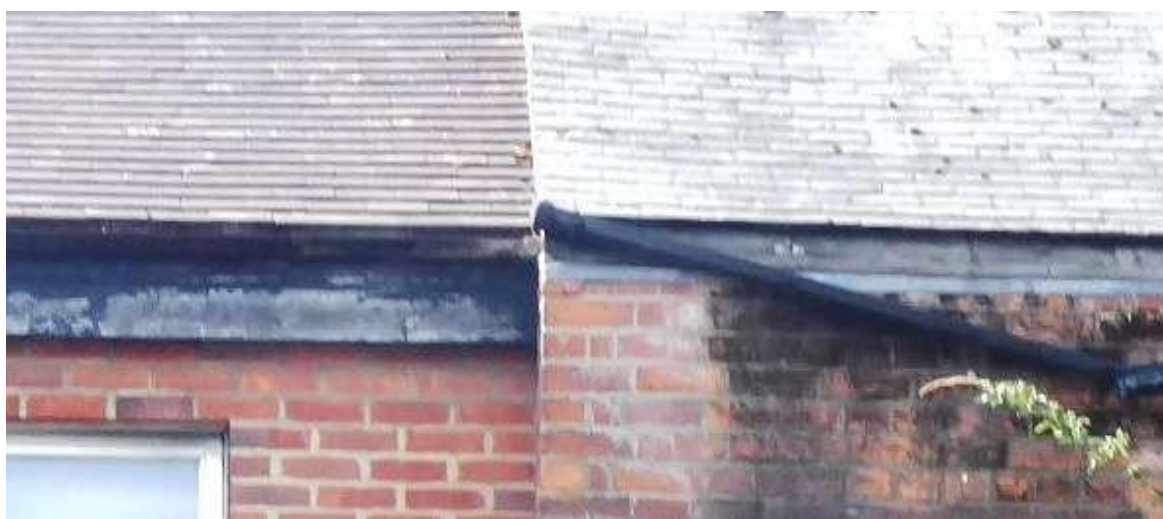
Fig 3.2.4: Eaves to front infill block (left) and main front (right)

- 3.2.4 The front infill block has a simple fascia board fixed to the head of the wall supporting half round section uPVC guttering. The eaves of the adjoining front cross range from the south to the north end have a simple timber fascia board fixed to plain head of the wall and supporting uPVC half round section guttering.
- 3.2.5 The gable at the north end of the front cross block to the front of the north block (N° 73) there is a projecting course of bricks laid stretcher bond up the slope to the top of wall. The verge of the slating finished directly over that, with a slight overhang that has been pointed with mortar to the underside. On the bottom of the rear slope this finishes on top of the top of the north side corbel course and at the bottom of the front slope there is projecting block that wraps round from the top of the front elevation.

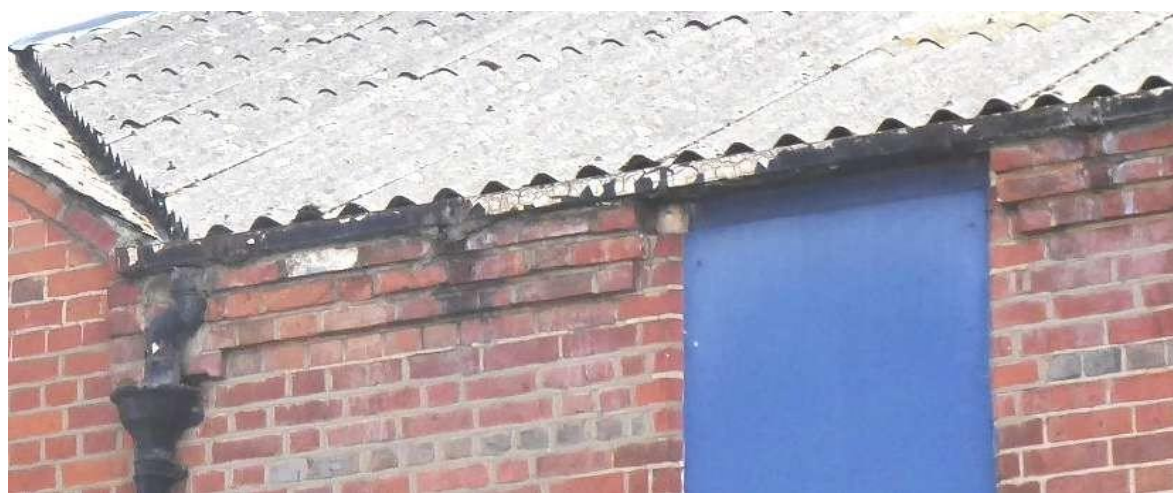
Fig 3.2.6: Eaves to north side of north block (73)

- 3.2.6 Along the north side of the north block (73), there is a three course projecting corbel course to the head of the wall that terminates with sideways corbels on either side of the first floor windows heads. This corbelling supports box section cast iron guttering under the eaves drip and which empties into hopper heads on top of circular section cast iron downpipes, at either end of this part of the block.

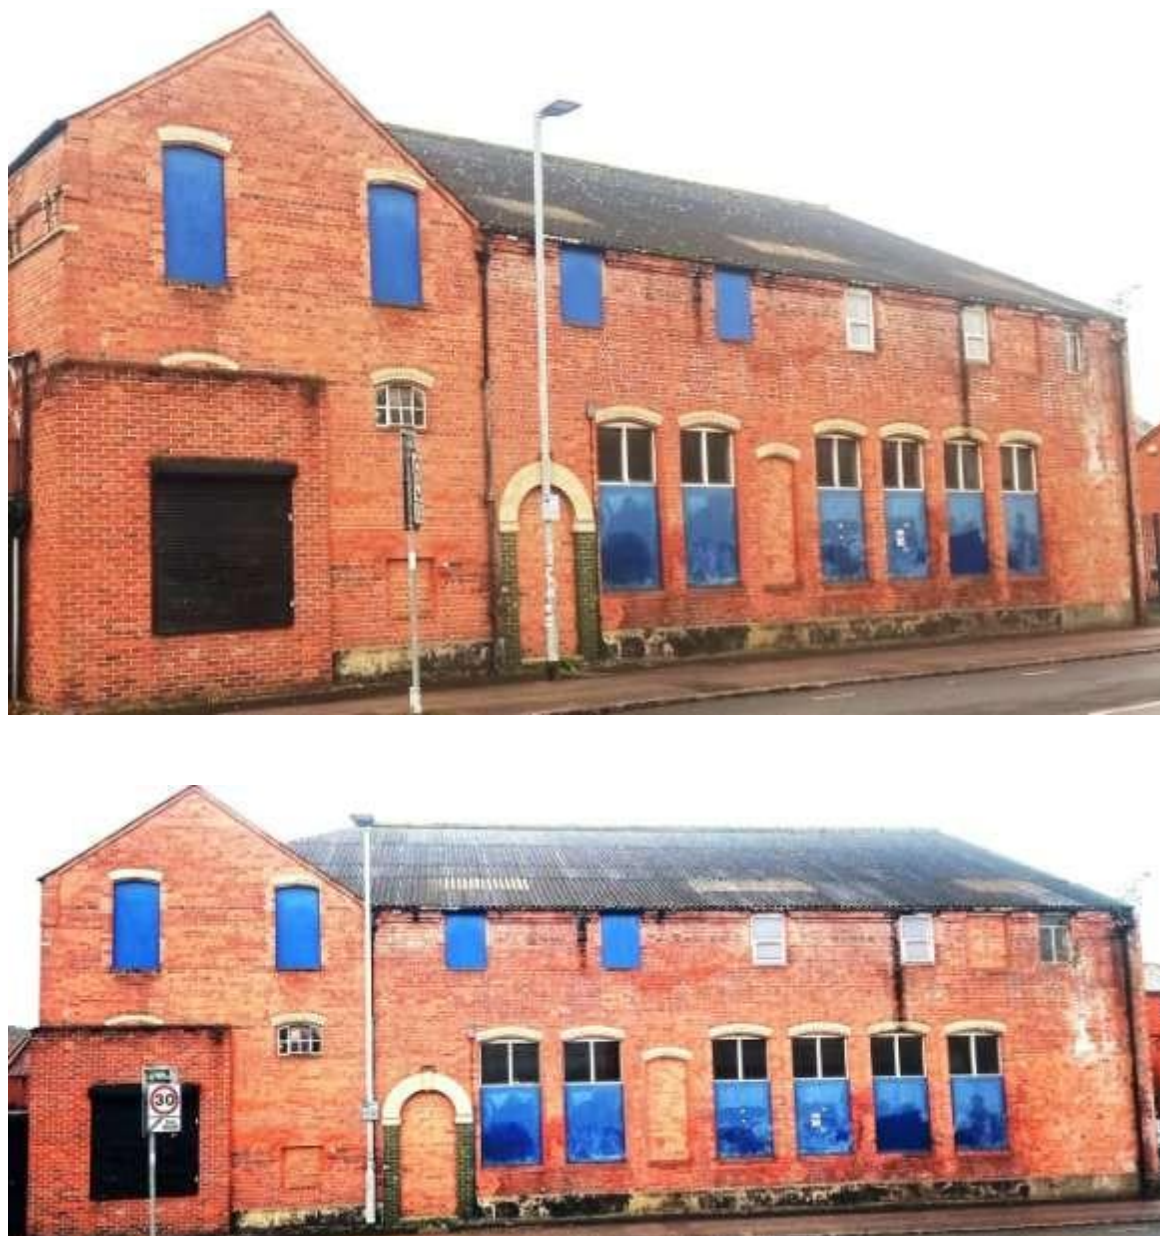
Fig 3.3.1: North elevation

- 3.3.1 The north wall of the block (N° 73) is built in a reddy orange brick and is about one and half bricks thick, which is laid in English bond up to about the head of the ground floor window arches and above which it changes to Flemish garden wall bond. Then four courses below the bottom of the wall head eaves corbel eave is a header course of dark red brown bricks extending from the west gable to the bottom of the rear roof slope to the front cross wing roof. This is all pointed with a slightly struck joint of orangey buff coloured mortar. Along the bottom of the wall to the pavement there is a painted rendered plinth band.

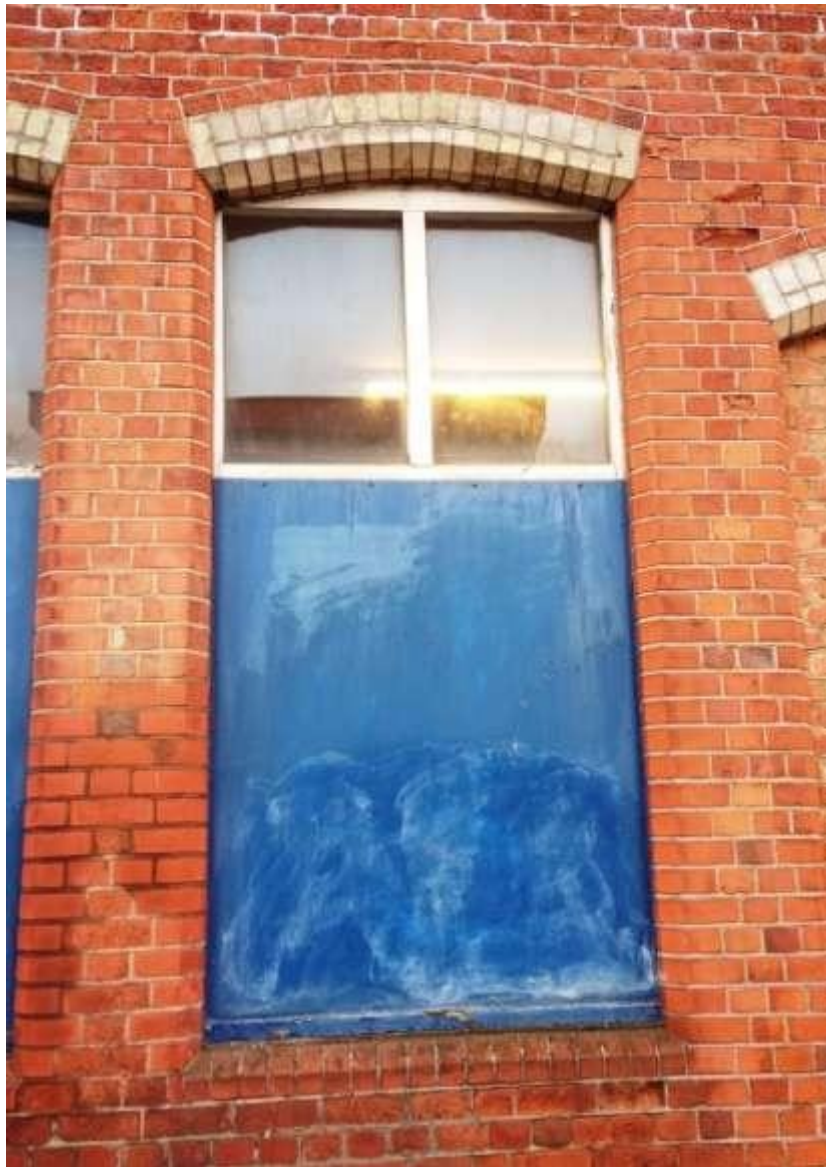
Fig 3.3.2: Ground floor window

- 3.3.2 The ground floor windows along the main north wall are effectively one and a half storey high set within openings that have splay headed bricks forming angle outer reveals, with a similar profile brick on edge to form the cills. Over these openings are brick cambered arches formed with a double course of pale buff coloured splay header bricks on edge topped with a course of plain header bricks. The first floor window openings have similar squint cills and reveals, but with no decorative heads as these are directly below the eaves.
- 3.3.3 Between the second from the east ground floor window and the centre east window there is what is what would seem to be a bricked-up narrow door opening that is formed in a similar manner to the window openings. This has a cill just below that of the adjacent windows, but has a lower head.

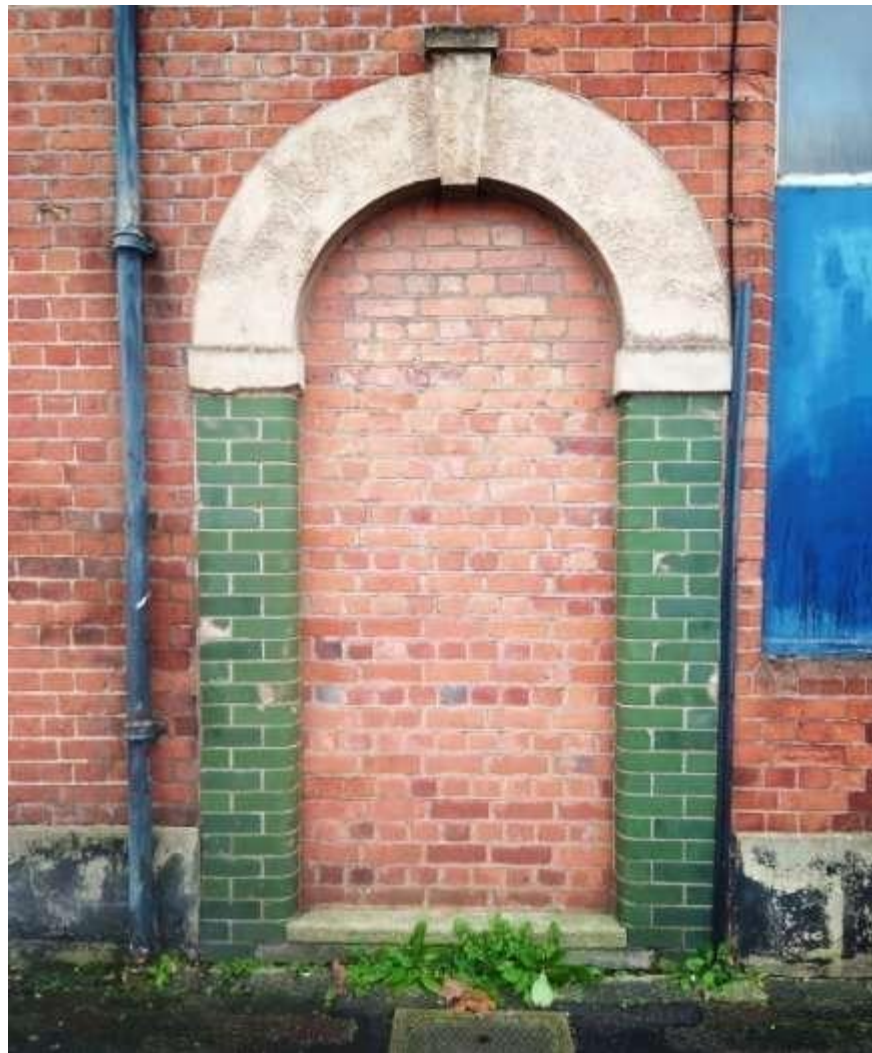
Fig 3.3.4: Closed-up door opening

- 3.3.4 Adjacent to, and just on the west side of the junction between the main north wall and the north gable to the front cross range of building there is a blocked up doorway at ground floor level. This has a semicircular stone arch with central keystone, which rests on green glazed bullnose profile brick jambs on either side. Most of the gloss from the face of the bricks has been lost through erosion or possibly abrasive cleaning.

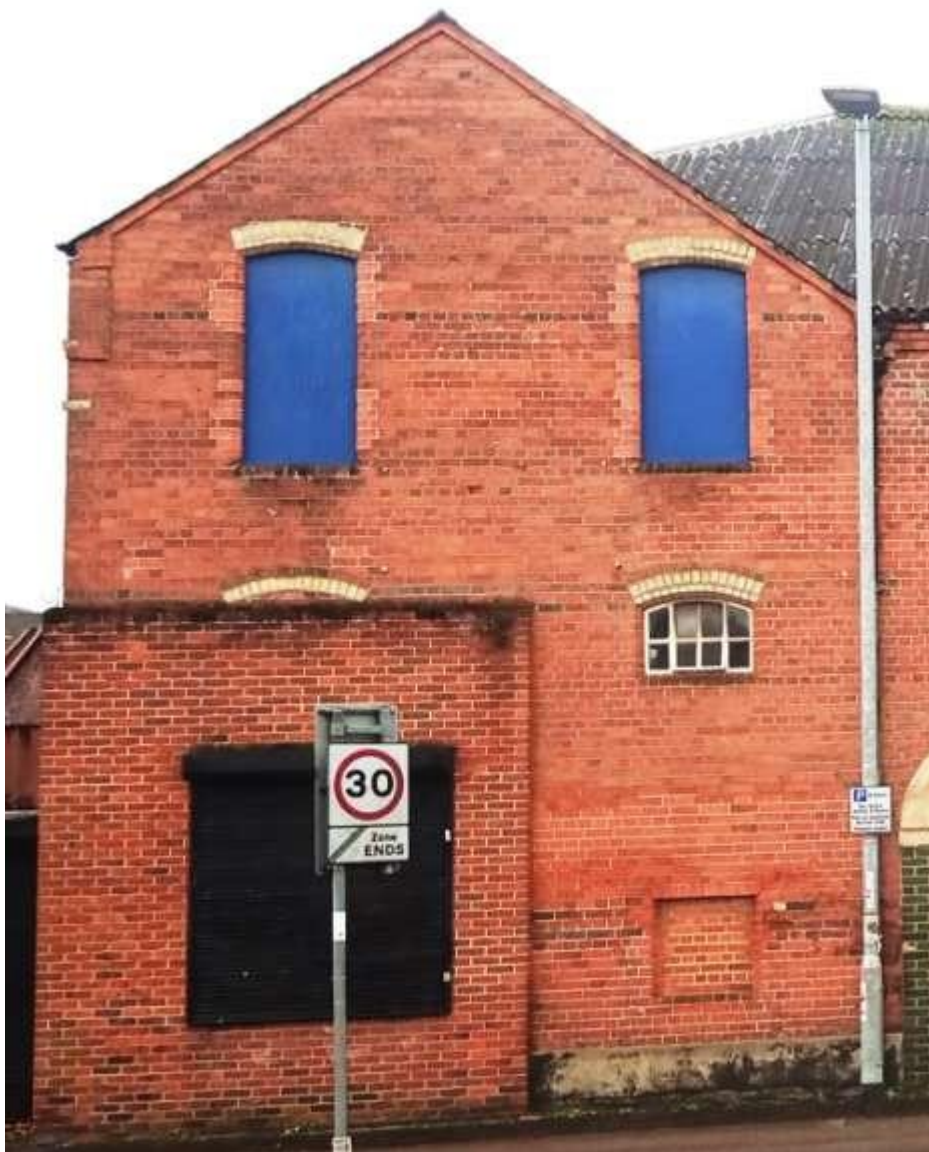
Fig 3.3.5: North gable to end of front cross wing

- 3.3.5 There is no obvious construction joint between the long north end wall to the rear part of N° 73 and the north gable to the front block to this part of the building. This

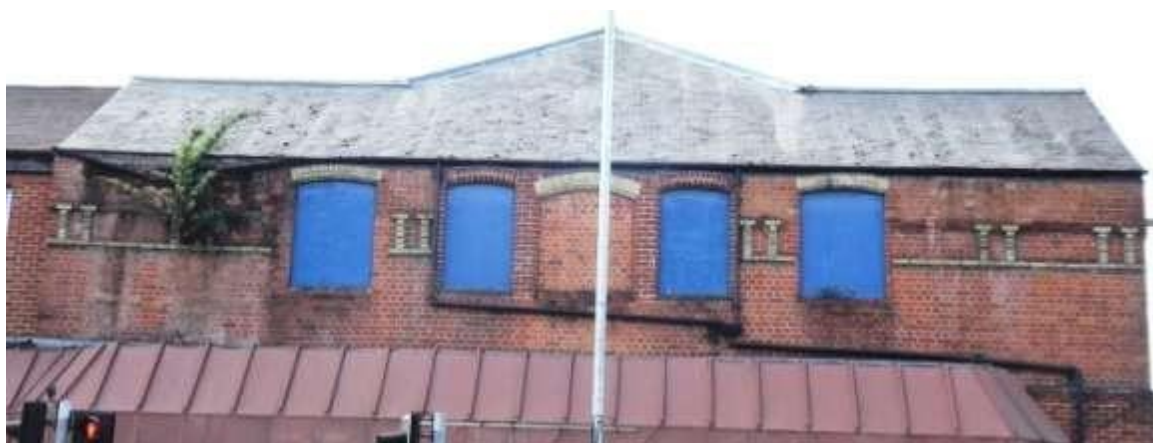
Fig 3.3.12: Upper section of Caversham Road front to N° 73

- 3.3.12 At first floor level to the Caversham Road face of the front cross range to N° 73, there are five windows that have been either boarded or bricked-up. Of these the outside and centre have openings, with dressings, similar to those seen in the north wall of the building, but where the two on each side of the centre are plainer and are modern inserts as indicated by the change in brickwork around them.

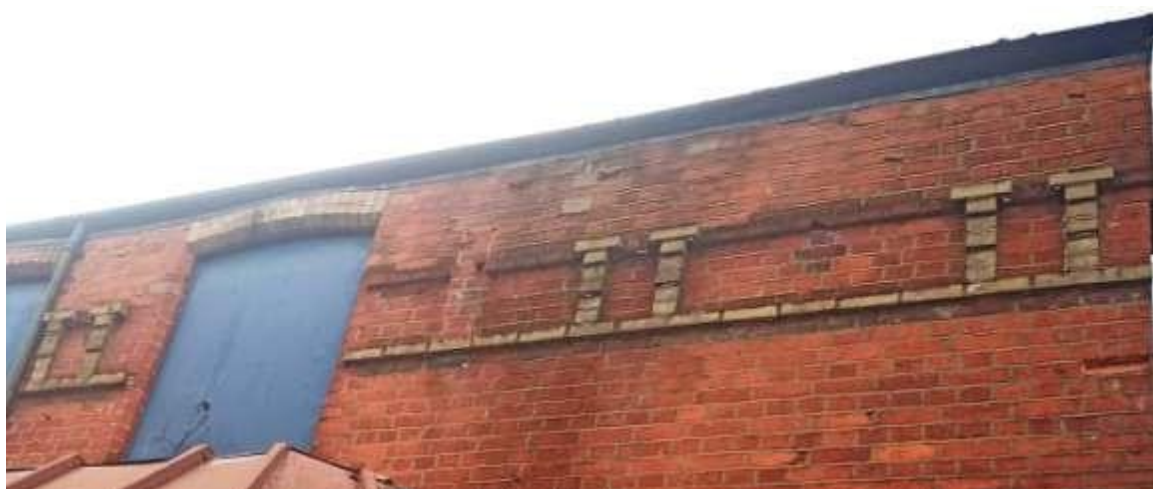
Fig 3.3.13: Decorative brickwork to front of N° 73

- 3.3.13 Across the front range elevation to Caversham Road, in an almost central position to the height of the first floor windows there is projecting decorative banding of

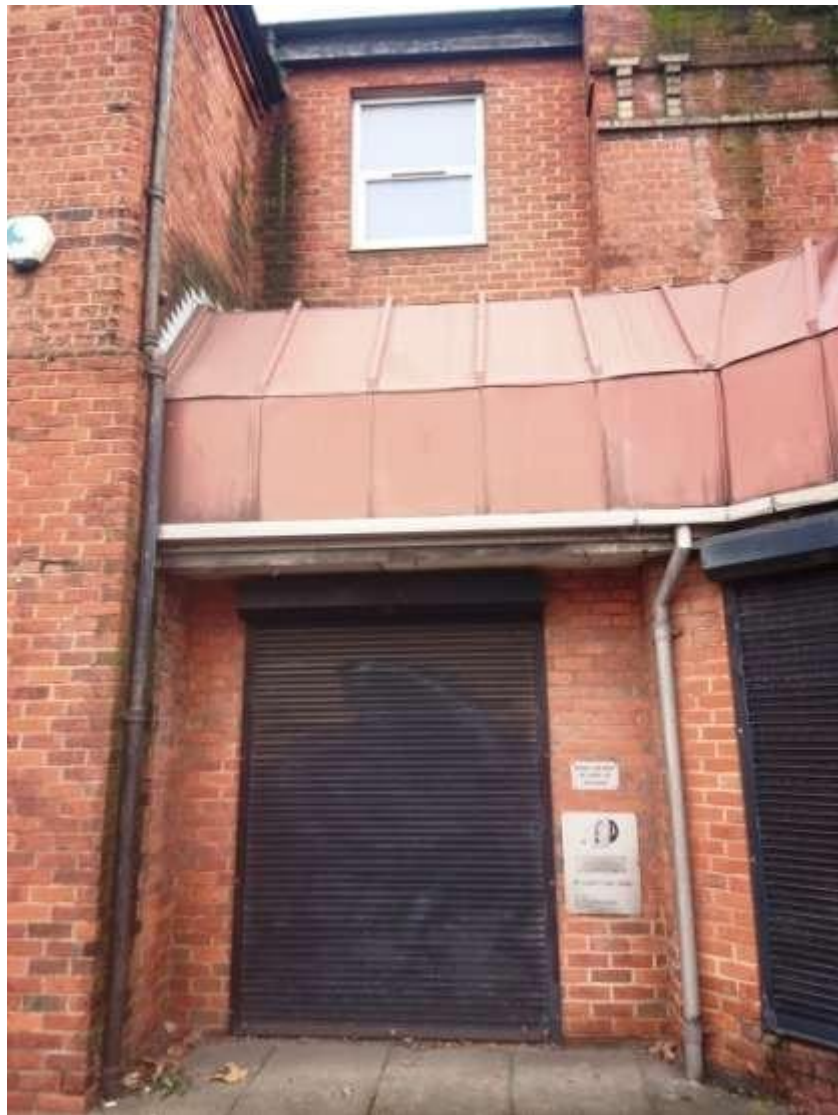
Fig 3.3.14: Front of infill block

- 3.3.14 The first floor south infill section to the south end of the front cross range is built in brickwork that matches that used for the modern shop front to the Caversham Road face of the building both in size and texture. This is laid in stretcher bond in a comparatively crude manner to the rest of the building and in this the window opening has no decorative work to the surround.

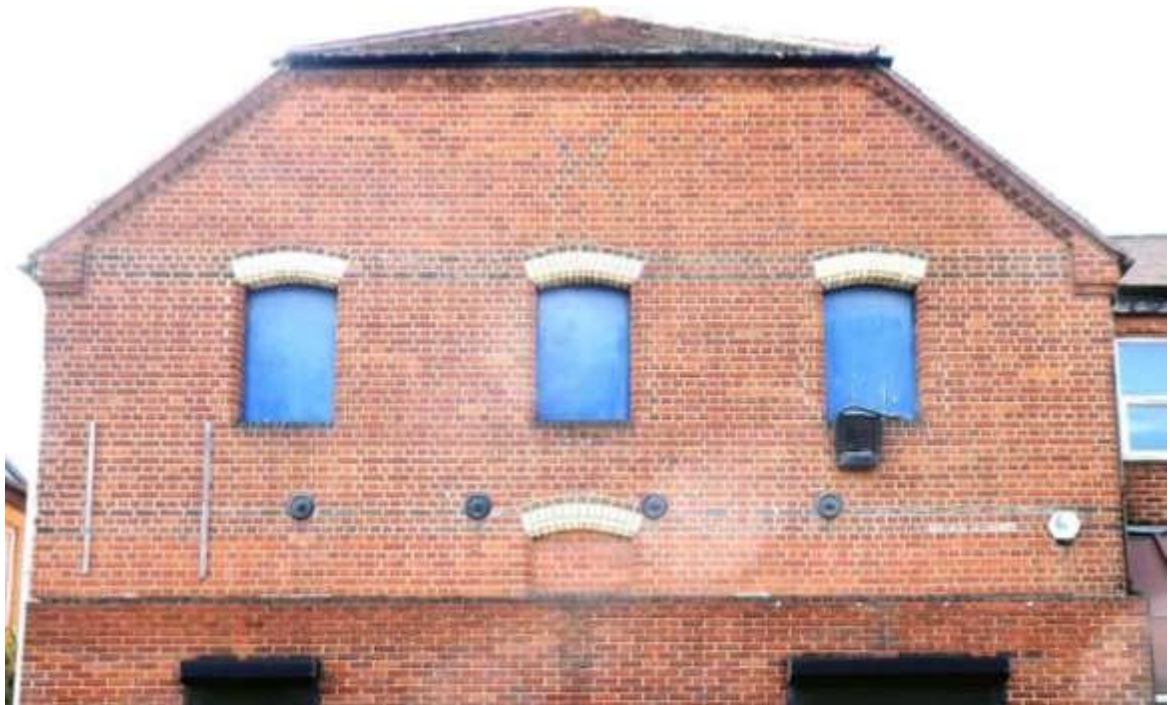
Fig 3.3.15: Upper east gable to N° 71

- 3.3.15 The upper part east end of the south block (N° 71), above the applied modern skin, is in brickwork, similar to the north block. This is laid in English bond with heavy type cement pointing to the joints and there are single splay bricks to the outer corners that runs up to just below eaves level where there is a run-out brick and this becomes a square corner. In the head of this gable there a decorative X formed with dark red brown header bricks.

- 3.3.16 Over the heads of the east gable windows, at both ground and first floor levels, are cambered arches of buff bricks as noted on the north side, but here the top header course is a contrasting dark red brown colour and single splay bricks to all the arises and cills. Running between the window heads at both levels are parallel courses of dark red brown bricks as noted on the north gable to the front range

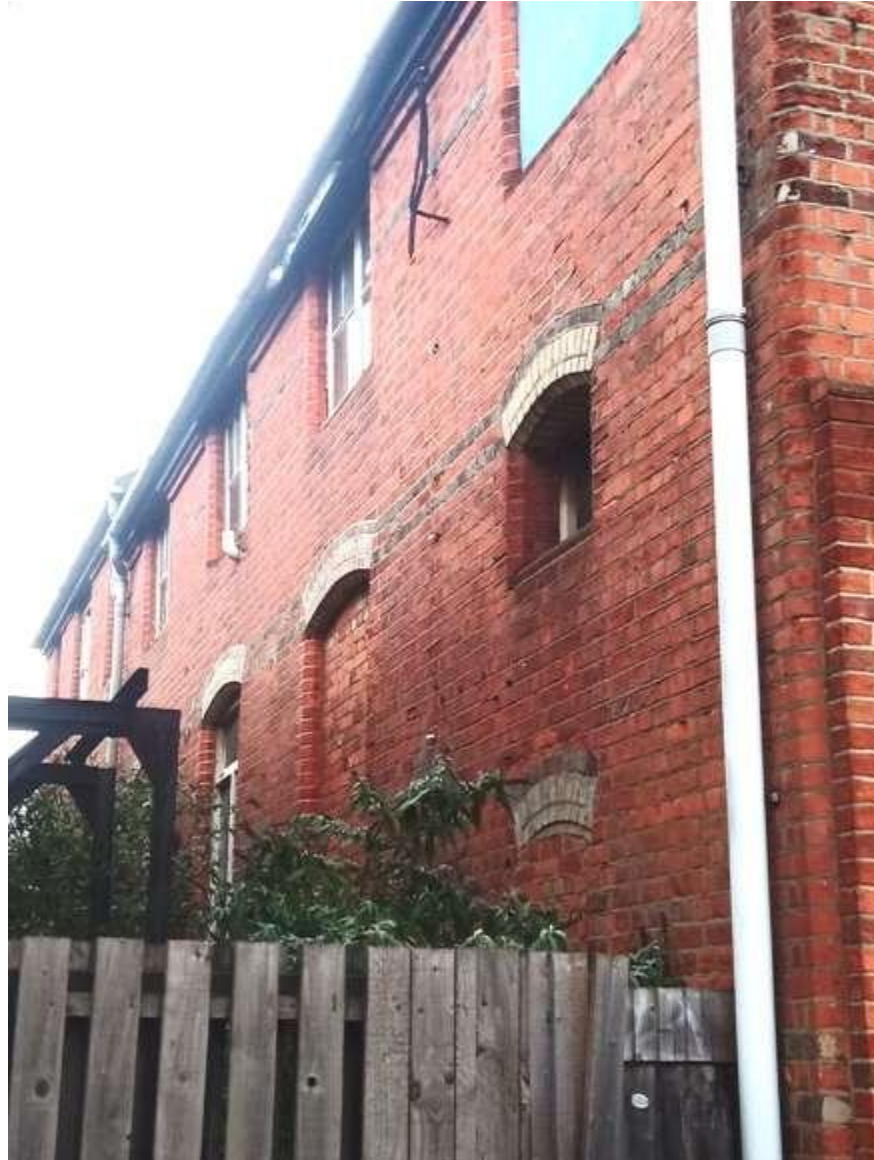
Fig 3.3.17: View of south elevation, showing fenestration pattern

- 3.3.18 At the east end of the south wall there are three levels of windows, suggesting these are the remains of the original fenestration pattern to the east section of this part of the building. The top has had its cill lowered as noted above, the centre is apparently unaltered and bottom one has been bricked-up. Then to the west of this set of windows the former centre row of windows have had their cills lowered

to incorporate the lower window openings as storey height openings and the upper floor windows have had their cills lowered to form deeper openings.
