## **Historic Building Record**

**71 – 73 Caversham Road,  
Reading, Berkshire.**

December 2024  
Reference: 24915A

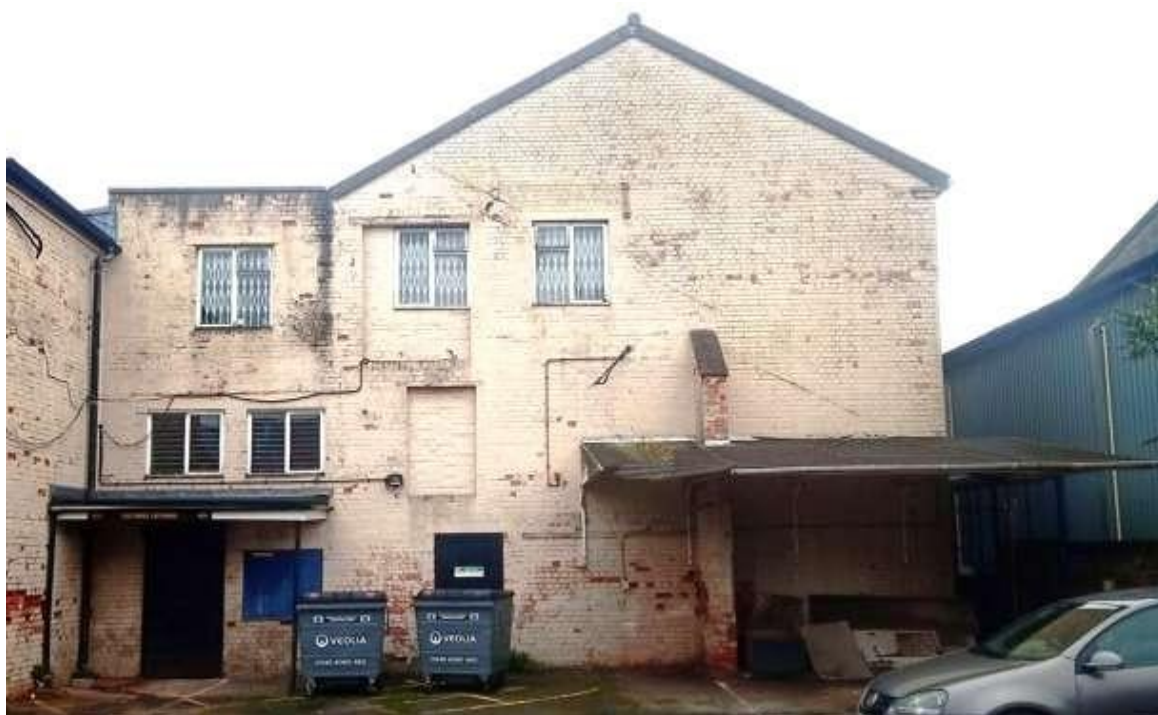
Fig 3.3.20: Rear gable to N° 71 and infill block (left)

- 3.3.20 Due to the position of the west section of the south block relative to the adjoining boundary and buildings on the neighbouring site we could not gain a comprehensive view of the south wall. Therefore we can make no further comment on its construction apart a very general one of it being similar to the east part, but with not as much decorative brickwork. From what could be seen on the internal face of this wall there was not a regular fenestration pattern at low and centre level as seen to the east section, with only one window in the centre, but a range at high level.

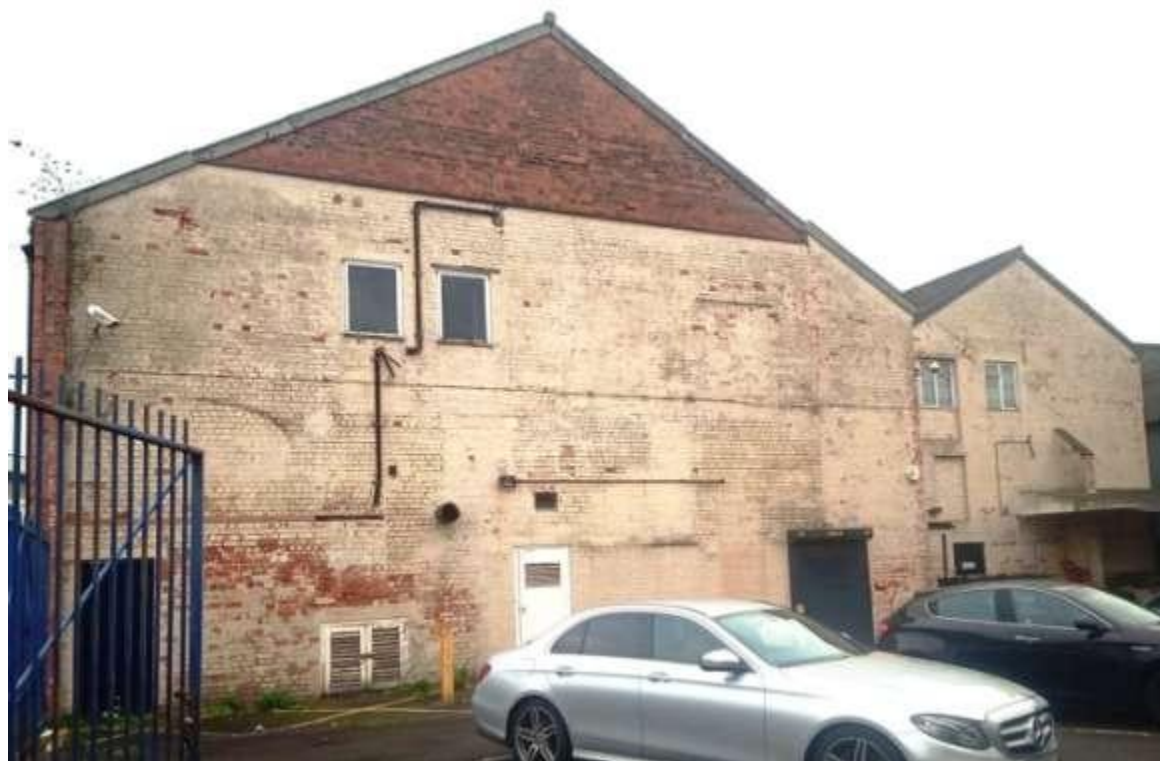
Fig 3.3.22: West gable to N° 73

- 3.3.23 The rear gable end of the north block (N° 73) extends to the west beyond the back walls to the in-fill block and that to the south block. This side wall as well as the main part of the gable is built in brickwork s solid construction where this is laid in English bond and painted. The top part of the gable has been rebuilt in a brick laid stretcher bond and is undecorated where it sits back over the wall below by approximately 100 mm. In the central part there is evidence of a former window or similar opening that has been closed-up as suggested by a difference in the bricks used. Below the south abutment of this infill section there is what appears to be a vertical scar running down the face of the wall, finishing over the head of a door where a wall has probably been removed.

Towards the south end there is a cambered brick arch in a plain section of brickwork as well as what appears to be a timber lintel. In approximately the centre of the wall, top to bottom and side to side, there are two further closed-up openings that would correspond to where there may have been an intermediate floor to the building. At ground level there is a pedestrian fire escape door, one to the lift shaft and a loading door.

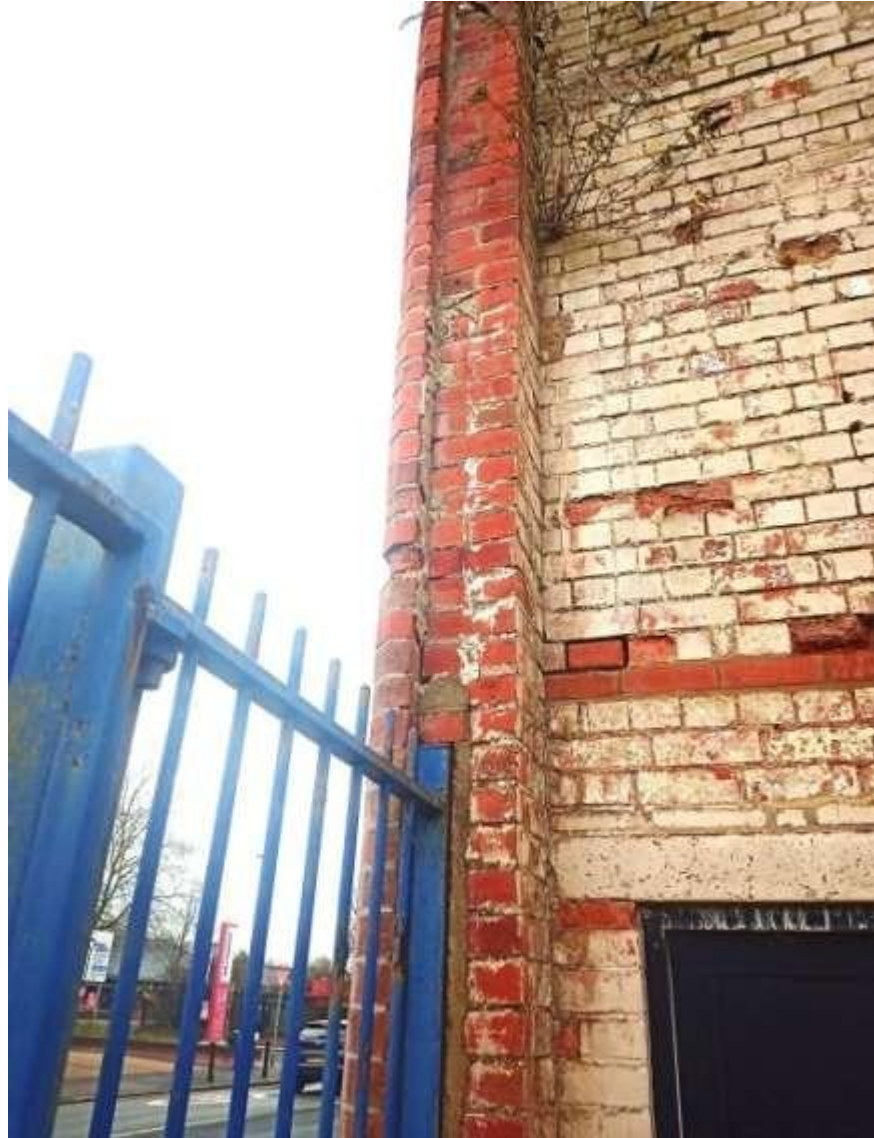
Fig 3.3.25: Link nib on northwest corner to removed building

- 3.3.25 The north wall protrudes slightly, almost forming a buttress type element beyond the northwest corner of the west gable. To this the outer face finishes with a column of splay bricks that project out about half a brick (110 mm) beyond the face

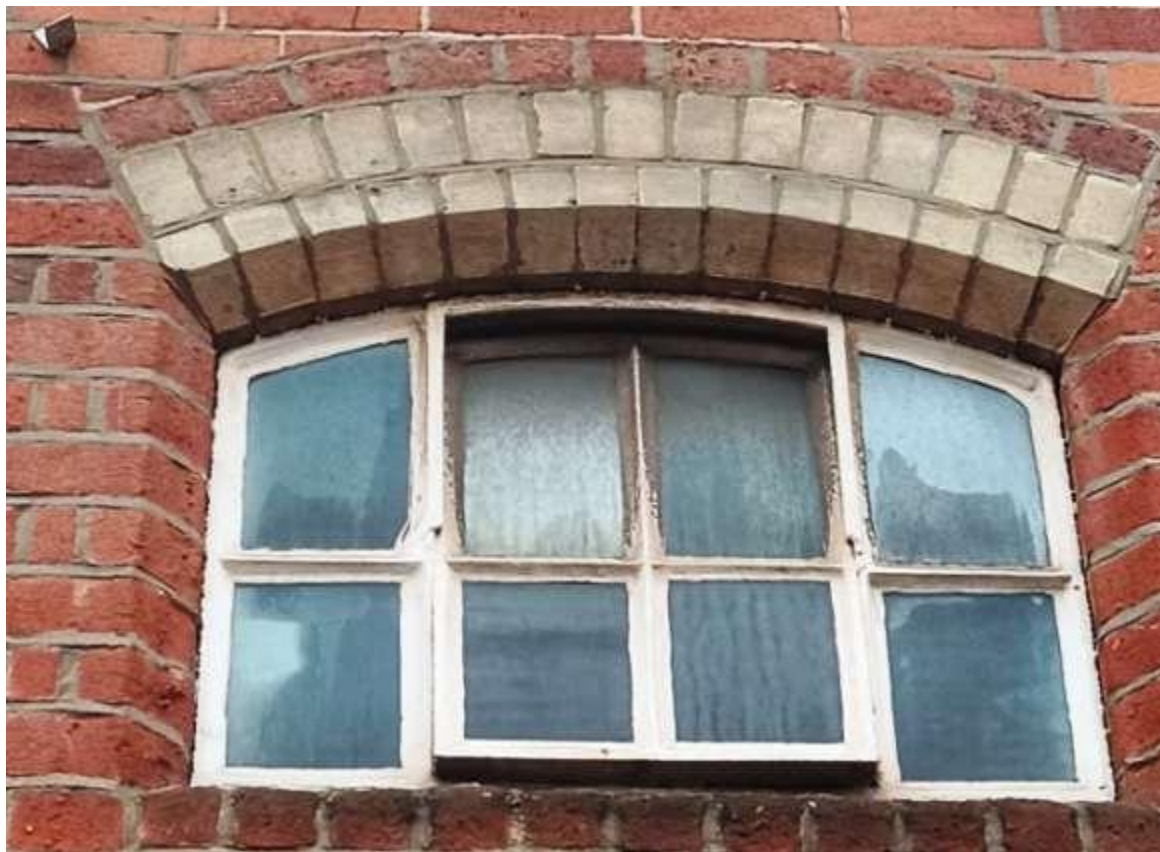
Fig 3.4.2: Cast iron window

- 3.4.1 The north side ground floor window openings contain large single glazed four pane windows, where the lower sections are larger than the upper and have been boarded over. The first floor windows, where they are not boarded over, are double glazed uPVC units with concrete lintels over them to the eaves.
- 3.4.2 In the north gable to the front cross wing there is a four pane cast iron, centre pivot, casement window with two pane fixed lights on either side. This may be a survival of the malthouse window pattern.

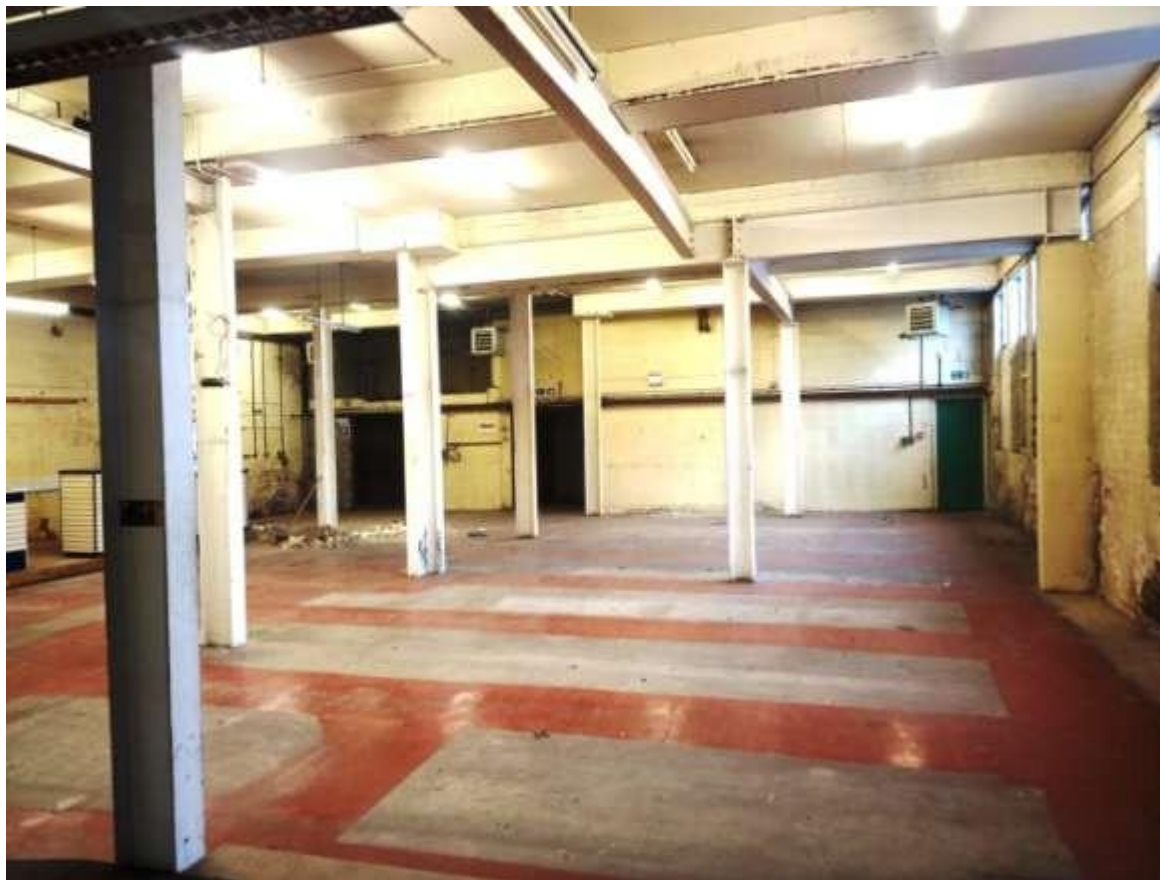
Fig 4.1: North block ground floor looking from front to back

- 4.1.1 This extends the whole length of N° 73 from the west gable to the retail display area to the back edge of the pavement to Caversham Road at the front and which extends from the north wall to Northfield Road and the side wall to the in-fill block. At the west end there are late 20<sup>th</sup> C concrete block walls laid fair faced that enclose a goods lift and an escape staircase from the floor above. At the front of the area, adjacent to the shop display front, there is a small store room formed from modern hollow wall construction faced with plasterboard or similar. Most of this space has most recently been used as retail showroom, as suggested by a scatter of residual advertising materials throughout this space.

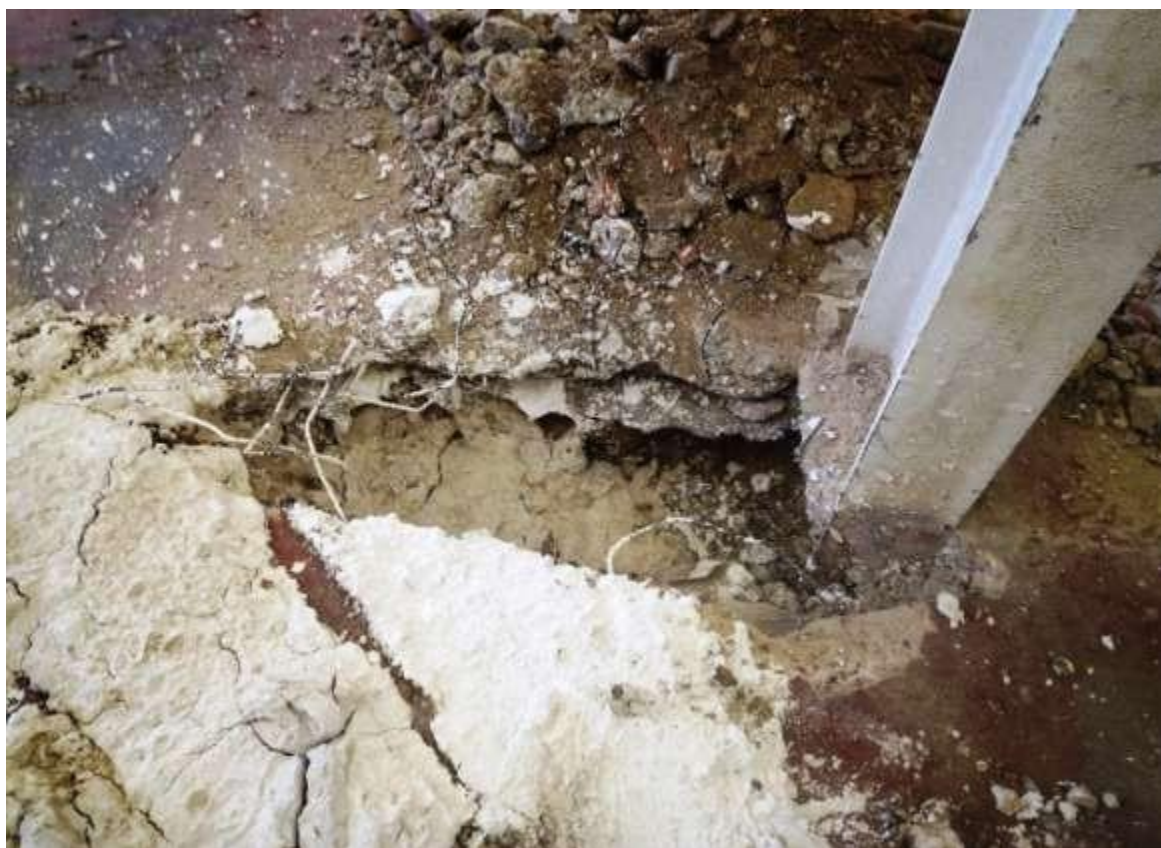
Fig 4.1.3: Ground floor slab

- 4.1.3 Throughout this area there are rows of late 20<sup>th</sup> C H section steel columns that supports beams that carry the apparently suspended timber floor above, as indicated by the construction seen from above. This has been underlined with some form of sheeting or boarding, as have some of the supporting beams, while others are not.
- 4.1.4 The floor through this area is a reinforced concrete structure, as seen where this has been opened up for inspection. This has a concrete slab, approximately 200 mm thick, over a polythene damp proof membrane, then scalplings and hard core under that and is typical of late 20<sup>th</sup> C construction.

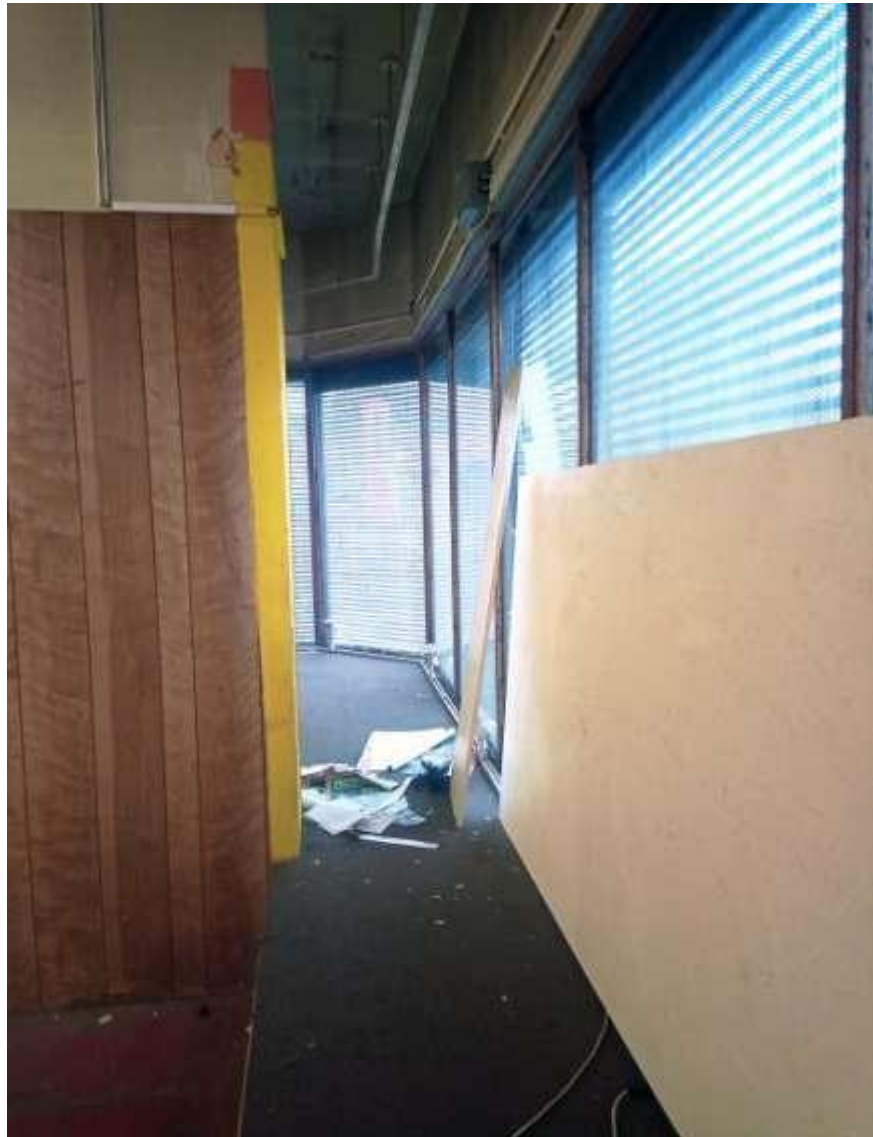
Fig 4.1.8: Interior of frontage retail display area.

- 4.1.8 At the front of the building to Caversham Road the original line of the front wall, above the applied shop front section, has been cut through and is supported by steel beams that are encased with timber boarding. Beyond that, is the area that

has been extended out to form the retail type shop front display area under the external zinc covered canopy.

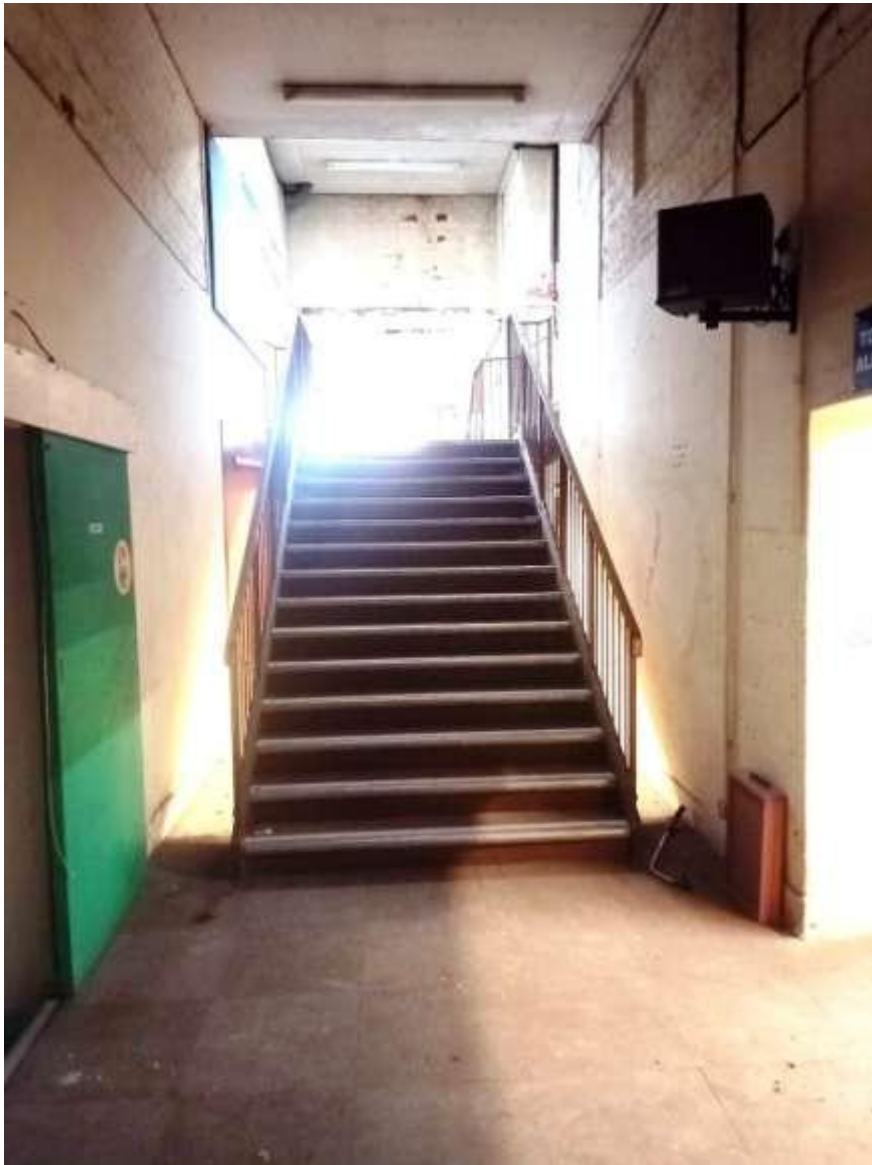
Fig 4.2: Front stairs from ground floor to mezzanine landing in infill block

- 4.2.1 This has a concrete floor that is slightly above that to the north block and approximately 300 mm above that in the south block. It is likely this element is of similar construction to that seen in the north block.

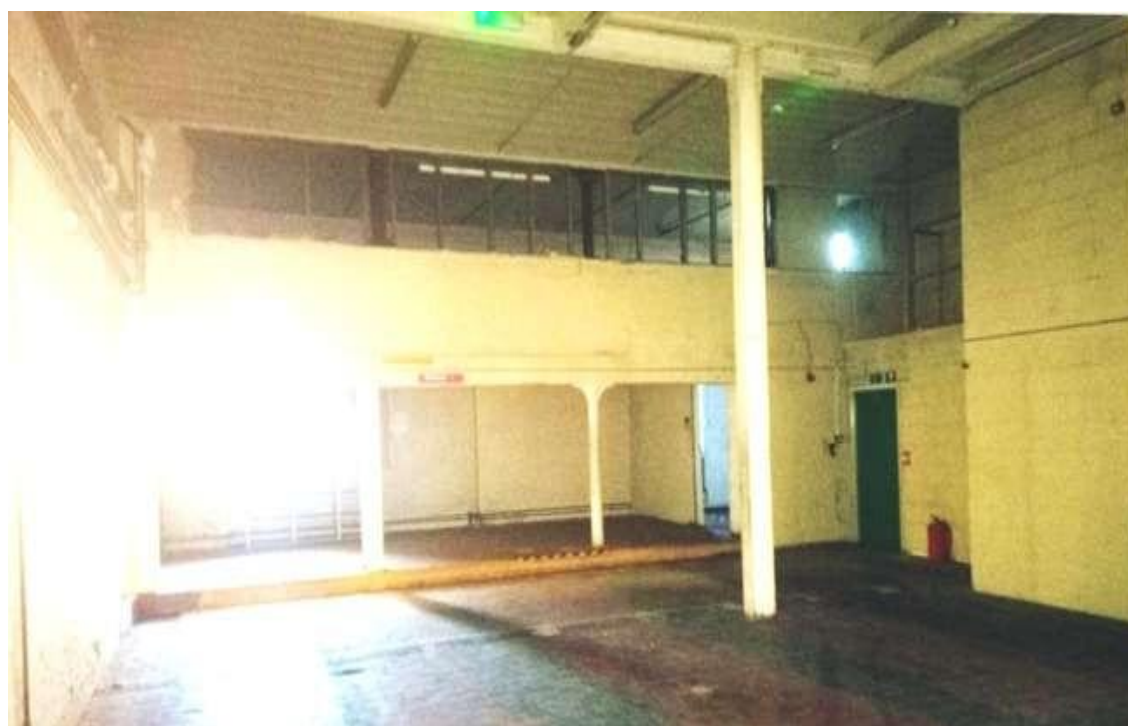
Fig 4.3: South block looking towards first floor offices to front

- 4.3.1 Across the front of this section there is a step-up in the floor of approximately 200 mm to the former office section of this part of the block. This part of the floor is of solid construction with a painted finish. The wall between this part and the area to the rear has been cut through on the line of the ground floor level change. This is supported by a steel beam supported on H section column and a circular cast iron post with a splayed support top. The floor to this upper office section does not

readily relate to a former central floor of the original malting and is of timber construction underlined with painted timber boarding.

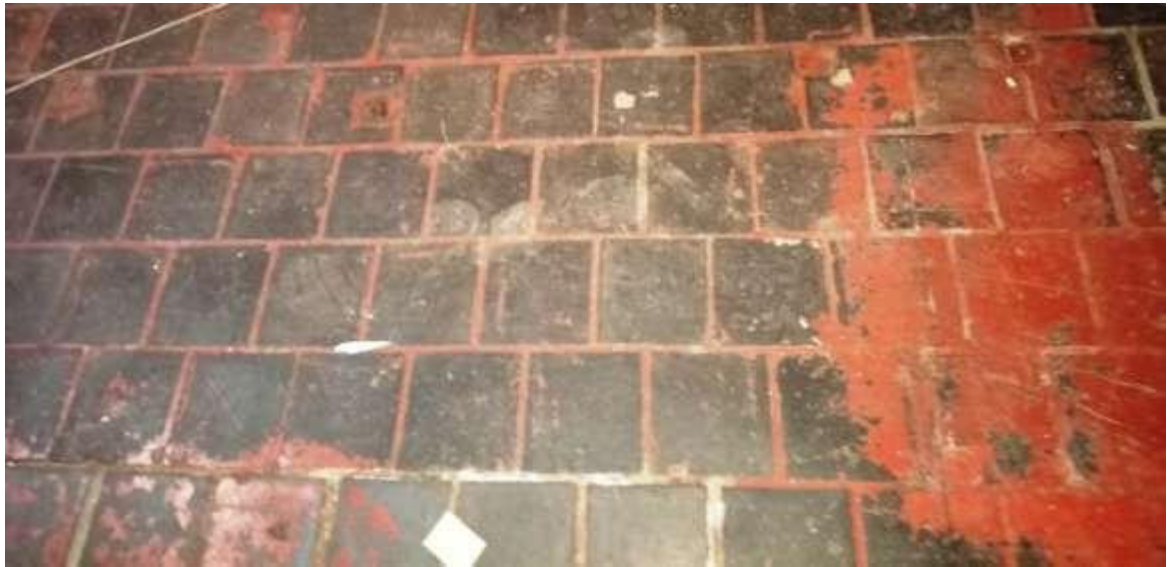
Fig 4.3.2: Floor tiling

- 4.3.2 The floor to the main part east section of the south block has solid floor covered with square black coloured quarry tiles that are approximately 150 x 150 mm and 19mm thick and are bedded in mortar on a concrete slab.

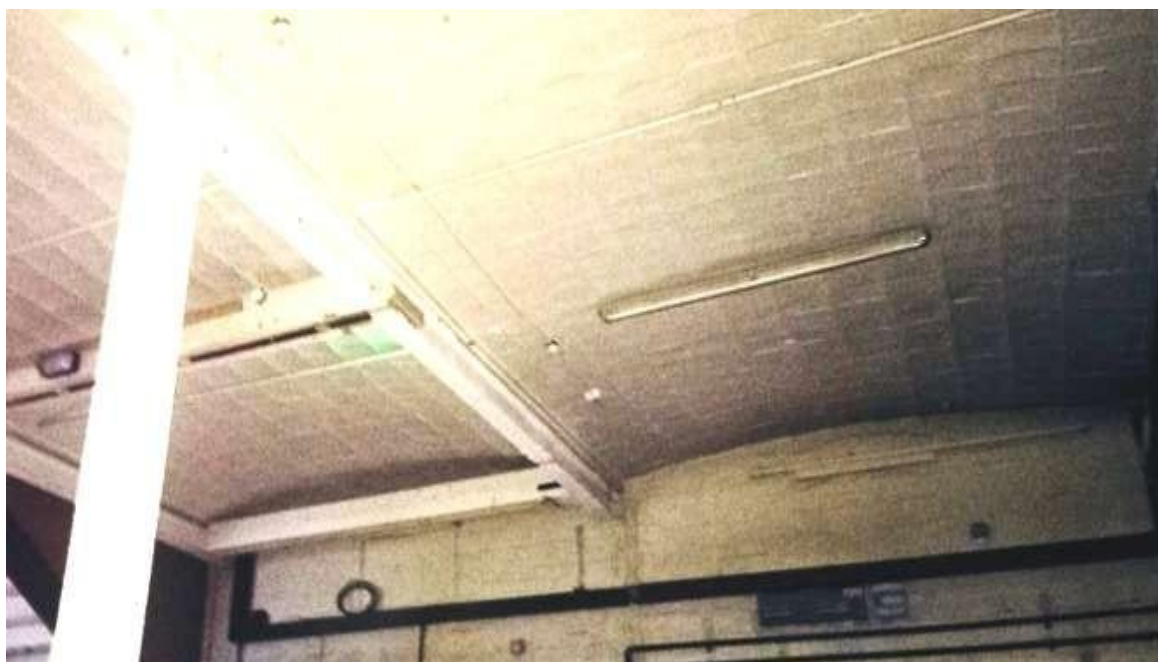
Fig 4.3.4: Underside of brick upper floor

- 4.3.4 At high level over the main body of the east section there is what appears to be the underside of a brick floor that arches between beams that span across the building. These have varying width, where they closed to the dividing wall between the east and west section of this block. This is typical of solid suspended floor construction of the late 19<sup>th</sup> C and may be the original upper floor to this building. This is supported on late 20<sup>th</sup> C H section steel posts carrying similar section steel beams over the top and to the underside of the floor beams.

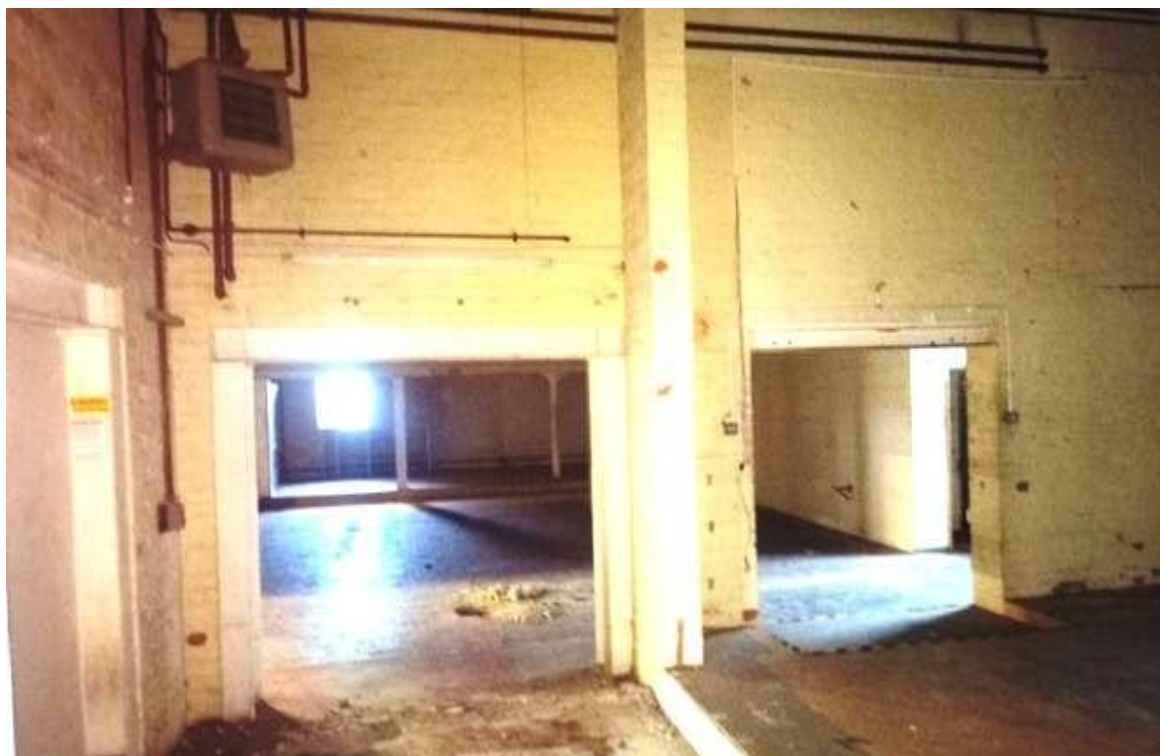
Fig 4.4.1: Front and rear section dividing wall of or N° 71 looking to the front

- 4.4.1 Dividing the front section of N° 71 from this part is a brick wall laid in English bond that is a 320 mm thick that has been painted. This has been cut through for door openings with steel H section lintels over the heads to connect the two parts. By the manner in which the upper east section floor finishes to this wall on the other side it would suggest it was built at the time of initial construction

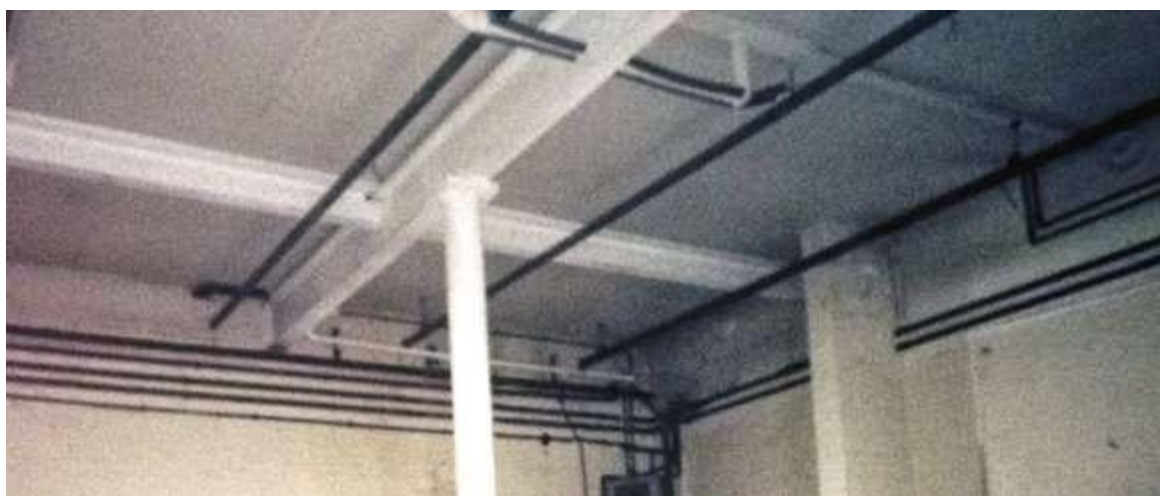
Fig 4.4.3: Support to underside of upper floor

- 4.4.3 In the middle of this section there is a tall cast iron post that supports a deep H section beam spanning from the back wall to the dividing wall and then two cross

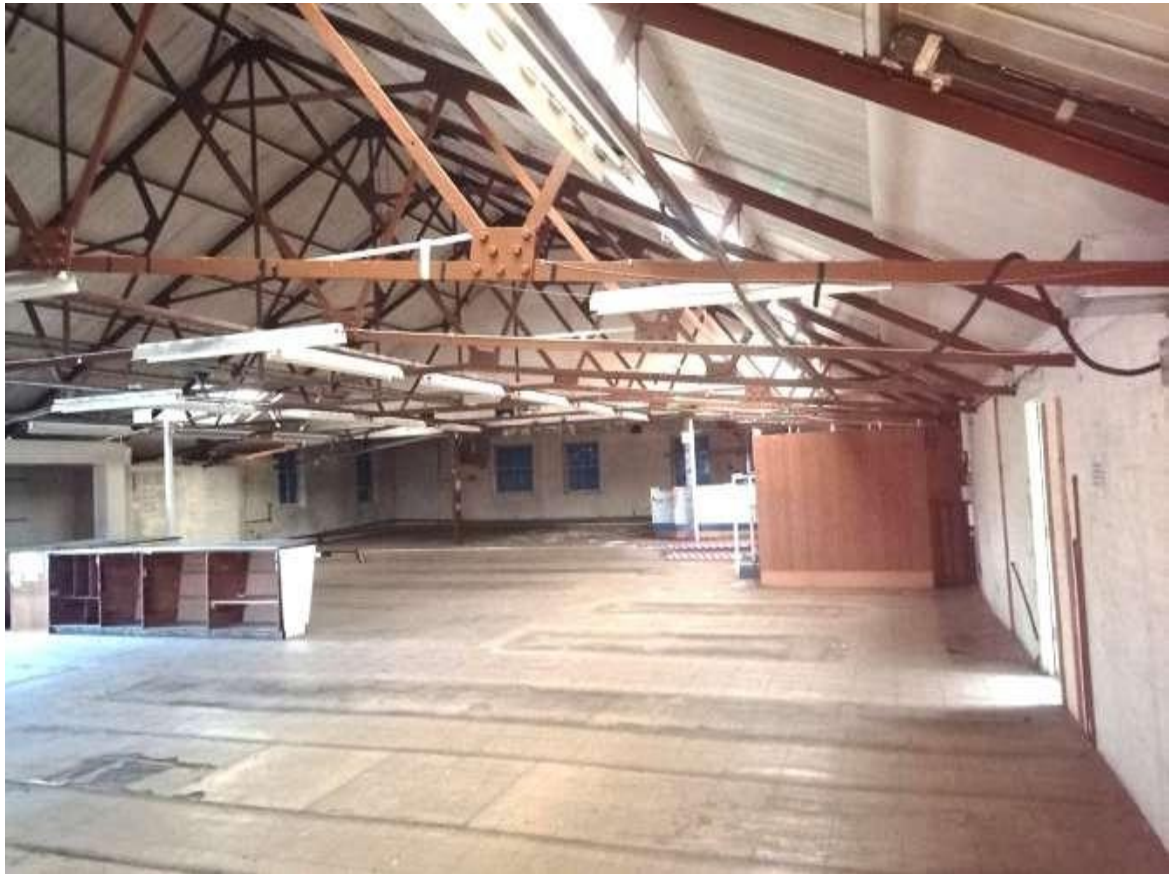
Fig 4.5: North block first floor looking towards the front

- 4.5.1 The surface of the north block first floor has a top that is a suspended timber structure covered with what appears to be vinyl asbestos floor tiles that are stuck to some form of boarding below, over what would seem to be timber joists.
- 4.5.2 The walls to the exterior are painted brickwork, generally as that noted on the ground floor. There no indications of closed-up window openings in the south wall.
- 4.5.3 At the west end modern there is a modern concrete block housing for a set of fire escape stairs and the lift shaft, which is as described for this structure on the ground floor.

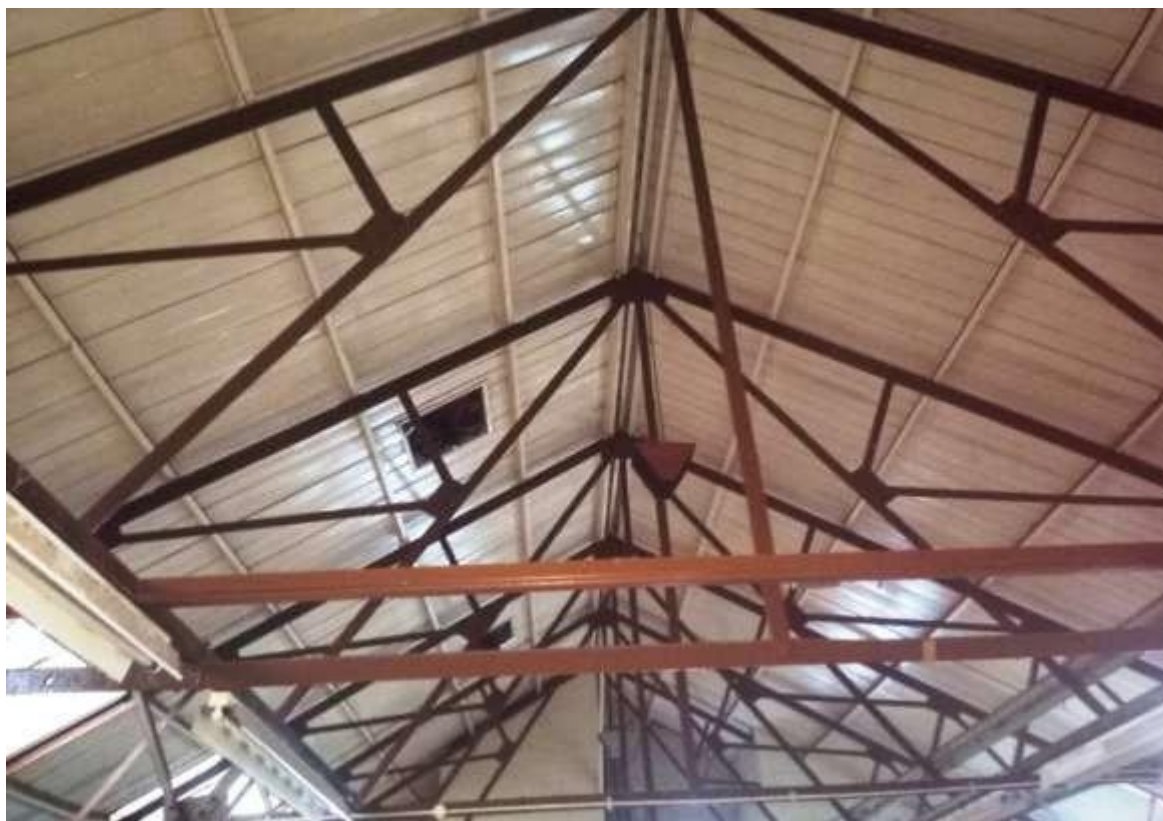
Fig 4.5.4: Roof trusses to north block man roof

- 4.5.4 The roof over this block, extending from the back of the front cross range to the west wall is supported on a series of painted steel framed Fink pattern trusses at approximately 1.5 m centres of late 19<sup>th</sup> C or early 20<sup>th</sup> type. These have a slightly raised centre section and where the outer bottom cords angle down to the eaves level at the head of the side walls. They are comprised of angle iron principal rafters and struts, with simple plain bar cords and ties and bolted gusset plate connections on all the joints. There is a vertical central tie rod in between them and then additional bracing added to the side sections.

- 4.5.5 The trusses support painted timber purlins where there are eight per side, including the eaves purlin, and a ridge board at the top. There are painted timber sarking boards running from the eaves, over the purlins, to the ridge.
- 4.5.6 In alternate upper purlin bays along the south slope there are large extractor fans under cowl hoods mounted over the external roof sheeting. Then in the lower bays, on both sides of the roof there are panels of translucent roof sheeting, as noted as part of the externally.
- 4.5.7 Over the front of this section, under the cross wing, there is a flat soffit of plasterboard. On the junction between this area and the main part to the rear

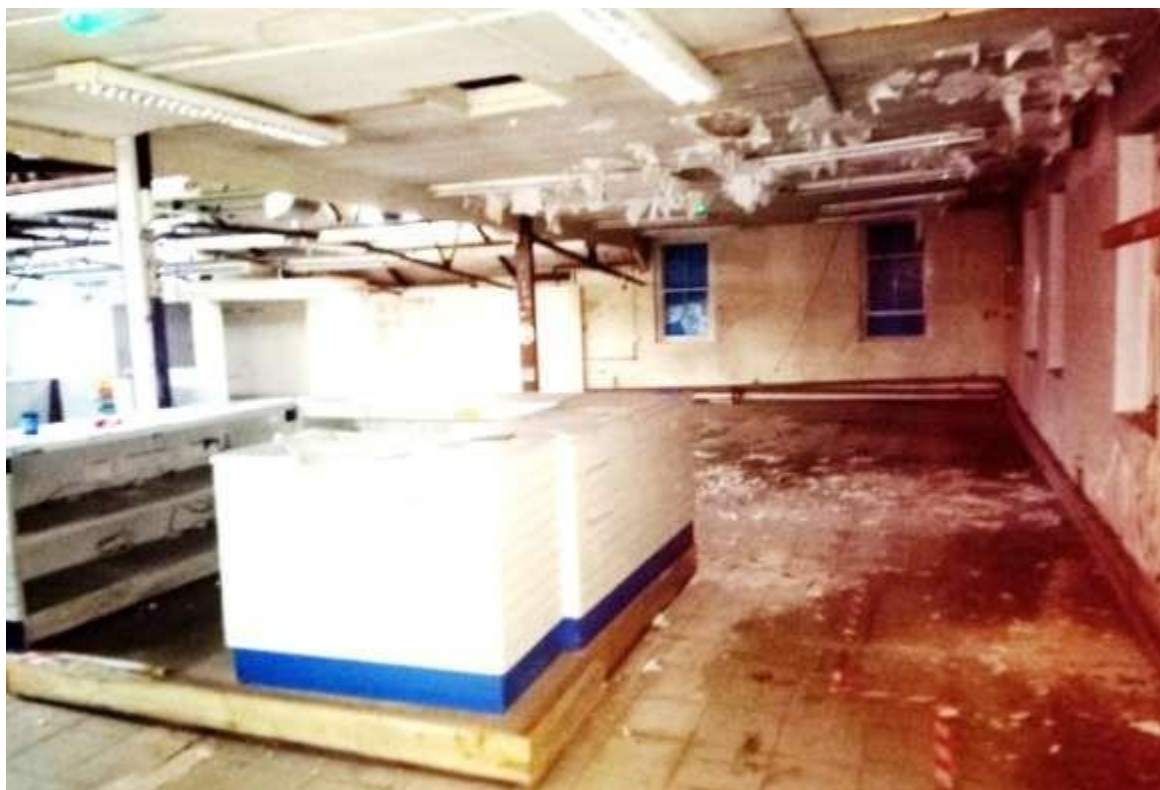
Fig 4.5.7: Front area to the first floor of the north block (73)

there is a beam against the east end truss to the rear roof that is supported on posts. Because of the close nature of this part we could not properly ascertain the roof structure above, but which is assumed to be a cut timber roof.

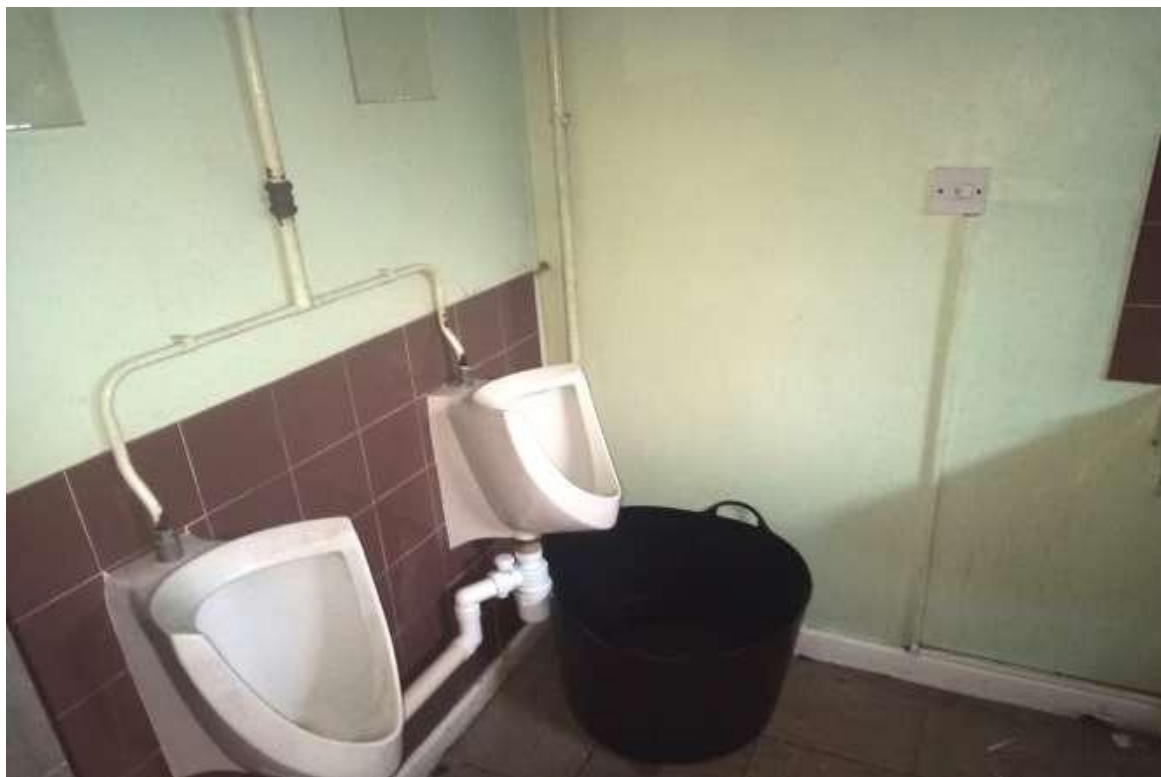
Fig 4.6.4: Toilets to rear section

- 4.6.3 Over the front part to this section is the pitched roof for the front link block into which a Velux type roof window is set in the rear slope and provides natural light over the internal corridor.
- 4.6.4 At the west end of this part, at nominal first floor level to the north block, there are toilets and staff restroom installed and from where a further door connects to the office area at the west end of the south block. The floor is a suspended timber structure generally as that described for the north area. The division walls are a mixture of modern fair faced concrete blockwork hollow partition construction with plaster finish and standard joinery doors fitted in openings. All sanitary and kitchen fittings are of a style and form dating to the fourth quarter of the 20<sup>th</sup> C

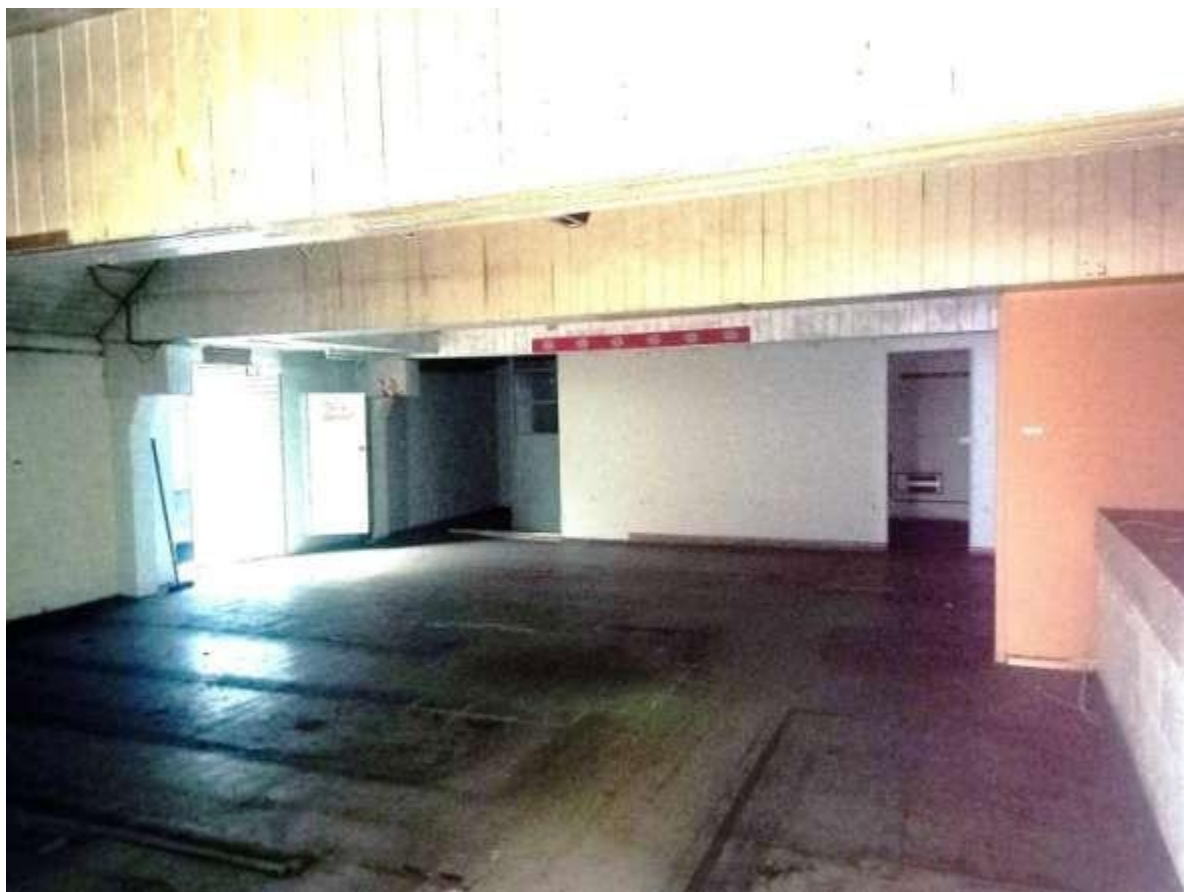
Fig 4.7: South block first floor first at east end

- 4.7.1 At the front of the east end of the south block the floor is a suspended timber structure, where this is what may have been a former office section and is approximately 200 mm higher than that to the infill block. This changes to a solid

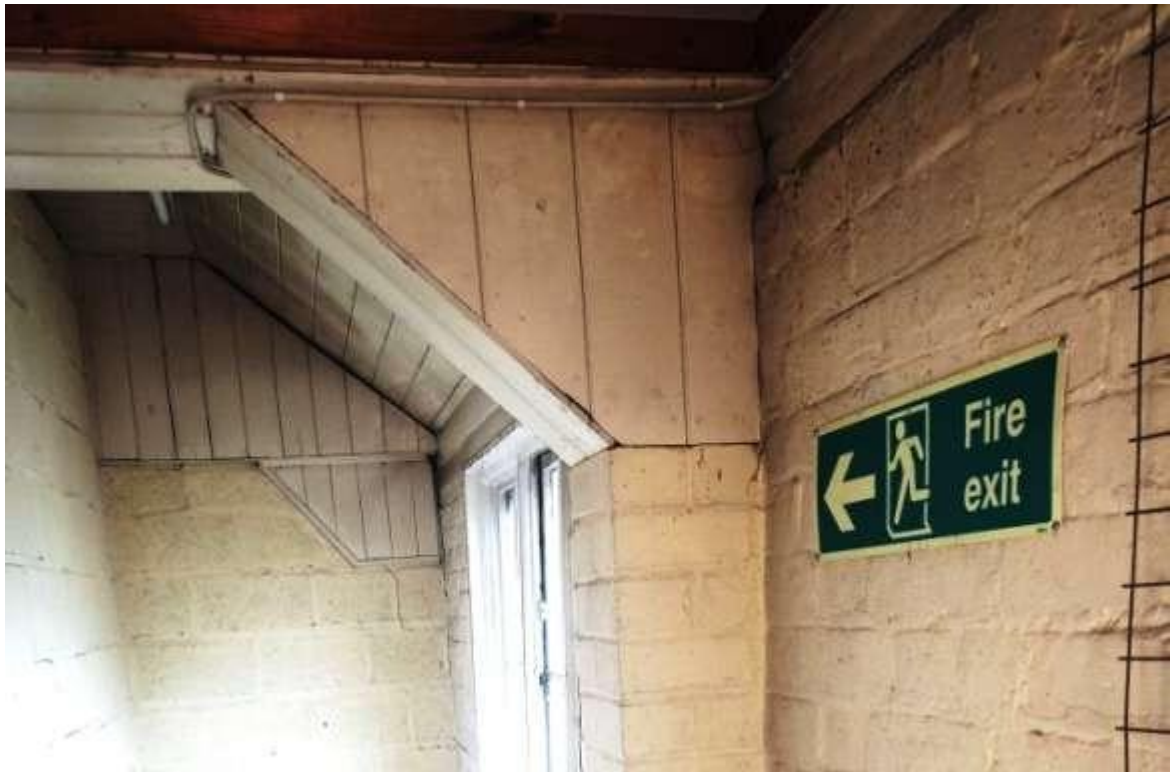
- 4.7.2 All the external walls have been plastered and painted, while along the south side of this part is a modern concrete block structure forming a fire escape provision and position. Across the front of this part of the building modern hollow partition walls of plasterboard on timber framing form a set of offices to the windows on the road elevation.
- 4.7.3 The trusses supporting the roof structure over this area are similar to those over the main part of the north block, where these are iron and plate fink trusses, with gusseted connections. However, these are supported on brick nibs that corbel out from the inner face of the walls on both sides to give support to the truss ends. The bottom sides of the trusses are clad with painted vertical timber boarding. Between the trusses there is a raised lay-in grid suspended ceiling system carrying timber fibre tiles.

Fig 4.7.3: Boxed truss end on brick nib

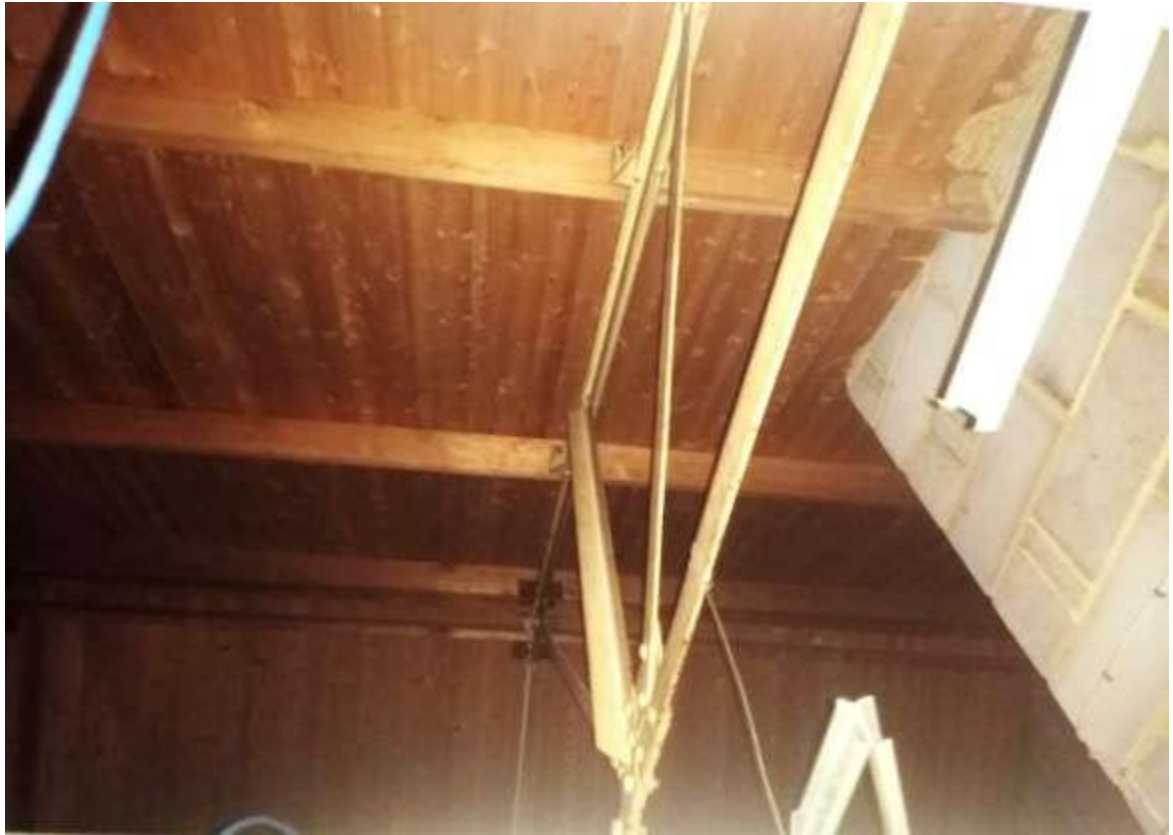
- 4.8.4 Over this part of the building is a flat soffit of lay-in grid suspended ceiling system carrying timber fibre tiles. This is carried on wires from metal trusses similar to the roof structure over the front part of this block although, here the purlins and sarking boards are not painted and truss ends are carried directly on the heads of the external walls.

Fig 4.8.4: South block roof truss at west end above suspended ceiling

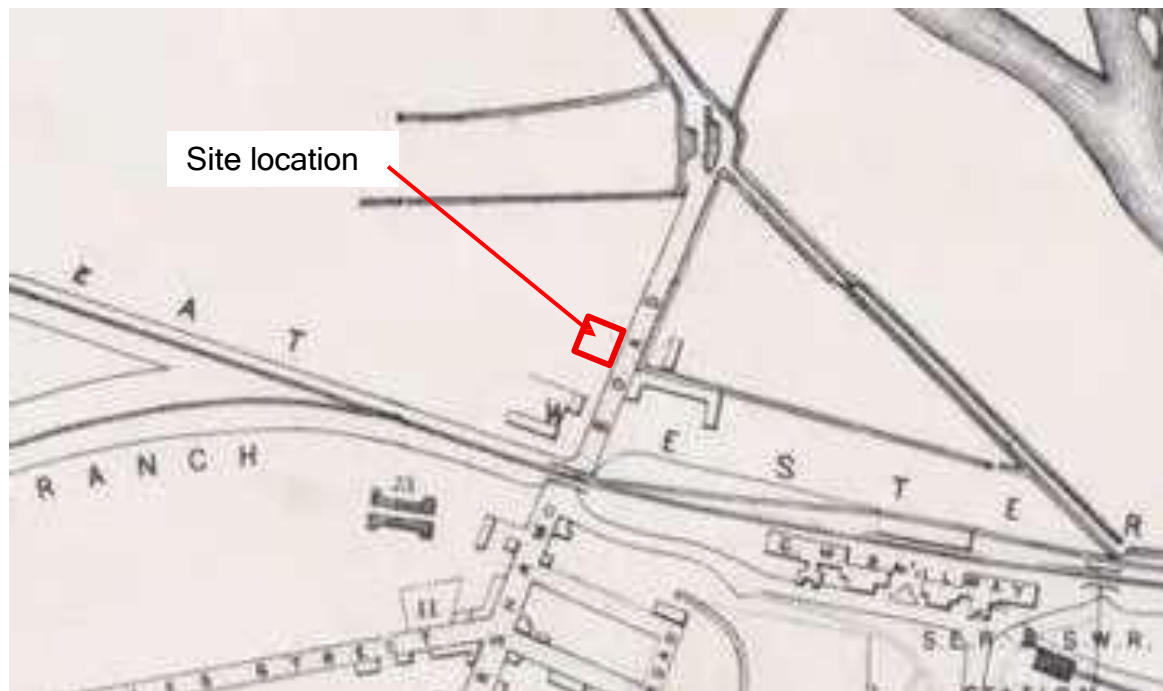
- 6.1.1 A map of Reading from post 1847, as it shows the line to Newbury. Even though it is at a reasonably large scale, it does not show Northfield Road or any other form of development on or in the immediate vicinity of this site.

Fig 6.1.1: Map of Reading post 1847

Fig 6.1.1 - Map of Reading circa 1840
