## **Historic Building Record**

**71 – 73 Caversham Road,  
Reading, Berkshire.**

December 2024  
Reference: 24915A

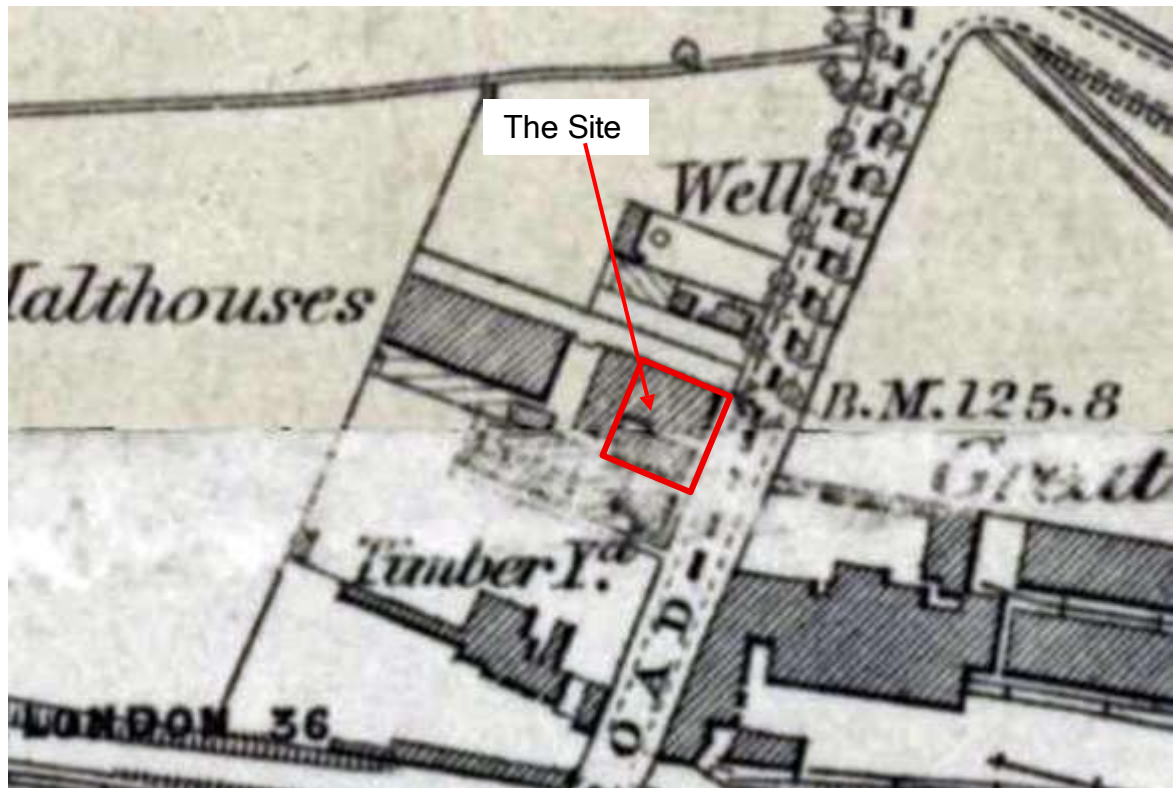
- 6.1.2 The first edition of the 25" to the mile scale Ordnance Survey (OS) map, published in 1878, shows there are group of buildings on this site that are generally labelled as „*Malthouses*’. There is a building against the south boundary, towards the front of the site, which would appear to be about the same size and length of the present south block (N° 71). The north block (N° 73) is against what was to become the Northfield Road side of the site and extends back as far as the present north side rear entrance gates and then returning partially across the west end of the other block. Between the south and north blocks there is a gap, although there is what could be a connection between them in a central position as well as another at the rear of the south block to the returned part of the north block. .

Fig 6.1.3: 1882 edition OS map extract

Fig 6.1.3 - scale 6” to the mile scale. Sheet Oxfordshire LVI and Berkshire XXXVII, 1882 and 1883, Author: Ordnance Survey

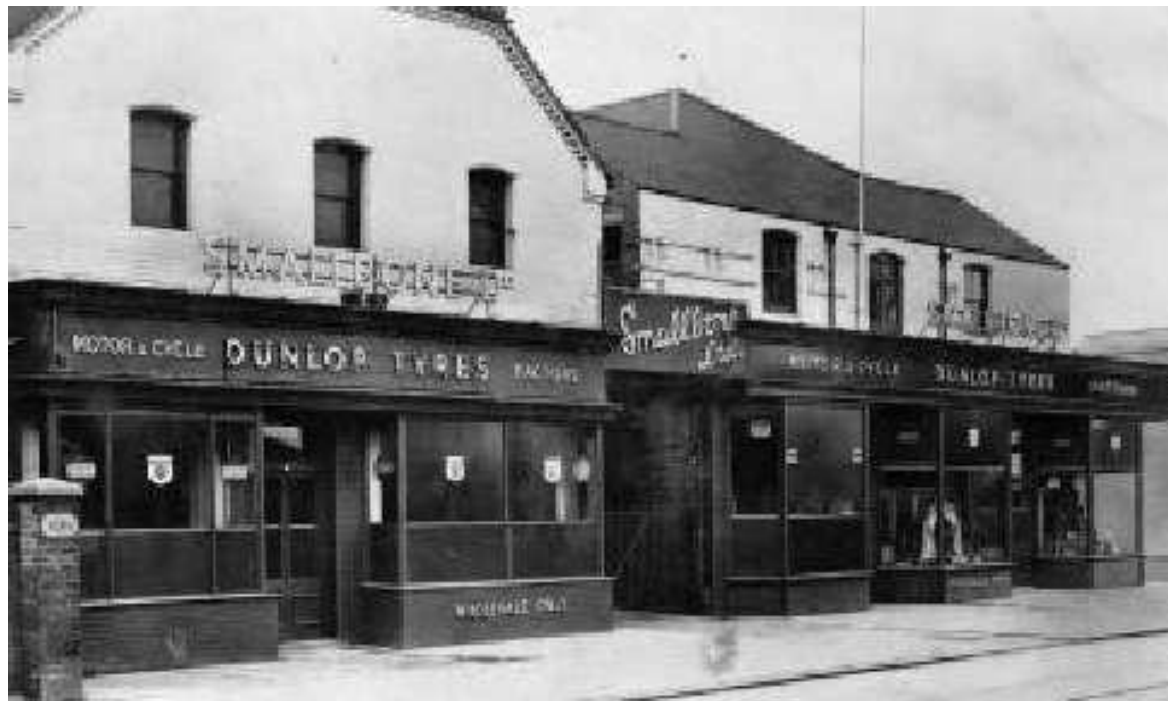
Fig 6.2.4: Frontage to Caversham road in the 1930 - 40s

- 6.2.4 The alteration and adaptation of the malthouse was evidently very thorough as evidenced from photographs taken in the early - mid 20<sup>th</sup> C. These show the windows along the north side having been completely altered with the loss of the mid storey fenestration and the ground floor window heads lifted to a double height as they are now. The front of the building on to Caversham Road was changed to one that presented the appearance of traditional small shop fronts of that time with plate glass windows and the walls above being rendered. What is now the infill block with the main shop entrance was then an access to a workshop behind.

Fig 6.2.4 - Photograph - Smallbone, Caversham Road

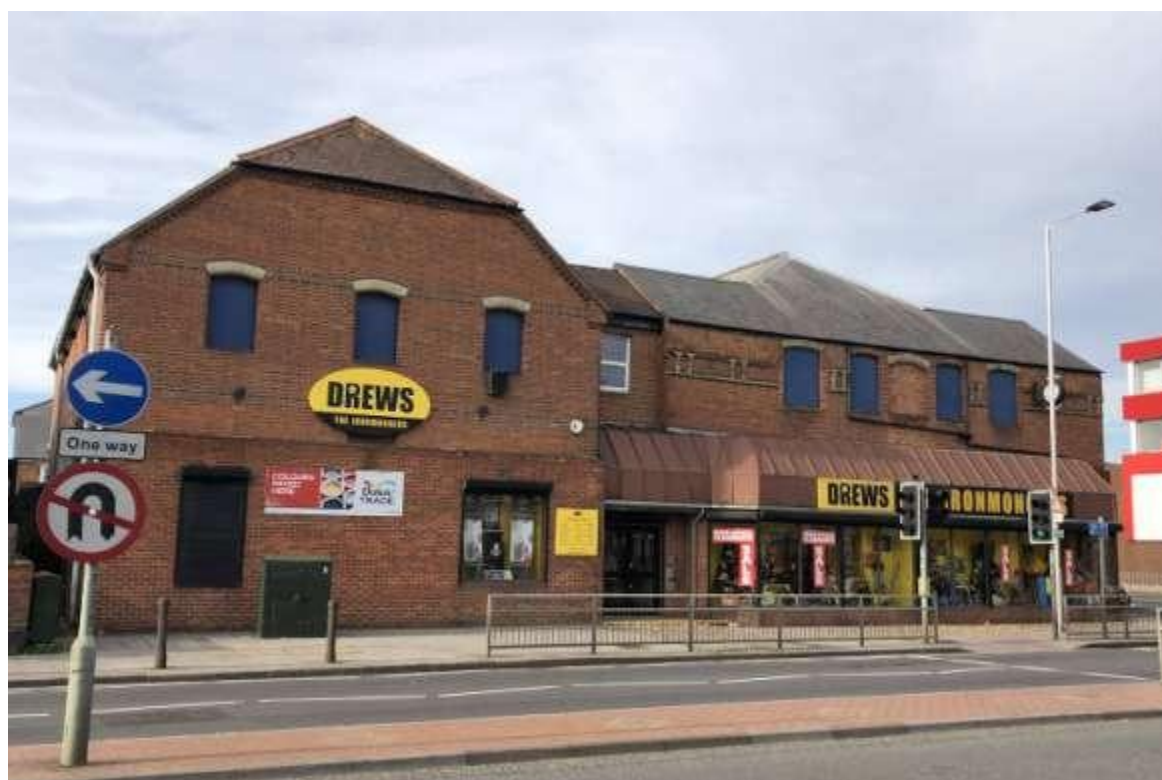
Fig 6.2.8: Frontage to Caversham Road at the time of Drews" closure

- 6.2.7 Percy H Smallbone was a motor engineer and he moved to the site in 1925 and stayed until 1947, and the remnant of whose name is seen in the „ghost sign" on the north wall. They were followed by Brown Brothers, who were described as motor accessories factors and later as electrical wholesalers. Drews, a firm of ironmongers and builders merchants, occupied the site in 1977 and remained there until closure in December 2018.

Fig 6.2.8 - Haslams, *71 – 73 Caversham Road sales brochure (undated)*

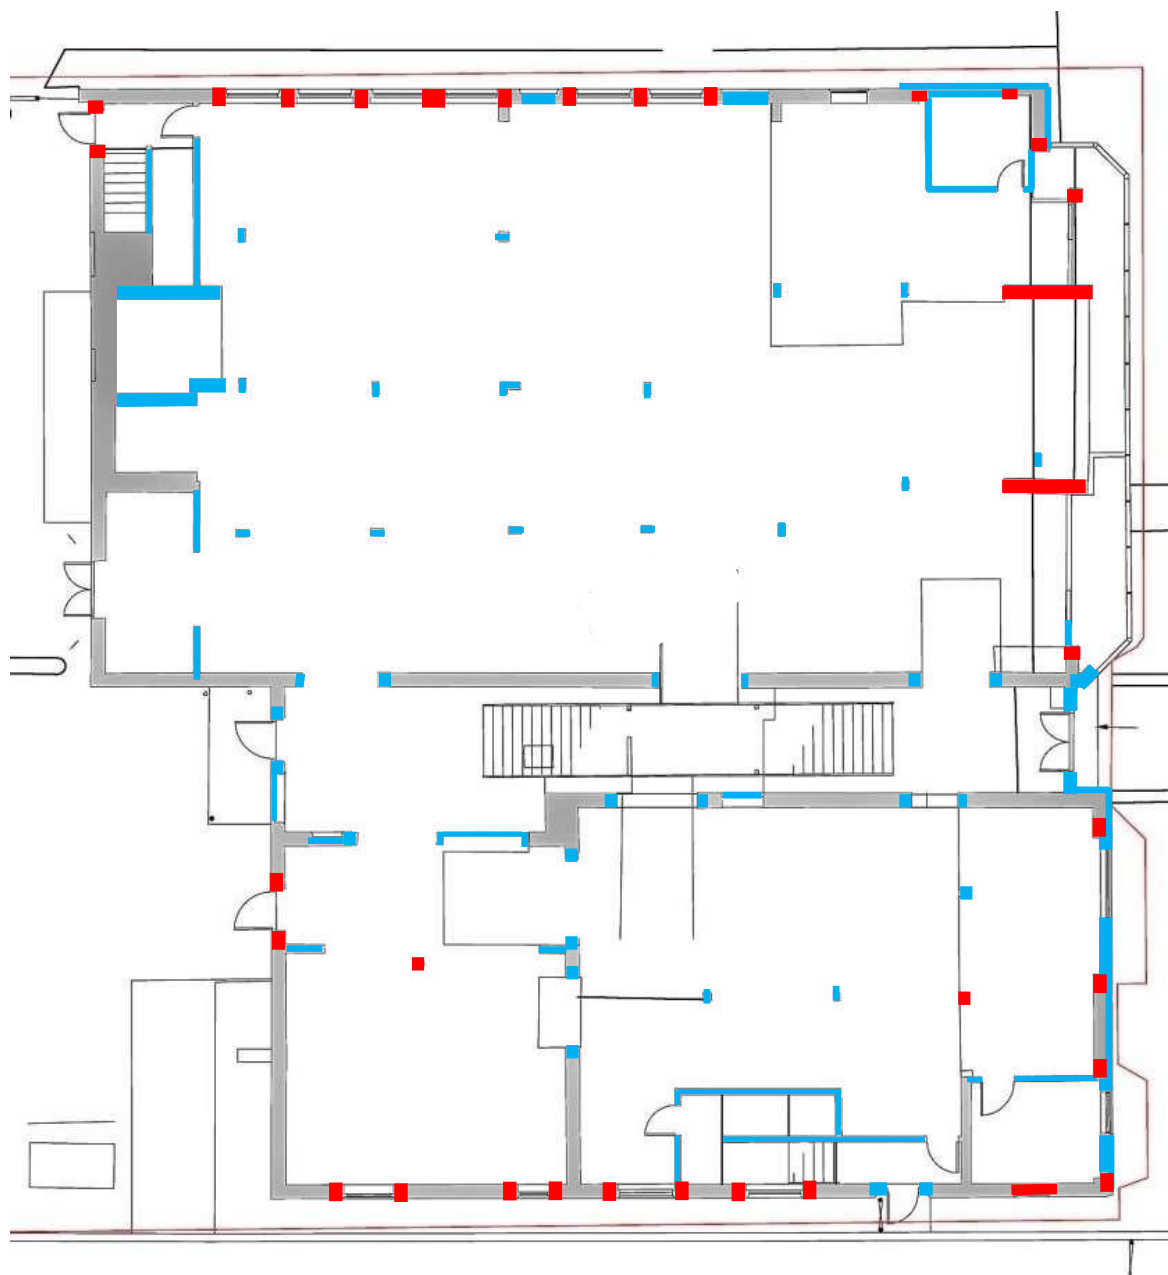
Fig 8.3: Ground floor plan (NTS)

- 8.2.9 In more recent years, when used by Drew's, the interior of the building was evidently altered more as can be suggested by the use of modern concrete blockwork and steel frames to open it up so as to form a large open warehouse type retail space. The offices in the front cross range were partially incorporated in to the trading area and the central gap became the main access provision for the site, with doors from both the front and back. Replacement offices were formed at the west end of the south block, together with staff welfare facilities.
