# 109 Castle Hill

## DESIGN AND ACCESS AND HERITAGE STATEMENT

Document No: 1345-HR-A-HS-XX-01  
Rev 02

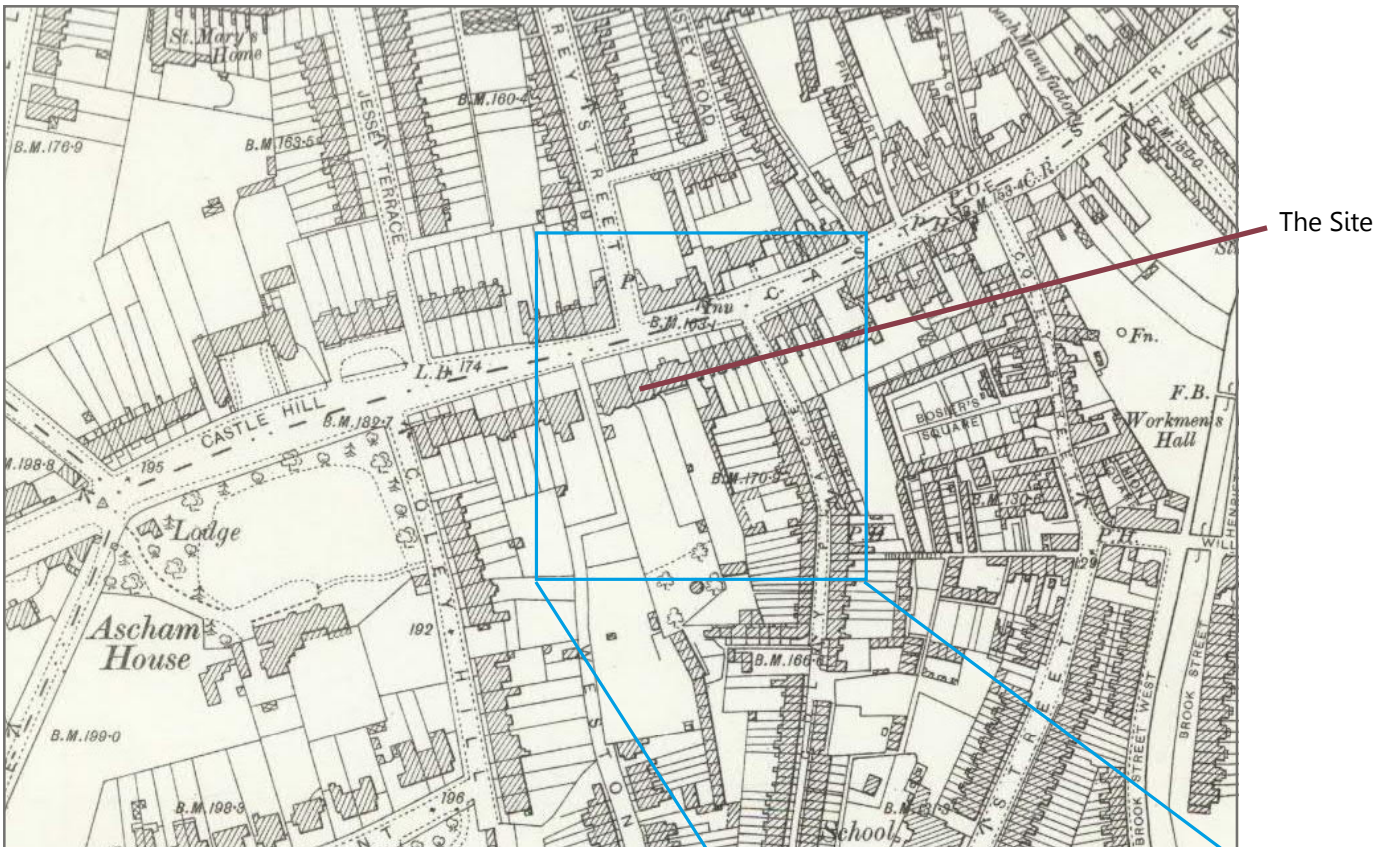
Image 9a: Extract of Ordnance Survey map of 1898, Reading Berkshire XXXVII.3, published 1900 (National Library of Scotland, 2025)

2.4.4 The OS map of 1898 shows no change to the outline of Wingham House, or its boundaries with its neighbours. The Kelly's Directory of 1899 lists No. 109 as being occupied by Robert Arnold Barker (a surgeon), No.111 remained a prep school, and 107 was occupied by Gerald Edward March MD, physician, which reflects generally occupation by educated, highly respected members of the community.

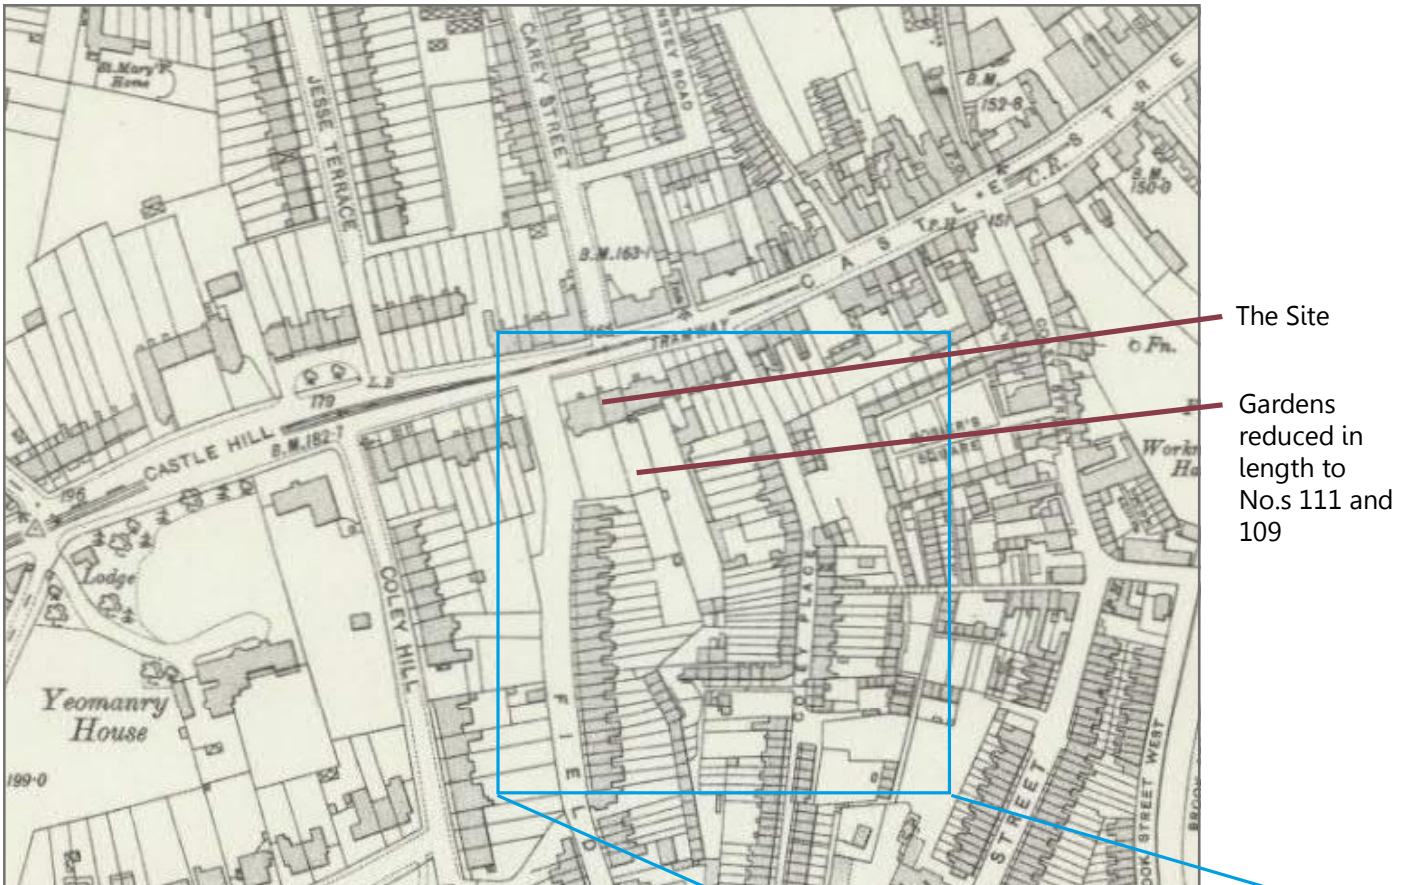
Image 10a: Extract of the Berkshire XXXVII.3 map from 1909/10, published 1912 (National Library of Scotland, 2025).

Path widened,  
No.113 demolished  
and Field Road  
created

2.4.5 The OS map of 1909/10 shows large-scale urban change, with the introduction of the tram along Castle Hill, the widening of the pathway by the demolition of No.113 Castle Hill to create Field Road, and what appears to be a coordinated sell-off of the rear gardens of both 109 and 111 Castle Hill to create a series of terraced houses with rear amenity spaces.

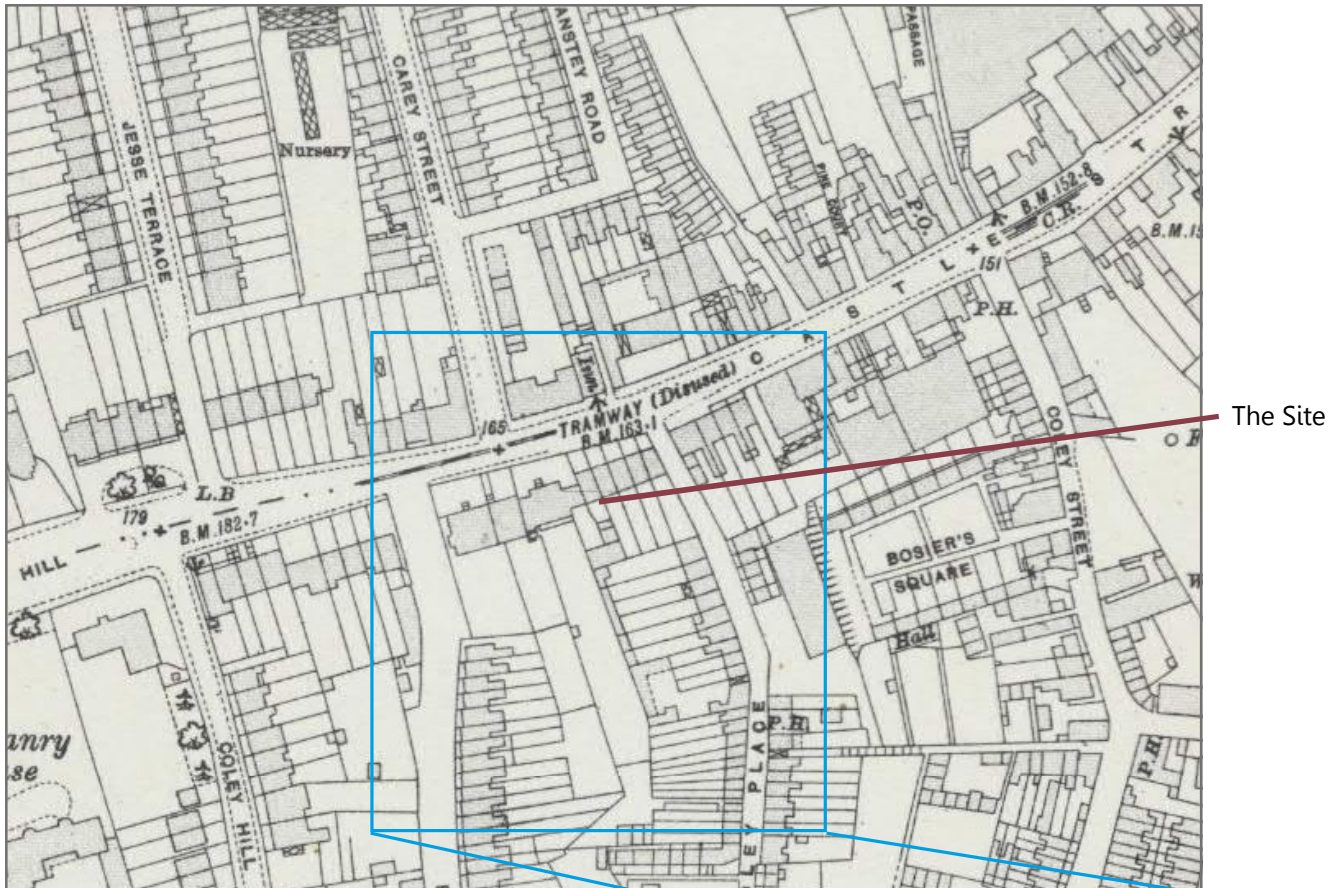
Image 11a: Extract of the Berkshire XXXVII.3 map from 1931/32, published 1934 (National Library of Scotland, 2025).

2.4.6 There is little change to The Site in the 1931/32 map, albeit the tramway is indicated as not in use.

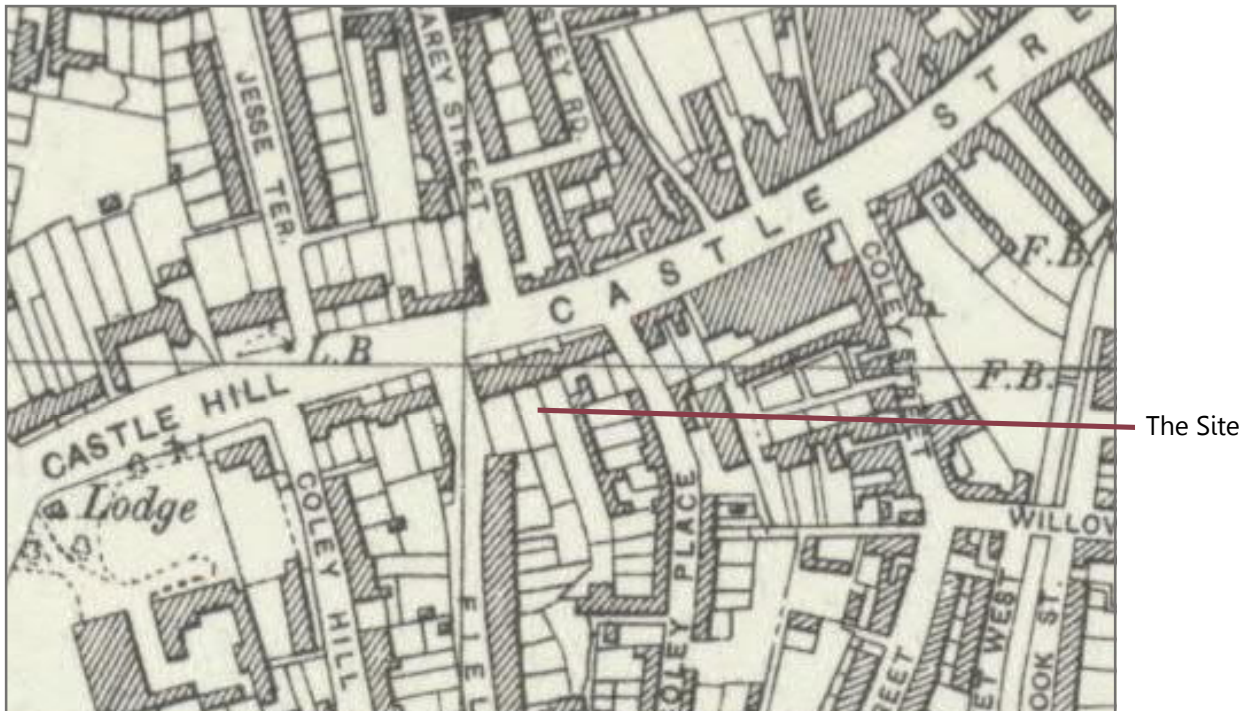
Image 12: Extract of the Berkshire XXXVII.NE map from 1938. Published: 1944. (National Library of Scotland, 2025).

2.4.7 The map of 1938 shows no discernible change to the Site compared to the previous OS map.

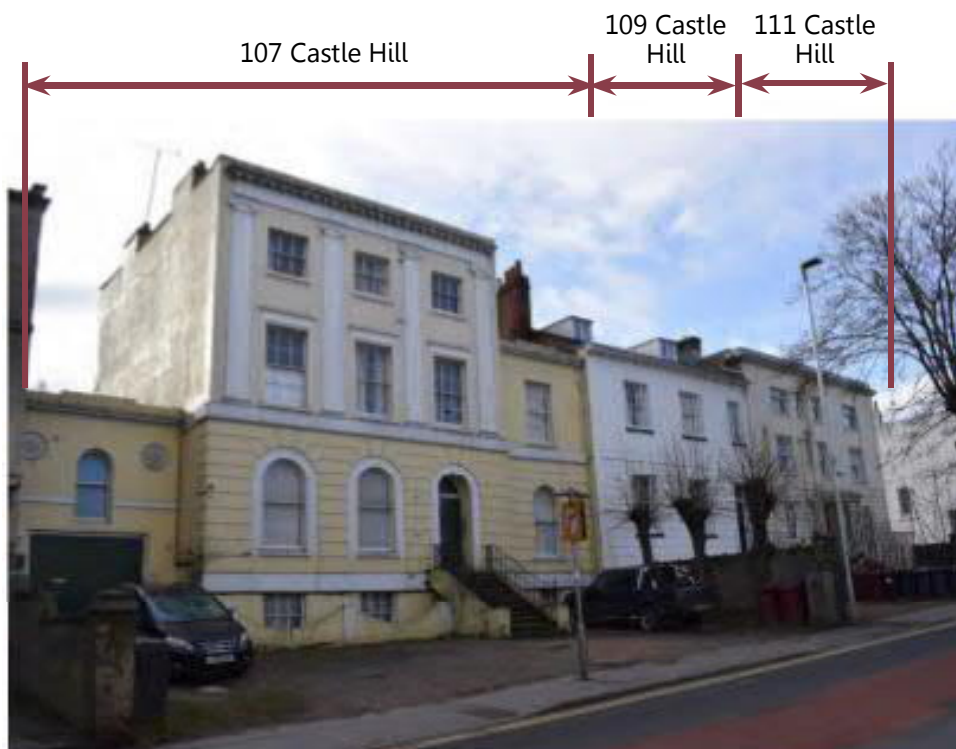
Image 13: Extract of a photograph from the Draft Conservation Area Approval document which shows 107-111 Castle Hill together, unobstructed by trees (RBC, 2020). All have a semi-basement plus 3 floors, however 109 appears rather smaller and less grand in scale compared to its neighbours  
Photo credit: David Neale

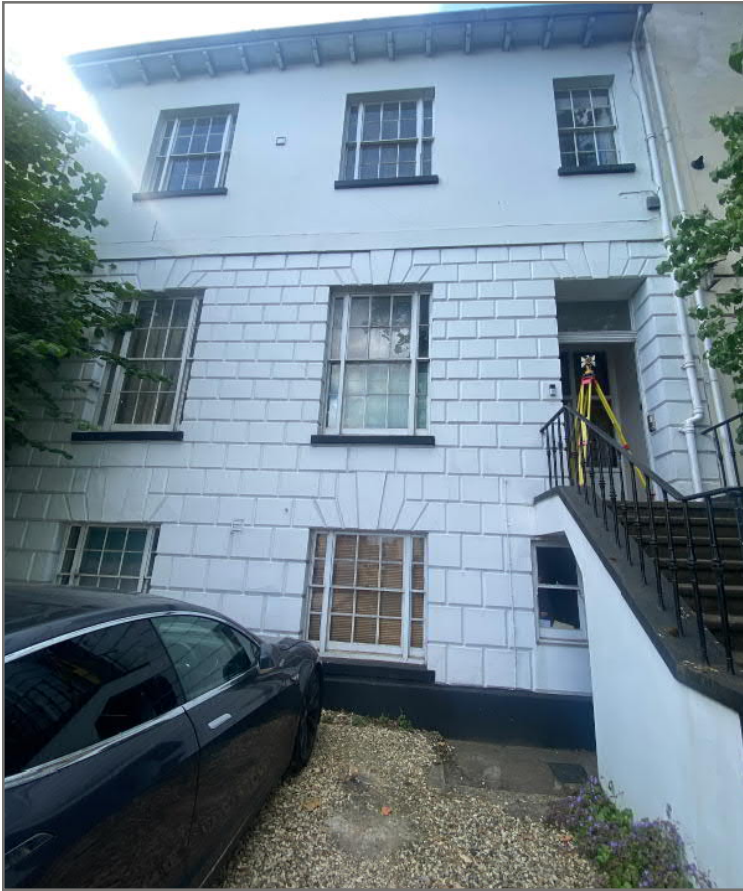
Image 14: View of north elevation with rusticated 'base' (Semi-Basement and raised Ground Floor)

The north elevation has three bays of fenestration, with the east and middle bays of triple set sash design, with narrow side lights. The entrance door is accessed via a long flight of steps - as noticeable on the OS maps - which had, in the past connected the visitor directly via a path to the street.

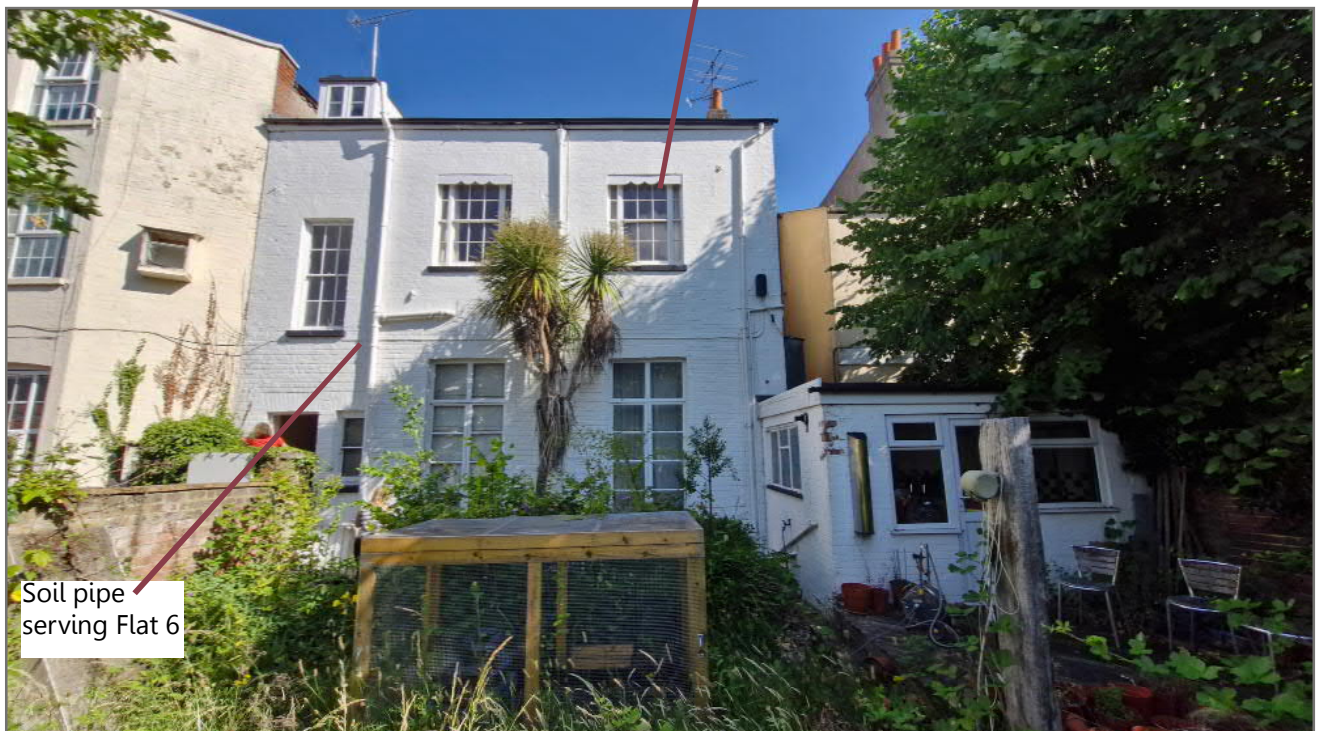
Image 15: View of south elevation from the garden

Soil pipe serving Flat 6

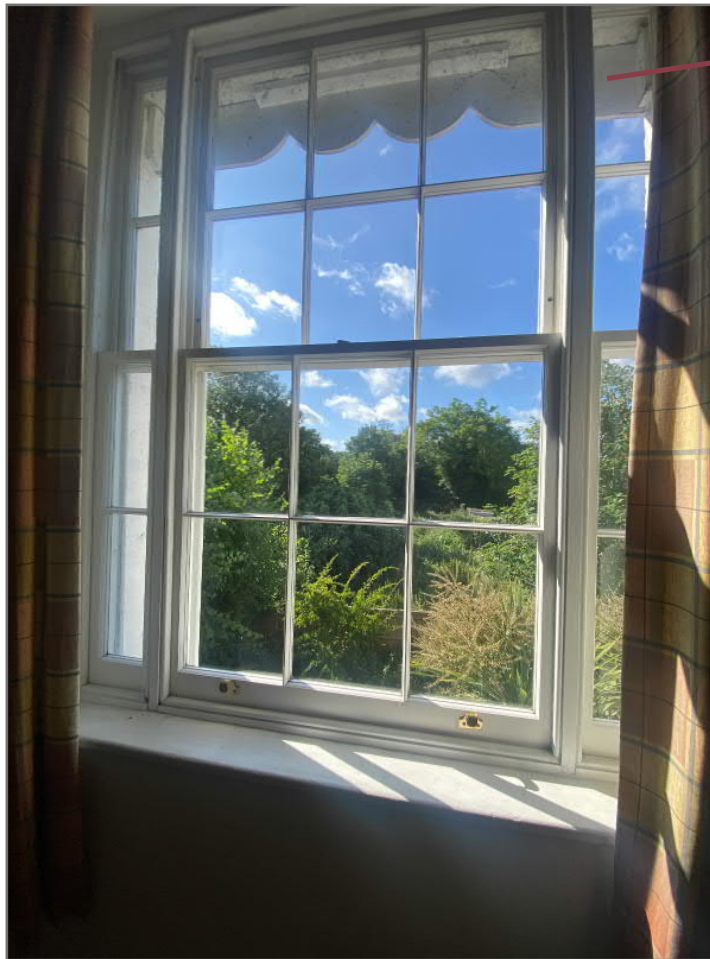
Shading device for  
awning - room faces  
south

Image 26: Lounge window, Flat 6

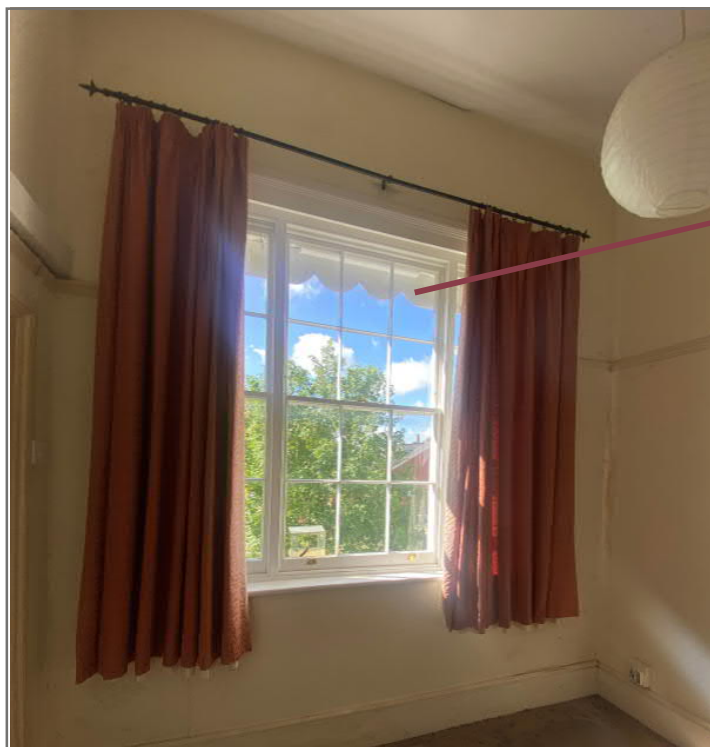
Shading device for  
awning - room faces  
south

Image 27: Bedroom window, Flat 6

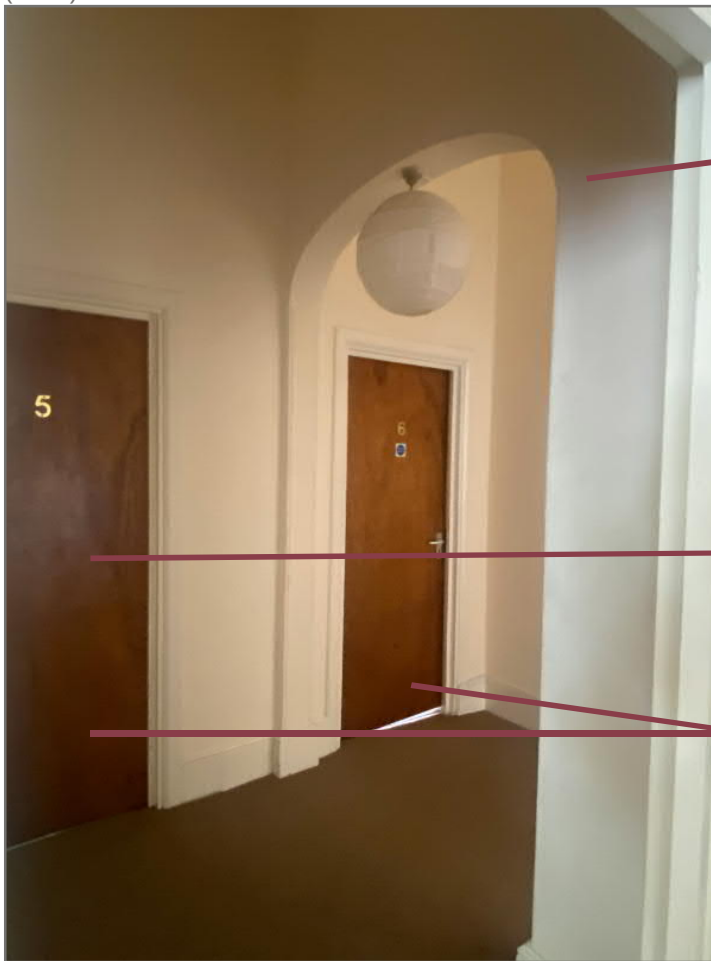
Arch to be retained - it is unlikely to be original

Modern door within stud-work wall - proposed to be moved (left) by 100mm to enable storage to be created inside Bedroom 1

Modern doors proposed to be replaced with white painted timber panel doors (30 minute fire doors)

The 1987 flat refurbishment saw low quality fire doors installed - refer to Image 28. The internal doors are proposed to be replaced with high quality painted timber panelled doors to improve the character of the spaces more appropriate to the period of the property.

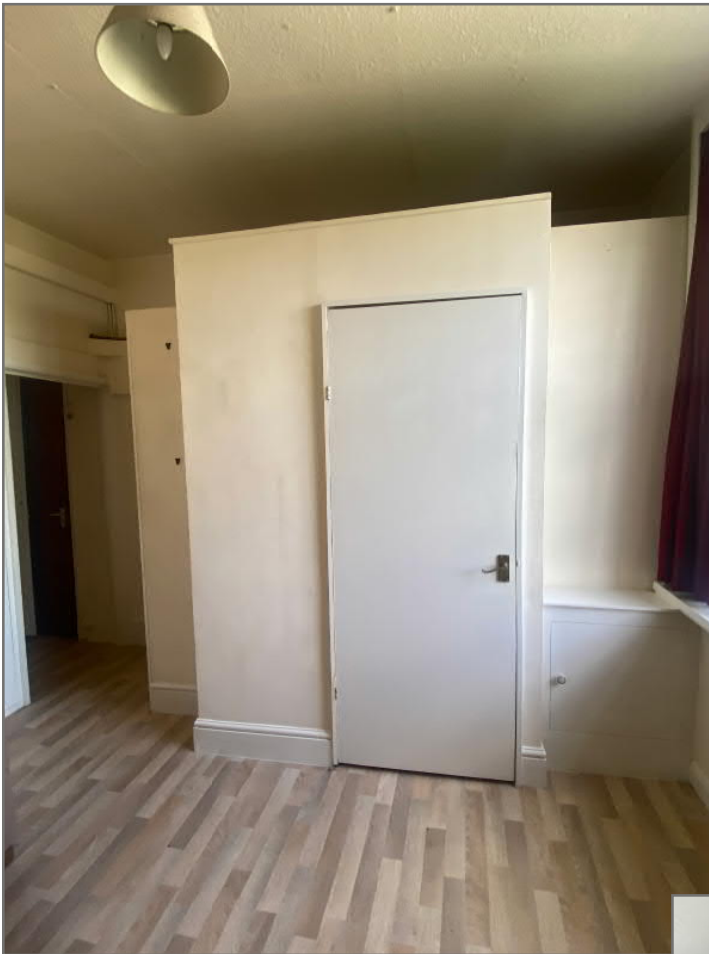
Image 30: Bathroom enclosure, Flat 5

Generally the rooms have high ceilings of 3.3m. There are very few retained features following the deep refurbishment to create the flats. The picture rail is a consistent feature to many of the spaces, however it is not evident in every main space; other joinery - skirting and doors - are modern. The floors below the floor finishes were not available for inspection. Three chimney breasts are evident, only one had a fireplace surround in-situ.

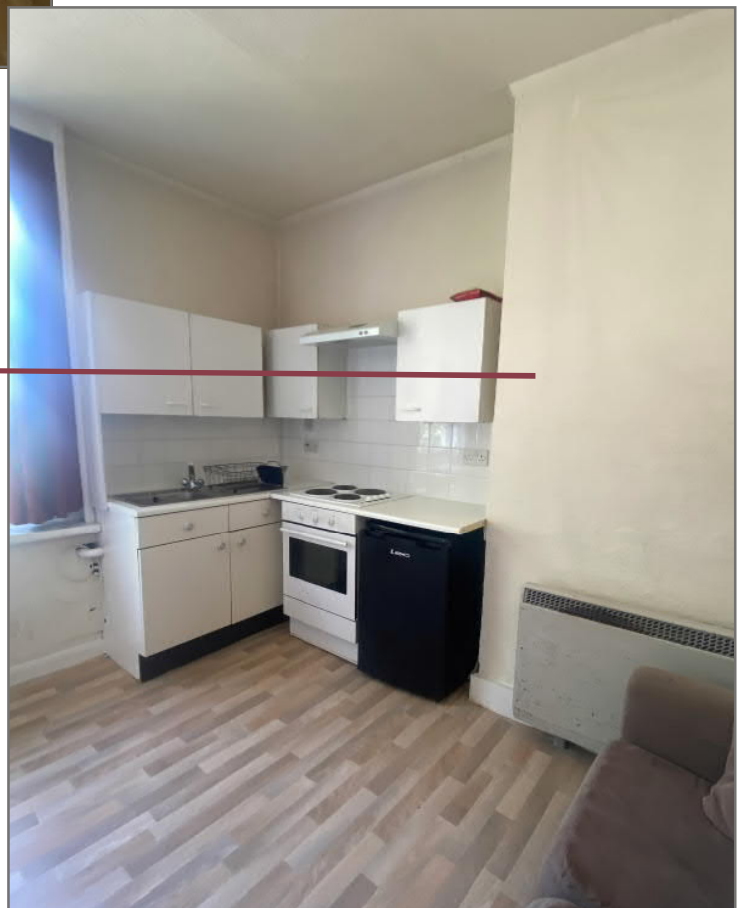
Chimney breast

Image 31: Kitchenette, Flat 5  
109 Castle Hill, Reading

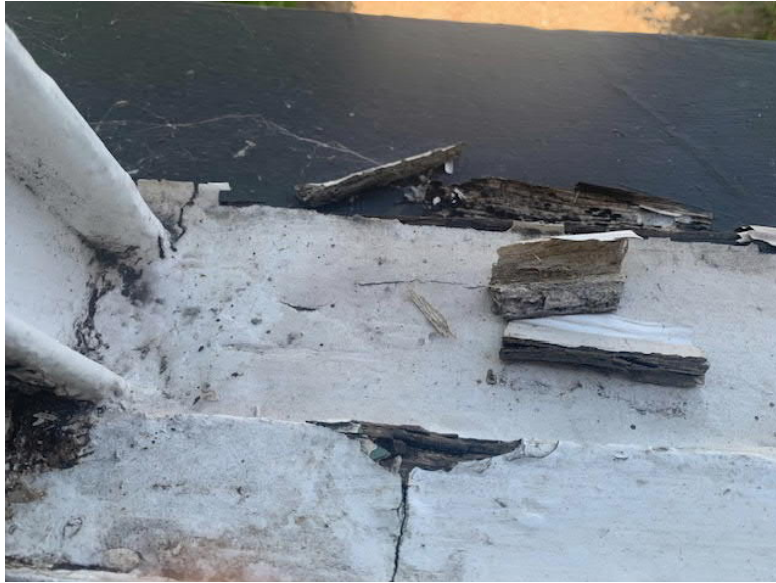
Image 34a: View of timber cill of central sash window - the paint has cracked open and water has become trapped beneath it causing the timber to rot

The central window to the front elevation has deteriorated from exposure to excessive moisture. This has become trapped beneath the modern paint and caused the timber beneath, to both the cill and the bottom rail, to rot - refer to Images 34a-c. It is proposed to replace the cill and bottom rail as they are both in a very poor state of repair and it is not considered appropriate to be able to scarf-in new timber owing to the excessive degree of timber removal necessary. The new timber would then be treated with linseed oil and linseed oil paint to provide a breathable paint finish to mitigate the likelihood of trapped moisture in the future. The repair is necessary to enable to arrest the declining condition of the window, and to enable the remaining portion of the original timber to be retained. The repair shall retain the design and operation of the original window. In the removal of original fabric it is therefore considered the impact upon the historic significance of the property is less than substantial harm at the lower end of the scale.

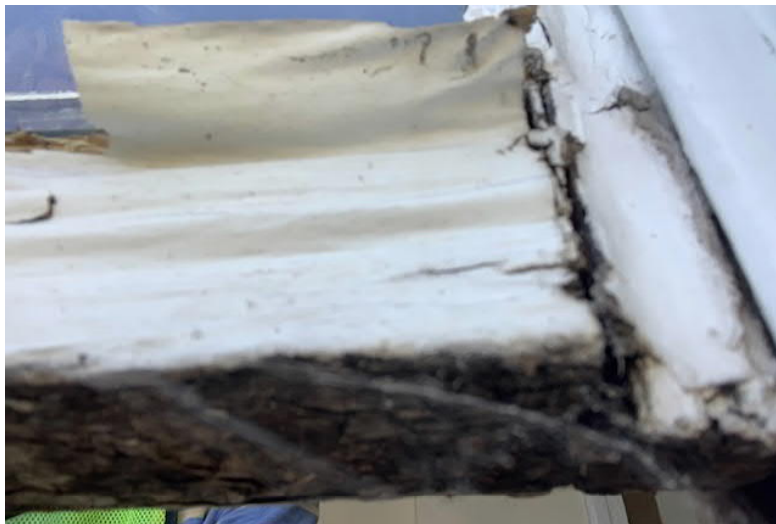
Image 34b: View of bottom rail of sliding sash of central sash window - the joint has opened and caused the timber to rot

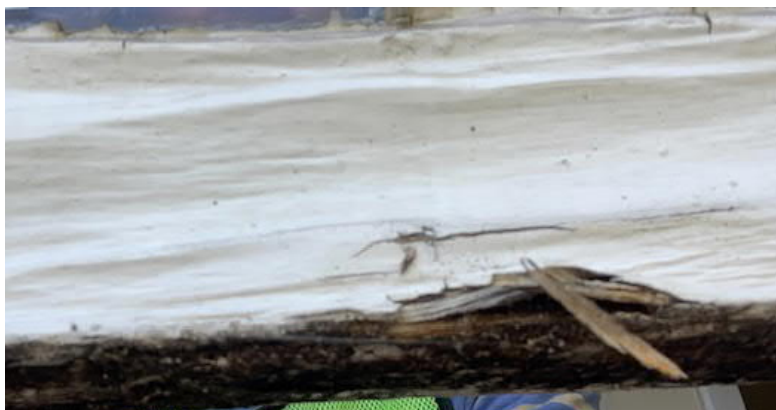
Image 34c: View of bottom rail of sliding sash of central sash window - the paint has failed and the timber below appears to be rotting

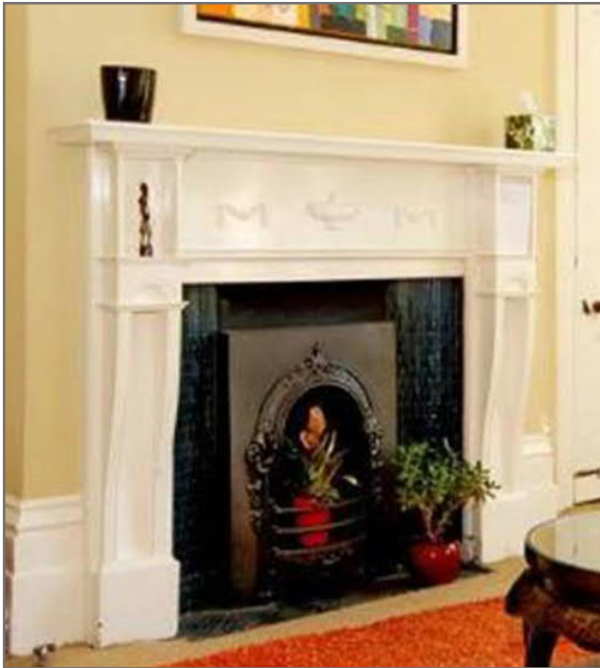
Image 35a: Ground Floor fireplace to rear reception room

- 2.6.2 As outlined, the remaining of the property was not available to view, however a previous letting brochure includes images of a Ground Floor and Semi-Basement fireplaces. It would be unusual to install such an elaborate fireplace to a Semi-Basement and it cannot be confirmed if these are original.

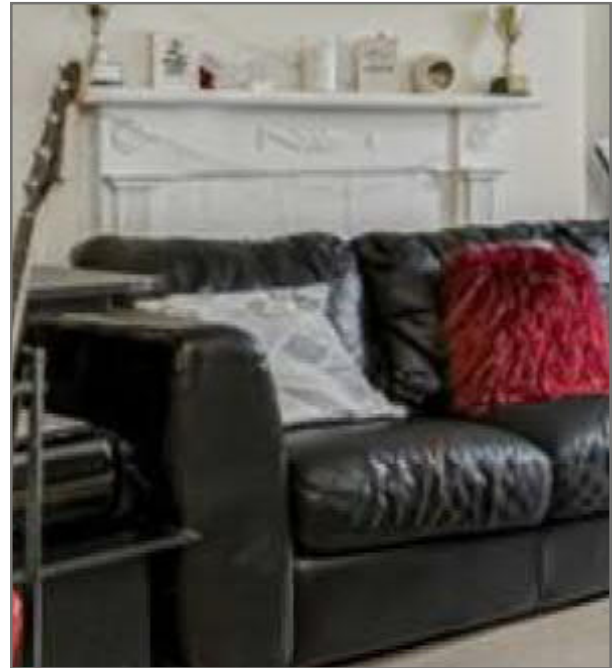
Image 35b: Semi-Basement Floor fireplace to rear reception room

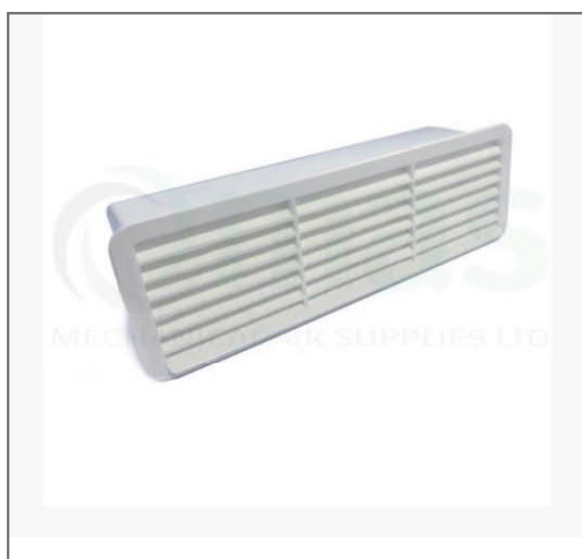
Image 40a: The proposed white ventilation grille for kitchen (rear elevation)

To meet the current building regulations for mechanical ventilation to high humidity spaces extraction ventilation is proposed within the dropped ceiling of the kitchen over the hobs, to be taken to the outside wall where a white vent is proposed to be inserted into the white painted brickwork. For the bathroom similarly the high humidity space requires mechanical ventilation to the outside and the ducted ventilation would be run within the dropped ceiling and out to the outside wall. Refer to Images 40a and b below for details of the proposed ventilation fittings, and the proposed locations on drawing 1345-HR-A-TP-0202.

The effective management of internal humidity from internal spaces is essential for the appropriate care of traditional building materials. The white painted metal grille proposed is a high quality product and would provide the means by which to manage the reduction in humidity to reduce the risk of damage to the original timber windows from accumulated condensation. This is considered on balance to cause less than substantial harm at the lower end of the scale upon the historic significance of the property with respect to the elevations.
