## Preliminary Ecological Appraisal and Roost Assessment

146 Southampton Street, Reading, RG1 2RD

This report is prepared to inform a planning application with the Reading Borough Council. The proposal is described as:

A single story rear extension, two story side extension, construction of an outbuilding and associated landscaping.

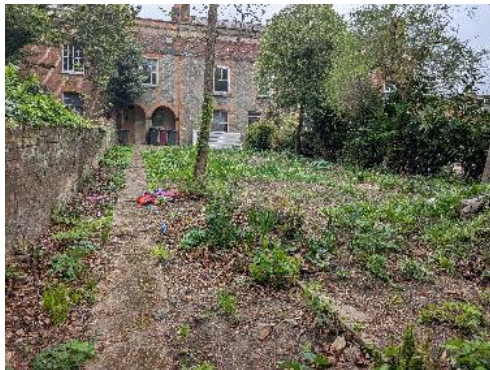
| | <b><i>to the height of the building the roof could not be seen in places. As 3 additional emergence are required, this is not considered to be a major limitation.</i></b> |
|---|---|
| Bat foraging and commuting habitat | <p>The scattered trees and hedgerow on site (Fig 1) provide suitable habitat for commuting and foraging bats. While more substantial habitat is present nearby, with woodland, a river and marshes to the southwest of site, the local connectivity is fragmented, with only scattered trees and disconnected hedgerow within surrounding residential gardens providing some low to moderate suitability for commuting and foraging bats. The overall sites suitability for foraging and commuting bats is moderate.</p> <p style="text-align: center;"><b>Fig 1</b></p> |

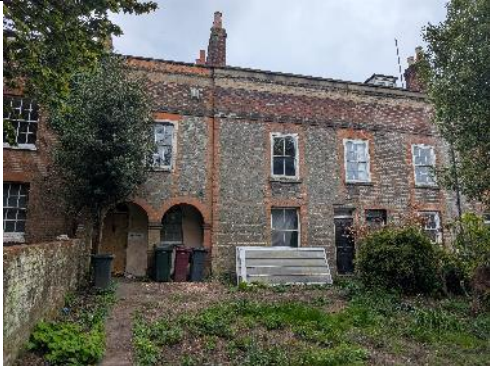
| | <b><i>to the height of the building the roof could not be seen in places. As 3 additional emergence are required, this is not considered to be a major limitation.</i></b> |
|---|---|
| B1 - overview | <p>B1 (Fig 2) is a terraced, gabled residential dwelling constructed of brick and mortar with a slate tile-clad roof. There are two, single-story extensions to the west of site with a pitched, slate tile clad roof. There are windows and doors on both the eastern and western elevations.</p> |

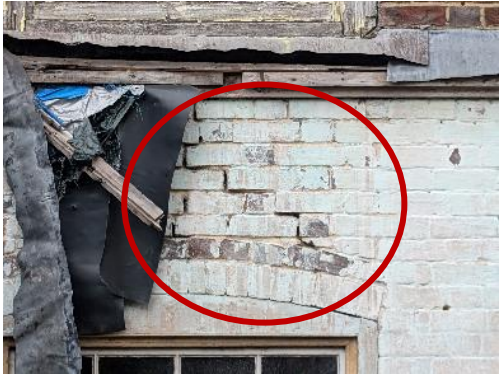
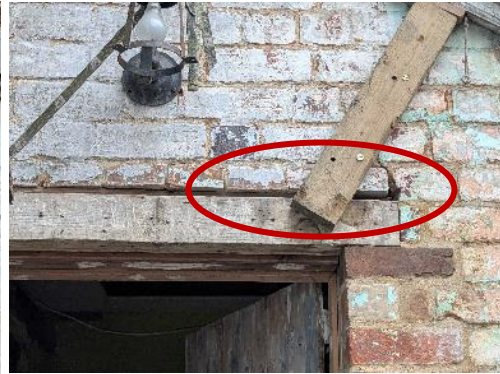
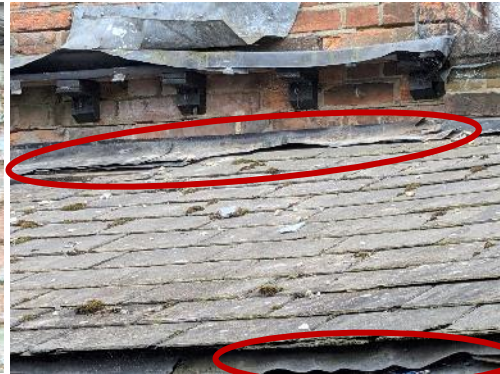
| B1 – exterior | <p>There are gaps in the mortar between bricks throughout (Fig 3), providing a suitable roosting feature for crevice dwelling bat species. There are gaps around window frames (Fig 4), providing a suitable roosting feature for crevice dwelling bat species. There is lifted lead flashing throughout the western elevation (Fig 5), providing a suitable roosting feature for crevice dwelling bat species.</p> <div style="display: flex; justify-content: space-around;"> </div> <p><b>Fig 3</b> <b>Fig 4</b> <b>Fig 5</b></p> <p>Roof tiles are lifted (Fig 6) and missing/slipped (Fig 7) throughout, providing a suitable roosting feature for crevice dwelling bat species and a potential point of access to the interior for void dwelling bat species. Some areas of the roof are heavily damaged and/or have been removed (Fig 8), providing a potential point of access to the interior for void dwelling bat species.</p> |

| B1 – suitability assessment | <p>B1 has been assessed as having <b>high habitat value</b> for roosting bats. There are a number of suitable roosting features externally for crevice dwelling bat species including missing mortar, gaps around door and window frames, lifted lead flashing, lifted and missing roof tiles and gaps at the eaves. Internal access was noted at the ridge, beneath roof tiles and in areas of damaged wall, with additional features internally for both crevice and void dwelling bat species including missing mortar, access to the chimney and access to the cavity wall and roof. While the local foraging and commuting value is not optimal, the nearby river could provide a suitable commuting route to and from site, connecting to other suitable habitat nearby. The buildings is therefore assessed as having high habitat value.</p> |

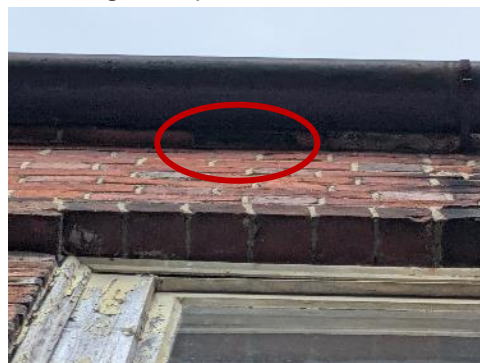
**Fig 9**

There is a gap at the eaves on the western elevation (Fig 9), and the southwestern extension (Fig 10), providing a suitable roosting feature for crevice dwelling bat species and a potential point of access to the interior for void dwelling bat species.

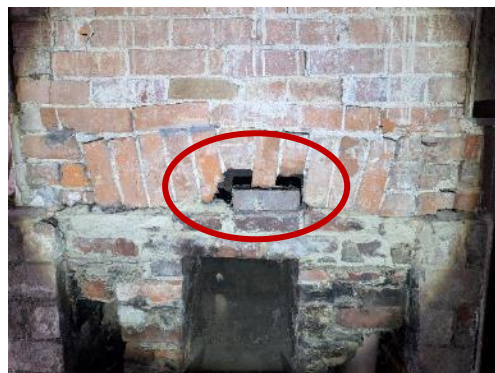
**Fig 14**

There are bricks missing around the chimney (Fig 14), providing a suitable roosting location for void dwelling bat species. There is also missing mortar between exposed bricks internally (Fig 15), providing a suitable roosting feature for crevice dwelling bat species. The walls are heavily damaged in places (Fig 16), providing access to the cavity wall which is a suitable roosting feature for both crevice and void dwelling bat species.

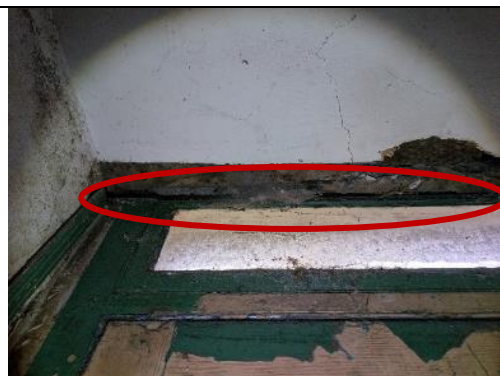
**Fig 17**

There are gaps around the doors internally (Fig 17), providing a suitable roosting feature for crevice dwelling bat species. A small void was visible but inaccessible from the ground floor (Fig 18) with a hole in the site, which could provide a suitable roosting feature for void dwelling bat species. Light ingress could be seen through the wall within the southwestern extension (Fig 19), providing a potential point of access to the interior.

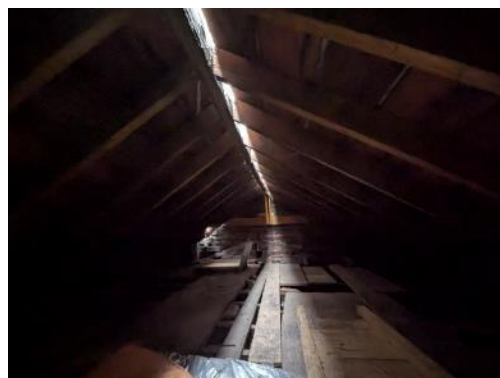
**Fig 20**

A separate loft void is present within B1 (Fig 20), though the hatches are left open and the roof of the floor below is heavily damaged (Fig 21) providing free access between the void and the rest of the house interior. The loft is fully boarded and is lined with timber. There are gaps between the timber beams (Fig 22) exposing the slate tiles below. This provides a suitable roosting feature for crevice dwelling bat species and a potential point of access to the loft void.

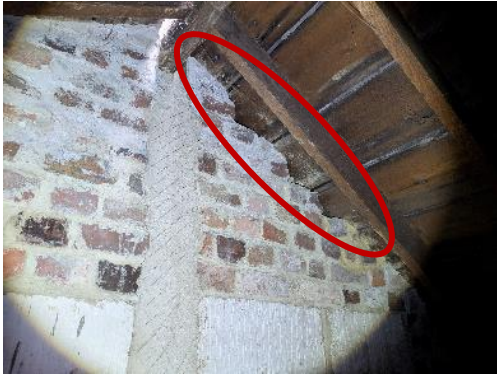
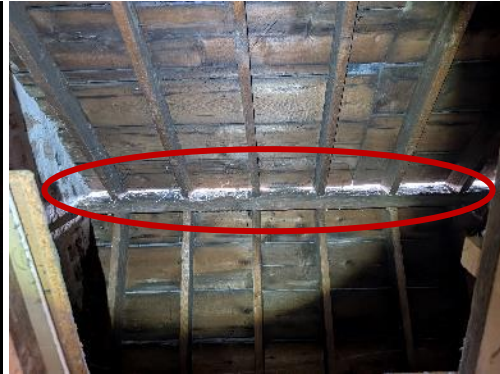
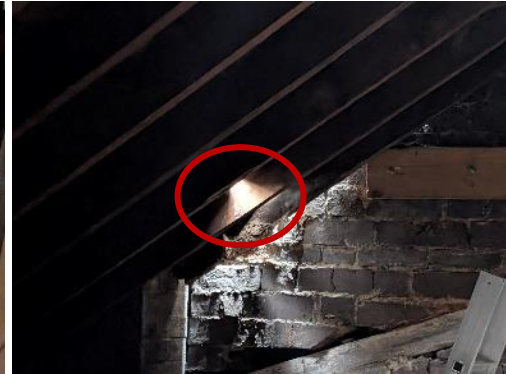
There are large gaps above the brick and mortar at the southern gable end (Fig 23), providing a suitable roosting feature for crevice dwelling bat species and a potential point of access to the loft void. Light ingress could be seen

| | <p>throughout the full length of the ridge (Fig 24) and from roof tiles at the northern end (Fig 25), providing a potential point of access to the interior.</p> <div style="display: flex; justify-content: space-around; align-items: center;"> </div> <div style="display: flex; justify-content: space-around; align-items: center;"> <p><b>Fig 23</b></p> <p><b>Fig 24</b></p> <p><b>Fig 25</b></p> </div> <p>High levels of light within the loft void resulting in this area being unsuitable for void dwelling bat species, however, access points within the loft void provide access to the rest of the house where other suitable roosting features are present.</p> <p>No bats or evidence of bats was identified in the interior of B1, however, due to some areas being inaccessible for health and safety reasons and others having high levels of debris from construction and damaged sections of the wall and roof, evidence may have been missed.</p> |

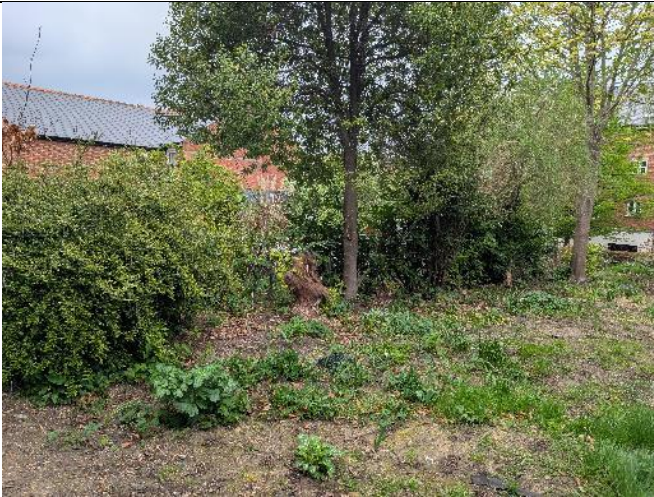
Picture 1: Hedgerow to the northeast of site.

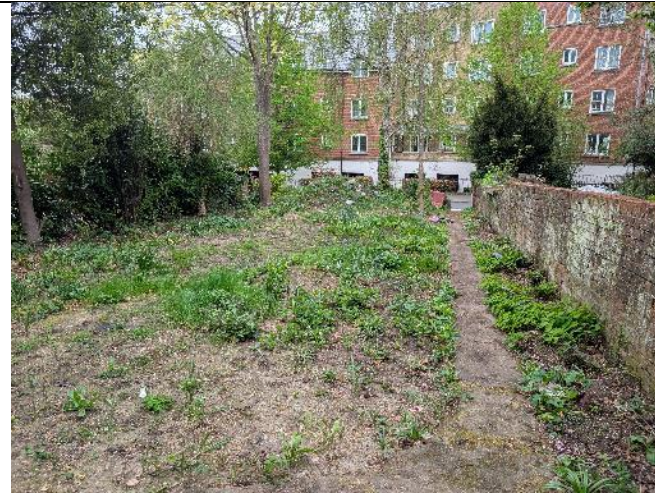
Picture 2: Vegetated garden, bare ground, scattered trees and hard standing to the east of site.

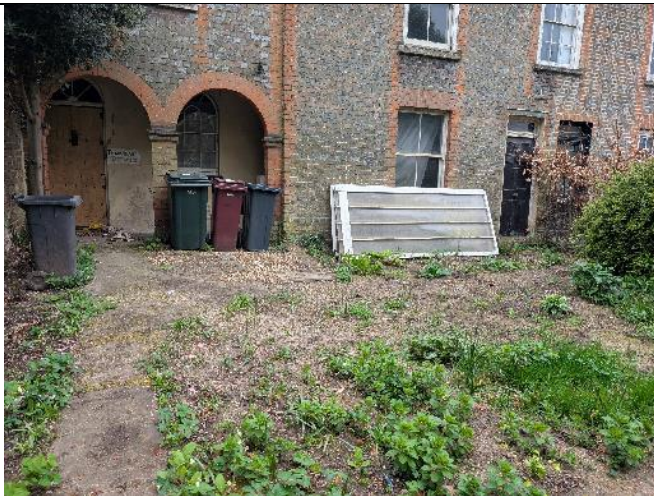
Picture 3: Vegetated garden and shingle to the east of B1.

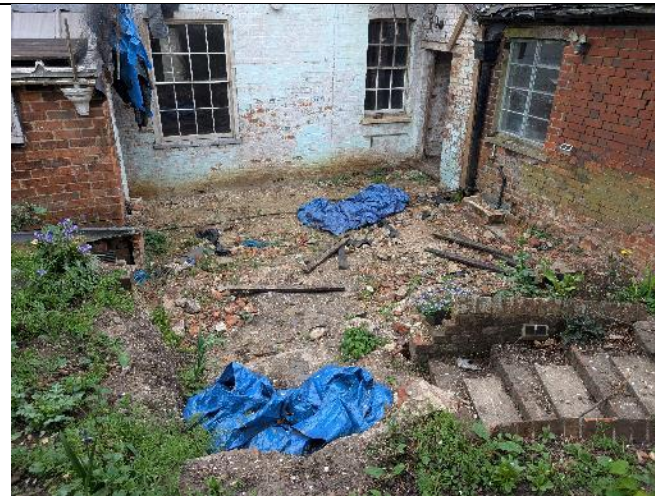
Picture 4: Partially removed hardstanding to the west of B1

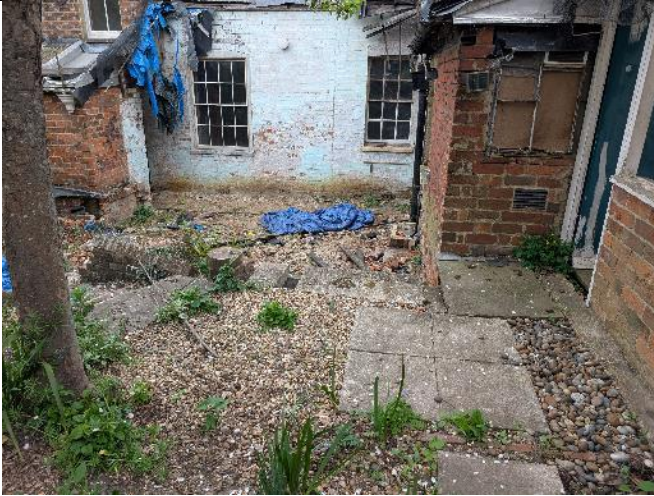
Picture 5: Shingle, hard standing and scattered trees to the west of B1

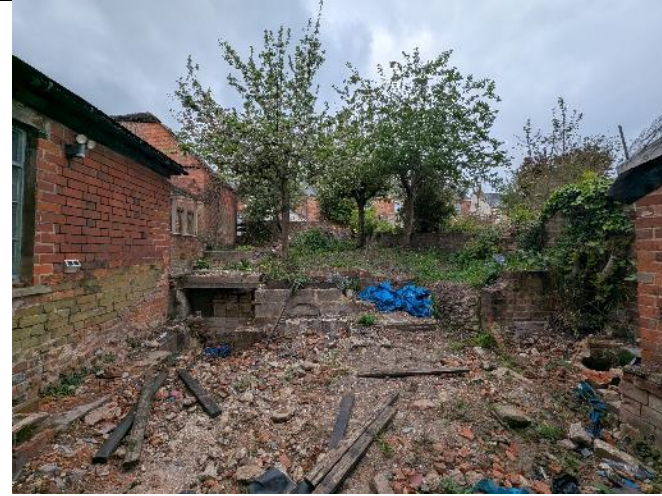
Picture 6: Developed land, bare ground with ruderal and scattered trees to the west of site

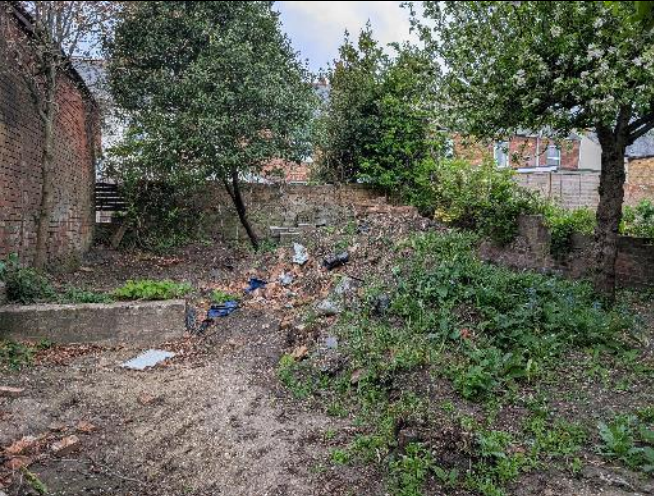
Picture 7: Bare ground, scattered trees and rubble pile to the west of site

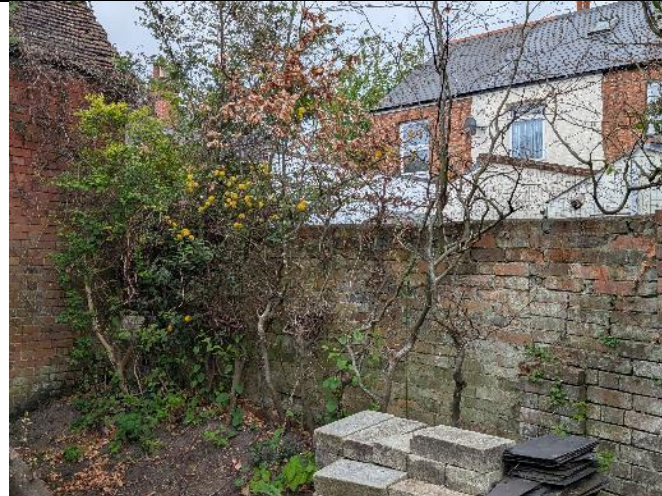
Picture 8: Defunct hedgerow to the west of site.
